Tsunami damage to coastal defences and buildings in the March 11th 2011 M_w 9.0 Great East Japan earthquake and tsunami

Stuart Fraser · Alison Raby · Antonios Pomonis ·
Katsuichiro Goda · Siau Chen Chian ·
Joshua Macabuag · Mark Offord · Keiko Saito ·
Peter Sammonds

Received: 8 September 2011 / Accepted: 8 March 2012
© Springer Science+Business Media B.V. 2012

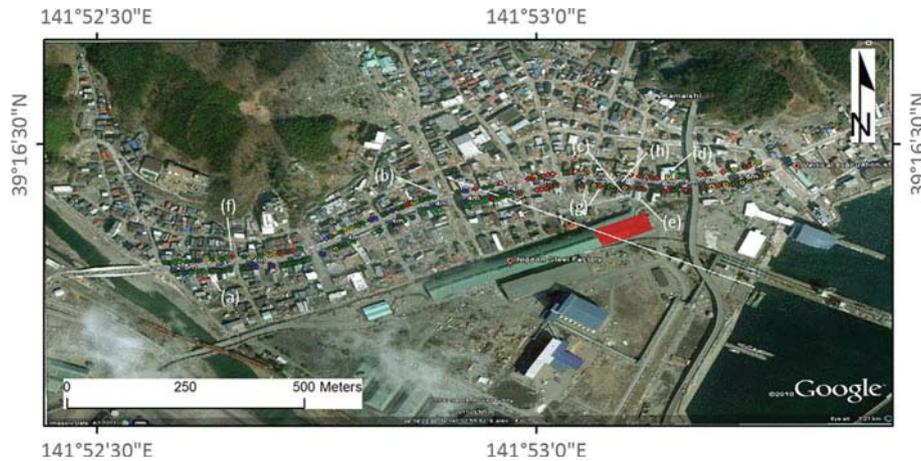
Observed failure modes included (i) out-of-plane failure of infill walls and panel walls in all construction types but particularly steel frame structures; (ii) debris impact damage (from minor damage of exterior cladding to major damage of non-structural components of steel frames); (iii) extensive glazing damage at ground-floor level, some damage to 1st and 2nd storey glazing; and (iv) soft-storey failure of several timber structures (Fig. 5).

Fig. 3 Damage survey in Kamaishi City with individual buildings plotted to show construction and damage level. Construction type is indicated by shape, EEFIT tsunami damage level by colour: *Diamonds* denote timber frame; *squares* denote RC; *circles* denote steel frame. *Blue* denotes D0, *green* denotes D1, *yellow* denotes D2, *orange* denotes D3, *red* denotes D4. Inundation depths, the collapsed section of Nippon Steel Factory building (red polygon), and vertical evacuation building are also shown. *White letters* show the position of buildings shown in Fig. 4

half of the surveyed timber frame buildings experienced damage level D4 (partial or complete collapse) and where they survived with less damage it was due to significant sheltering by other more resistant structures.

No steel frame or RC structures suffered partial or complete collapse in the survey area, and a limited number suffered heavy damage (D3): 15 % and 4 % respectively. Most steel frame (77 %) and RC (83 %) buildings suffered heavy non-structural damage but the structural frames or walls were often only lightly damaged (D1–D2). At the eastern end of the survey area most timber buildings suffered complete collapse and several had been washed away or cleared away, while steel frame buildings suffered damage level D1–D3, and RC buildings D1–D2. The survey indicates a general reduction in damage with distance from the port and increase in ground elevation towards the west, although variable levels of local sheltering were also observed due to the dense nature of development. There is some indication of sheltering provided by the large trussed steel portal frame building (red polygon in Fig. 3), the eastern-most (structurally isolated) end of which suffered partial collapse. At the western end of the survey transect (inundation depths of 2.5 to 3 m, adjacent to the river) timber frame structures generally sustained damage D1–D2, while one building at an exposed street corner sustained damage of D3. Evidence suggests that flow velocity was low at this end of the transect; plastic shop signs and some glazing remained undamaged despite being submerged.

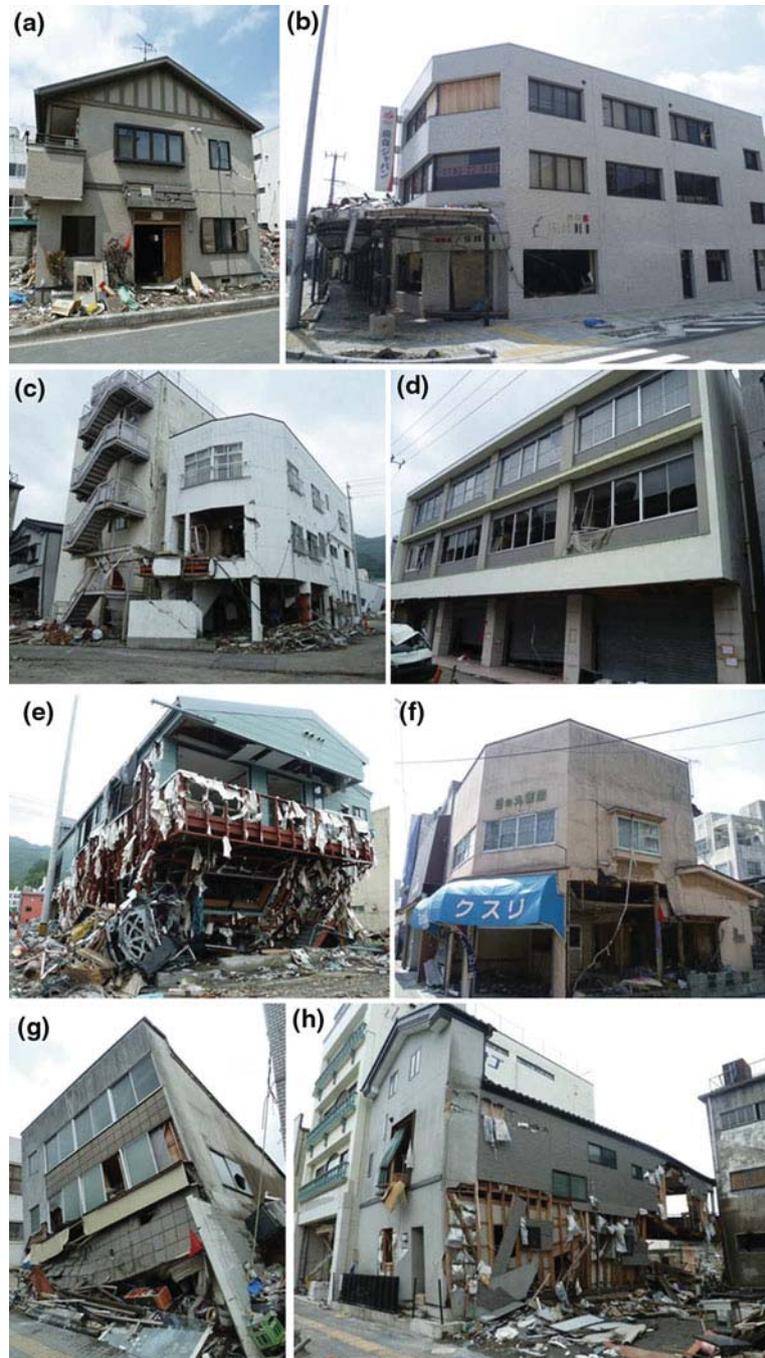
Fig. 4 Photographs of structures surveyed in Kamaishi City, providing examples of the EEFIT tsunami damage scale applied for different structure types: **a** Timber frame structure, observed damage level D1; **b** Steel frame, D1; **c** Steel frame, D2; **d** RC shear wall, D2; **e** Steel frame, D3; **f** Timber frame, D3; **g** Timber frame, D4; **h** Timber frame, D4. The position of each photograph is indicated on Fig. 3 by the photograph letter

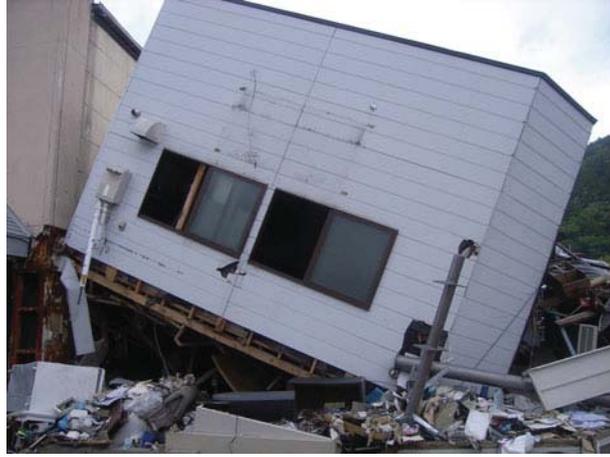
Regarding the observed soft-storey failure, short period component ground motions recorded at K-NET station IWT007, 1.5 km west of Kamaishi port, were of sufficiently magnitude and duration to cause deformation in these structures, indicating that the soft-storey failure of some 2-storey timber frame buildings could be due to ground shaking. However, in areas that were not inundated, timber buildings performed well with respect to ground shaking. This suggests that, in this case, this style of failure may be due to tsunami loading rather than ground shaking, despite the apparent sheltering of these timber buildings. Over

Fig. 5 Soft storey collapse of a timber structure observed in Kamaishi City. The 2nd storey appears to have remained intact due to central steel beam supporting the second storey

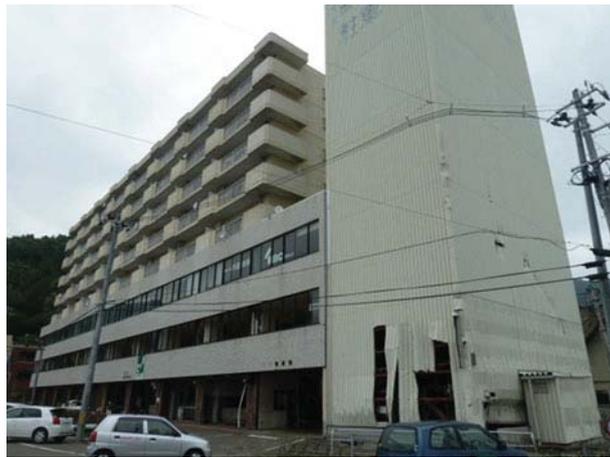
Fig. 6 Eight storey un-braced RC shear wall apartment block and designated evacuation building in Kamaishi City. A steel frame structure is located on the seaward face and sustained minor damage from debris impact. Two external staircases to the 4th floor exist on the other side of the building. This building was inundated to the 3rd storey

RC infill panels which were severely damaged. The building was inundated to the 3rd storey, but adequate elevation and absence of structural damage meant that occupants were able to evacuate to the designated evacuation area on the 4th storey and above.

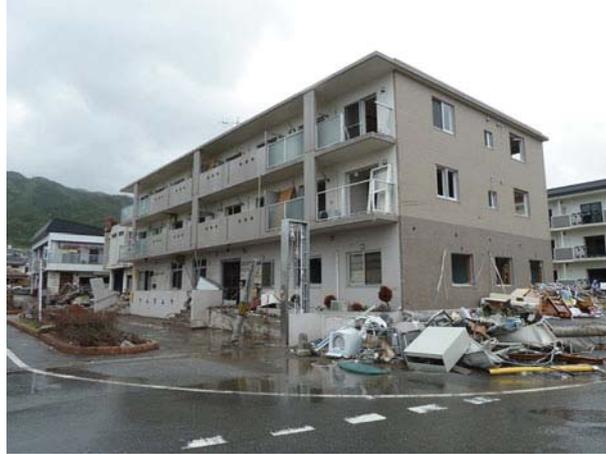
Fig. 7 Apartment building of RC shear wall construction in Ōfunato City. Seaward side of the building is shown. Inundation reached the ceiling of the 3rd floor, but the structure remained intact. This landward side of the building was sheltered from debris impact during the tsunami return flow

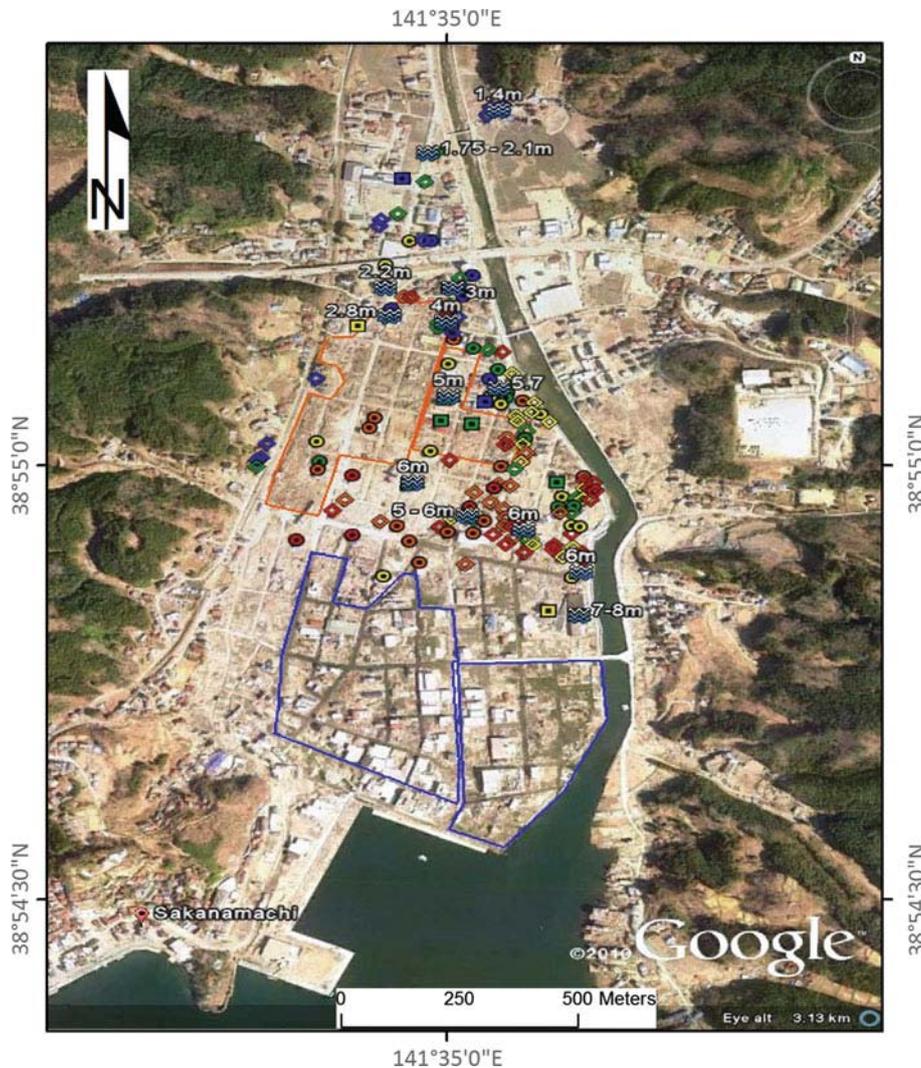
An extensive area of damage was surveyed in the northern part of Kesenuma City from 450 m inland to 1.1 km inland (Fig. 8). Flooding associated with 0.74 m of co-seismic subsidence (Geo-Spatial Information Authority of Japan 2011c) prevented closer access to the shoreline. Timber frame structures suffered heavy damage to collapse (90 % sustained damage level D4), 60 % of steel frame structures registered moderate to heavy damage (D2–D3), and 78 % of the surveyed RC structures sustained light damage (D1). A large number of timber frame buildings had been washed away or destroyed by fire and the building footprints were not visible during the survey. Field observations have therefore been augmented with building footprint data to estimate the total original number of buildings. Steel frame and RC buildings remain standing in areas most affected by fire, therefore all buildings identified from the GSI building footprints with no corresponding surveyed building are assumed to be timber frame, damage level D4 (collapse).

Highly variable damage was induced by flows of similar depths in this survey area. Although many timber frame structures are in a state of partial or complete collapse, there were a significant number which remained standing (with damage level D1–D3) in flows of 5–7 m depth, which is inconsistent with the 2 m wash-away threshold for Japanese timber houses observed in the 1960 Chilean tsunami (Sasaki 1960, in Shuto 1993). A comprehensive report into building damage from all affected areas by the Japanese Ministry of Land Infrastructure Transport and Tourism (2011) (MLIT) shows a clear threshold for heavy damage or collapse to buildings at around 2.0 m: at 1.0–1.5 m inundation height, only 9 % of buildings were washed away or rendered unrepairable, while this increases to 31 % at 1.5–2.0 m. At 2.0–2.5 m 66 % of buildings were washed away or not repairable. The inconsistency between this and the EEFIT survey highlights the importance of local effects on influencing damage levels to individual buildings.

Fig. 8 Damage survey in Kesennuma City with individual buildings plotted to show construction and damage level. *Diamonds* denote timber frame construction, *squares* denote RC, *circles* denote steel frame. Damage level is indicated by colour—*Blue* D0, *green* D1, *yellow* D2, *orange* D3, *red* D4. Inundation depths, heavily fire damaged areas (*orange* outline) and subsided area (*blue* outline) are also shown. The subsided area was flooded at the time of survey. Inset shows survey location in the context of Kesennuma Bay

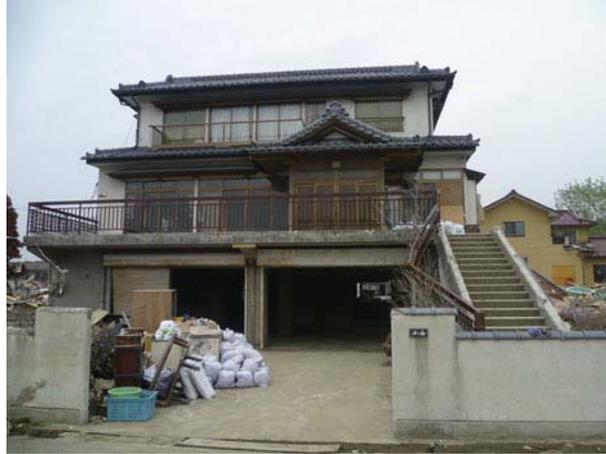
A number of timber frame dwellings constructed with an RC ground-floor structure (Fig. 9), or on artificially raised land were present in the surveyed area. The impact of raising residential timber frame buildings was generally positive, with the majority sustaining light to moderate damage depending on tsunami inundation depth or debris impact, as opposed to suffering heavy damage or collapse when built on concrete ring foundations just above ground level.

Fig. 9 An example of a timber frame dwelling constructed with an RC ground floor structure. The main house is 3 m above ground level, 780 m inland and 60 m from the river. Despite inundation depth of approximately 6 m in this area, the house had sustained very little non-structural damage

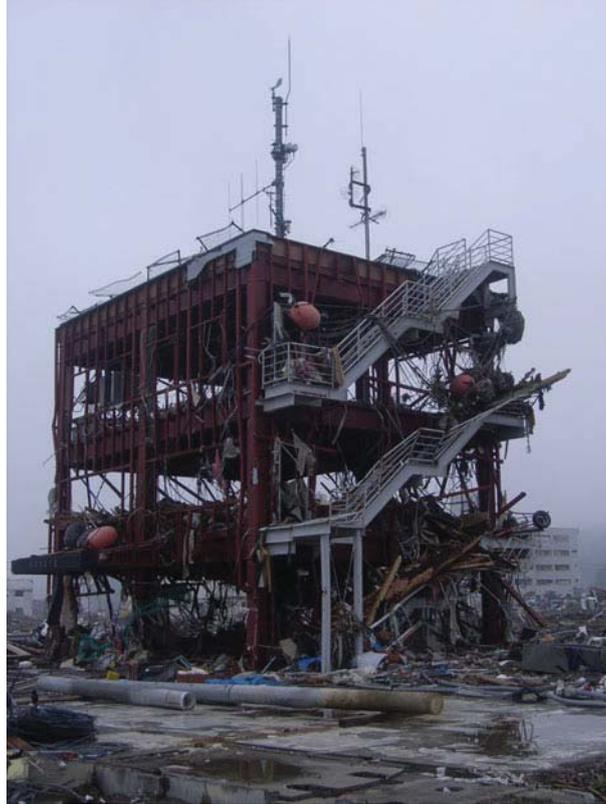
Steel frame buildings sustained heavy damage and EEFIT observed collapse of several 2- to 3-storey RC buildings from debris impact and significant scour. The 3-storey steel frame Crisis Management Department (CMD) building (38°40' 40.06" N, 141° 26' 46.82" E; 470 m from the harbour front) remained standing with heavy damage after being inundated to its roof at 10 m above ground level (Fig. 11).

Fig. 11 The 3-storey steel frame Crisis Management Department (CMD) building, located 470 m from the harbour front. This building was inundated to the roof (at 10 m elevation above ground level) and sustained loss of all cladding although the structure remains standing. Damage to this building and the deaths of CMD staff resulted in the loss of crisis management facilities and expertise in the immediate aftermath of the tsunami

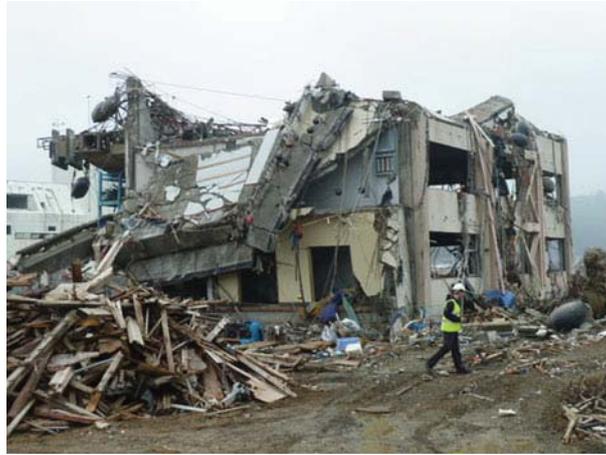
Fig. 12 RC building in Shiomi-cho, Minami-Sanriku, 100 m from the sea ($38^{\circ} 40' 29.10''$ N, $141^{\circ} 26' 44.96''$ E) showing collapse of upper storeys. Several other RC buildings in the immediate vicinity of this building had suffered collapse with evidence of severe scour and debris impact

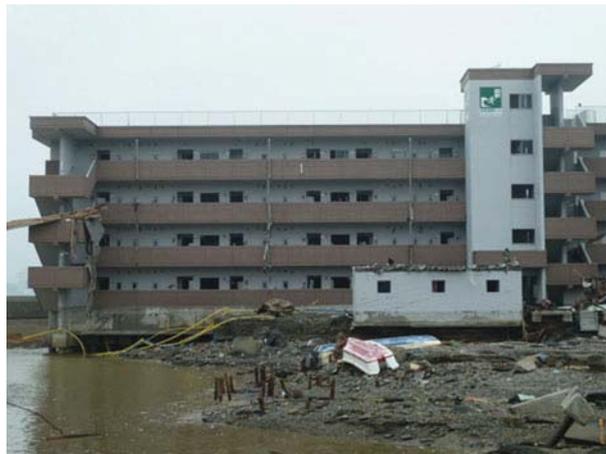
Fig. 13 The Matsubara apartment block and designated vertical evacuation building in Minami-Sanriku. This photograph shows the landward side of the building with scour of at least 2 m at its northern end (a similar amount of scour was also observed at the southern end). Observations of this side of the building show little structural damage despite 16 m inundation height

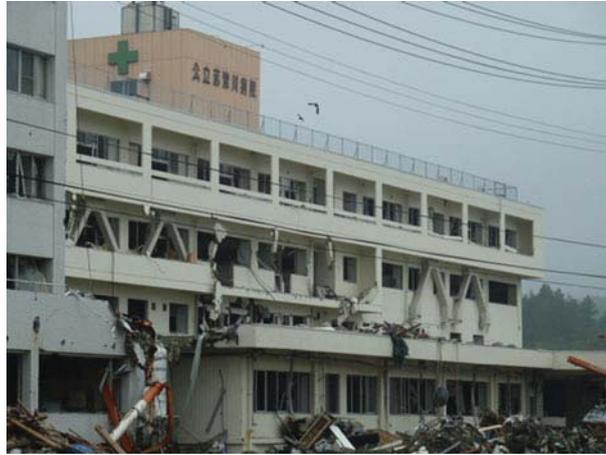
Fig. 14 Shizugawa Hospital, Minami-Sanriku, which was inundated to 11 m depth but was used in evacuation to the roof. This photograph shows the landward side of the building with evidence of damage to the balcony at the 4th storey

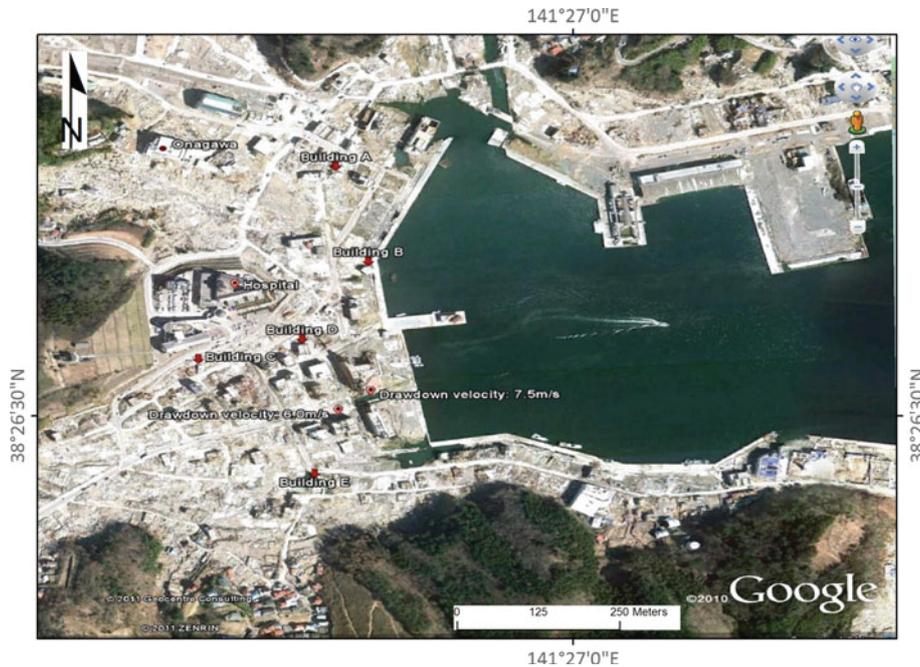
Fig. 16 Satellite image of the harbour in Onagawa Town, indicating the (i) final locations of overturned RC and steel frame buildings (*blue points*, marked with building tag A–E) as observed by EEFIT; (ii) the track of building movement from the original position indicated by *arrows* (Tokimatsu et al. 2011); and (iii) positions of two velocity estimations made for return flow velocity using video footage

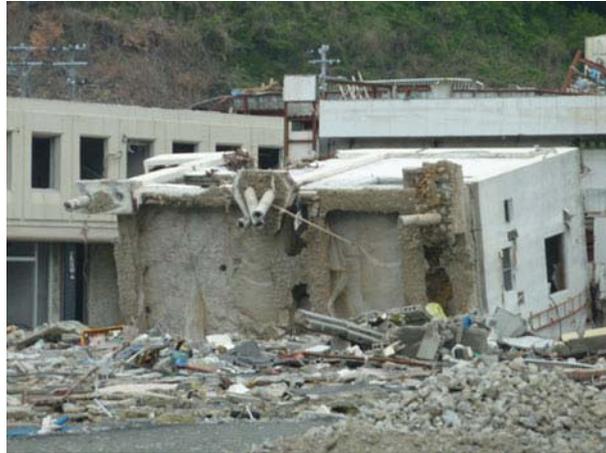
A 2-storey RC shear wall office building with piled foundations was overturned landward during tsunami inflow ('Building A'; Fig. 17). The structure had one pile at each corner, and three closely spaced piles at each of the central pile caps. The rebar in each pile did not extend very far down the pile and they appeared quite lightly reinforced at the top, suggesting they were designed only for shear, rather than also for tension. The uppermost (originally seaward) piles remained connected to the pile cap and were relatively straight, suggesting that they had been pulled out of the ground and then failed in tension. In contrast, the bottom (originally landward) piles were sheared off closer to the foundation and were all bent downwards; this suggests the lateral forces imparted by tsunami flow were concentrated on the landward piles, which became the pivot point in the overturning motion. Overturning in this case may have been initiated by debris strike, evidence of which was observed at the top of the structure.

Fig. 17 Foundations of an overturned two-storey RC shear wall structure with piled foundations in Onagawa Town—'Building A'. Evidence of impact at the roof of the building on its seaward side indicates that this failure may have been initiated by debris strike

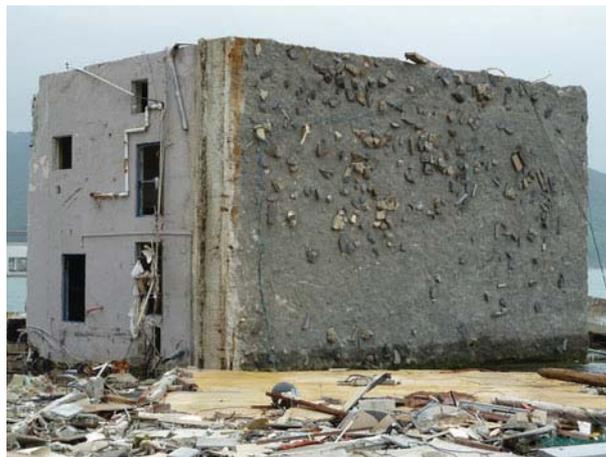
Fig. 18 An overturned two-storey RC shear wall structure with raft foundations at the harbour edge in Onagawa Town—'Building B'

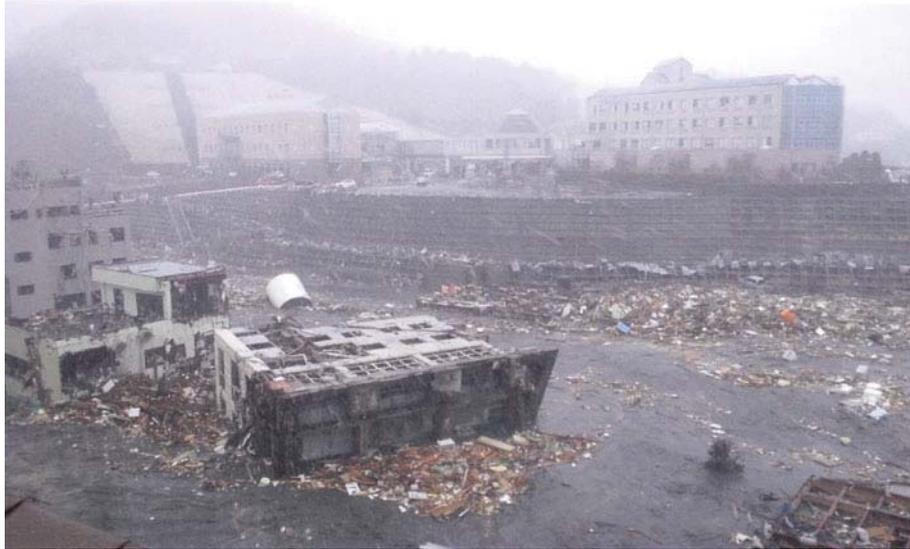
Fig. 19 An overturned 3-storey steel frame building ('Building D') on piled RC foundation with evidence of debris impact on the (originally) seaward face of the building. This photograph was taken from a neighbouring building during tsunami inundation, courtesy of Miyagi Prefectural Office

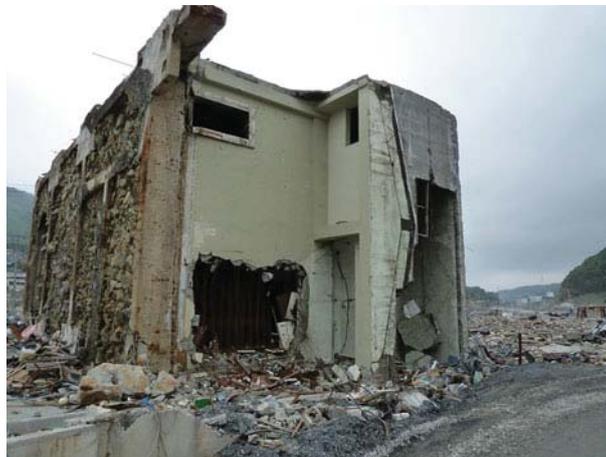
A 3-storey RC shear wall structure ('Building E'; Fig. 20) had shallow pad footing with ground beams of small dimensions, with one of the corner pads effectively acting as a pile cap rather than pad footing, possibly due to locally weak soil. No piles remained connected to the pile caps in this case, suggesting a higher level of shear in the overturning motion than experienced at the other piled buildings.

Fig. 20 A 2-storey RC shear wall structure with shallow pad footing foundation ('Building E'). Evidence of small piles on at least one of the corner columns can be seen, but no piles remained attached at the time of our visit. The building has also sustained out-of-plane failure of an infill wall at the ground floor

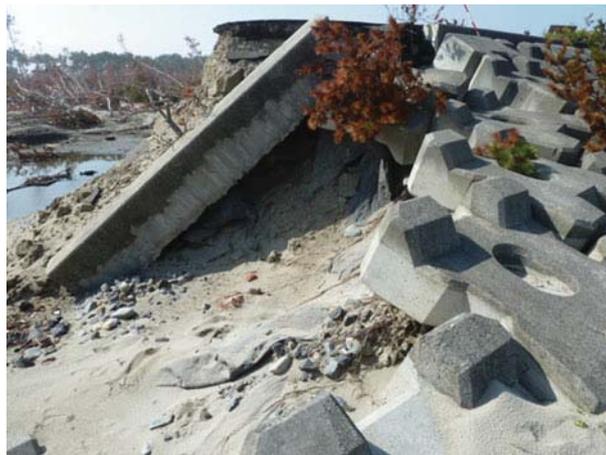
The concrete defences at Arahama Beach had failed in several places and the sand infill had been washed out (Fig. 21), while concrete blocks had been removed and washed up to 100 m landward into the coastal pine forest. Many residential properties of timber frame construction suffered complete collapse or had been demolished by the time of our investigation. Significant scour of the sandy soil (old beach deposits) on the seaward side of buildings had caused tilting and exposure of foundations in some buildings. Out-of-plane failure of infill

Fig. 21 Failure of a concrete block revetment at Arahama Beach. Sand fill had been washed out of the revetment, causing collapse of the concrete blocks and pathway along the crest of the defence

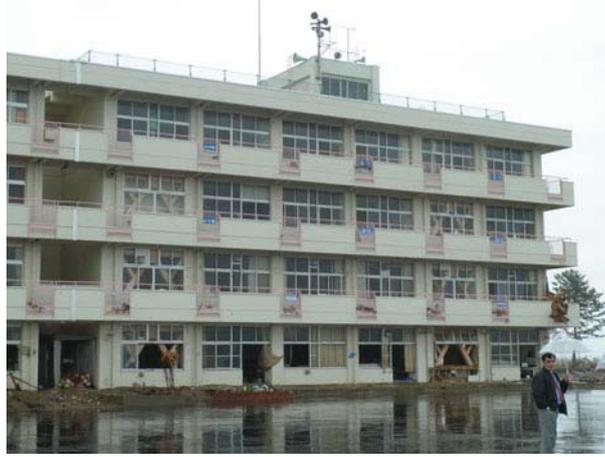
Fig. 22 The south side of Arahama Elementary School, which was successfully used for vertical evacuation. Timber-clad steel bracing is visible in windows of the lower floors. Damage to non-structural components at the ground floor is shown, along with debris at the seaward end of the building on the second floor. The roof shows evacuation infrastructure including warning sirens and fencing around an evacuation area. There is external access to the roof on the north side of this building

Arahama Elementary School ($38^{\circ} 13' 20.52''$ N, $140^{\circ} 58' 49.88''$ E; Fig. 22), performed its secondary function as a vertical evacuation refuge well during this event. The 4-storey pre-2001 RC structure comprised shear walls on the narrow external seaward and landward faces. The building had been previously retrofitted with steel bracing members to strengthen its central section. The bracing was situated only on one side of the central shear walls and only at the lower 3 storeys. The lowest 2 storeys of the building were flooded up to ceiling level. The building had rooftop railings, direct external roof access via a large brightly painted steel staircase to the rear and two sets of rooftop sirens. No vertical evacuation signage was clearly displayed on the building. Debris had entered the building in the longitudinal (perpendicular to the shoreline) direction, with timber and 3 cars inside the central ground-floor corridor indicating significant flow velocity through the central corridor that ran the length of the building. All other observed damage was non-structural: glazing and contents, and

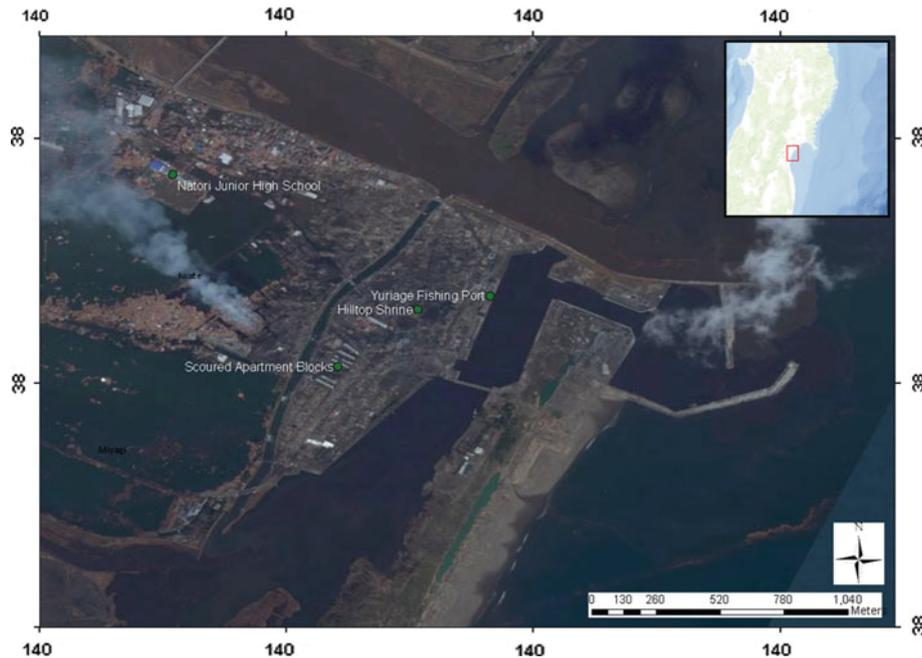
Fig. 23 Post-tsunami aerial photograph of Yuriage District, Natori City, showing almost complete destruction of this residential area, although the part of Yuriage adjacent to the river embankment (northern edge of this image) sustained less damage

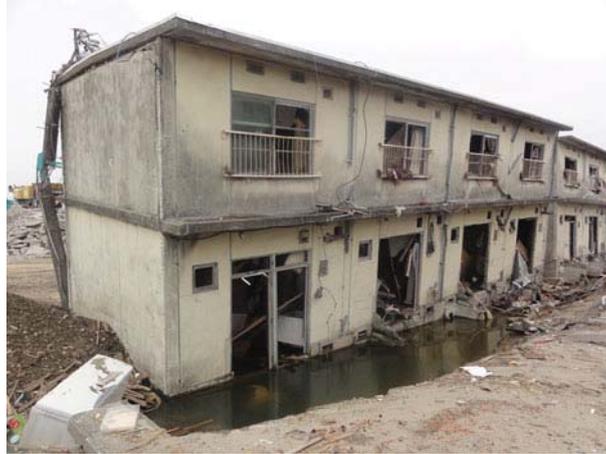
Fig. 24 View along the north side of one apartment block in Yuriage, illustrating scour at the seaward end of one apartment building. Loss of soil providing bearing capacity to support the footings resulted in tilting of this building

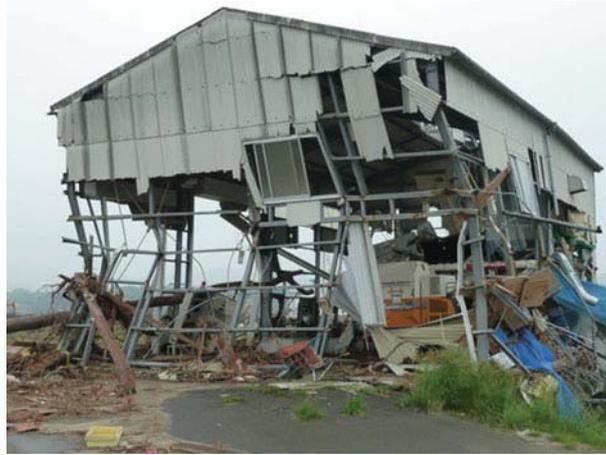
Fig. 25 A steel frame agricultural building located 1 km inland at Yamamoto Town, Miyagi Prefecture. A tree trunk, apparently from the damaged coastal pine forest, struck a structural column on the south-east (seaward) corner of the building, buckling the structural and non-structural members. Tsunami flow has removed cladding to a height of over 4 m
