**GRAPPLING WITH COMPLEXITY:
FINDING THE CORE PROBLEMS BEHIND
AIRCRAFT ACCIDENTS**

A thesis presented in partial fulfilment of the requirements for the degree of
Doctor of Philosophy in Aviation

Dmitri Victorovitch Zotov

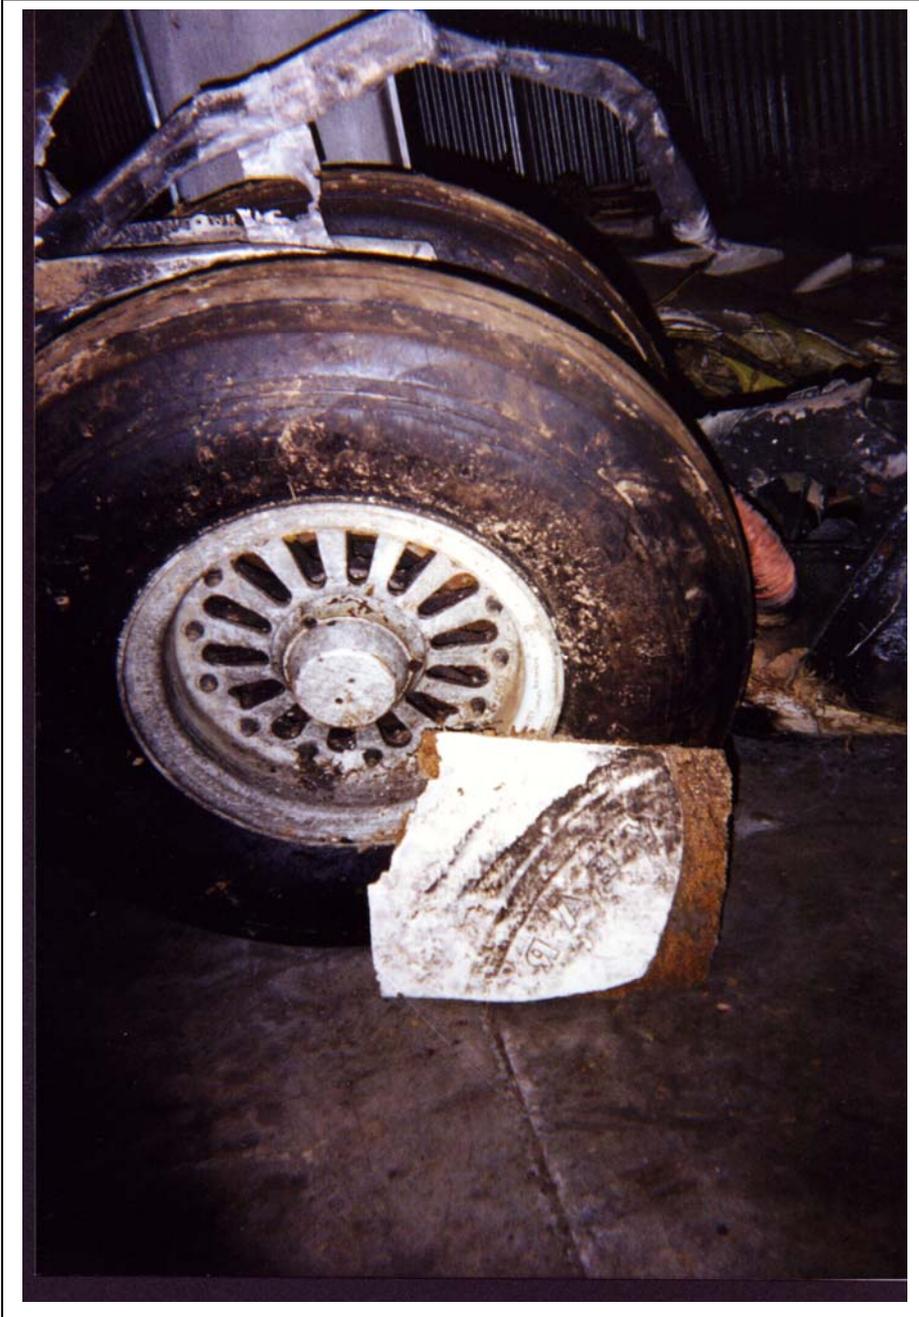
Figure 38. Witness mark on right hand undercarriage door.

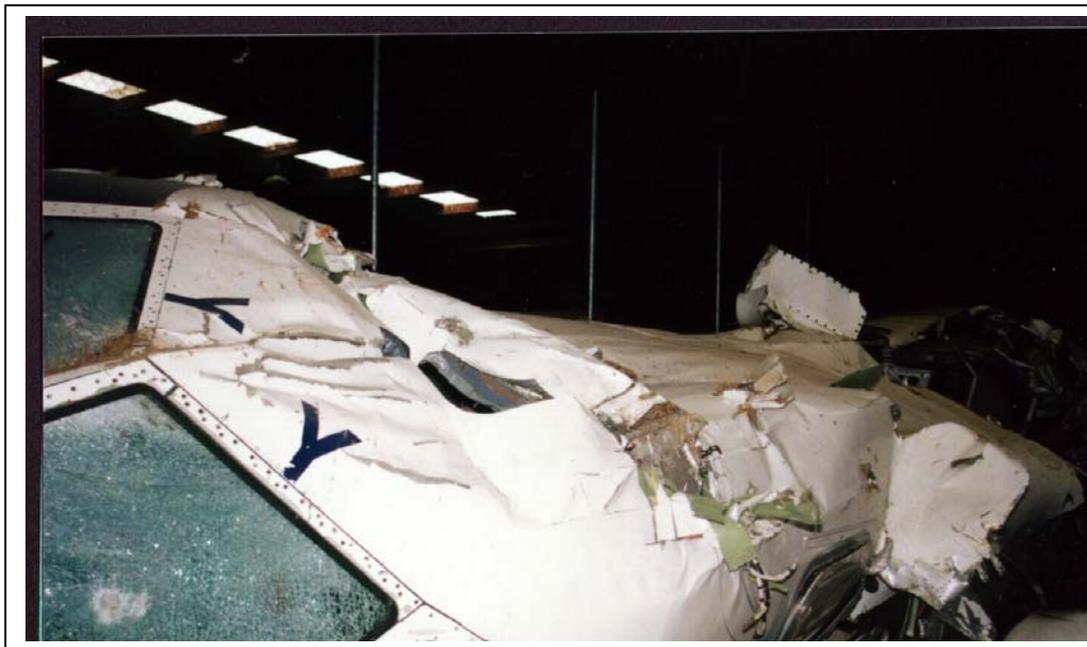
Figure 39. View from front of fuselage, showing crush lines and ingrained dirt.

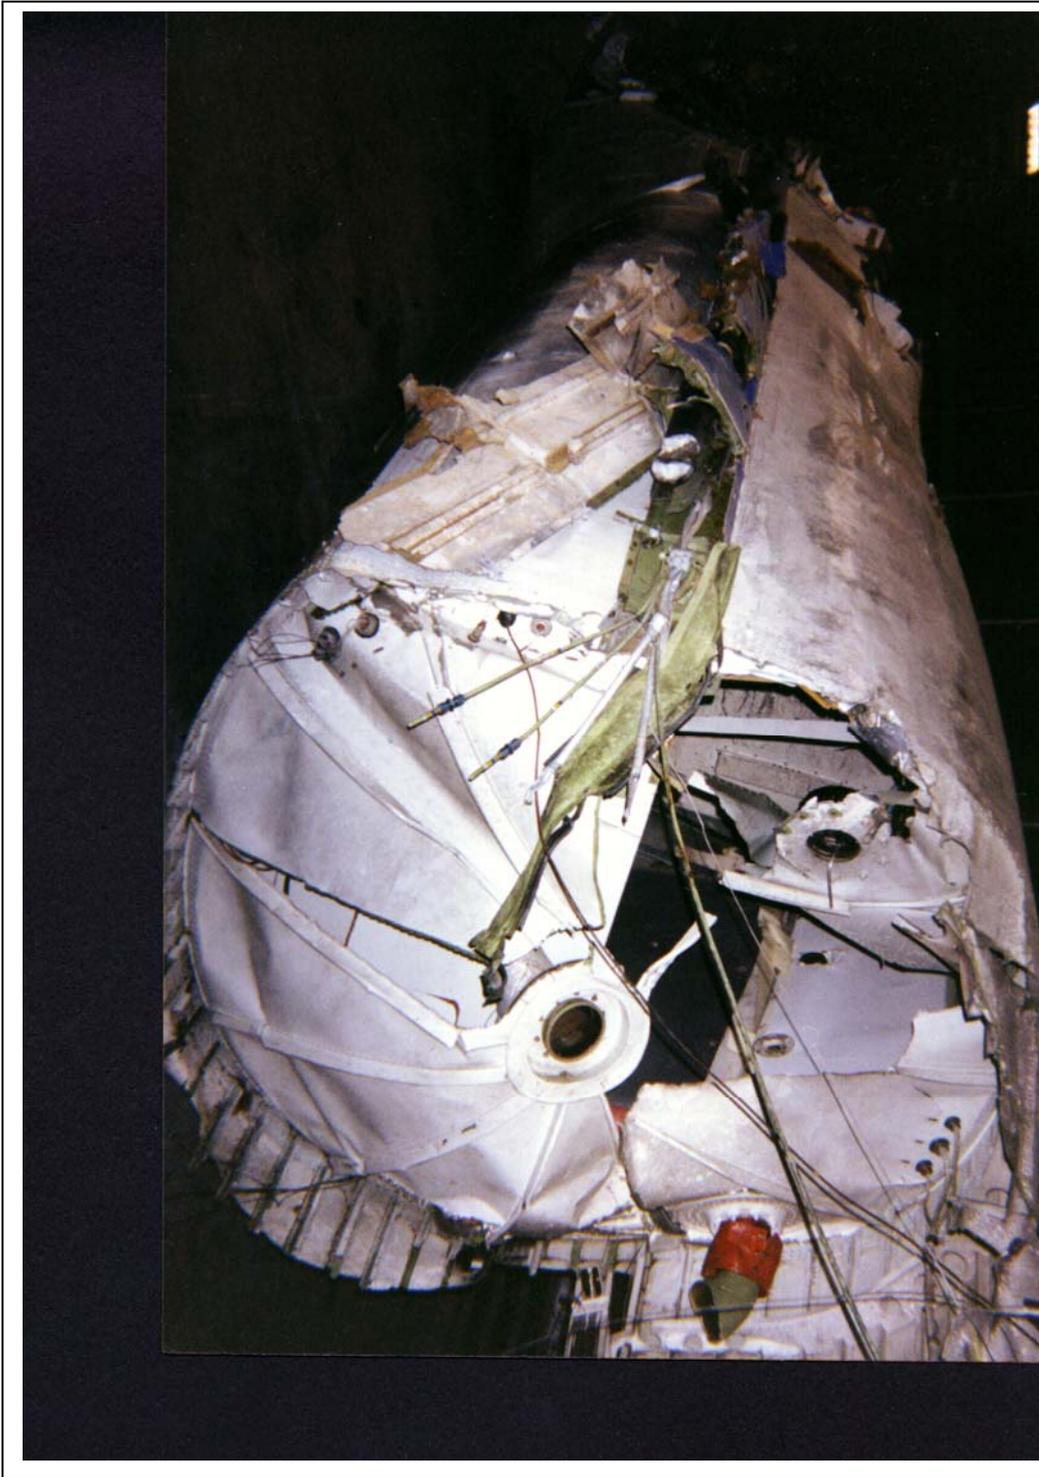
Figure 40. View from top rear of fuselage, showing crush line, torsional damage to rear bulkhead, and stub of fin wiped to the left.

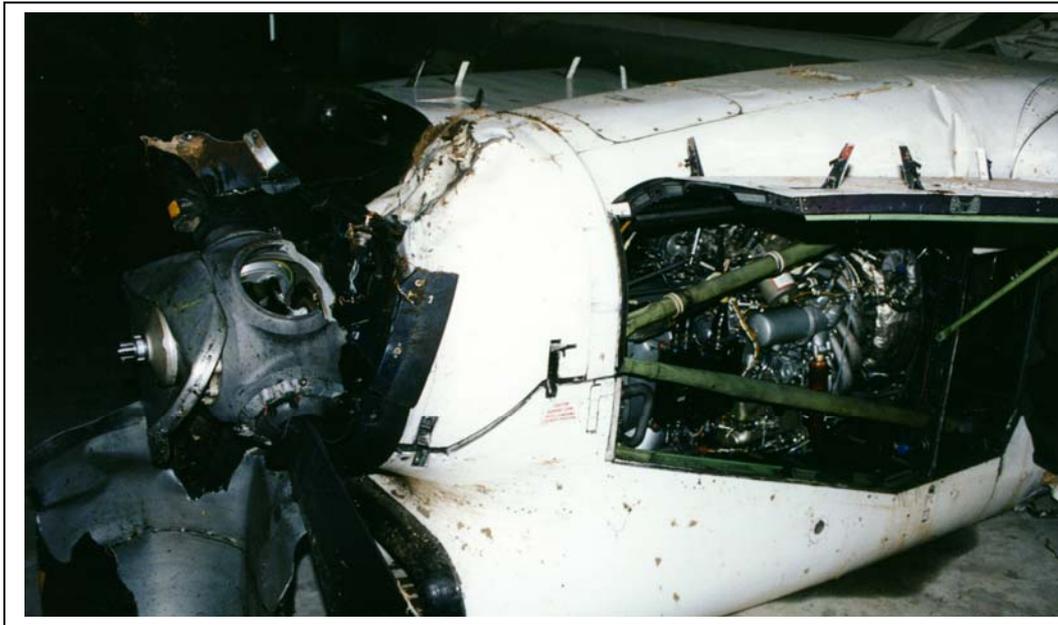
Figure 41. Left engine nacelle, showing lack of damage to underside, and inverted ground contact. Damage to the propeller shows that it was in this position, and rotating, when the nacelle struck the ground.

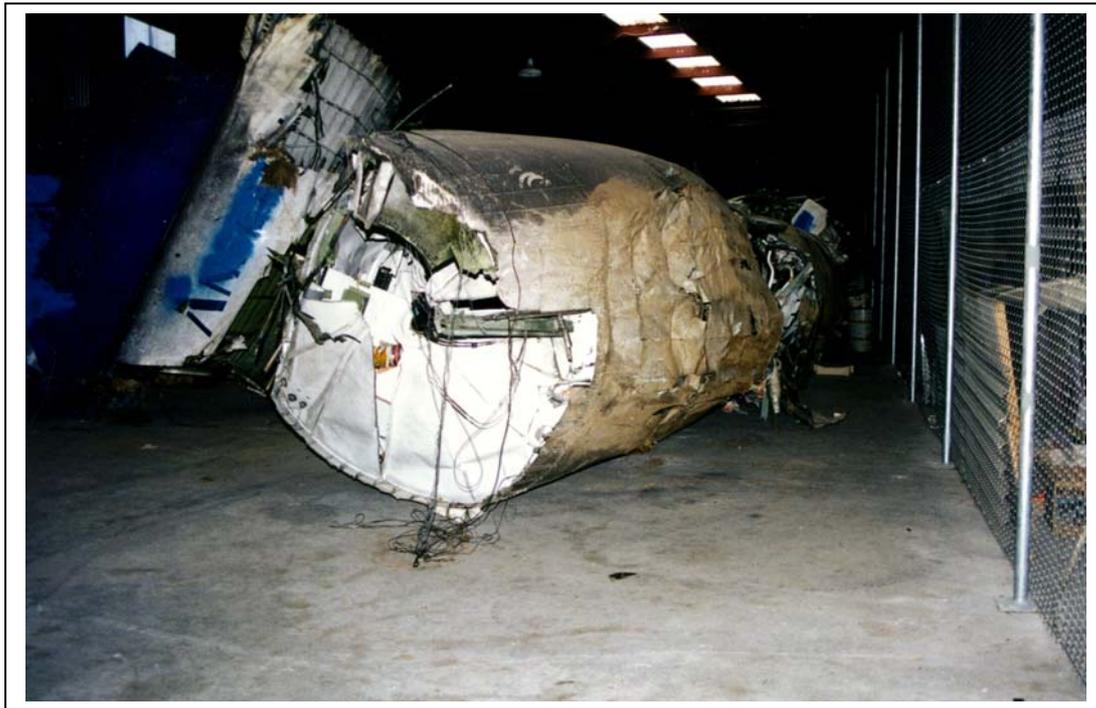
Figure 42. View from bottom rear of fuselage. Impact damage is ahead of rear bulkhead. Note flattening at top of rear fuselage.

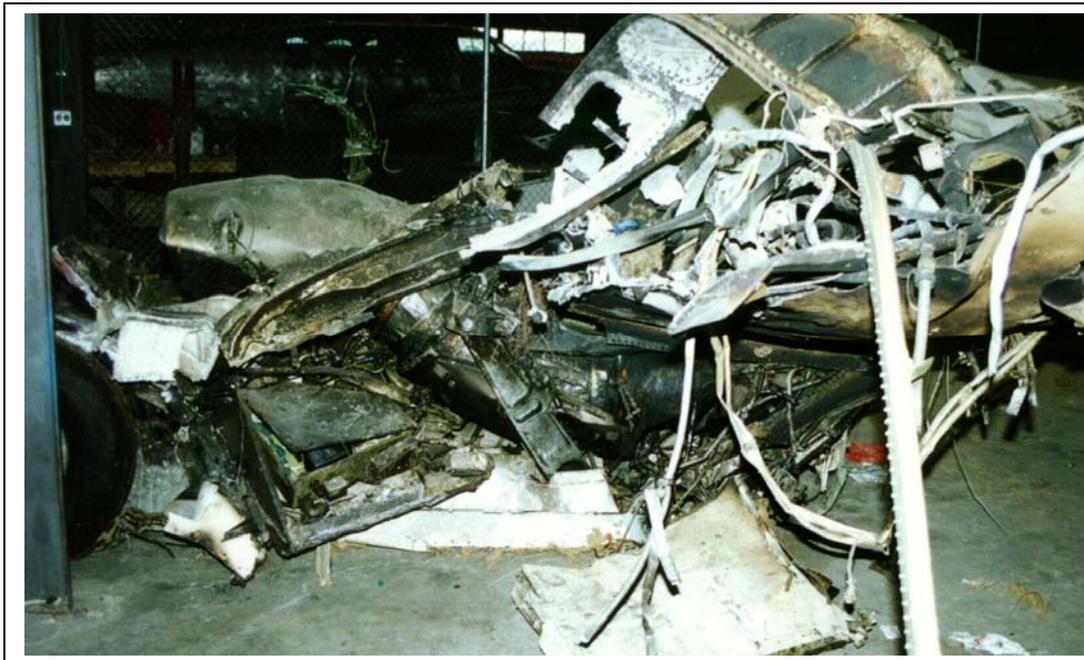
Figure 43. Starboard wing outboard of nacelle. Downward deflection of lower surface; spar web pulled away from spar caps. There has been no loading of the web in shear.

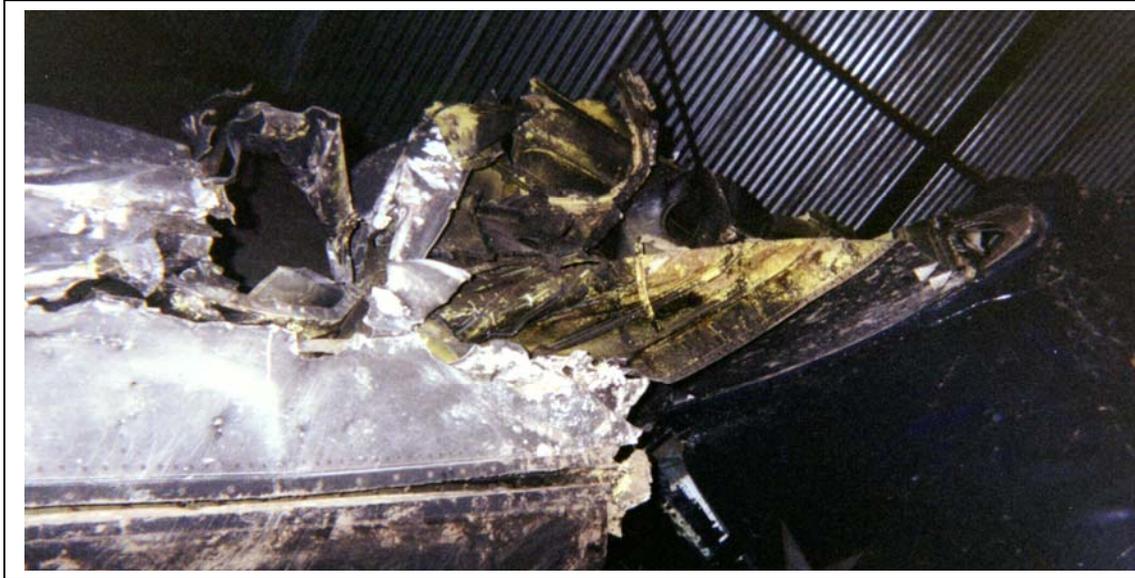
Figure 44. Damage to upper skin of starboard tailplane. The square hole has extensive sooting inside; the deflection damage has very little sooting. Soot deposits around rivets are fairly even, suggesting static fire.

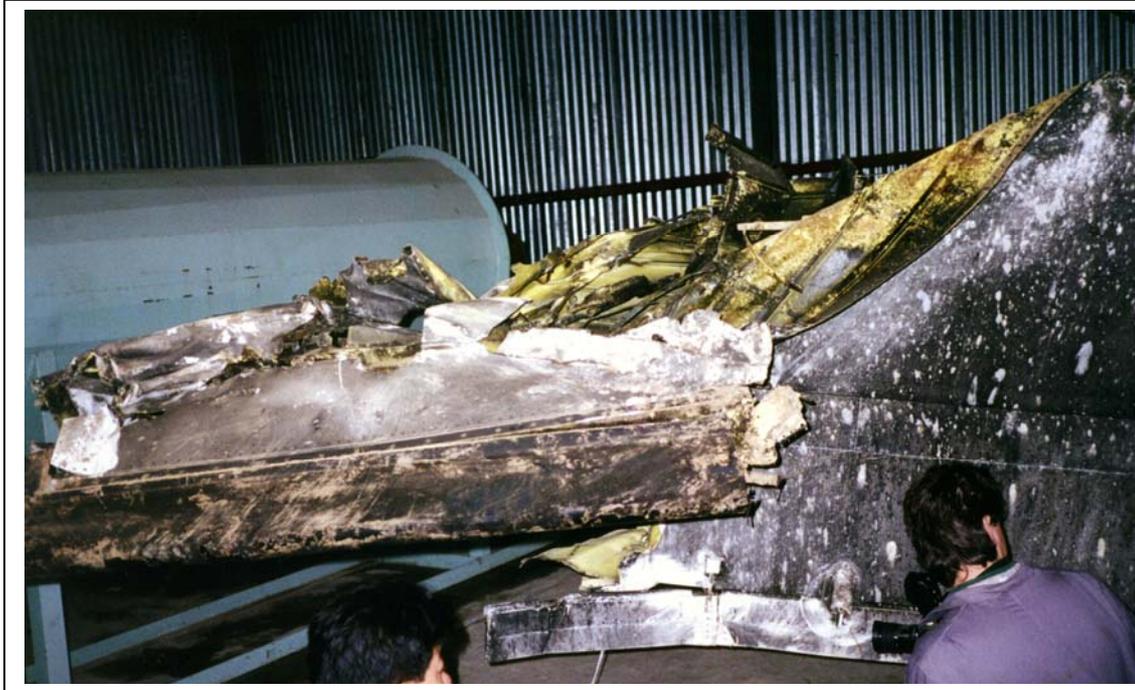
Figure 45. Damage to leading edge of fin and upper surface of tailplane. There was no corresponding damage on the outer portion of the right wing.
