Tsunami damage to coastal defences and buildings in the March 11th 2011 M_w 9.0 Great East Japan earthquake and tsunami

Stuart Fraser · Alison Raby · Antonios Pomonis ·
Katsuichiro Goda · Siau Chen Chian ·
Joshua Macabuag · Mark Offord · Keiko Saito ·
Peter Sammonds

Received: 8 September 2011 / Accepted: 8 March 2012
© Springer Science+Business Media B.V. 2012

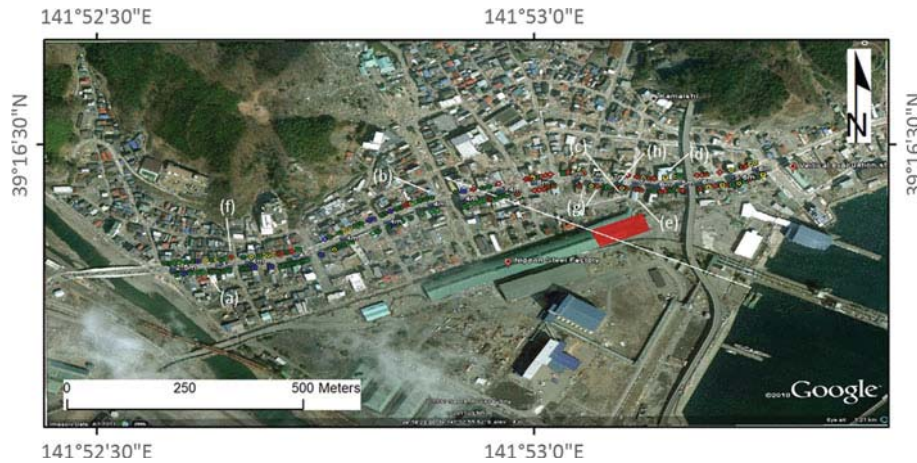
Fig. 3 Damage survey in Kamaishi City with individual buildings plotted to show construction and damage level. Construction type is indicated by shape, EEFIT tsunami damage level by colour: *Diamonds* denote timber frame; *squares* denote RC; *circles* denote steel frame. *Blue* denotes D0, *green* denotes D1, *yellow* denotes D2, *orange* denotes D3, *red* denotes D4. Inundation depths, the collapsed section of Nippon Steel Factory building (red polygon), and vertical evacuation building are also shown. *White letters* show the position of buildings shown in Fig. 4

half of the surveyed timber frame buildings experienced damage level D4 (partial or complete collapse) and where they survived with less damage it was due to significant sheltering by other more resistant structures.

No steel frame or RC structures suffered partial or complete collapse in the survey area, and a limited number suffered heavy damage (D3): 15 % and 4 % respectively. Most steel frame (77 %) and RC (83 %) buildings suffered heavy non-structural damage but the structural frames or walls were often only lightly damaged (D1–D2). At the eastern end of the survey area most timber buildings suffered complete collapse and several had been washed away or cleared away, while steel frame buildings suffered damage level D1–D3, and RC buildings D1–D2. The survey indicates a general reduction in damage with distance from the port and increase in ground elevation towards the west, although variable levels of local sheltering were also observed due to the dense nature of development. There is some indication of sheltering provided by the large trussed steel portal frame building (red polygon in Fig. 3), the eastern-most (structurally isolated) end of which suffered partial collapse. At the western end of the survey transect (inundation depths of 2.5 to 3 m, adjacent to the river) timber frame structures generally sustained damage D1–D2, while one building at an exposed street corner sustained damage of D3. Evidence suggests that flow velocity was low at this end of the transect; plastic shop signs and some glazing remained undamaged despite being submerged.

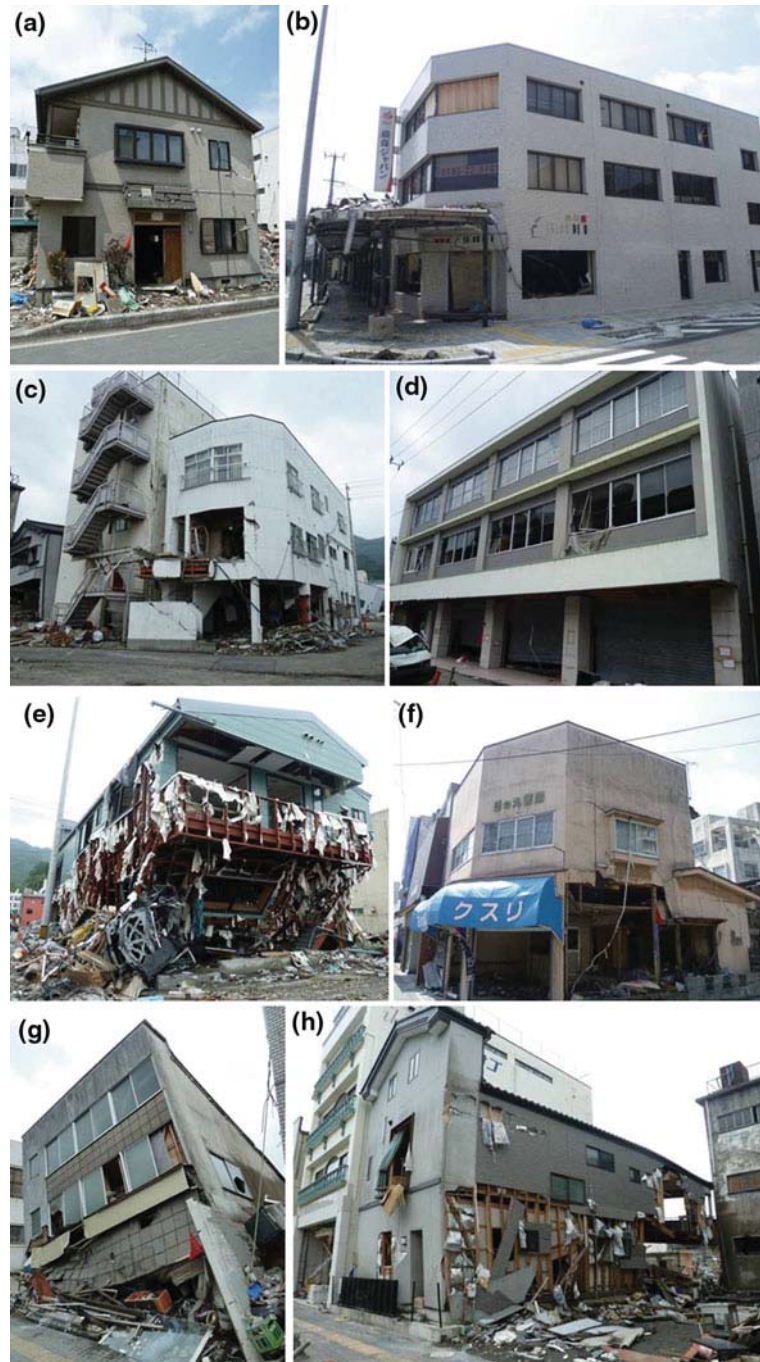
Observed failure modes included (i) out-of-plane failure of infill walls and panel walls in all construction types but particularly steel frame structures; (ii) debris impact damage (from minor damage of exterior cladding to major damage of non-structural components of steel frames); (iii) extensive glazing damage at ground-floor level, some damage to 1st and 2nd storey glazing; and (iv) soft-storey failure of several timber structures (Fig. 5).

Fig. 4 Photographs of structures surveyed in Kamaishi City, providing examples of the EEFIT tsunami damage scale applied for different structure types: **a** Timber frame structure, observed damage level D1; **b** Steel frame, D1; **c** Steel frame, D2; **d** RC shear wall, D2; **e** Steel frame, D3; **f** Timber frame, D3; **g** Timber frame, D4; **h** Timber frame, D4. The position of each photograph is indicated on Fig. 3 by the photograph letter

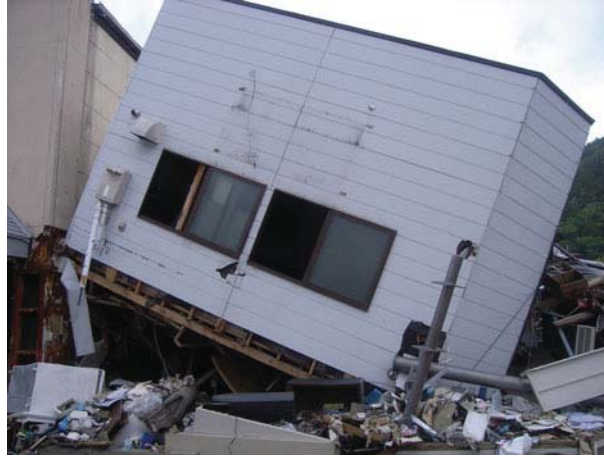
Regarding the observed soft-storey failure, short period component ground motions recorded at K-NET station IWT007, 1.5 km west of Kamaishi port, were of sufficiently magnitude and duration to cause deformation in these structures, indicating that the soft-storey failure of some 2-storey timber frame buildings could be due to ground shaking. However, in areas that were not inundated, timber buildings performed well with respect to ground shaking. This suggests that, in this case, this style of failure may be due to tsunami loading rather than ground shaking, despite the apparent sheltering of these timber buildings. Over

Fig. 5 Soft storey collapse of a timber structure observed in Kamaishi City. The 2nd storey appears to have remained intact due to central steel beam supporting the second storey

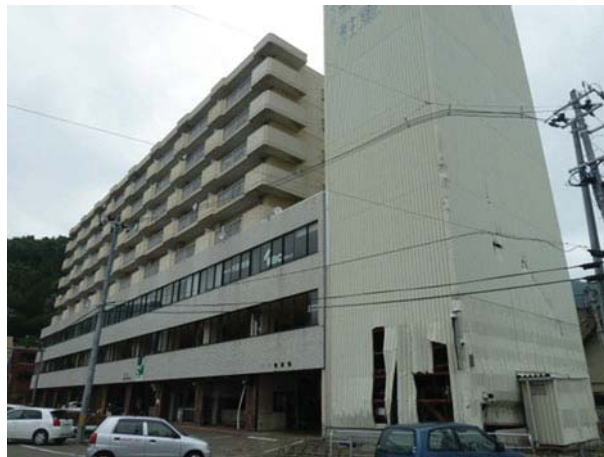
Fig. 6 Eight storey un-braced RC shear wall apartment block and designated evacuation building in Kamaishi City. A steel frame structure is located on the seaward face and sustained minor damage from debris impact. Two external staircases to the 4th floor exist on the other side of the building. This building was inundated to the 3rd storey

RC infill panels which were severely damaged. The building was inundated to the 3rd storey, but adequate elevation and absence of structural damage meant that occupants were able to evacuate to the designated evacuation area on the 4th storey and above.

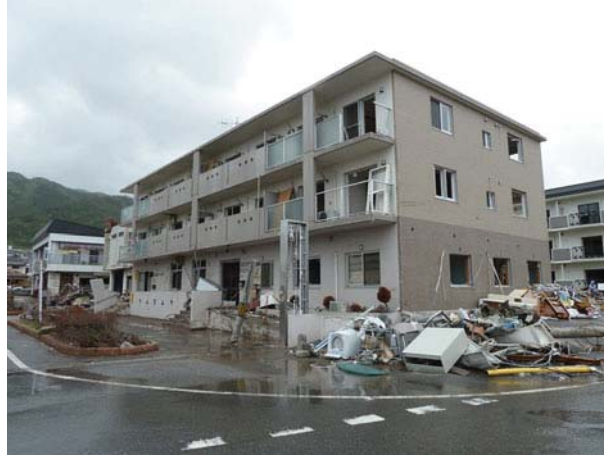
Fig. 7 Apartment building of RC shear wall construction in Ōfunato City. Seaward side of the building is shown. Inundation reached the ceiling of the 3rd floor, but the structure remained intact. This landward side of the building was sheltered from debris impact during the tsunami return flow

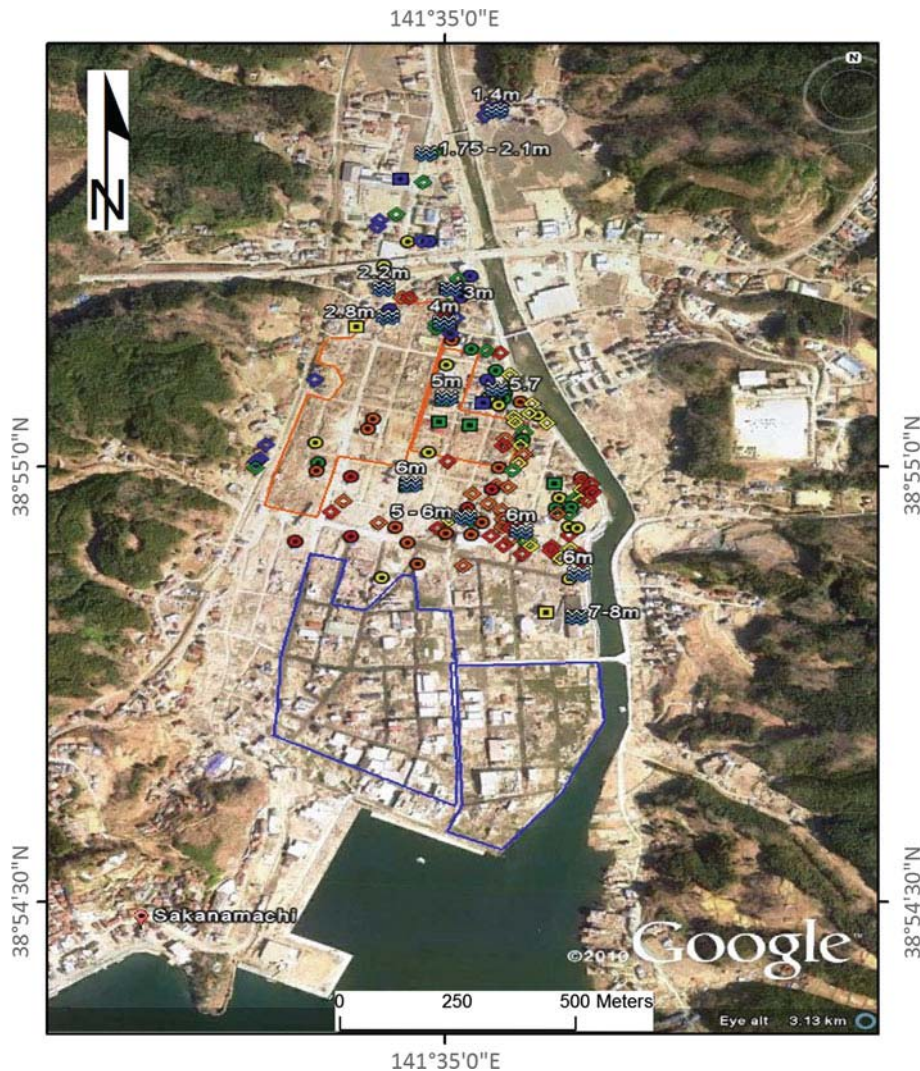
An extensive area of damage was surveyed in the northern part of Kesennuma City from 450 m inland to 1.1 km inland (Fig. 8). Flooding associated with 0.74 m of co-seismic subsidence ([Geo-Spatial Information Authority of Japan 2011c](#)) prevented closer access to the shoreline. Timber frame structures suffered heavy damage to collapse (90 % sustained damage level D4), 60 % of steel frame structures registered moderate to heavy damage (D2–D3), and 78 % of the surveyed RC structures sustained light damage (D1). A large number of timber frame buildings had been washed away or destroyed by fire and the building footprints were not visible during the survey. Field observations have therefore been augmented with building footprint data to estimate the total original number of buildings. Steel frame and RC buildings remain standing in areas most affected by fire, therefore all buildings identified from the GSI building footprints with no corresponding surveyed building are assumed to be timber frame, damage level D4 (collapse).

Highly variable damage was induced by flows of similar depths in this survey area. Although many timber frame structures are in a state of partial or complete collapse, there were a significant number which remained standing (with damage level D1–D3) in flows of 5–7 m depth, which is inconsistent with the 2 m wash-away threshold for Japanese timber houses observed in the 1960 Chilean tsunami ([Sasaki 1960](#), in [Shuto 1993](#)). A comprehensive report into building damage from all affected areas by the [Japanese Ministry of Land Infrastructure Transport and Tourism \(2011\)](#) (MLIT) shows a clear threshold for heavy damage or collapse to buildings at around 2.0 m: at 1.0–1.5 m inundation height, only 9 % of buildings were washed away or rendered unrepairable, while this increases to 31 % at 1.5–2.0 m. At 2.0–2.5 m 66 % of buildings were washed away or not repairable. The inconsistency between this and the EEFIT survey highlights the importance of local effects on influencing damage levels to individual buildings.

Fig. 8 Damage survey in Kesennuma City with individual buildings plotted to show construction and damage level. *Diamonds* denote timber frame construction, *squares* denote RC, *circles* denote steel frame. Damage level is indicated by colour—Blue D0, green D1, yellow D2, orange D3, red D4. Inundation depths, heavily fire damaged areas (orange outline) and subsided area (blue outline) are also shown. The subsided area was flooded at the time of survey. Inset shows survey location in the context of Kesennuma Bay

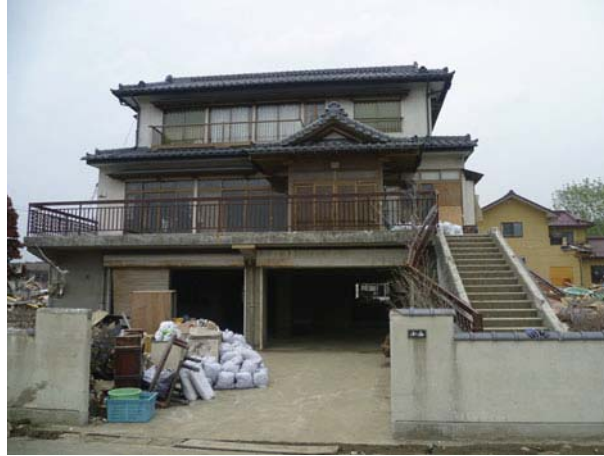
A number of timber frame dwellings constructed with an RC ground-floor structure (Fig. 9), or on artificially raised land were present in the surveyed area. The impact of raising residential timber frame buildings was generally positive, with the majority sustaining light to moderate damage depending on tsunami inundation depth or debris impact, as opposed to suffering heavy damage or collapse when built on concrete ring foundations just above ground level.

Fig. 9 An example of a timber frame dwelling constructed with an RC ground floor structure. The main house is 3 m above ground level, 780 m inland and 60 m from the river. Despite inundation depth of approximately 6 m in this area, the house had sustained very little non-structural damage

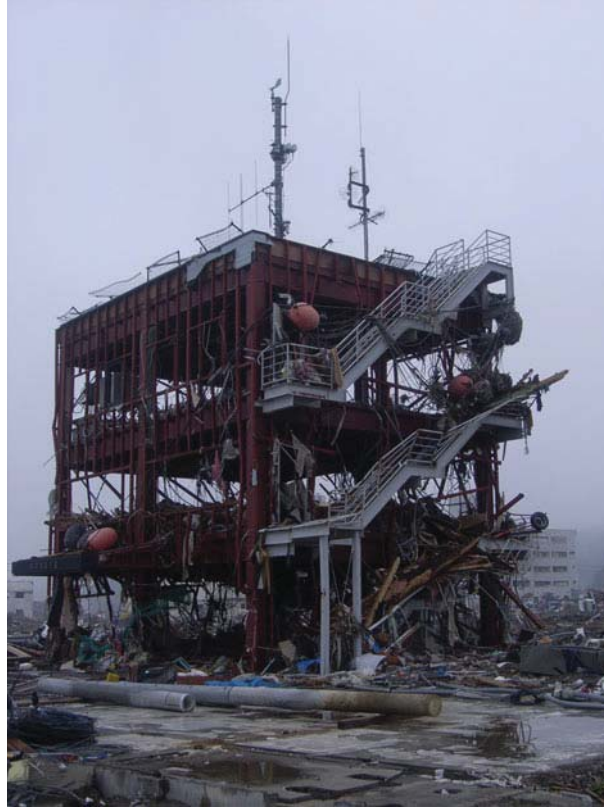
Steel frame buildings sustained heavy damage and EEFIT observed collapse of several 2- to 3-storey RC buildings from debris impact and significant scour. The 3-storey steel frame Crisis Management Department (CMD) building (38°40' 40.06'' N, 141° 26' 46.82'' E; 470 m from the harbour front) remained standing with heavy damage after being inundated to its roof at 10 m above ground level (Fig. 11).

Fig. 11 The 3-storey steel frame Crisis Management Department (CMD) building, located 470 m from the harbour front. This building was inundated to the roof (at 10 m elevation above ground level) and sustained loss of all cladding although the structure remains standing. Damage to this building and the deaths of CMD staff resulted in the loss of crisis management facilities and expertise in the immediate aftermath of the tsunami

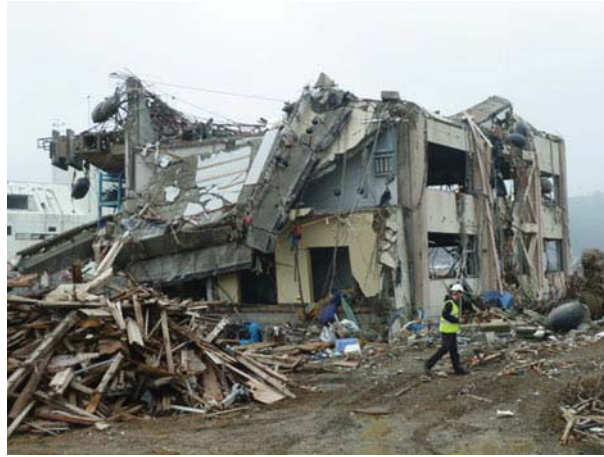
Fig. 12 RC building in Shiomi-cho, Minami-Sanriku, 100 m from the sea ($38^{\circ} 40' 29.10''$ N, $141^{\circ} 26' 44.96''$ E) showing collapse of upper storeys. Several other RC buildings in the immediate vicinity of this building had suffered collapse with evidence of severe scour and debris impact

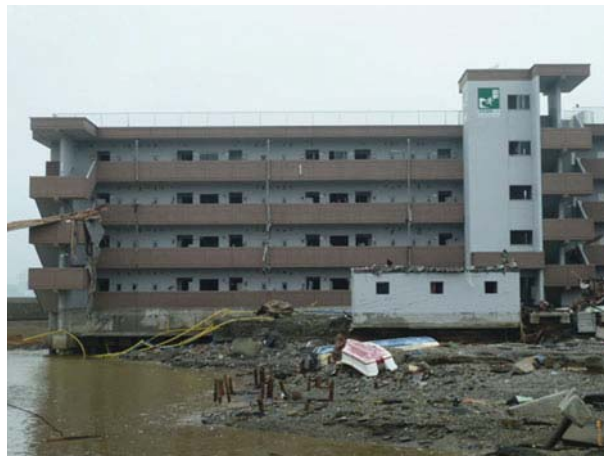
Fig. 13 The Matsubara apartment block and designated vertical evacuation building in Minami-Sanriku. This photograph shows the landward side of the building with scour of at least 2 m at its northern end (a similar amount of scour was also observed at the southern end). Observations of this side of the building show little structural damage despite 16 m inundation height

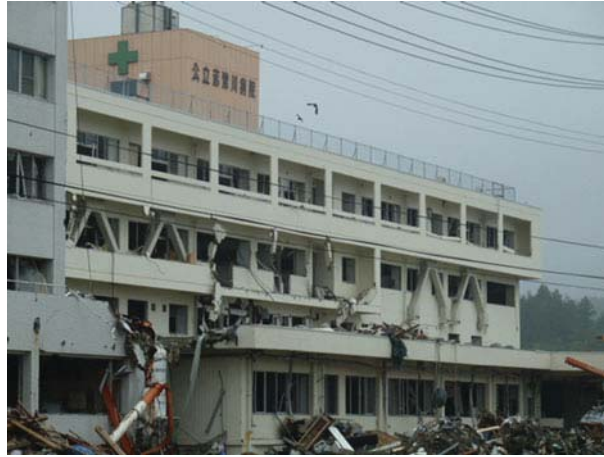
Fig. 14 Shizugawa Hospital, Minami-Sanriku, which was inundated to 11 m depth but was used in evacuation to the roof. This photograph shows the landward side of the building with evidence of damage to the balcony at the 4th storey

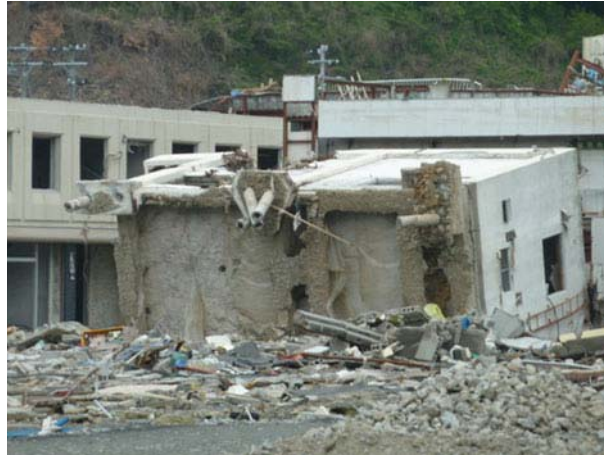
A 2-storey RC shear wall office building with piled foundations was overturned landward during tsunami inflow ('Building A'; Fig. 17). The structure had one pile at each corner, and three closely spaced piles at each of the central pile caps. The rebar in each pile did not extend very far down the pile and they appeared quite lightly reinforced at the top, suggesting they were designed only for shear, rather than also for tension. The uppermost (originally seaward) piles remained connected to the pile cap and were relatively straight, suggesting that they had been pulled out of the ground and then failed in tension. In contrast, the bottom (originally landward) piles were sheared off closer to the foundation and were all bent downwards; this suggests the lateral forces imparted by tsunami flow were concentrated on the landward piles, which became the pivot point in the overturning motion. Overturning in this case may have been initiated by debris strike, evidence of which was observed at the top of the structure.

Fig. 17 Foundations of an overturned two-storey RC shear wall structure with piled foundations in Onagawa Town—'Building A'. Evidence of impact at the roof of the building on its seaward side indicates that this failure may have been initiated by debris strike

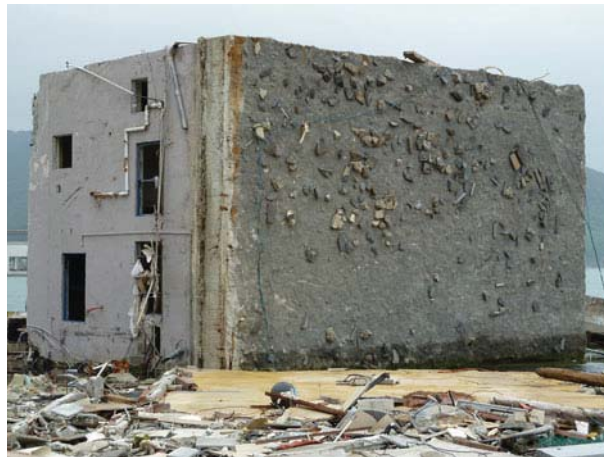
Fig. 18 An overturned two-storey RC shear wall structure with raft foundations at the harbour edge in Onagawa Town—'Building B'

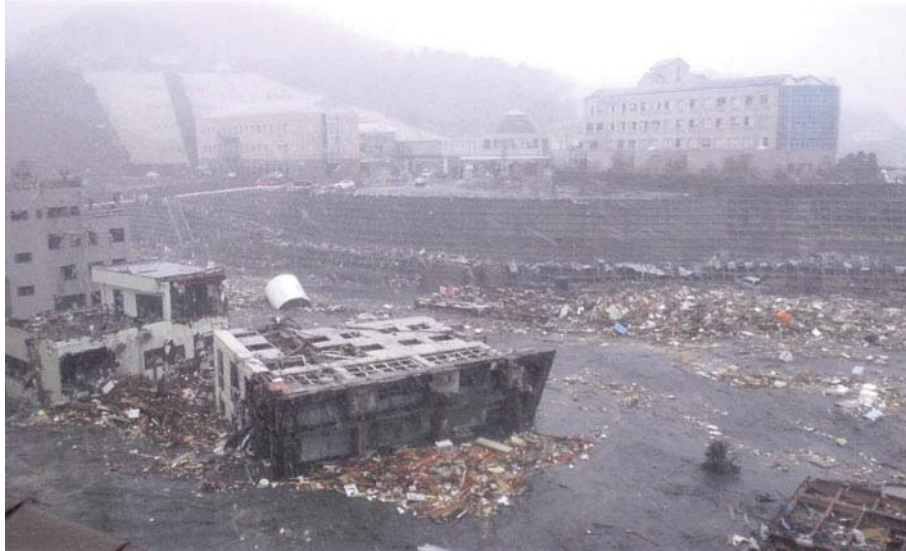
Fig. 19 An overturned 3-storey steel frame building ('Building D') on piled RC foundation with evidence of debris impact on the (originally) seaward face of the building. This photograph was taken from a neighbouring building during tsunami inundation, courtesy of Miyagi Prefectural Office

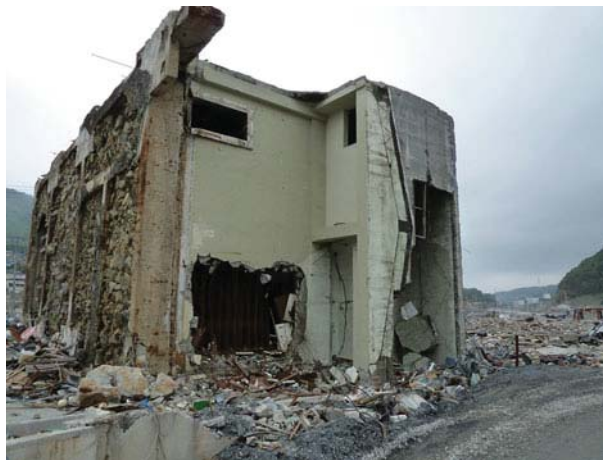
A 3-storey RC shear wall structure ('Building E'; Fig. 20) had shallow pad footing with ground beams of small dimensions, with one of the corner pads effectively acting as a pile cap rather than pad footing, possibly due to locally weak soil. No piles remained connected to the pile caps in this case, suggesting a higher level of shear in the overturning motion than experienced at the other piled buildings.

Fig. 20 A 2-storey RC shear wall structure with shallow pad footing foundation ('Building E'). Evidence of small piles on at least one of the corner columns can be seen, but no piles remained attached at the time of our visit. The building has also sustained out-of-plane failure of an infill wall at the ground floor

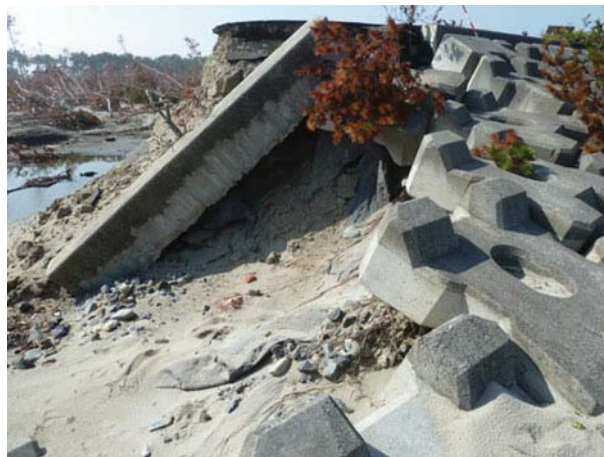
The concrete defences at Arahama Beach had failed in several places and the sand infill had been washed out (Fig. 21), while concrete blocks had been removed and washed up to 100 m landward into the coastal pine forest. Many residential properties of timber frame construction suffered complete collapse or had been demolished by the time of our investigation. Significant scour of the sandy soil (old beach deposits) on the seaward side of buildings had caused tilting and exposure of foundations in some buildings. Out-of-plane failure of infill

Fig. 21 Failure of a concrete block revetment at Arahama Beach. Sand fill had been washed out of the revetment, causing collapse of the concrete blocks and pathway along the crest of the defence

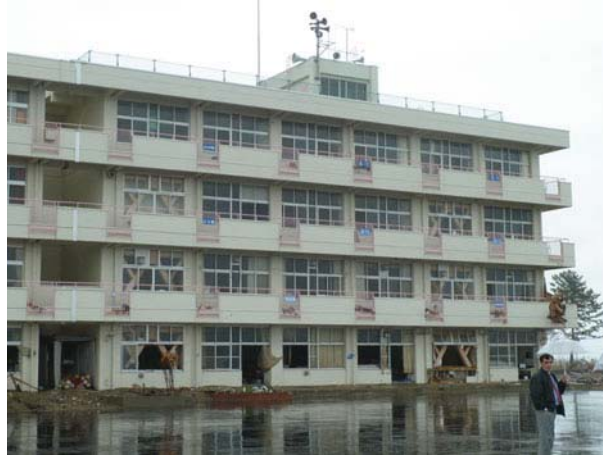
Fig. 22 The south side of Arahama Elementary School, which was successfully used for vertical evacuation. Timber-clad steel bracing is visible in windows of the lower floors. Damage to non-structural components at the ground floor is shown, along with debris at the seaward end of the building on the second floor. The roof shows evacuation infrastructure including warning sirens and fencing around an evacuation area. There is external access to the roof on the north side of this building

Arahama Elementary School ($38^{\circ} 13' 20.52''$ N, $140^{\circ} 58' 49.88''$ E; Fig. 22), performed its secondary function as a vertical evacuation refuge well during this event. The 4-storey pre-2001 RC structure comprised shear walls on the narrow external seaward and landward faces. The building had been previously retrofitted with steel bracing members to strengthen its central section. The bracing was situated only on one side of the central shear walls and only at the lower 3 storeys. The lowest 2 storeys of the building were flooded up to ceiling level. The building had rooftop railings, direct external roof access via a large brightly painted steel staircase to the rear and two sets of rooftop sirens. No vertical evacuation signage was clearly displayed on the building. Debris had entered the building in the longitudinal (perpendicular to the shoreline) direction, with timber and 3 cars inside the central ground-floor corridor indicating significant flow velocity through the central corridor that ran the length of the building. All other observed damage was non-structural: glazing and contents, and

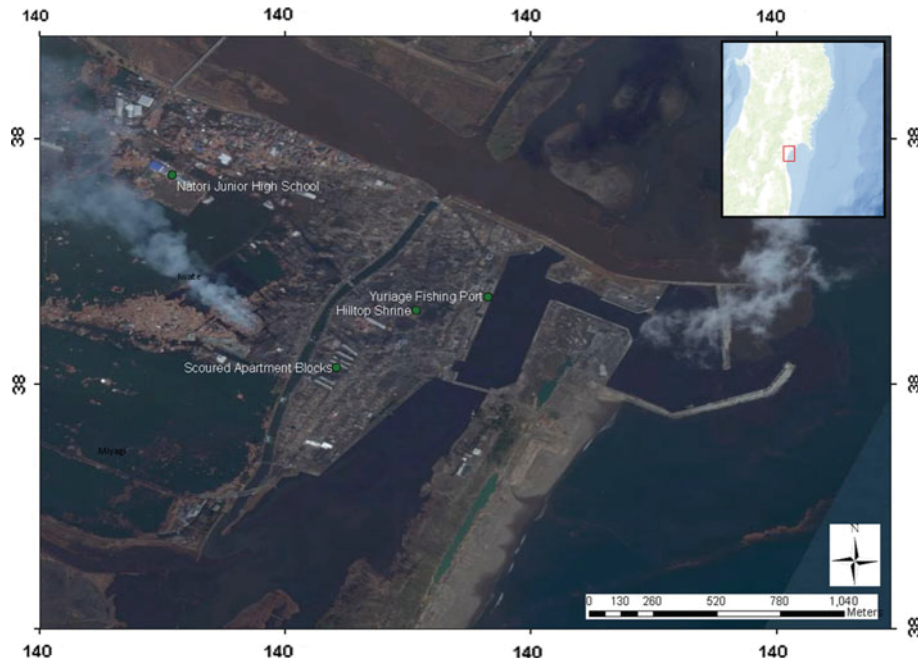
Fig. 23 Post-tsunami aerial photograph of Yuriage District, Natori City, showing almost complete destruction of this residential area, although the part of Yuriage adjacent to the river embankment (northern edge of this image) sustained less damage

Almost all timber frame residential buildings in Yuriage sustained complete collapse (D4). Steel and RC structures sustained damage ranging from light (D1) to collapse (D4). The RC port building sustained out-of-plane failure of all hollow concrete block masonry infill walls and partial collapse, and the wharf itself suffered significant scour and partial collapse. The majority of reinforcement in the concrete block infill walls was un-deformed rebar. Consistent failure direction of columns immediately inland of the port structure indicates flow

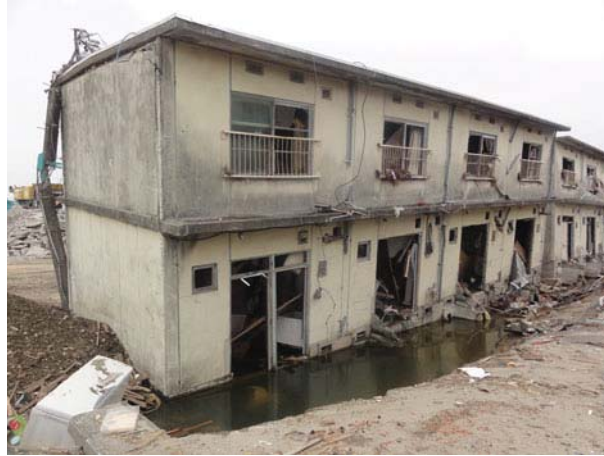
Fig. 24 View along the north side of one apartment block in Yuriage, illustrating scour at the seaward end of one apartment building. Loss of soil providing bearing capacity to support the footings resulted in tilting of this building

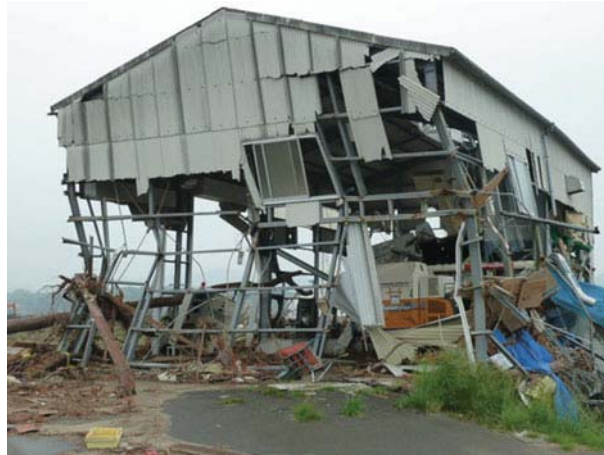
Fig. 25 A steel frame agricultural building located 1 km inland at Yamamoto Town, Miyagi Prefecture. A tree trunk, apparently from the damaged coastal pine forest, struck a structural column on the south-east (seaward) corner of the building, buckling the structural and non-structural members. Tsunami flow has removed cladding to a height of over 4 m
