International Journal of Disaster Risk Reduction

Cyclone resistant housing in Fiji: The forgotten features of traditional housing

Mohamed Elkhartoutly^{*}, Suzanne Wilkinson

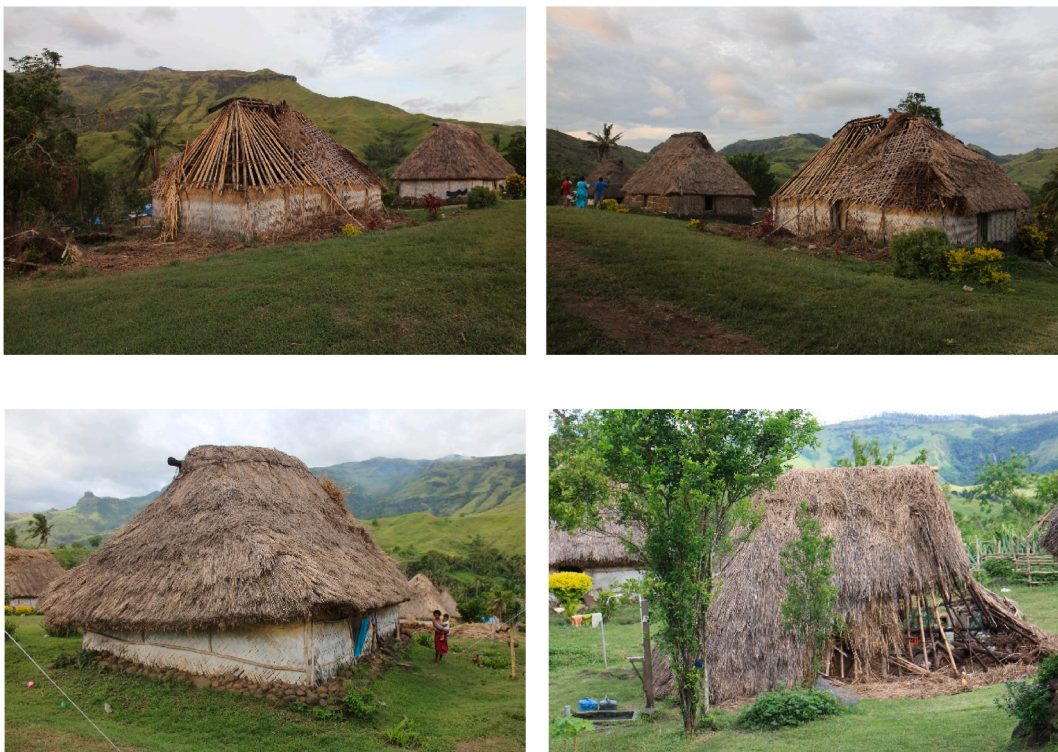
“The houses with king posts, twelve were damaged. Nevertheless, those are very old buildings ... only 12 were partly damaged, and none of them was completely damaged. —Navala village focus group.

As a result of the cyclone, 70 traditional *bure* were totally damaged. Two of the four timber-framed houses were destroyed. In addition to the destroyed houses, 12 traditional *bure* were partly damaged (see Fig. 5 and Fig. 6). The partially damaged houses were the larger version of the *bure* that included direct posts in the middle of the house. Damage to the village's crops and cassava plantations affected the food security of the village community, and the village needed outside help to recover.

Fig. 5. Partially damaged *bure* houses, with only roof thatches destroyed (Source: The Author).

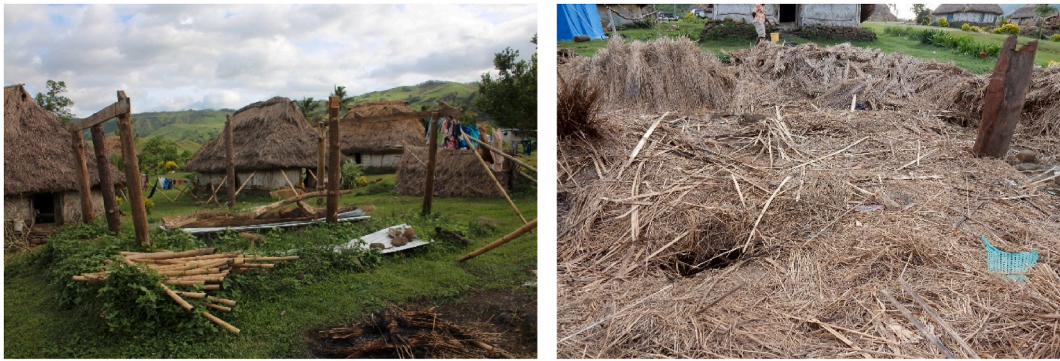
“The smaller version of the bure was damaged. There were 70 of them out of 140.” —Navala village focus group.

Fig. 6. Completely damaged *bure* houses (Source: Author).

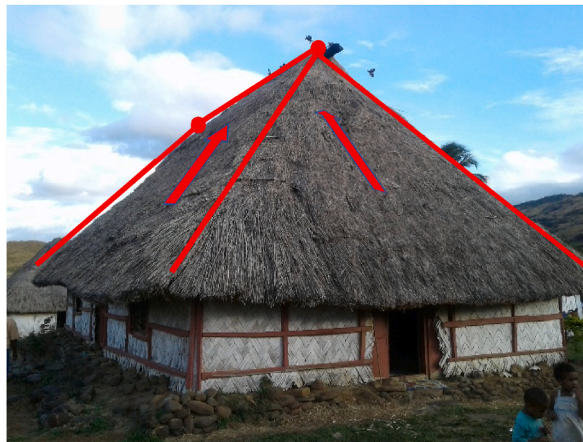
Both models of the traditional *bure* houses found in Navala have hipped roofs, as shown in Fig. 16. The hipped roof with four inclined sides was proven to resist strong wind better than gabled roofs [45,46]. As in Fig. 17, the roof slope was measured at 55° from the horizontal plane for the large model and 60° for the smaller model. Even though several studies suggested 30° slope hip roof as optimum for resisting strong wind like [45,47,48]; and few studies even tested 45° slope roof proving less negative wind pressure on the windward [49]. Observation in Navala showed that the large house models with a 55° roof slope showed less damage during the cyclone than the smaller model with a 60° roof slope. The roof rafters are mainly made out of bamboo cane or straight branches, previously seen in Fig. 12 (right). The roofs structural connections are lashed with natural ropes made of flattened bamboo reeds.

Fig. 16. Traditional house with hipped roof highlighted.

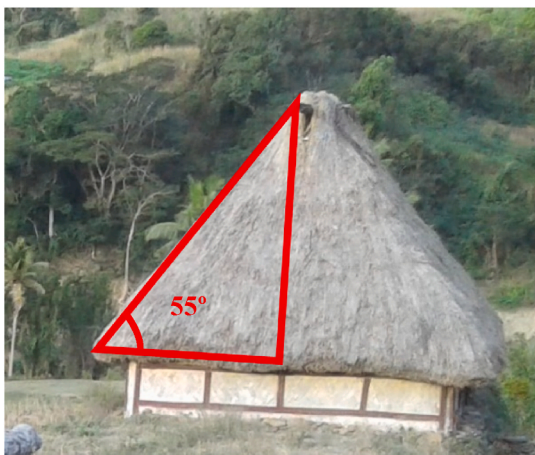
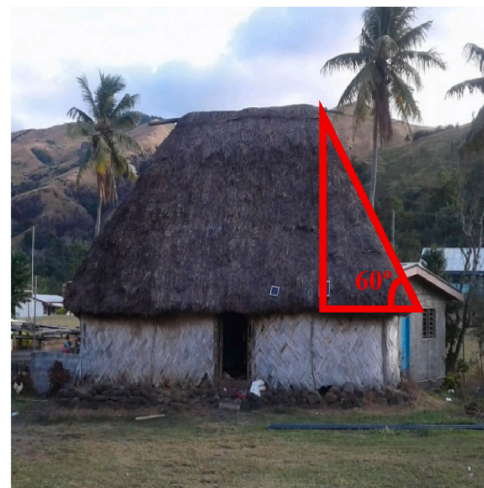
Fig. 17. Steep-sloped hipped roofs, the large model on the left, the smaller model on the right (Source: The Author).

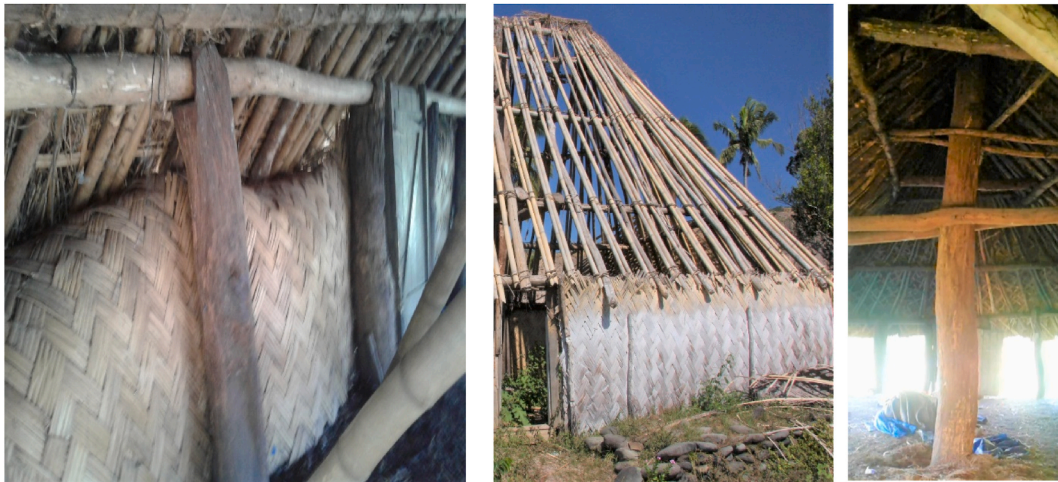
Structural connections are essential for cyclone resistance. In Navala, as shown in Fig. 18, it was observed that there are three types of structural connections standard in both bure models; (1) the connection between prominent members, (2) the connection be-

Fig. 18. Interlocking connection (left), lashed connection between rafters and purlins (middle), central post connection (right).

tween primary and secondary members and (3) the connection between secondary members. These connections were all lashed connections using natural ropes. In addition, there was an interlocking connection between the wall posts and the wall's main horizontal beams Fig. 18 (left). Observations of bures with central posts showed those houses that were less damaged during the cyclone, having a central post, as in Fig. 18 (right), taking the loads from the roof structure from various components and delivering them directly to the house foundation.

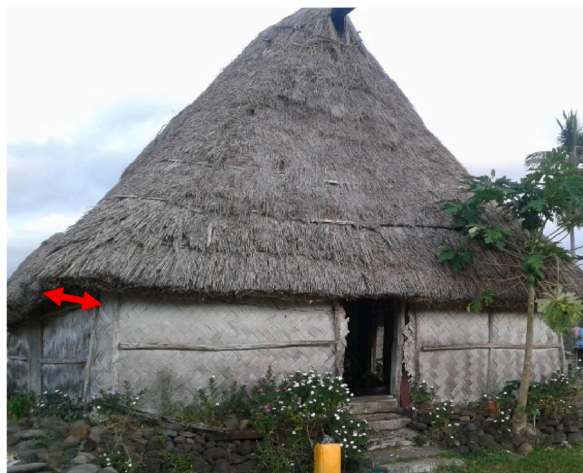
Fig. 19. Roof narrow extensions (eaves).

The eaves were of minimum width and did not extend beyond the thickness of the roof thatches. To make the bures even stronger, roof thatches were tied to a lattice made of bamboo cane. The lattice acts as a damper in substantial wind conditions, allowing the roof to move slightly rather than breaking the roof structure.

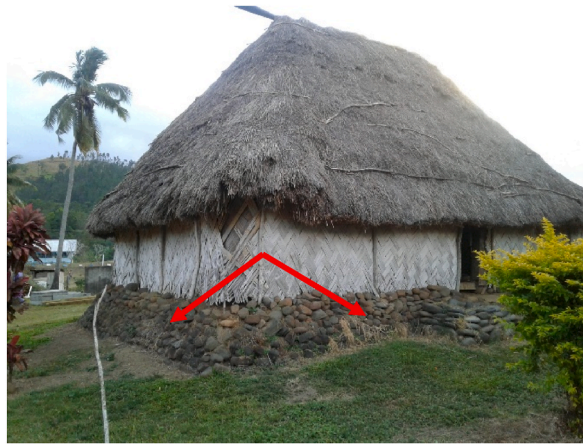
Strong foundations have been reported to be essential for cyclone-resistant housing. The people of Navala built the traditional houses on elevated mounds with a rock face on the perimeter Fig. 20 to provide a strong foundation for the timber post and to protect the house from being washed away in heavy rainfall. The foundations in Navala can reach 1 m high. The timber posts are deeply embedded into the foundation, with bore depths ranging from 1.5 m for the corner and wall posts to 3 m deep for the central posts.

Fig. 20. Bure house on a rock-face mound (*yavu*) (Source: Author).

The houses were all built on a raised rock foundation, a recommended practice in flood-prone areas, as the heavy rain associated with cyclones results in a strong flow of surface water that could wash out the house. English et al. [66] recommended a raised foundation for constructing houses in flood-prone areas. Navala villagers have naturally adopted this cyclone and flood-prone feature in traditional housing.

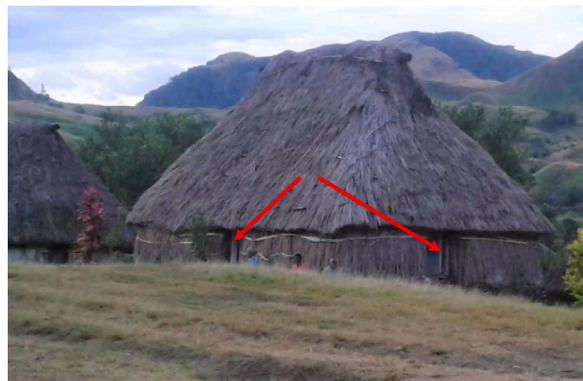
door opening was short and narrow with a sawn timber frame and door (see Fig. 21). In general, the traditional houses of Navala have short walls, no windows, and small wall openings for the doors.

Fig. 21. House with thatched walls and roof and three short, narrow doors. (Source: Author).
