A Working Paper Series in Physical Geography
2010/2

Quantification of channel planform change on the lower Rangitikei River, New Zealand, 1949-2007: response to management?

Jane M. Richardson
Ian C. Fuller

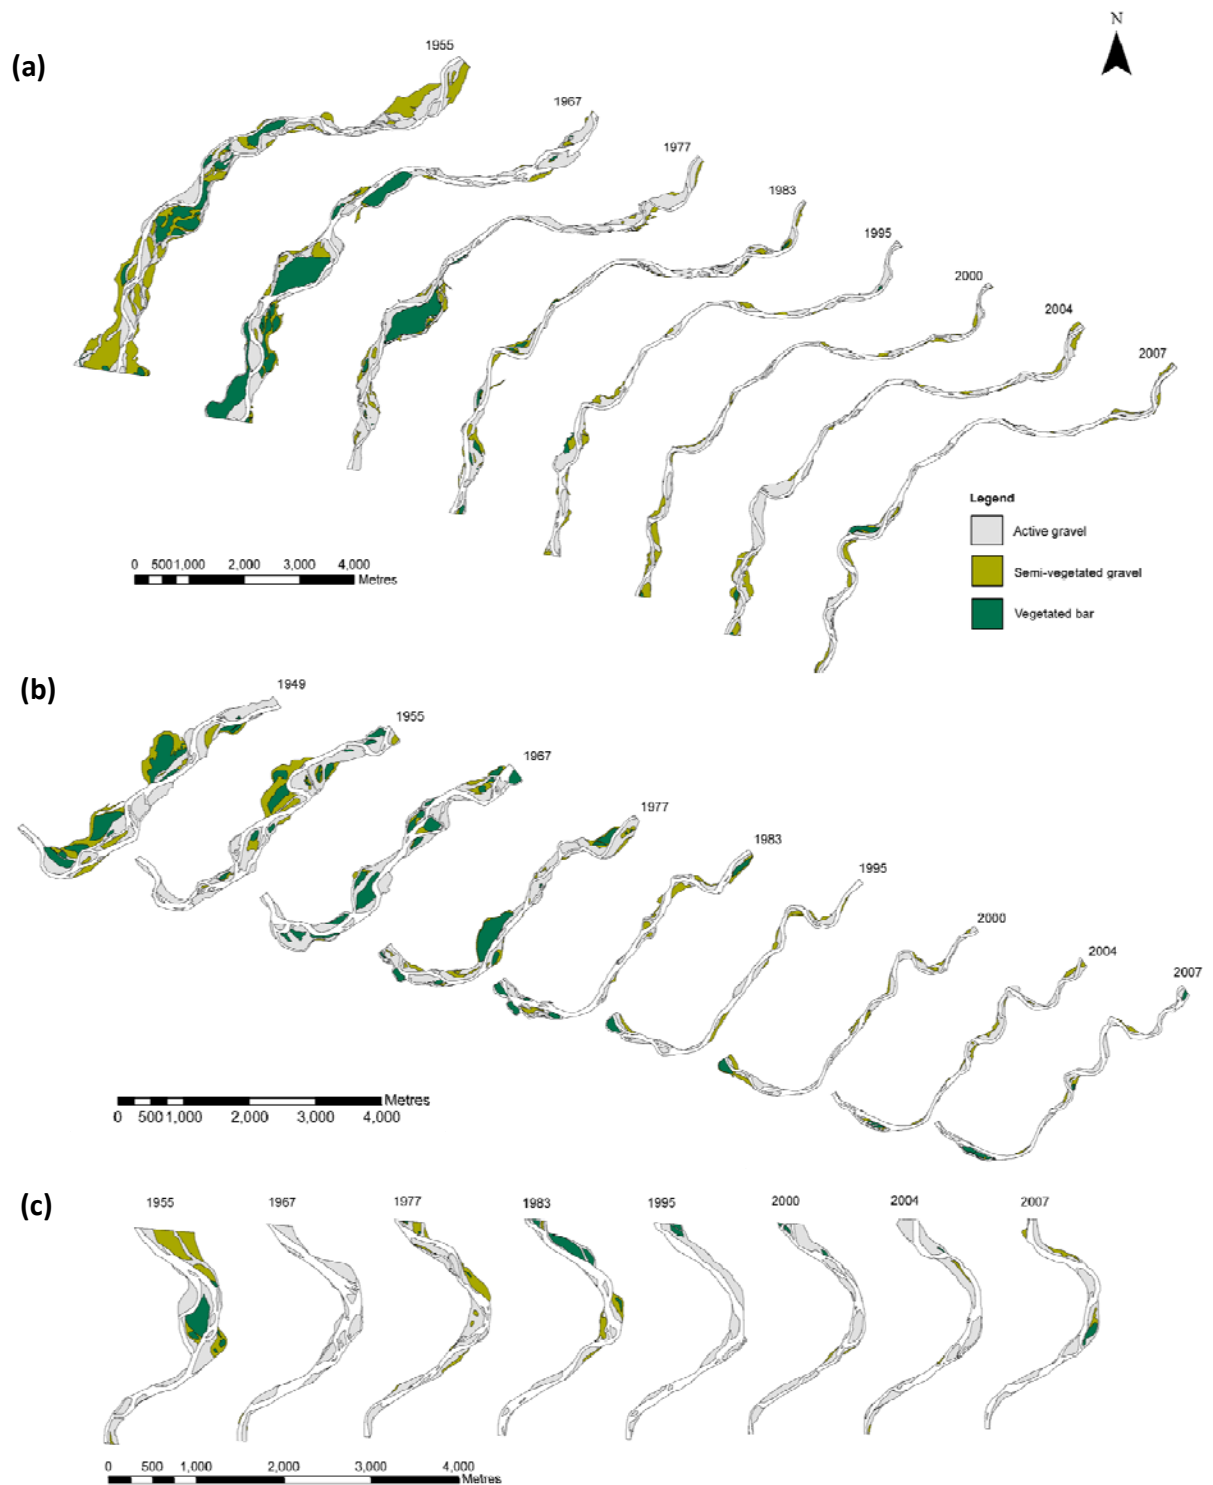
Figure 3. (a) Channel planform changes at the Bulls Bridge reach, lower Rangitikei River, derived from aerial photographs (1955-2007); (b) Channel planform changes at the Flock House reach, lower Rangitikei River, derived from aerial photographs (1949-2007); (c) Channel planform changes at the Kakariki reach, lower Rangitikei River, derived from aerial photographs (1955-2007). Flow is from north to south in each.

Historic planform reconstructions of each reach (Figure 3) show that in 1949 and/or 1955 the wide active channel was multi-threaded, comprising numerous bare gravel, vegetated and semi-vegetated mid-channel bars, high flow chute channels, abandoned anabranches and extensive lateral bar surfaces displaying various degrees of vegetation development. By 2007 all three reaches narrowed considerably, display less morphological complexity and are predominantly laterally stable single thread reaches. The 2007 active channel almost entirely comprises active gravel surfaces, with relatively small isolated patches of semi-vegetated and vegetated lateral bars evident (Figure 3).

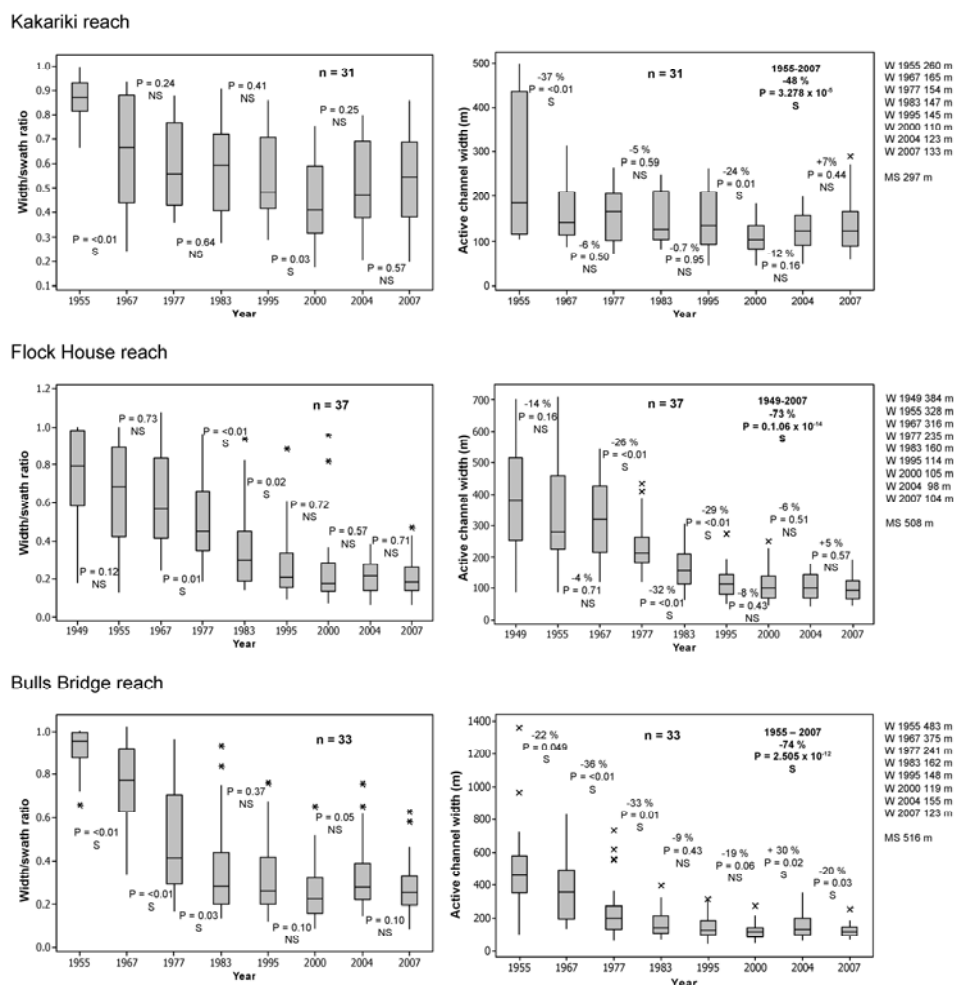
Figure 4. Rangitikei River active channel width and width/swath ratio changes in the study reaches between 1955 (1949 Flock House) and 2007; boxes represent inner and outer quartiles; vertical lines represent the upper limit = Q3 + 1.5(Q3-Q1) and lower limit = Q1-1.5(Q3-Q1); crosses are extreme values; n, number of width measurements; MS, mean value of floodplain swath; W, mean values of active channel width for each date; values in percent represents the rate of channel narrowing between dates; results of a parametric t-test are presented; S indicates significant differences of channel width and width/swath ratio between dates; NS, not significant.

The reduction in active channel widths derived from 30 cross sections in each reach is statistically significant (Figure 4). These results support the qualitative assessment of change derived from planform maps (Figure 3). Since 1983 the data suggest channel width has remained relatively stable with slight reductions in 2000 before an increase in 2004 (Figure 5). Overall between 1955 and 2007 the mean channel width of the Rangitikei River at Bulls Bridge reach has altered substantially, reducing by 74% (Figure 4). At Flock House mean active channel width reduced by 73% and at Kakairiki a 48% reduction occurred. Reach stability was also assessed by calculating the ratio of active channel width to total active channel width (or floodplain swath) for the three study the reaches (Figure 4). Channel width to floodplain swath ratios between 1955 and 1983 indicate a period of channel adjustment and narrowing before remaining relatively stable to 2007.

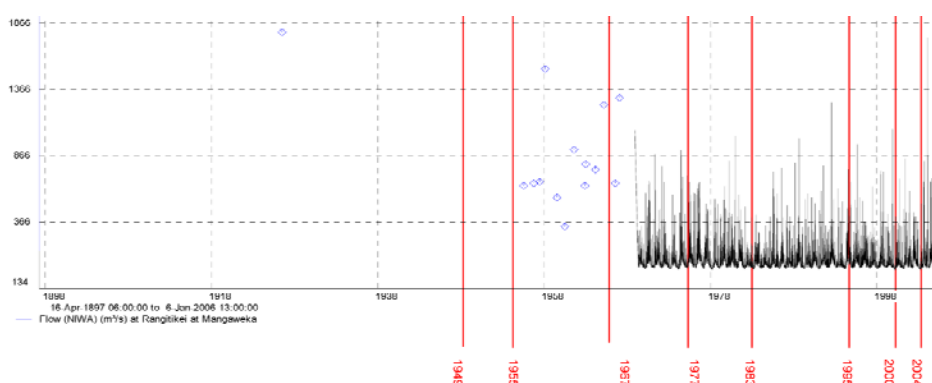
Figure 10. Flood hydrograph for the Rangitikei River gauged at Mangaweka, 16 April 1897 to 2006. Aerial photograph dates labelled (Courtesy of Brent Watson, Horizons Regional Council, Sept 2008).

Relatively small-scale alterations in the climate and flood regime can produce significant morphological adjustment in river channels (Rumsby and Macklin, 1994; Wishart *et al.*, 2008). The Mangaweka flow gauging site provides the longest continuous record of river flow for the Rangitikei River (Figure 10). Flow at Mangaweka comprises 79 to 88% of the flow at Kakariki during low flow periods (Horizons Regional Council, 2004) and so can be considered relatively representative of the general flow conditions occurring at the study reaches in the lower river. Figure 10 shows the flood peaks recorded at Mangaweka prior to 1970 in addition to the more recent continuous flow record. The data series shows no clear alteration in flood frequency or magnitude over the period of observation which would likely be responsible for river channel morphological change. It is also unlikely that the Moawhango dam in the upper catchment and associated flow diversion has contributed to channel change, since its influence is not detectable in the flow record at high flows and the effect on flood flow in the lower Rangitikei is estimated to be only a 0.4 percent reduction in flow (Horizons Regional Council, 2004). There is no evidence to suggest that there has been any change in the flood regime in the Rangitikei River from these records, although such changes have been identified in gravel-bed rivers in Scotland and northern England over a similar time period (Rumsby and Macklin, 1994; Werrity and Lees, 2001; Wishart *et al.* 2008). However there is no reason why New Zealand rivers should be in phase with British systems, in fact evidence suggests an anti-phase relationship (Macklin *et al.* 2009).
