**The Effectiveness of Riparian Buffer Zones
for Protecting Waterways during Harvest in
the Pipiwai Forest in Northland,
New Zealand**

A thesis presented in partial fulfilment of the requirements for the degree of
Master of Applied Science in Natural Resource Management

Massey University
Palmerston North, New Zealand

October 2007

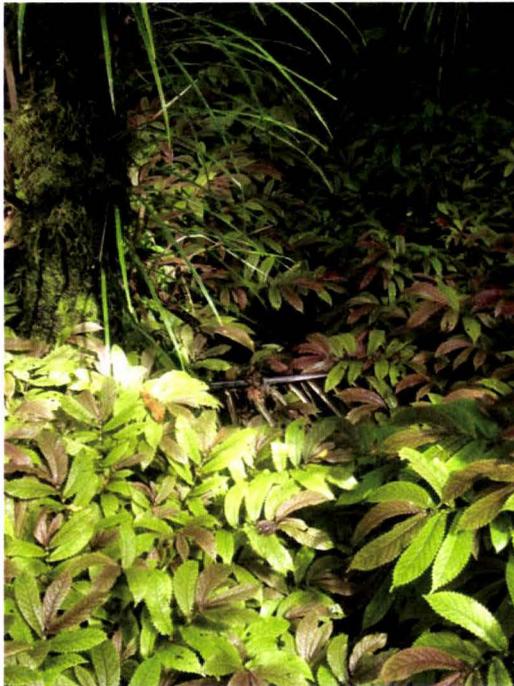
Figure 4.2 RBZ sample site one

RBZ sample site one. The native trees forming RBZ sample site one are over six metres tall and comprised of various species, including *Beilschmiedia tarairi* and *Podocarpus totara* with dense streamside undergrowth dominated by *Elatostema rugosum*. The rest of the under-storey is made up of common native species such as tree ferns, *Rhopalostylis sapida* and *Geniostoma rupestre*. The buffer zone is on average 15m wide on the right bank and over 30m on the left bank. The stream banks are clay while the bed is dominated by gravel and sand. The stream bank vegetation almost totally overhangs the stream giving it 90% shade all day.

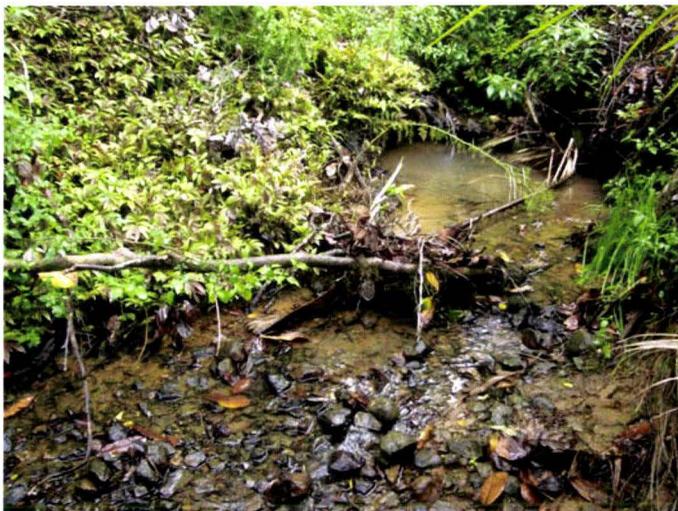
Figure 4.3 RBZ sample site two.

RBZ sample site two. The trees in RBZ sample site two are mainly mature *Beilschmiedia tarairi* over six metres tall, while the undergrowth is mostly sparse with ferns and a few shrubs. The removal of the plantation trees had increased the amount of sunlight penetrating the vegetation and caused an increase in weed growth. The

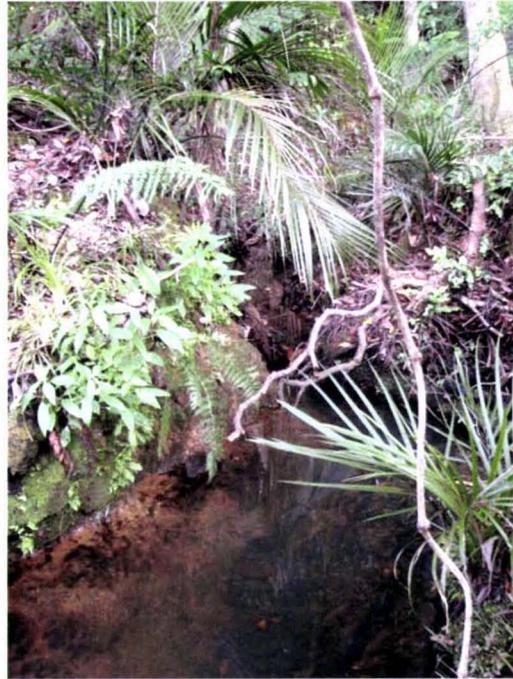
Figure 4.4 RBZ sample site three.

RBZ sample site three. RBZ sample site three is comprised of mainly mature *Beilschmiedia tarairi* trees over six metres tall that formed a closed canopy. There were large amounts of native leaf litter in and around the stream. The stream has a partial clay bed overlaid with stones. Under-storey vegetation was sparse, comprised mainly of ferns and *Rhopalostylis sapida* palms but the canopy and bank overhangs gave 80% shade to the stream. Buffer zones are over 30m wide on both banks.

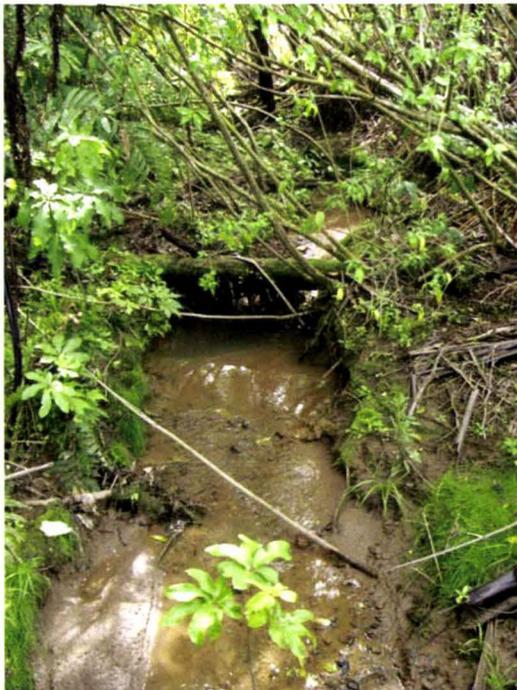
Figure 4.5 RBZ sample site four.

RBZ sample site four. The stream at RBZ sample site four is buffered mainly by *Leptospermum scoparium* and *Schefflera digitata* that are between three and four metres tall. On the stream banks there are weeds as well as native *carex* grasses and ferns. The streambed is comprised of mainly fine gravel and sand with some clay, and as such contained few stable substrates. The buffer zone on the left bank is 5m wide and the right bank is 30m wide. There was 60% shading by the native vegetation.

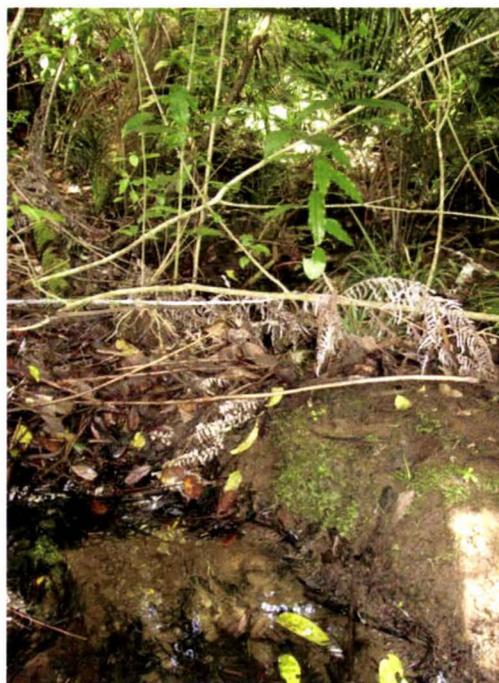
Figure 4.6 RBZ sample site five.

RBZ sample site five. The trees at RBZ sample site five are mature native *Beilschmiedia tarairi* and *Agathis australis* which are over 6m tall and form closed canopy which provides 95% shade for the stream. The stream is wide and shallow with a very soft mud bottom and contained large amounts of leaf litter which in places formed dams. The buffer zone on the right bank is 30m wide while the one on the left bank is over 40m wide. Under-storey plants were again typical of other sites with ferns, *Rhopalostylis sapida*, *Geniostoma rupestre* and seedlings.

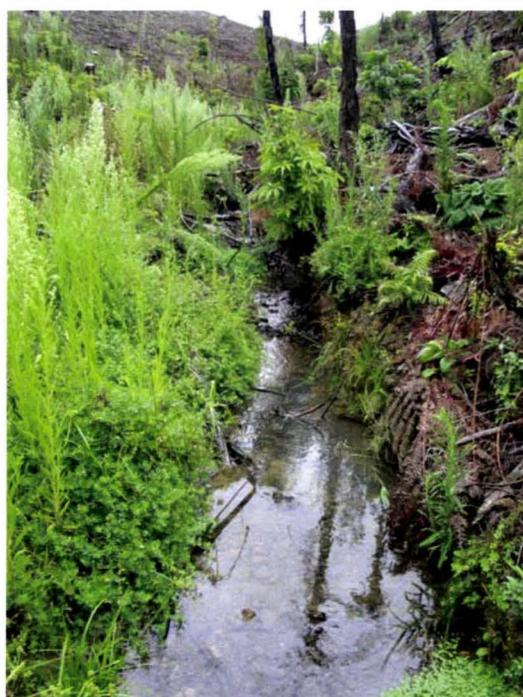
Figure 4.7 Clearcut sample site one.

Clearcut sample site one. Clearcut sample site one was harvested in the autumn of 2004 using ground based harvest machinery. Trees were harvested within 2m of the stream and left slash next to and in the stream. Outside the sample area small debris dams had formed. The photo shows tall weeds growing on the right bank and low growing weeds and regenerating native vegetation on the left bank. The sparse vegetation and bank overhangs gave the stream 10% shade.

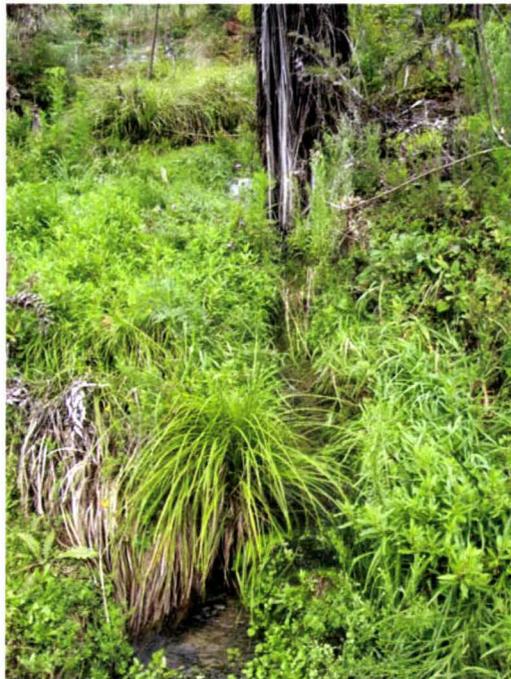
Figure 4.8 Clearcut sample site two.

Clearcut sample site two. Clearcut sample site two was harvested at the end of 2003 using ground based harvesting. Trees were harvested within 1-2m of the stream with no slash left in or near it. There were a significant number of aquatic plants growing in the stream, including watercress and green filamentous algae. The banks were covered with grass and weeds, (which included the natives *Carex comans* and *Cyperus ustulatus*). There were also some ferns present but very few woody plants. The dense and overhanging vegetation provided the stream with 40% shade.

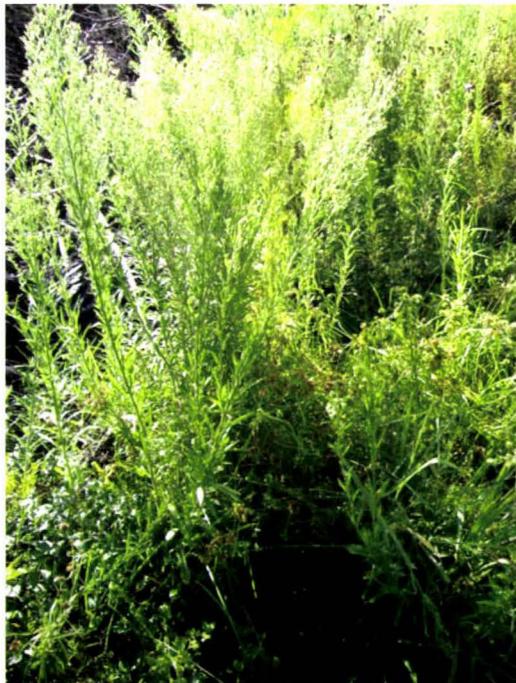
Figure 4.9 Clearcut sample site three.

Clearcut sample site three. Clearcut sample site three was harvested in the summer of 2004 using a cable hauler. Trees were harvested within 2m of the stream as well as hauled across it. There were large amounts of slash on both banks (which can be seen on the left of the photo) but none in the stream. This had been cleared from the stream by hand. The dense weed and grass growth (including natives *Carex comans* and *Cyperus ustulatus*) combined with the high stream banks and narrow stream provided 95% stream shading.

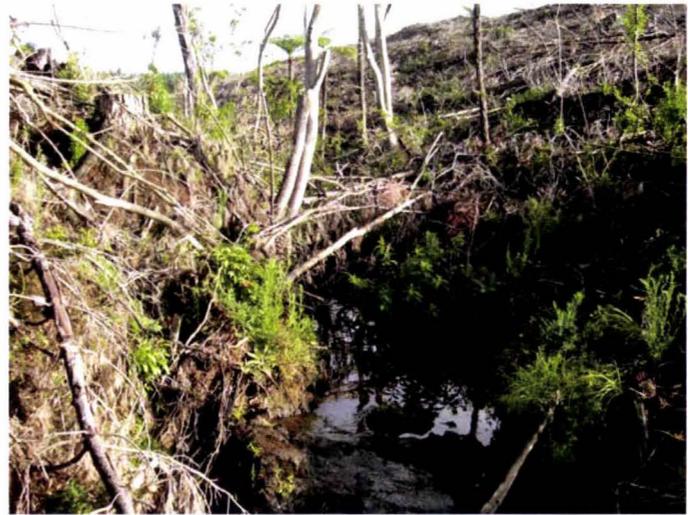
Figure 4.10 Clearcut sample site four.

Clearcut sample site four was harvested in 2004 using ground based machinery. Harvesting occurred within 2m of the stream and left slash on both banks, suspended across the stream and in the stream. The right hand stream bank was unstable and active erosion was depositing

soil near the water's edge. There were a few native plants growing or regenerating in the riparian management zone, but the area was mostly bare ground covered with slash. As a result there was very little cover and only 30% shade.

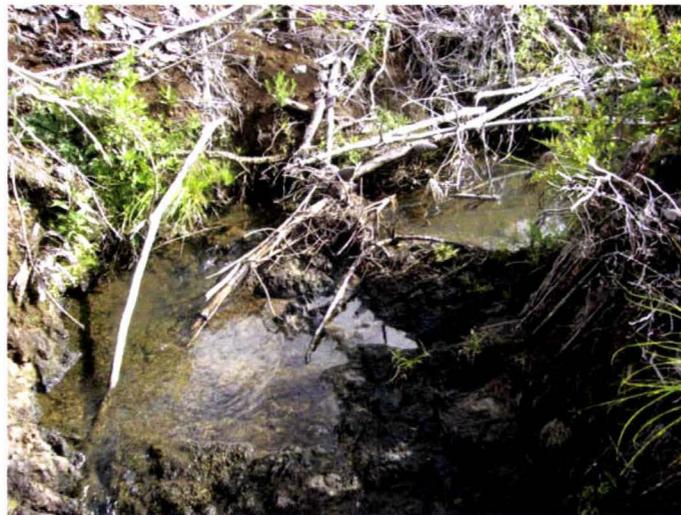
Figure 4.11 Clearcut sample site five.

There was very little stream side vegetation, subsequently, the 30% stream shade came mainly from bank overhangs and slash.

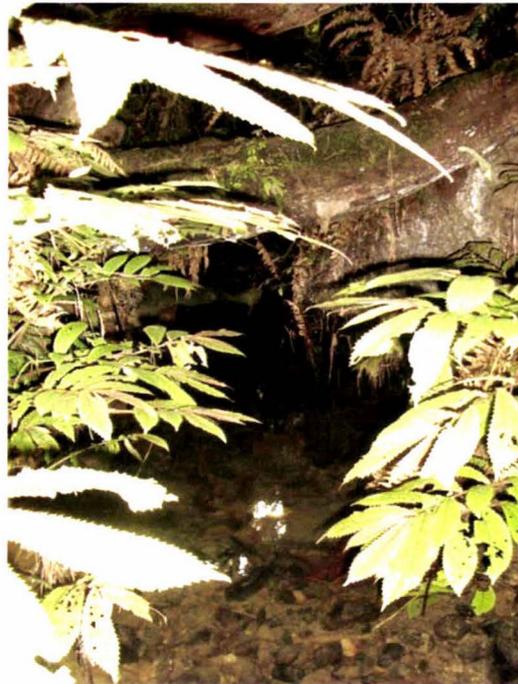
Figure 4.12 Pine sample site one.

Pine sample site one. Pine sample site one has a stony bottom with sloping banks approximately three metres high. There are no pine trees planted on these banks, the closest were five metres from the waters edge. The pine trees had formed a closed canopy and there was an under-storey of native vegetation including ferns, tree ferns *Ripogonum scandens*, *Elatostema rugosum* and other shrubs and seedlings. The very thick tree cover provided 95% shade.

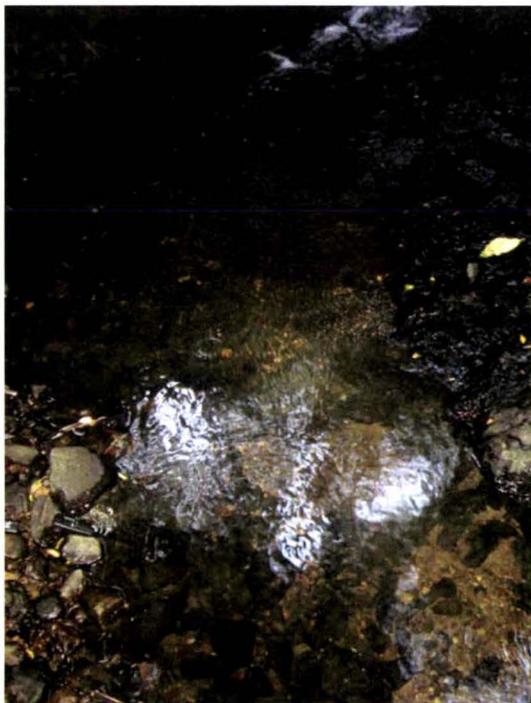
Figure 4.13 Pine sample site two.

Pine sample site two. The stream at pine sample site two has a stony and bedrock bed. Its bedrock banks rise steeply out of the stream to five metres on the right bank and over 10 on the left bank. This part of the plantation had no pine trees within 15m of right bank and 25m of the left bank. The riparian vegetation is comprised of native trees over six metres tall which form a closed canopy and an under-storey of shrubs and plants. The canopy is dense and provides 95% shade; despite this there were very few needles or leaves in the stream.

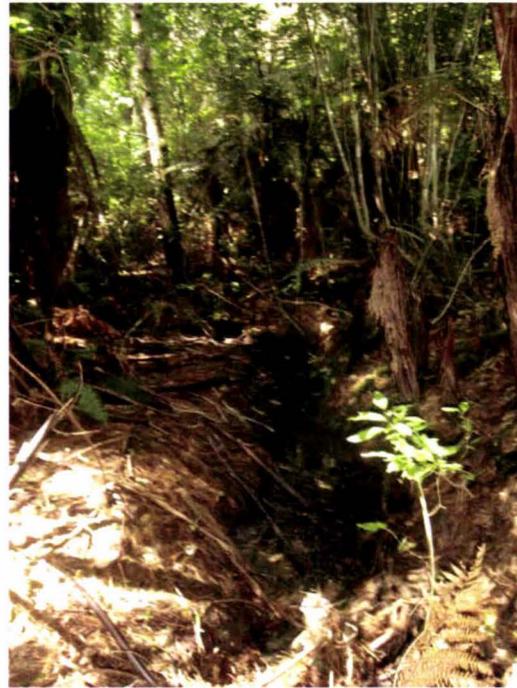
Figure 4.14 Pine sample site three.

Pine sample site three. Pine sample site three is a flat site with pine trees planted to within 1m of the stream. The stream banks are clay, as is part of the streambed, which is also comprised of stones and gravel. Growing beneath the closed pine canopy was a dense under-story of native plants and trees. The vegetation provided 95% shade, and added pine needles, pieces of wood and other plant material to the stream.

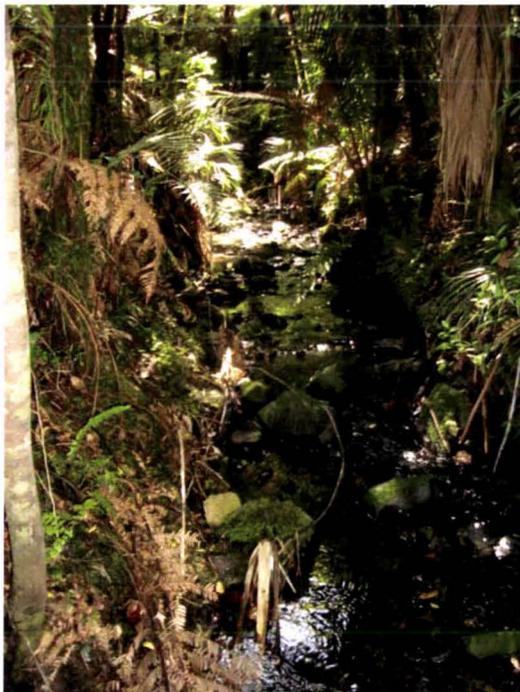
Figure 4.15 Pine sample site four.

Pine sample site four. The pine trees at pine sample site four were set back 15-20m from the left bank while the right had no pine trees present. The right bank, at the sample site is a wedge of ground that divides this stream from the stream used for sample site five (the two streams joined a short distance downstream of the sample sites). Native vegetation makes up the forest around the stream. The canopy trees are over six metres tall and have made closure, this, combined with the under-storey of ferns and smaller trees, give the stream 95% shade. The stream is stony and contained leaf litter and pieces of wood.
