A Working Paper Series in Physical Geography
2010/2

Quantification of channel planform change on the lower Rangitikei River, New Zealand, 1949-2007: response to management?

Jane M. Richardson
Ian C. Fuller

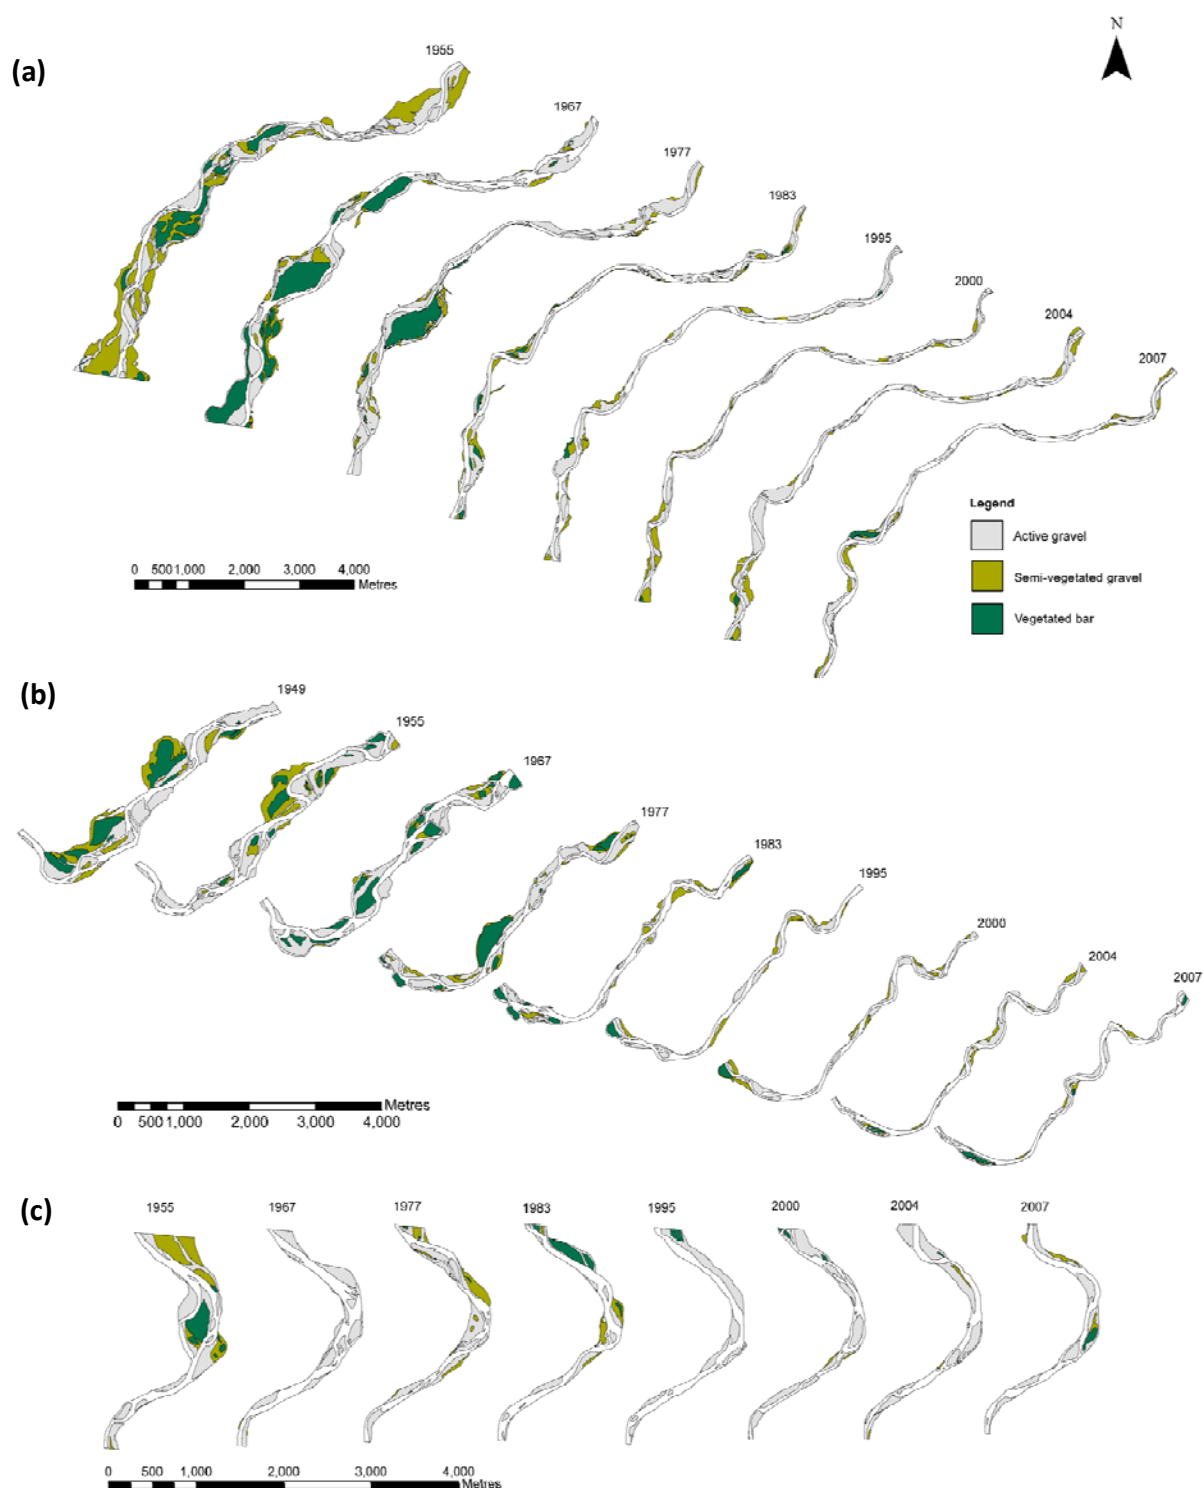
Figure 3. (a) Channel planform changes at the Bulls Bridge reach, lower Rangitikei River, derived from aerial photographs (1955-2007); (b) Channel planform changes at the Flock House reach, lower Rangitikei River, derived from aerial photographs (1949-2007); (c) Channel planform changes at the Kakariki reach, lower Rangitikei River, derived from aerial photographs (1955-2007). Flow is from north to south in each.

Historic planform reconstructions of each reach (Figure 3) show that in 1949 and/or 1955 the wide active channel was multi-threaded, comprising numerous bare gravel, vegetated and semi-vegetated mid-channel bars, high flow chute channels, abandoned anabranches and extensive lateral bar surfaces displaying various degrees of vegetation development. By 2007 all three reaches narrowed considerably, display less morphological complexity and are predominantly laterally stable single thread reaches. The 2007 active channel almost entirely comprises active gravel surfaces, with relatively small isolated patches of semi-vegetated and vegetated lateral bars evident (Figure 3).

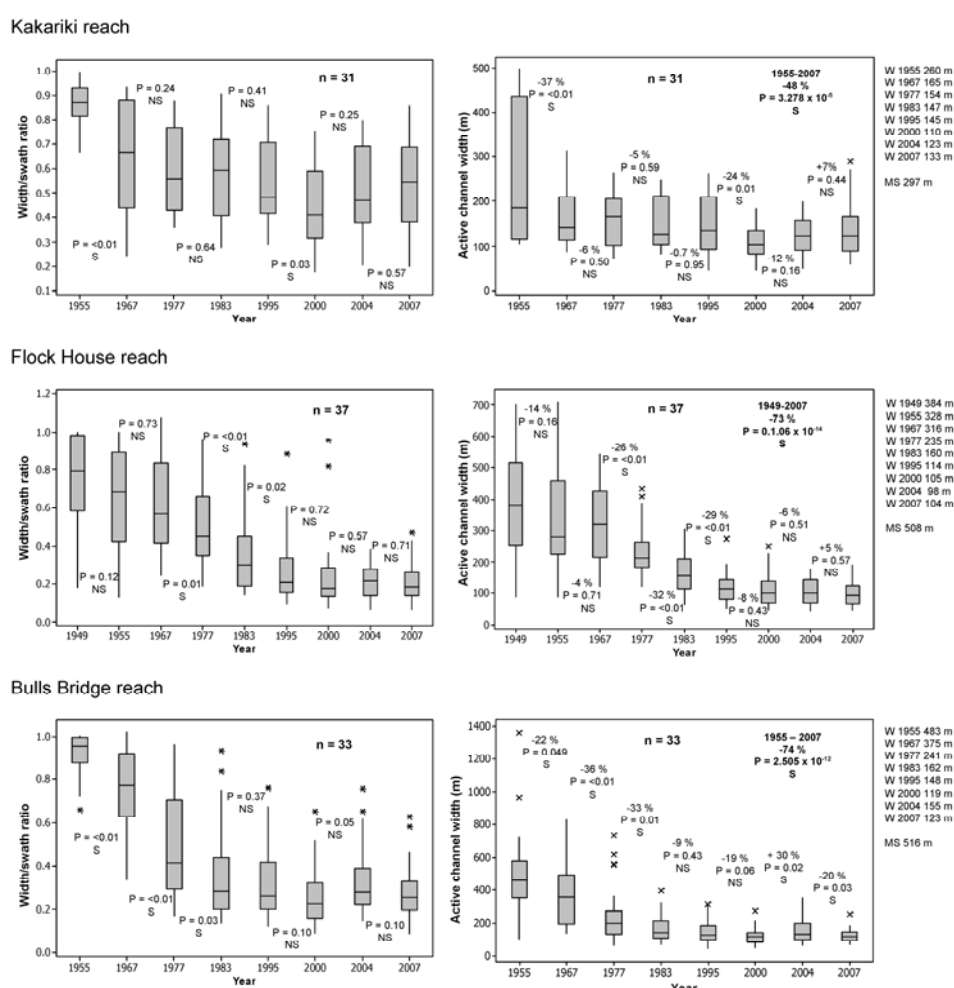
Figure 4. Rangitikei River active channel width and width/swath ratio changes in the study reaches between 1955 (1949 Flock House) and 2007; boxes represent inner and outer quartiles; vertical lines represent the upper limit = $Q3 + 1.5(Q3-Q1)$ and lower limit = $Q1 - 1.5(Q3-Q1)$; crosses are extreme values; n, number of width measurements; MS, mean value of floodplain swath; W, mean values of active channel width for each date; values in percent represents the rate of channel narrowing between dates; results of a parametric t-test are presented; S indicates significant differences of channel width and width/swath ratio between dates; NS, not significant.

The reduction in active channel widths derived from 30 cross sections in each reach is statistically significant (Figure 4). These results support the qualitative assessment of change derived from planform maps (Figure 3). Since 1983 the data suggest channel width has remained relatively stable with slight reductions in 2000 before an increase in 2004 (Figure 5). Overall between 1955 and 2007 the mean channel width of the Rangitikei River at Bulls Bridge reach has altered substantially, reducing by 74% (Figure 4). At Flock House mean active channel width reduced by 73% and at Kakairiki a 48% reduction occurred. Reach stability was also assessed by calculating the ratio of active channel width to total active channel width (or floodplain swath) for the three study the reaches (Figure 4). Channel width to floodplain swath ratios between 1955 and 1983 indicate a period of channel adjustment and narrowing before remaining relatively stable to 2007.

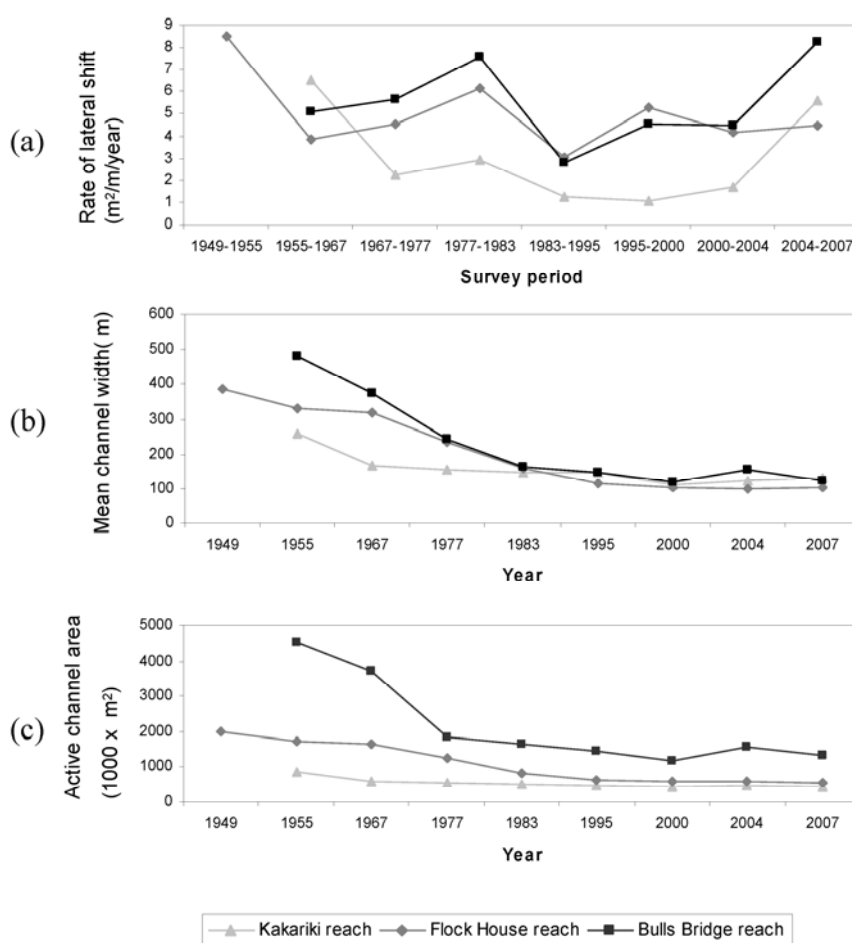
Figure 5. Changes in active channel parameters (a) rate of lateral shift (b) mean channel width and (c) active channel area, for the Kakariki, Flock House and bulls Bridges study reaches.

The rates of lateral channel shift calculated for each reach indicate that there has been movement of the channel midpoint and that the rate of this movement over time has been variable (Figure 5a). Although direct comparison of the rates of lateral shift is made difficult by the unequal number of years between records it does give some indication of channel stability over the study duration. The Flock House reach was subject to the greatest rates of channel midpoint migration during the period 1949-1955 with a rate of over $8 \text{ m}^2 \text{m}^{-1} \text{year}^{-1}$ calculated (Figure 5a). The Bulls Bridge reach experienced the greatest rate of lateral shift during two periods, 1977-1983 and 2000-2004. For the Kakariki reach the rate of lateral shift was highest between 1955-1967 and 2004-2007. The results illustrate similarities in the way the Flock House and Bulls Bridge reaches have behaved over time, with the variation in the rates of lateral rate shift mirroring each other between 1955 and 2004 (Figure 5a).

Quantitative analysis of active channel composition change was carried out for each of the study reaches of the lower Rangitikei River (Figure 5c). What is immediately evident is a marked reduction in

the active channel area for all three reaches between 1949 and 1983. Analysis of channel modification revealed that in less than 30 years the active channel area contracted by 64% at Bulls and 68% at Flock House (Figure 5c). Since 1983 there have been relatively small changes in the active channel area. A small (25%) expansion of the Bulls Bridge active channel between 2000 and 2004, but by 2007 the extent of the active channel had reduced again. At Flock House after 1995 very little variation in the total area occupied by the active channel is evident (Figure 5c).

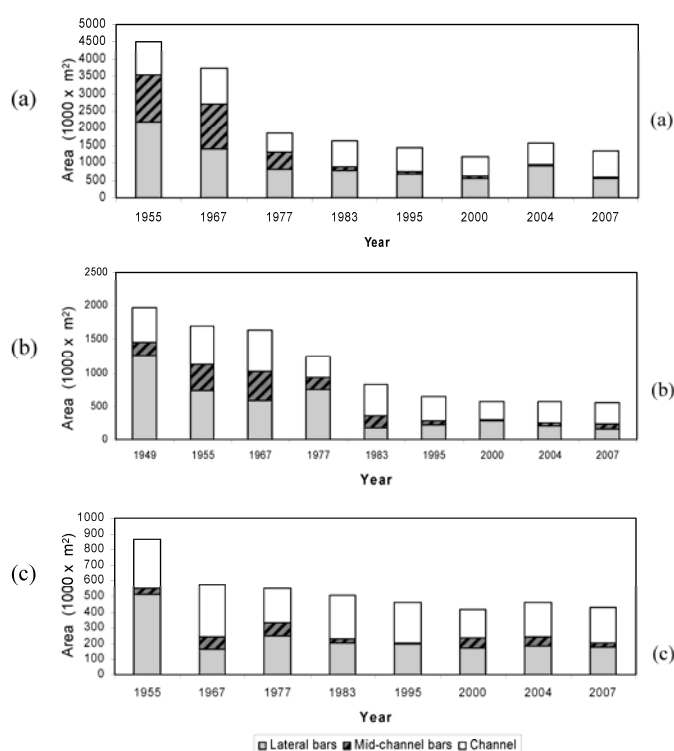
Figure 7. Changes in active channel geomorphology showing mid-channel and lateral bar area at: (a) Bulls Bridge, (b) Flock House, (c) Kakariki.

GIS analysis of the active channel not only included the composition of the active channel but also differentiated between areas of wetted channel, lateral and mid-channel bars (Figure 7). Although the aerial photographs were taken during periods of low flow there will be some fluctuation in the relative proportion of bar type and wetted channel area. Despite these limitations some clear trends can be identified, with a reduction in the extent of lateral and mid-channel bars between 1955 and 1983 clearly visible. For example, in 1955 30% of the active channel area at Bulls Bridge comprised mid-channel bars, by 1983 this reduced to 5%.

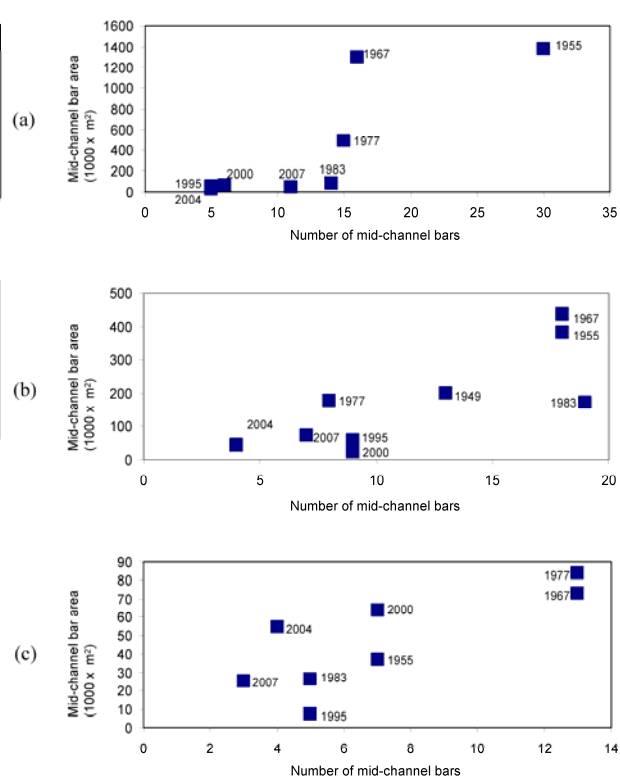
Figure 8. Changes in the number and area of mid-channel bars 1955 (1949 Flock House)-2007 at: (a) Bulls Bridge, (b) Flock House, (c) Kakariki.

Figure 8 shows that not only has there been a reduction in the area associated with mid-channel bars between 1955 and 1983 but that the actual number of bars has also decreased. Lees and Werritty (1999) used an analysis of total medial bar area and number of bars to identify a trend from braided to single thread planform. This study uses a similar approach which identifies a reduction in braiding with fewer mid-channel bars detected within the study reaches and an associated reduction in the area of mid-channel bars between 1955 and 1983 (Figure 8). Whilst Bulls Bridge and Flock House show similar

trends (Figure 8a-b), results from Kakariki do not show a clear trend (Figure 8c), although there is some indication that the reach was more braided in 1967 and 1977. A braiding index summarises these changes (Figure 9a), showing a clear reduction in braiding over the period of study. Commensurate with this reduction in braiding is an overall increase in reach sinuosity, although the trend is not dramatic (Figure 9b).

In February 2004 the Rangitikei River catchment along with many other areas in the lower half of the North Island were subject to heavy rainfall as a consequence of an intense '150 year' storm. Rainfall in the Ruahine Ranges exceeded 200 mm in 24 hours at most sites (Meteorological Society, 2004). The hydrograph for the Rangitikei River gauged at Mangaweka recorded a maximum flow of 1756 m³ sec⁻¹ as a result of this rainfall (NIWA, 2008). Aerial photographs taken in 2004 record changes in active channel planform occurring in response to a low frequency high magnitude flood event. The Bulls Bridge reach alone showed any evidence of change in the extent of the active channel. Analysis of the planform in 2004 showed with a small (5%) increase in the area of active gravel (Figure 6a and 7a) corresponding with a slight increase in lateral bar area returning to pre-2004 extent by 2007 (Figure 7a). Mean active channel width increased by 30% as result of the flood but reduced by 20% before 2007 (Figure 4). These findings indicate that the high flood flows resulted in inundation and mobilisation of previously stable lateral bar surfaces, increasing the active channel boundaries temporarily. No increase in braiding index and only a slight increase in sinuosity due to bend extension was identified in the Bulls Bridge reach (Figure 9). The rate of lateral shift calculated for the Bulls Bridge and Kakariki reaches increased in the period of observation following the flood, suggesting a degree of post flood adjustment had occurred (Figure 5a). In contrast the Flock House and Kakariki reaches showed no evidence of expansion of the active channel area or morphological units within the active channel boundaries (Figures 5c and 6). Sinuosity increased slightly in the Kakariki reach and more strongly in the Flock House reach following the 2004 flood event (Figure 9b). Neither reach displayed any marked change in braiding index, number or area of mid-channel bars (Figure 8b, 8c and 9a).

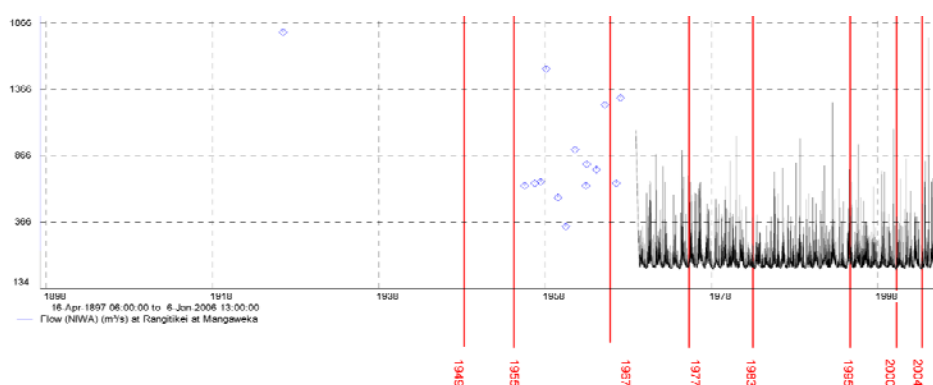
Figure 10. Flood hydrograph for the Rangitikei River gauged at Mangaweka, 16 April 1897 to 2006. Aerial photograph dates labelled (Courtesy of Brent Watson, Horizons Regional Council, Sept 2008).

Relatively small-scale alterations in the climate and flood regime can produce significant morphological adjustment in river channels (Rumsby and Macklin, 1994; Wishart *et al.*, 2008). The Mangaweka flow gauging site provides the longest continuous record of river flow for the Rangitikei River (Figure 10). Flow at Mangaweka comprises 79 to 88% of the flow at Kakariki during low flow periods (Horizons Regional Council, 2004) and so can be considered relatively representative of the general flow conditions occurring at the study reaches in the lower river. Figure 10 shows the flood peaks recorded at Mangaweka prior to 1970 in addition to the more recent continuous flow record. The data series shows no clear alteration in flood frequency or magnitude over the period of observation which would likely be responsible for river channel morphological change. It is also unlikely that the Moawhango dam in the upper catchment and associated flow diversion has contributed to channel change, since its influence is not detectable in the flow record at high flows and the effect on flood flow in the lower Rangitikei is estimated to be only a 0.4 percent reduction in flow (Horizons Regional Council, 2004). There is no evidence to suggest that there has been any change in the flood regime in the Rangitikei River from these records, although such changes have been identified in gravel-bed rivers in Scotland and northern England over a similar time period (Rumsby and Macklin, 1994; Werrity and Lees, 2001; Wishart *et al.* 2008). However there is no reason why New Zealand rivers should be in phase with British systems, in fact evidence suggests an anti-phase relationship (Macklin *et al.* 2009).

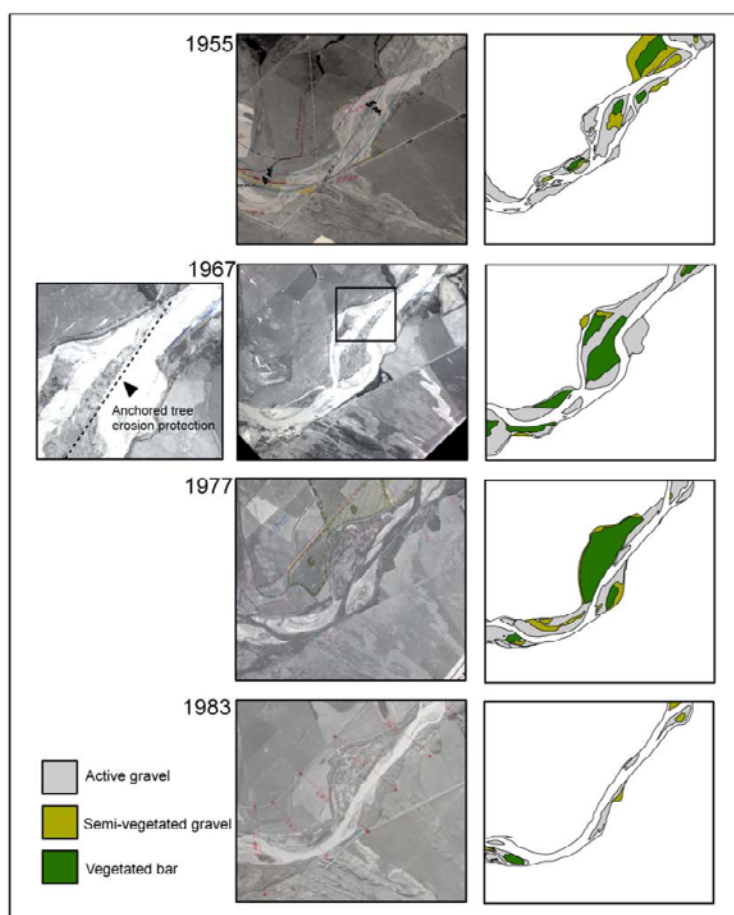
Figure 11. The effect of anchored tree erosion protection on channel planform in the Flock House reach of the lower Rangitikei River, 1955 to 1983.

The Rangitikei River scheme commenced in the early 1950s with a programme of river control involving bank protection work using anchored tress and protective planting to stabilise banks. The stabilising effect of bank vegetation is well reported (e.g. McKenny *et al.*, 1995; Marston *et al.*, 1995; Gurnell, 1997; Abernethy and Rutherford, 1998). Observation of channel planform changes that have occurred in selected reaches of the lower Rangitikei suggest that bank protection measures implemented through the Rangitikei River Scheme have been particularly effective in controlling bank erosion. Figure 11 shows how a line of anchored trees placed in the active channel before 1967 has influenced channel form in this section of the Flock House reach. In 1955 this part of the channel was wide, multi-channelled and with a large mid-channel bar present. A line of anchored trees installed down the length of the mid-channel bar prior to 1967 effectively cut off the side channels from the main thalweg. Further vegetation stabilisation of the bar surface prevented reactivation of the abandoned channels, maintained a narrower single-thread planform and culminated in complete disconnection from the active channel by 1983. Closer inspection of aerial photographs and reconstructed planform maps

reveals the extensive role that the bank protection works played in modifying the active channel throughout the Flock House, Bulls Bridge and Kakariki reaches. Quantitative and qualitative evidence of channel change suggests that the early bank protection measures were particularly successful at reducing the active channel width and area, with the majority of the changes occurring prior to 1983 with relative stability since then. These findings are in agreement with research that has found that the development and encroachment of riparian vegetation, either through land use change or river engineering, has played a major role in promoting geomorphic change within river systems (Gurnell, 1997; Marston *et al.*, 1995; Liébault and Piégay, 2002).
