**IMPROVING PRODUCTIVITY IN ROAD PAVEMENT  
MAINTENANCE AND REHABILITATION IN NEW ZEALAND**

**Masters Thesis**

A Thesis presented in fulfillment of the requirements for the degree of Master of  
Construction Management

Massey University, Albany

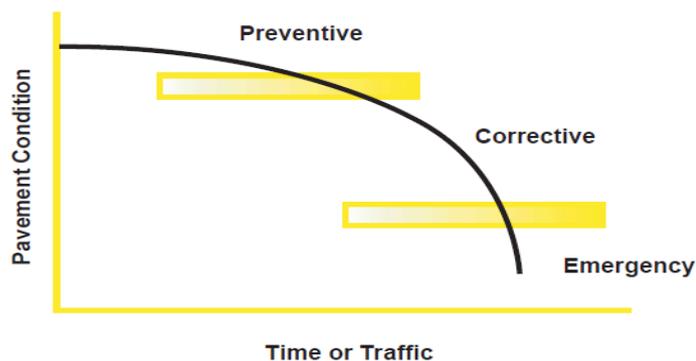
**Figure 2** : Categories of pavement maintenance

As categorised by Johanns and Craig (2002), pavement maintenance can be divided into three types. First is preventive maintenance, the second type is corrective maintenance, and the third is emergency maintenance. Of these three types of maintenance, preventive maintenance is the most important type. Preventive maintenance is significantly more cost effective and efficiency promoting than costly corrective maintenance or reconstruction. The cost of corrective pavement maintenance that could be reduced through inexpensive early preventive maintenance is significant. The below Figures (2 & 3) show the time and effect of this type of maintenance.

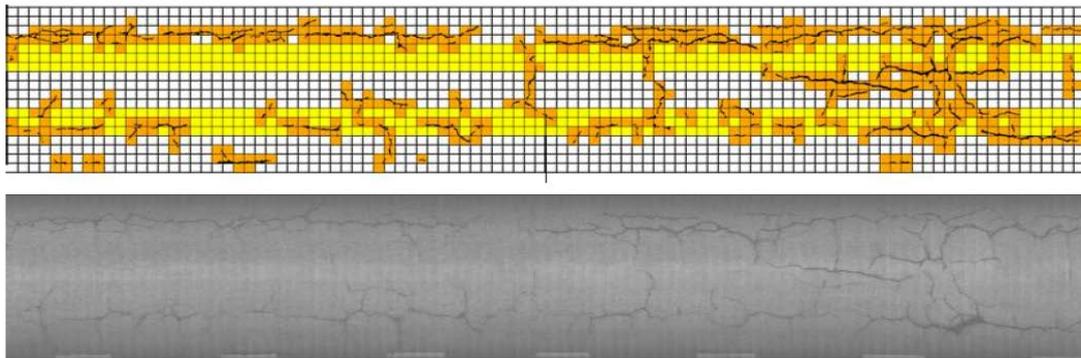
**Figure 5** : Picture of Detected Cracks

In Europe, the PAVUE system ("Ramboll, 2011) has operated in the Netherlands and Finland. Ramboll's system can be equipped with either multiple video cameras or line scan cameras for collection of continuous images of the road surface, which are automatically analysed with the Automated Image Evaluation System (AIES) (Gavilan et al., 2011, p. 9631).

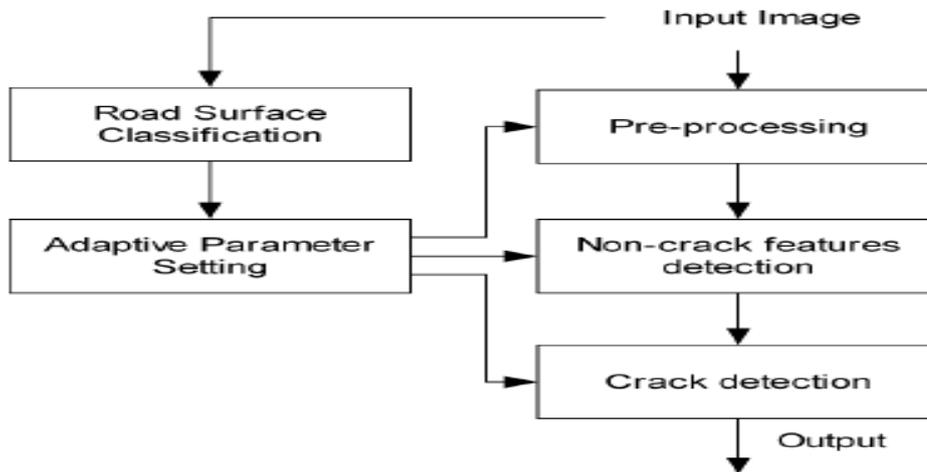
**Figure 6:** Global overview of a proposed adaptive road distress detection strategy

The below flowchart (Figure 7) shows the global overview of a proposed adaptive road distress detection system that is divided into four main stages: road surface classification, pre-processing, non-crack features detection, and crack detection. The output of the classifier is used to adapt the system parameters (Gavilan et al., 2011).

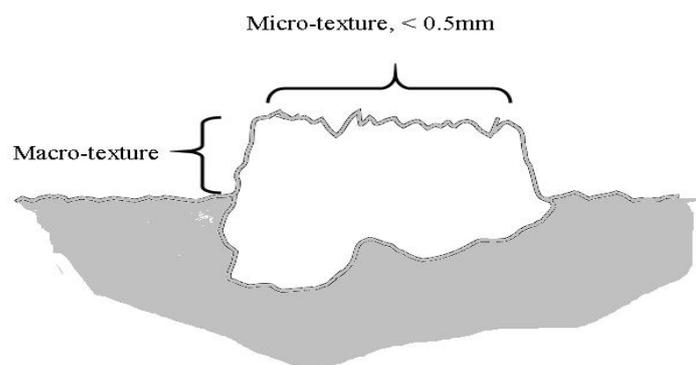
**Figure 7:** Macro-texture

Micro texture is the fine scale texture of individual aggregate particles and macro texture is the projection of wear-resistant coarse aggregates above the pavement surface (Phillips & Kazmierowski, 2010), as displayed in Figure 8.

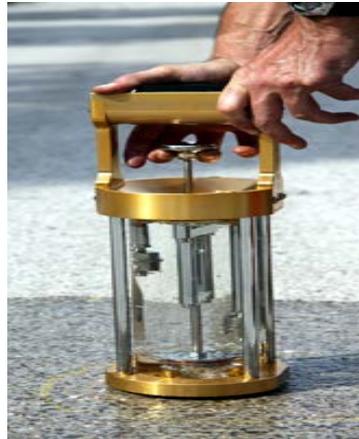
**Figure 6:** Outflow meter

works based on measuring the time for a fixed volume of water to escape from a measured cylinder with a rubber bottom (Wang, Yan, Huang, Chu, & Abdel-Aty, 2011). An example of an outflow meter is depicted in Figure 9.

Currently contact measurement methods are the most usual and traditional methods for measuring the macro texture. These methods include the outflow meter and sand patch, with the sand patch as the most usual method. The outflow meter estimates the pavement texture indirectly. The outflow meter

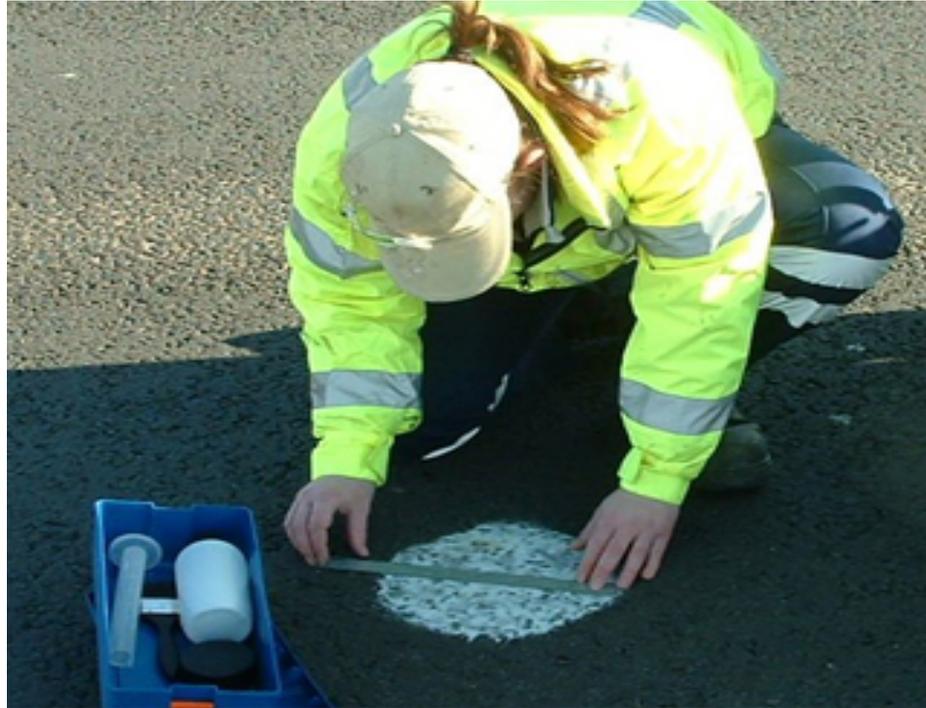
**Figure 7:** Sand Patch Test

The sand patch test relies on a given volume of sand, which is spread out on a road surface. The standard procedure is as follows: a fixed volume of sand ( $45 \pm 0.5$  ml) with granulation between 300 and 600  $\mu\text{m}$  is distributed to form a circular patch, the diameter of which is measured. By dividing the volume of sand with the area covered, a value is obtained that represents the average depth of the sand layer, i.e. an average (texture depth) (Huang et al., 2011; Pavestech, 2012). Figure 9 shows a sand patch test being undertaken.

Sand patch testing is repeated every 50m and is taken for each wheel path and one on the center of two. The value for all readings is averaged, and the value obtained is used in road maintenance design. However, this method of texture testing has some limitations, such as taking a long time to perform. The operation of this test is normally done in moving traffic and with changing climate, so operators are faced with road hazards, and reproducibility of the test is poor (Huang et al., 2011; Pidwerbesky, Waters, Gransberg & Stemprok, 2006). However, to overcome these disadvantages, alternative tactile texture measurements, such as laser sensing and image processing techniques, have been developed.

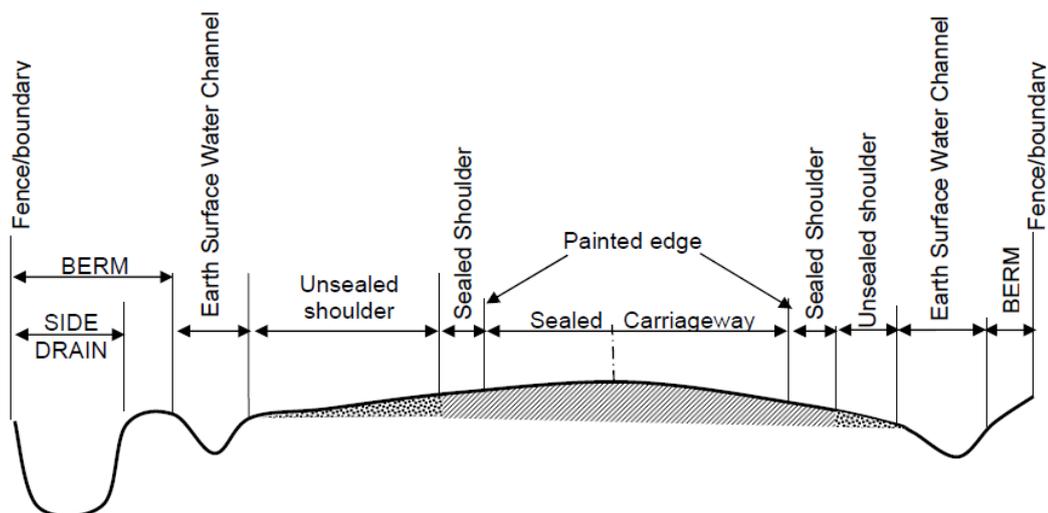
**Figure 8:** Cross section of rural roads

For a comprehensive understanding of the following definition about road defects and conditions, it will be useful to show a typical cross section of roads (Figures 10 and 11).

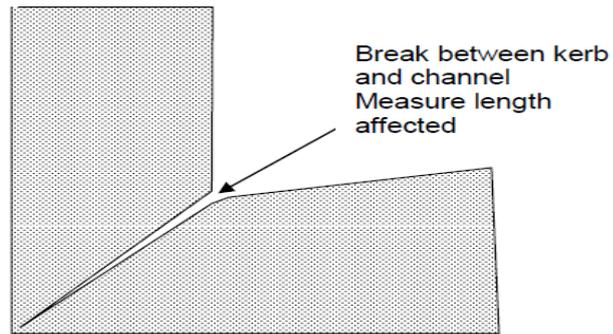
**Figure 10:** Broken channel

Any channel that is badly cracked or broken and will let waters flow steadily to the base and sub-base material is called a broken channel. Inadequate joints between kerbing blocks and separation between two sections of the channel, are also classed as broken channels, as seen in Figure 12.

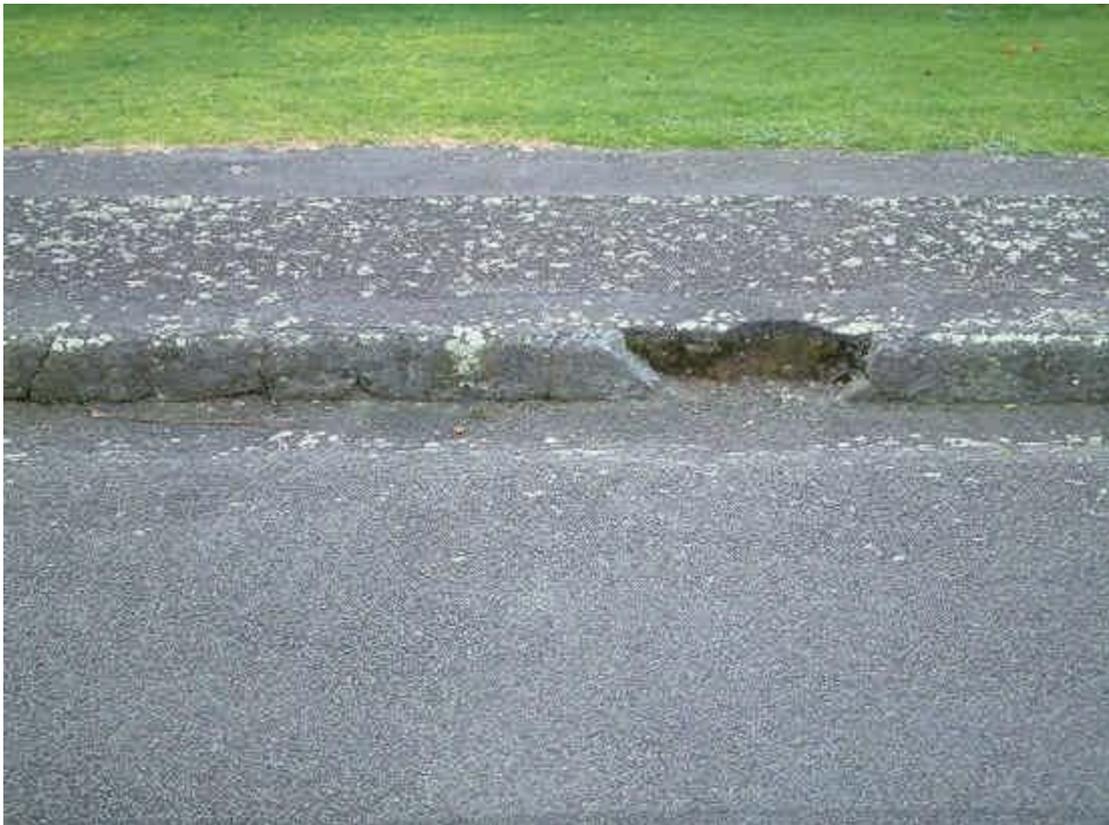
The photos below (Figures 13-15) show broken channels, inadequate kerb block joints and separation between the channel and back of the kerb.

**Figure 11:** Example of a broken channel

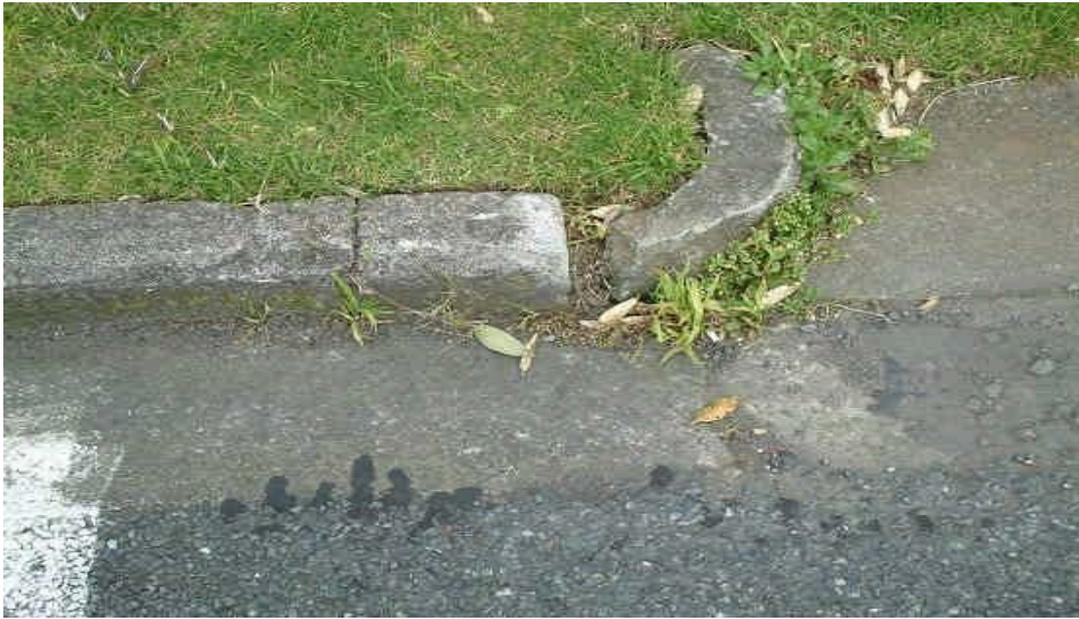
**Figure 12:** A badly broken kerb

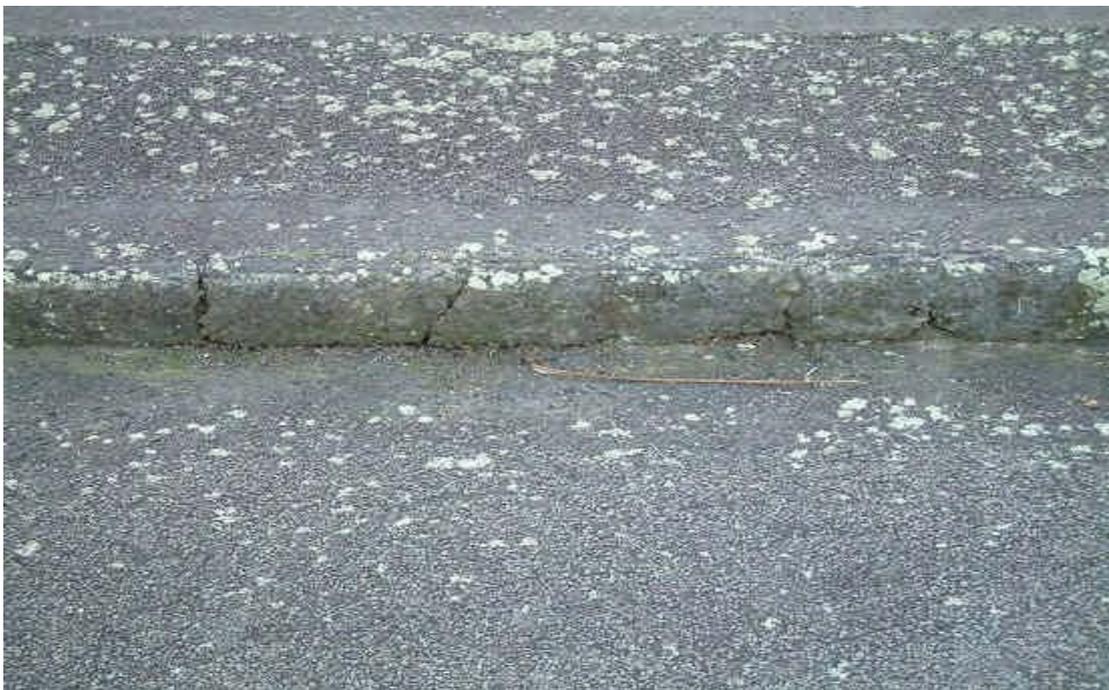
Figure 14 shows an example of a broken kerb and channel that are readily leaking water through to the sub-base of the carriageway.

**Figure 13:** A broken section of channel adjoining a vehicle crossing

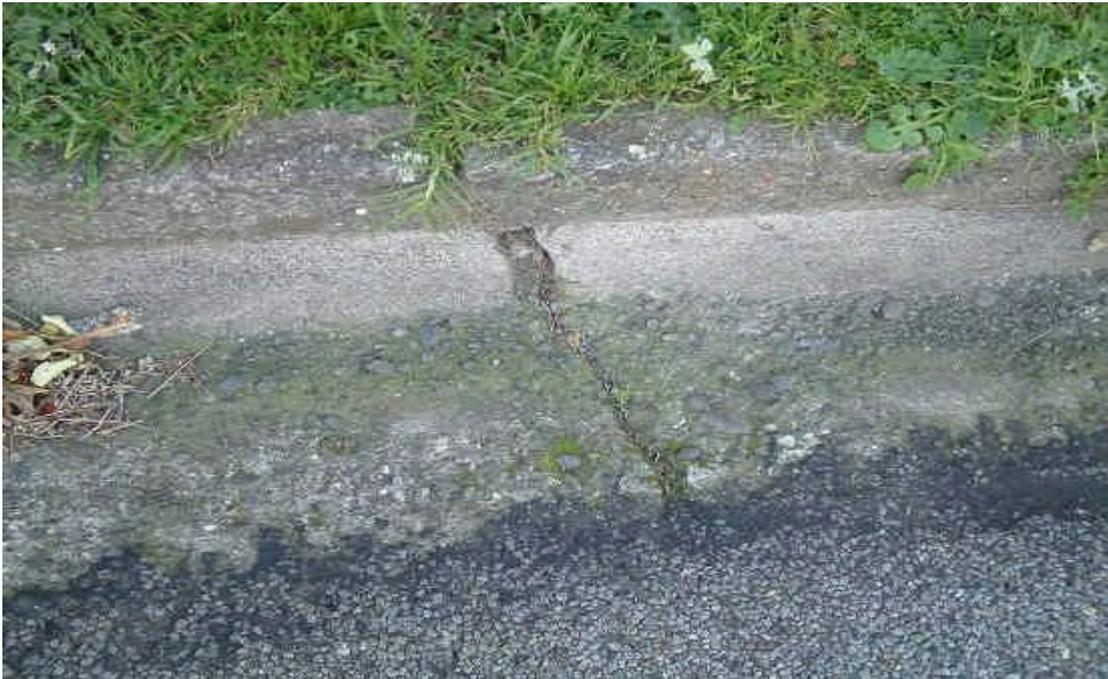
Separation between the channel and the kerb up-stand is to be rated as broken.

**Figure 14:** Single crack in the kerb

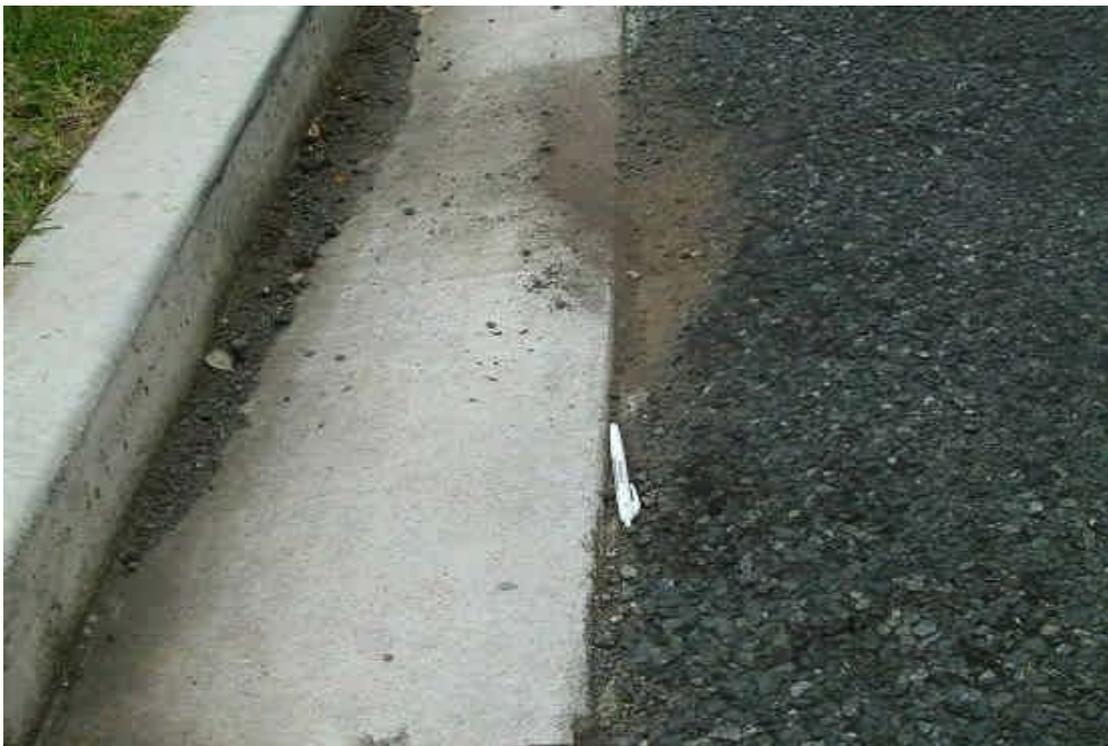
This photo (Figure 19) is a good example of a lip channel above the carriageway surface.

**Figure 17:** High lip channel

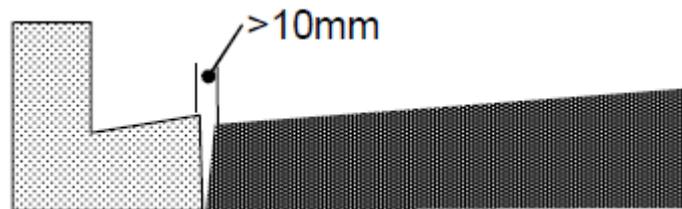
These kinds of failures happen when the space (more than 10mm) is between the channel and the carriageway. The length of channel that is affected needs to be recorded, as well as the length of kerb where there is structure separation between the kerb and the carriageway, if existent.

**Figure 18:** Broken surface at channel lip

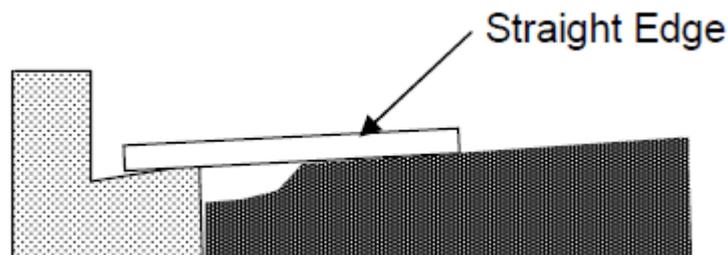
**NOTE:** If the defect is the same as in Figure 20, it indicates that the broken surface is the cause of a high lip, and it should be rated as broken surface.

**Figure 19:** Broken surface at channel lip

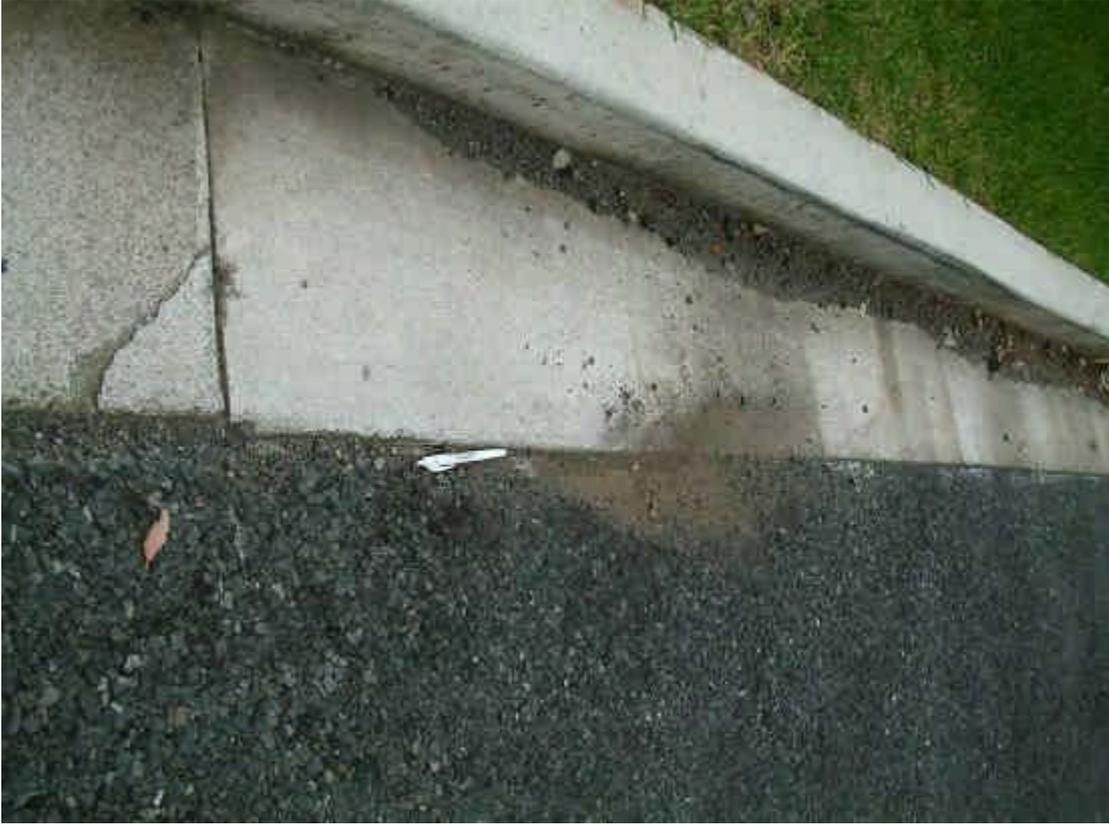
**Figure 20:** A break in the carriageway surface alongside the channel

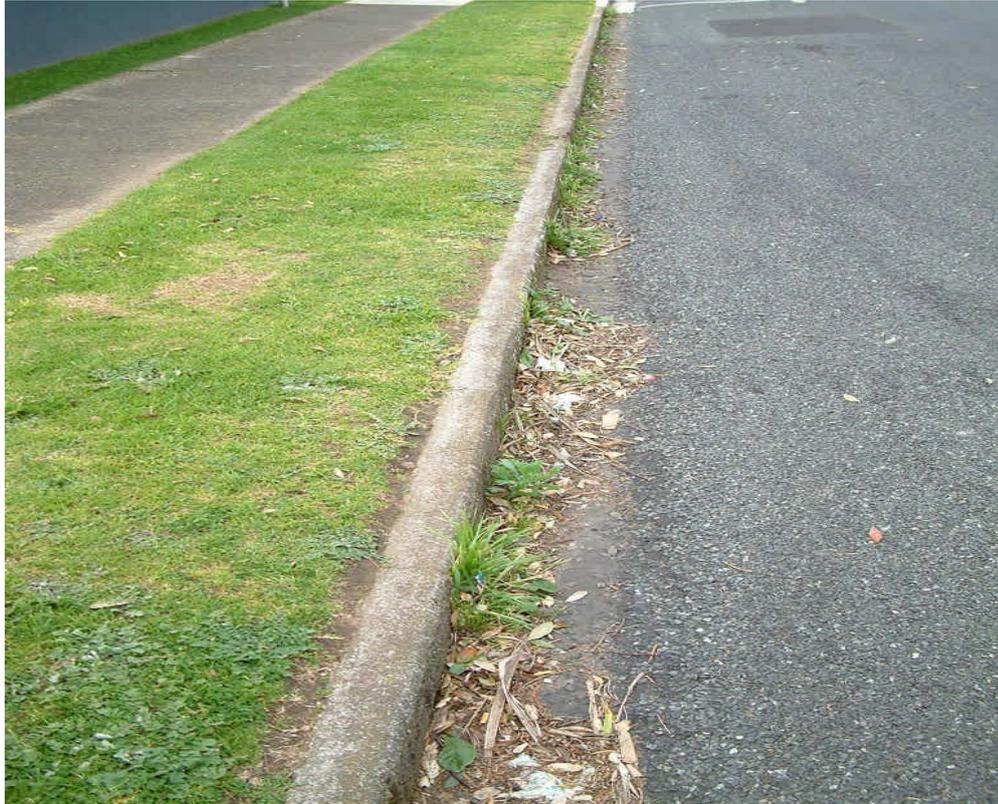
If weed growth, firm-settle debris or other obstructions block 75% of the channel width and stop water flowing, thereby conducting water onto the carriageway, it is called a blocked channel. The following pictures (Figures 23 and 24) show two examples of a blocked channel.

**Figure 21:** Kerb and channel blocked by debris and weed growth

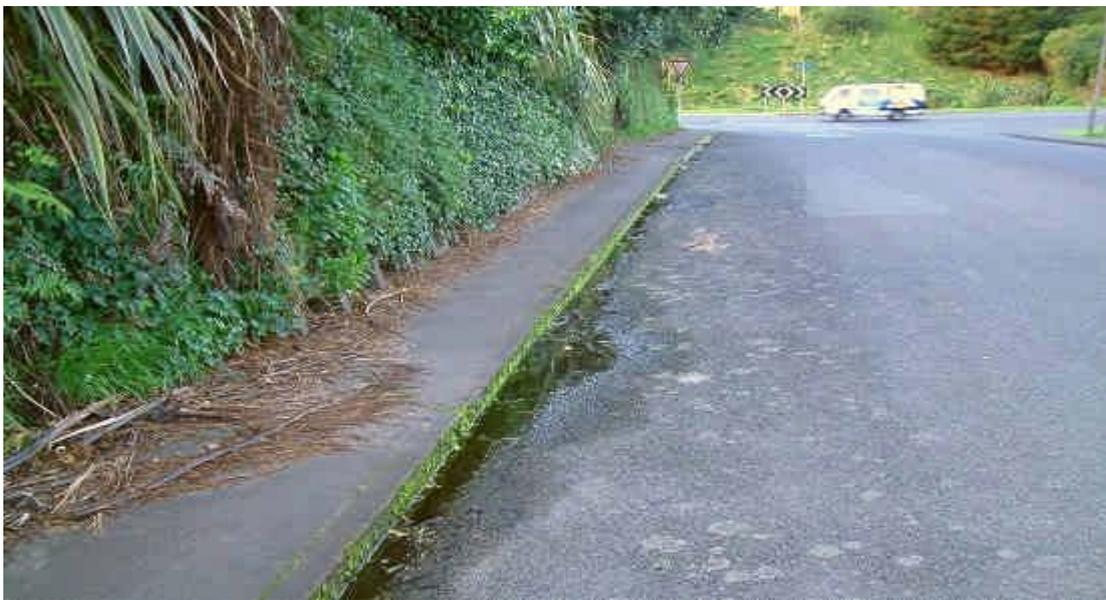
Figure 25 shows an example of an uphill grade kerb and channel.

**Figure 23:** Water ponding in a channel can indicate uphill grade

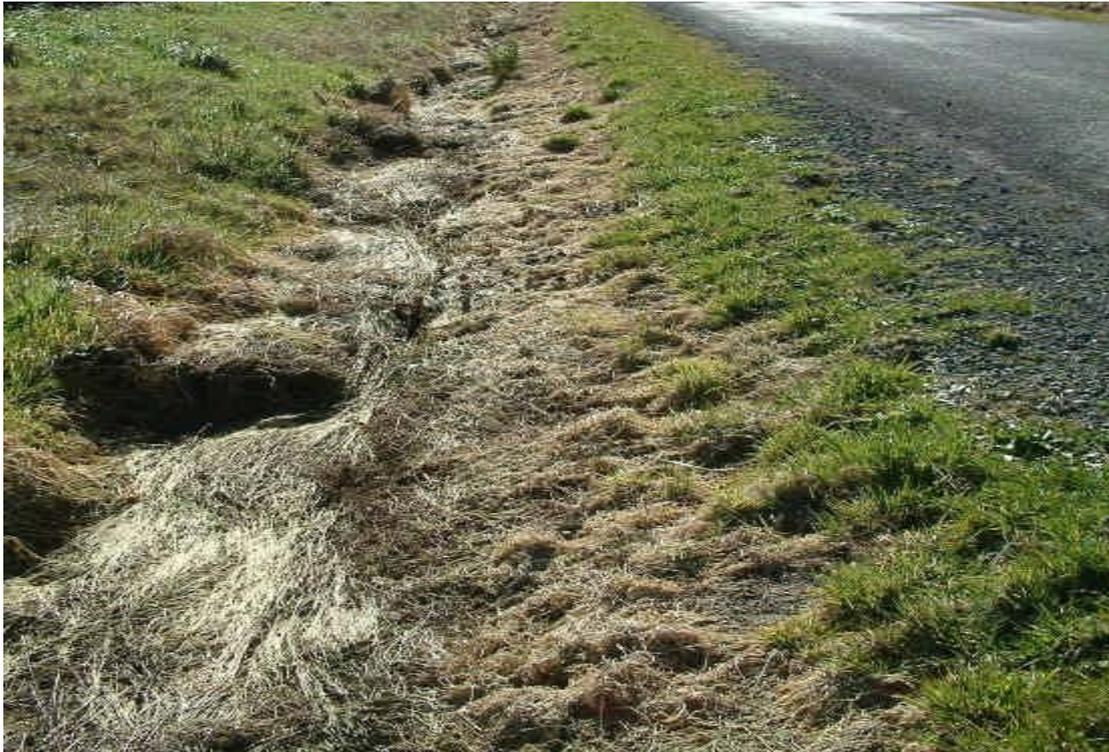
Vegetation, slips, soil, aggregate or general debris may block the ESWC (Figures 26-29). If the channel is not able to transfer water from the pavement to cutoffs/culverts, it will be rated as a blocked channel.

**Figure 24:** ESWC blocked by a solid mass of vegetation

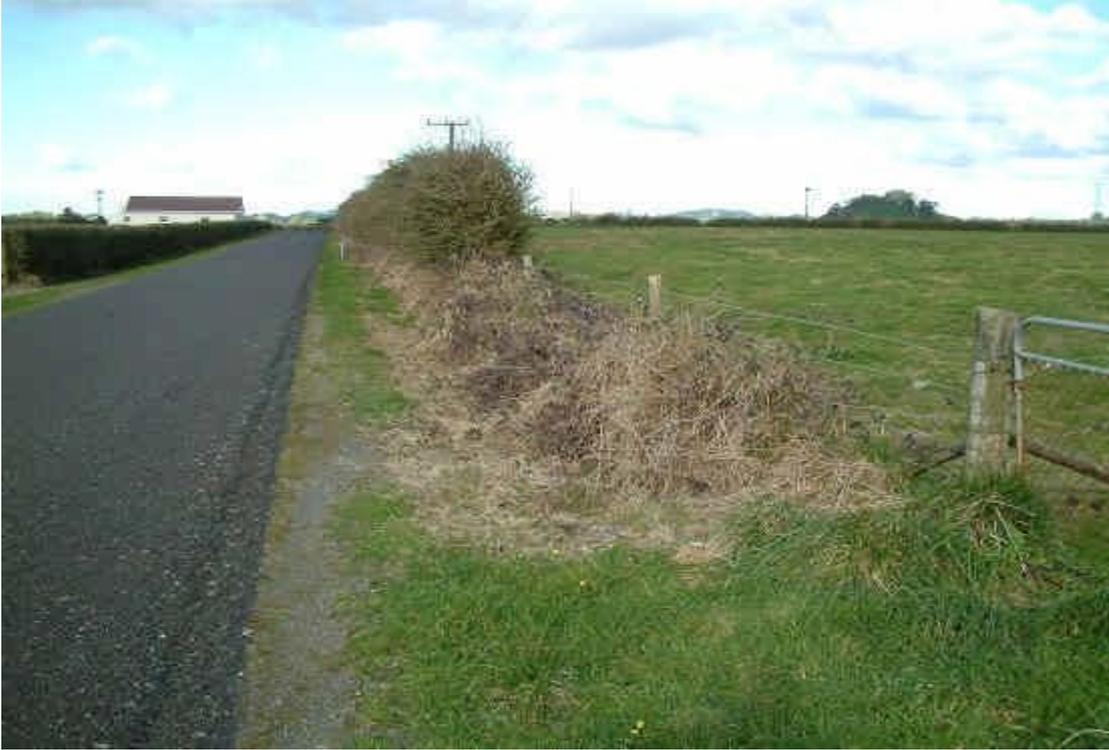
**Figure 25:** ESWC blocked by weed growth

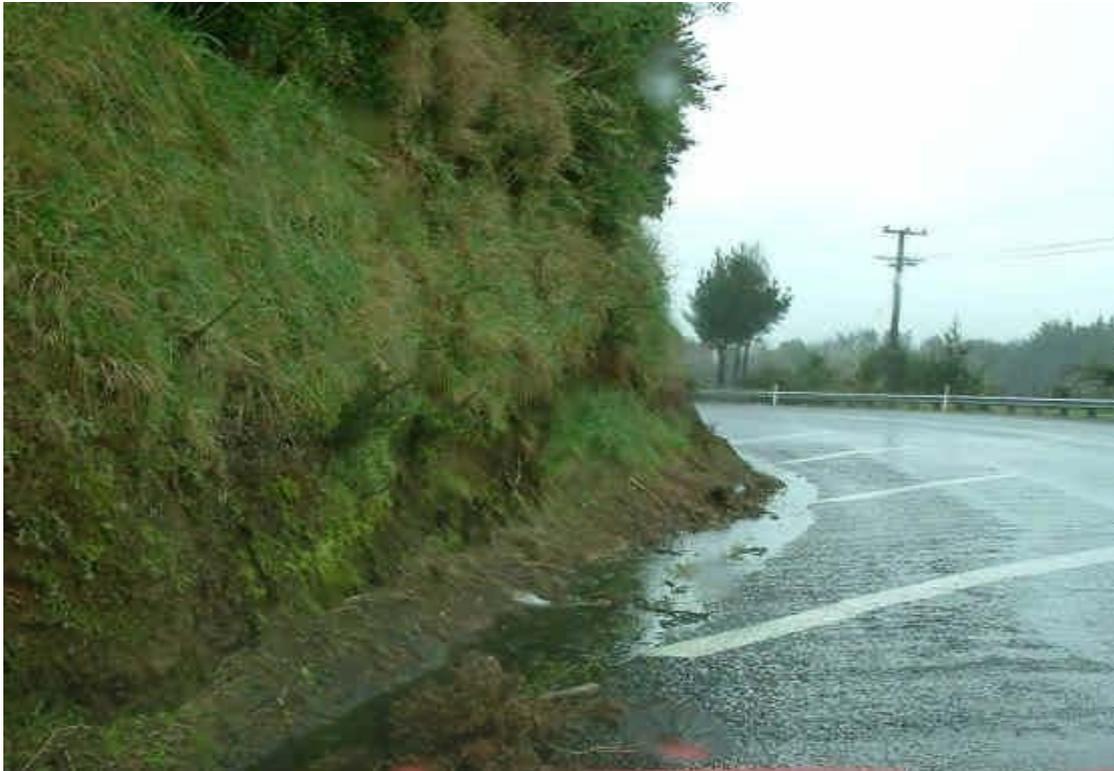
In Figure 28 the culvert has been blocked; the inlet for the culvert can just be seen and the length of the culvert would be recorded as blocked.

**Figure 27:** ESWC Blocked by a slip

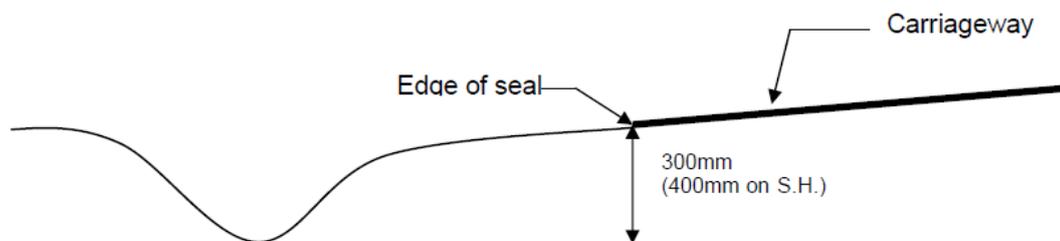
If the depth of the adjoining carriageway surface to the invert is less than 300mm (400mm for highways), it will be rated as an inadequate, as depicted in Figure 30.

**Figure 28:** Shoulder cross section

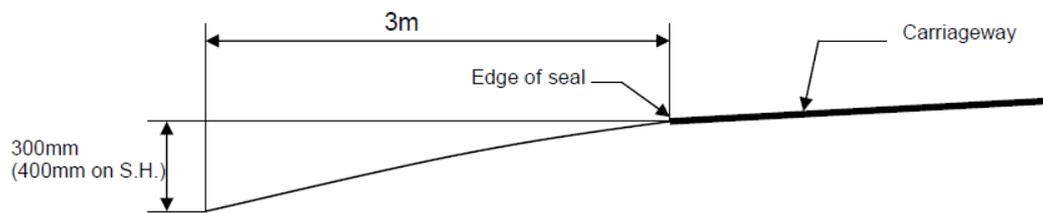
"Where there is no defined ESWC but the ground falls away from the carriageway, the depth is assessed at a point 3m from the edge of seal" (Transfund New Zealand, 1997, p.30)(Figure 31).

**Figure 29:** Shoulder cross section

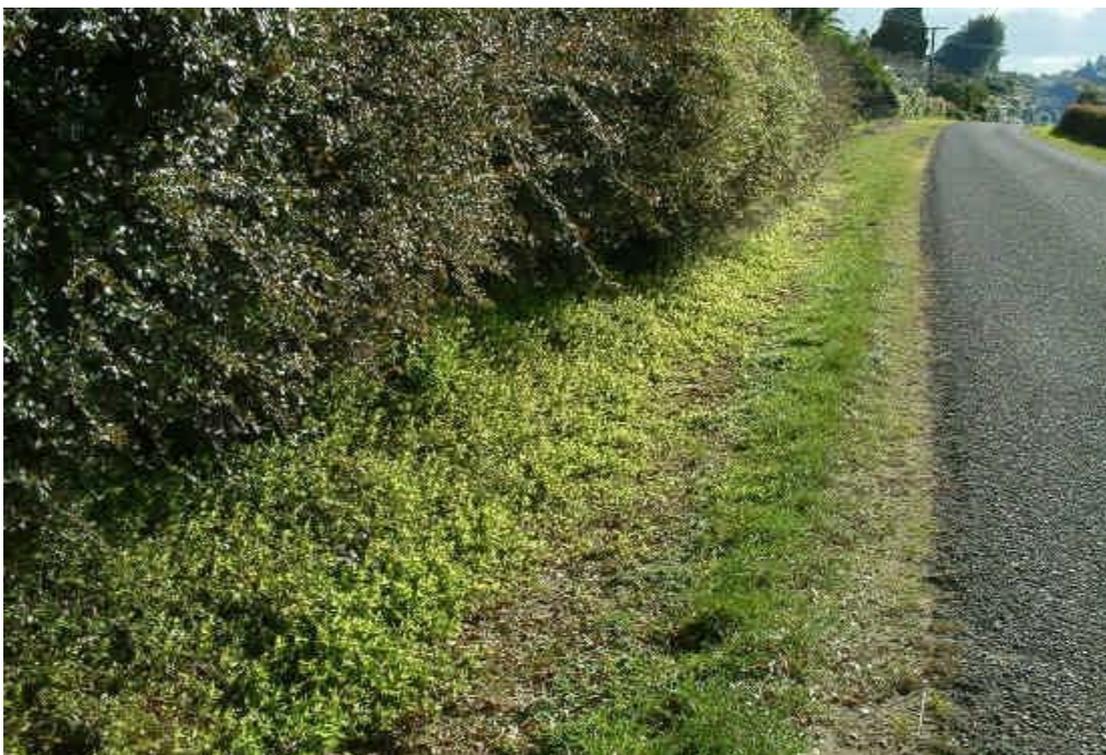
**Figure 30:** An inadequate ESWC

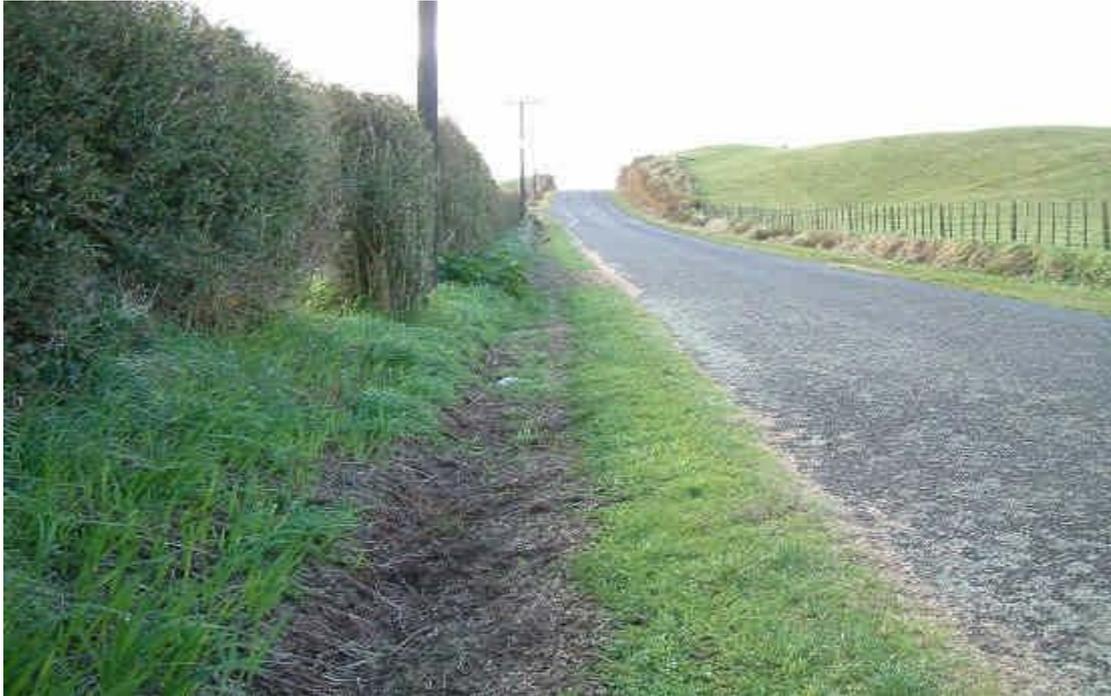
**Figure 31:** Inadequate ESWC

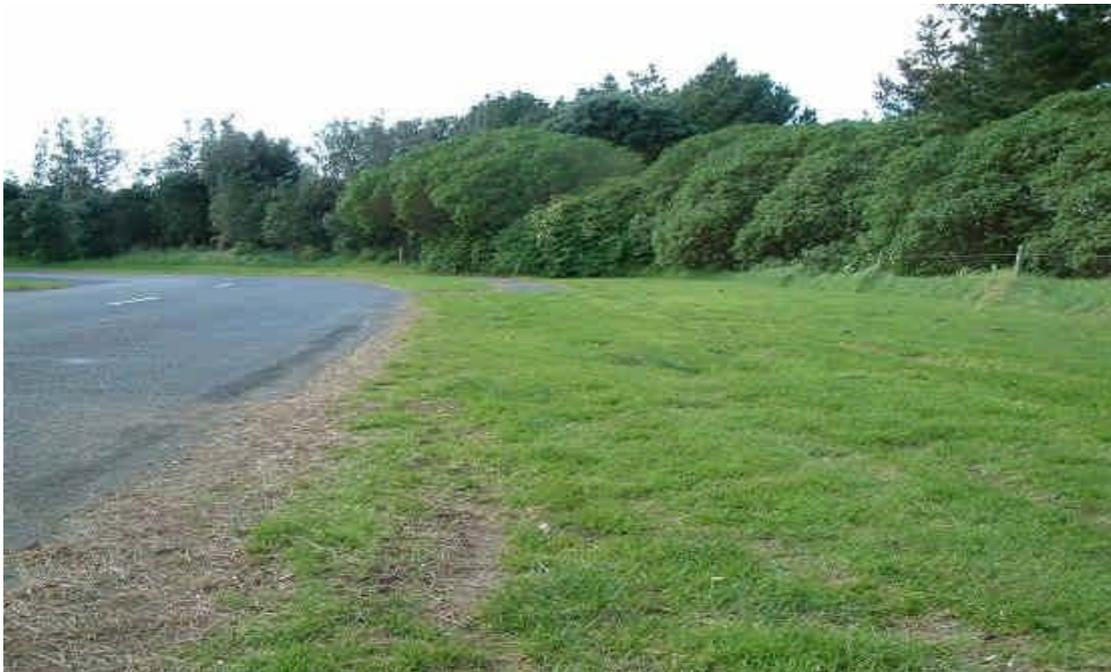
Figure 33 shows inadequate ESWC because of the depth of the channel. The weed growth would slow water down but would not cause it to pond.

**Figure 32:** Inadequate ESWC

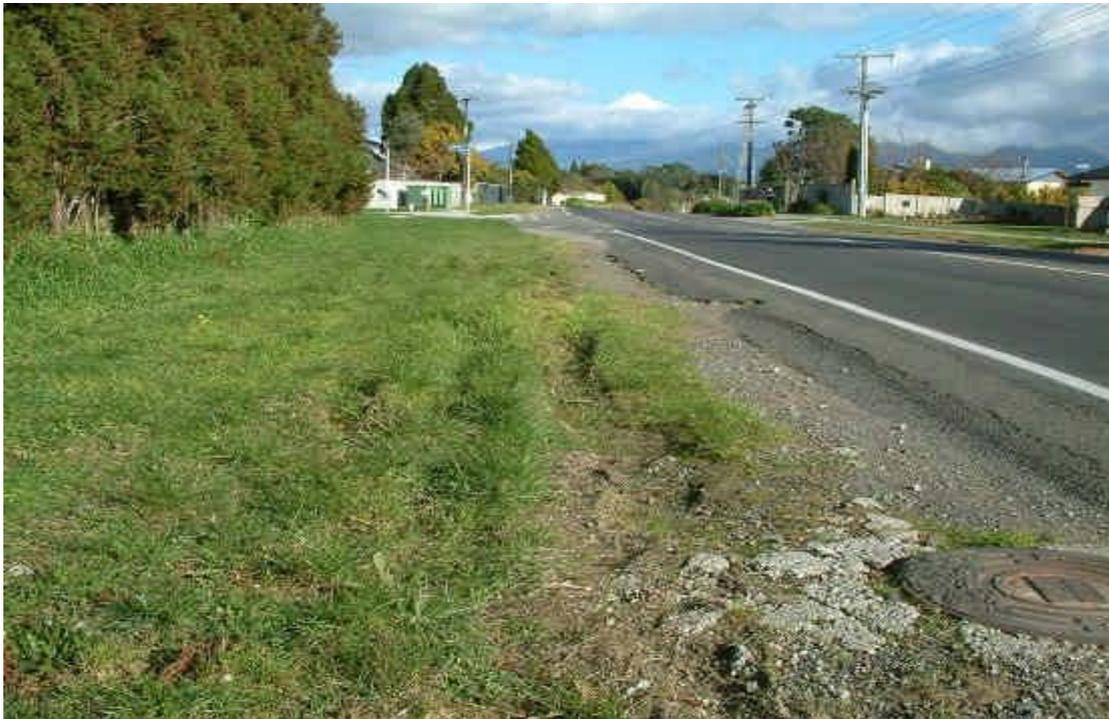
Typically high shoulders with edge rutting would be rated as ineffective shoulders. Low shoulders that do not impact on the flow of water should not be rated (Transfund New Zealand, 1997).

**Figure 33:** Ineffective shoulder due to deep tyre track

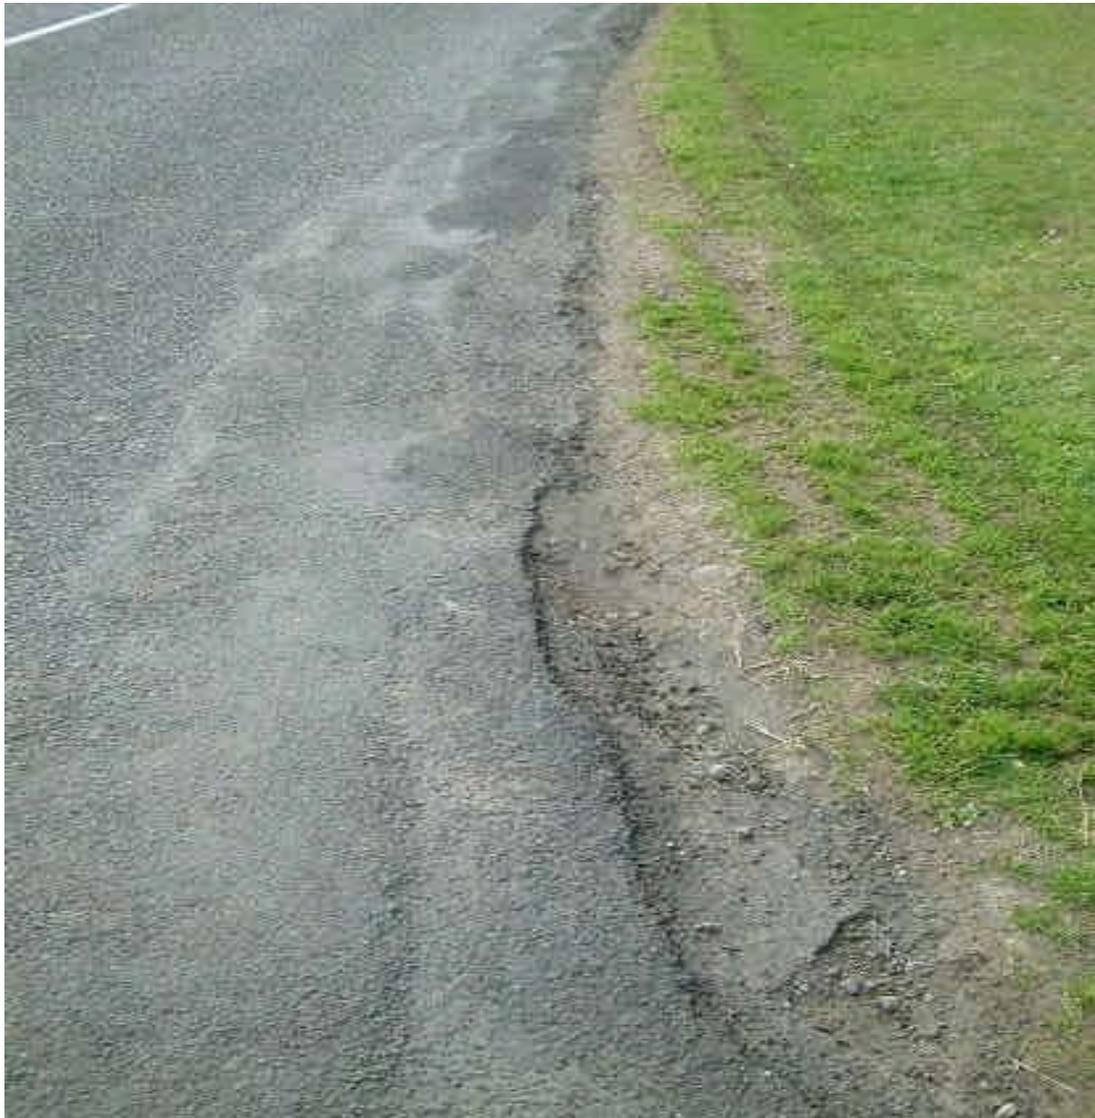
If, for any reason, the shoulder was too much higher than the carriageway surface and it does not let water flow away from the carriageway, it will be rated as an ineffective shoulder. Another problem, illustrated in Figure 36, is an ineffective shoulder due to deep tyre tracks.

**Figure 34:** Shoulder is ineffective due to the wheel rut along the edge of the carriageway

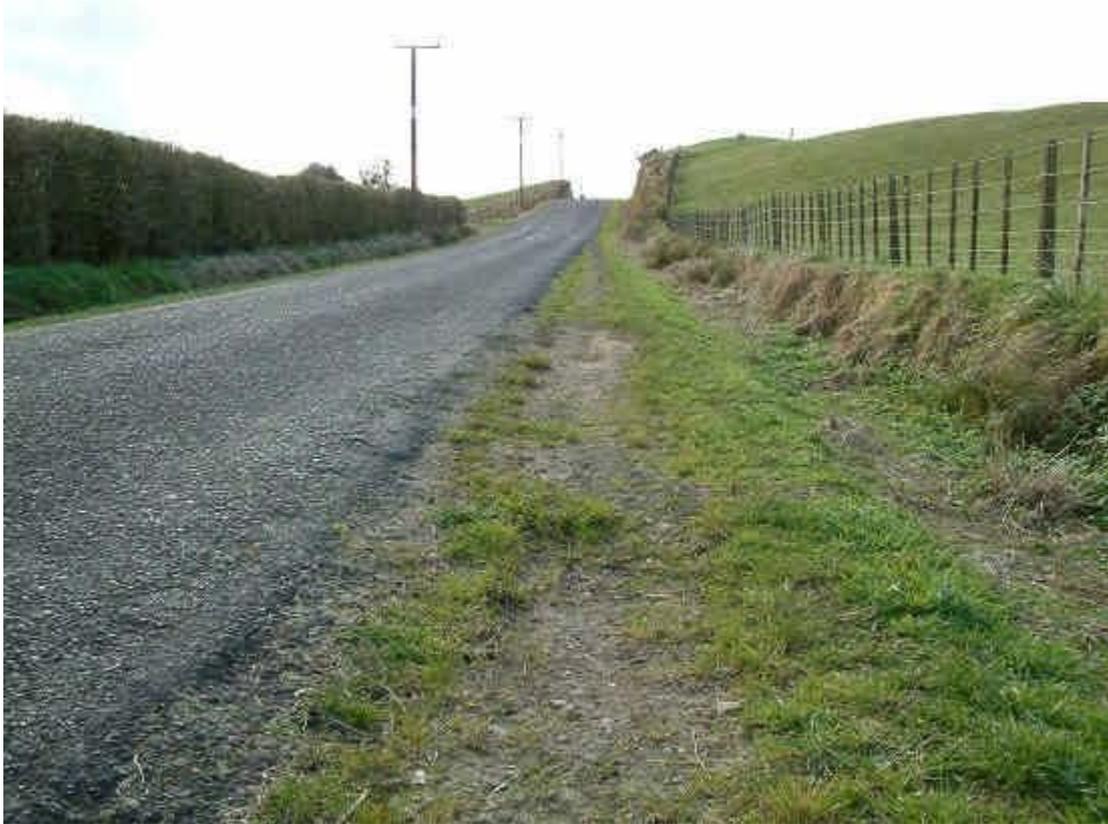
**Figure 35:** Ineffective shoulder due to the high area between the carriageway and the ESWC

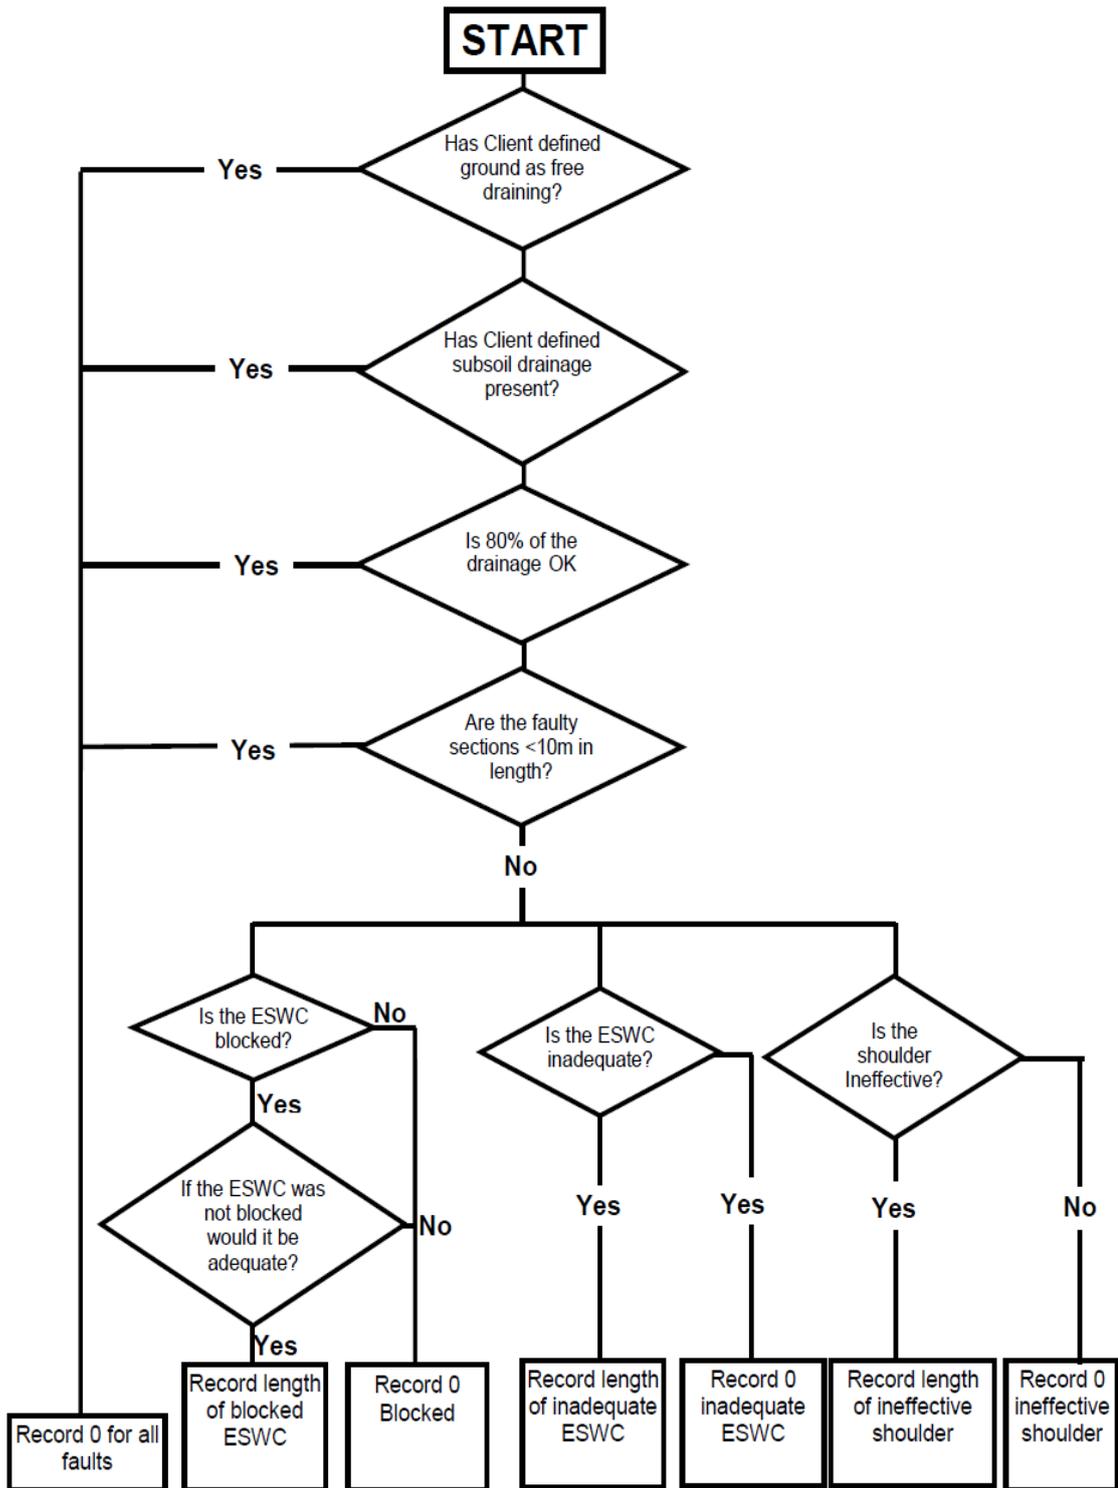
Figure 36: Flowchart of ESWC rating method

ESWC RATING FLOW DIAGRAM

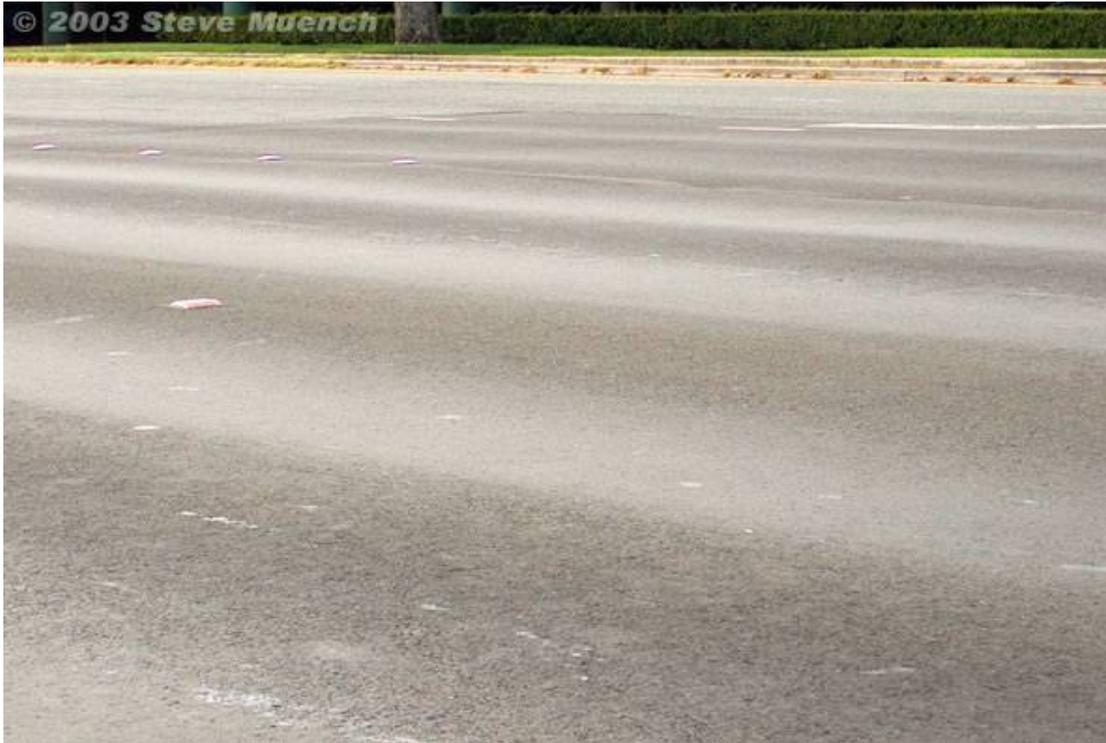
**Figure 37:** Shallow rutting
