**IMPROVING PRODUCTIVITY IN ROAD PAVEMENT  
MAINTENANCE AND REHABILITATION IN NEW ZEALAND**

**Masters Thesis**

A Thesis presented in fulfillment of the requirements for the degree of Master of  
Construction Management

Massey University, Albany

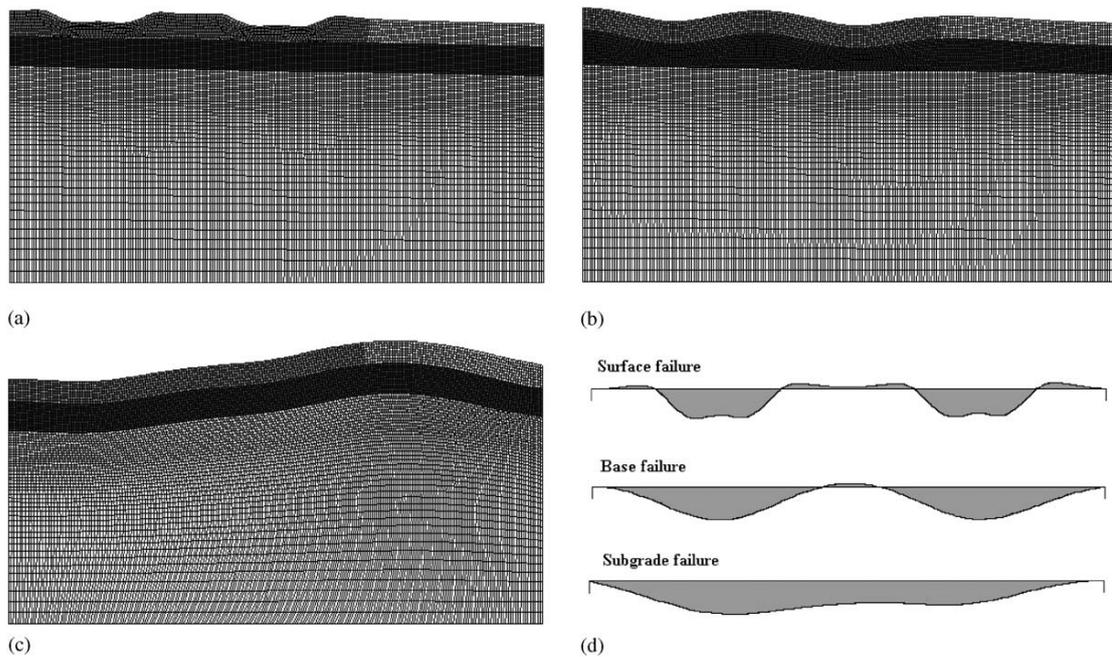
Also, Fang, Haddock, White, and Hand (2004) stated that "improper design, poor materials or construction quality, poor drainage conditions, and/or any combination of these factors may result in an inadequately designed layer" (p.51).

**Figure 38:** Finite element analysis results (FEA)

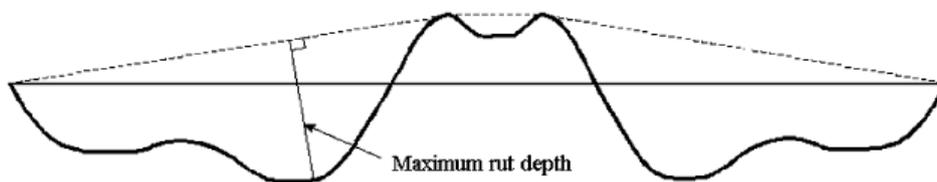
When the depth of wheel path exceeds 30mm and is measured under a 2m long straight edge, rutting tends to funnel down and up over a length of failure road. It is important to mention that only the length of rutting that has 30mm depth or more will be recorded (Transfund New Zealand, 1997).

**Figure 39:** Definition of maximum rut depth of a transverse surface profile

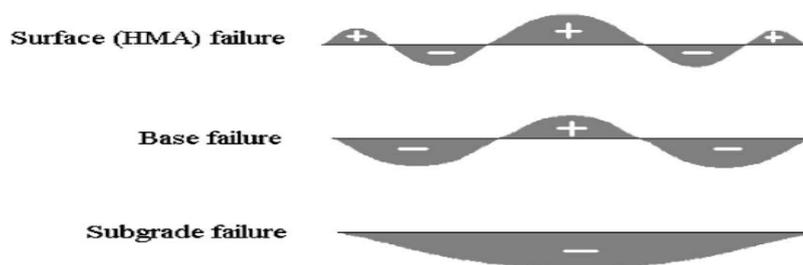
In addition, Fung et al. (2004) illustrated the shape of the transverse surface profiles, Figure 43, but they indicated that "sub grade heave could not coexist with rutting because the sub grade would be weakened by the heavy, and an increase rutting rate would result in a sub-grade failure" (p. 3).

**Figure 41:** Shape of transverse surface profiles

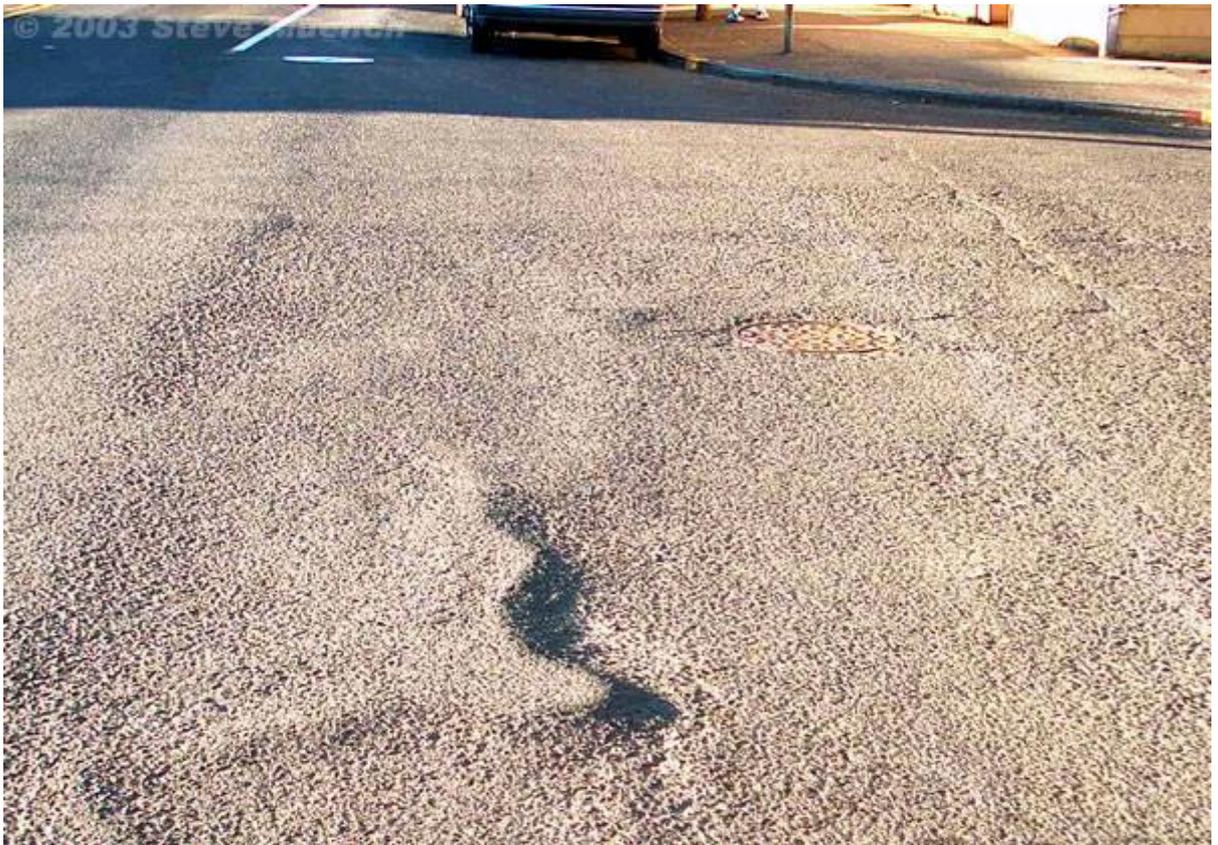
A form of plastic movement typified by ripples (corrugation) or an abrupt wave (shoving) across the pavement surface. The distortion is perpendicular to the traffic direction. Usually occurs at points where traffic starts and stops (corrugation) or areas where HMA abuts a rigid object (shoving) (Pavement Interactive, 2009).

**Figure 43:** Shoving

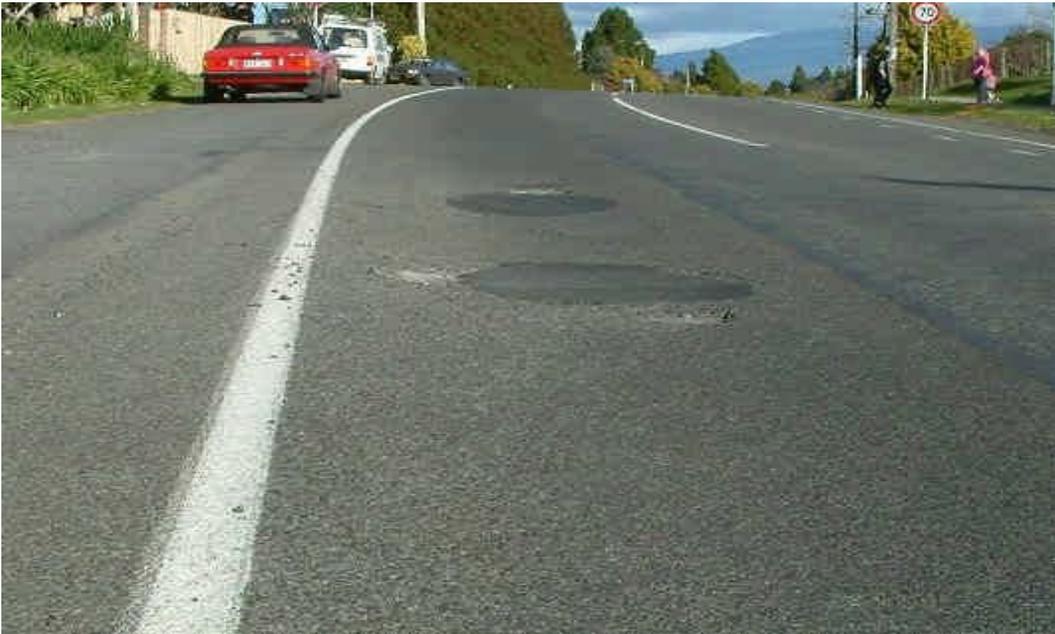
**Figure 44:** A large shoved area

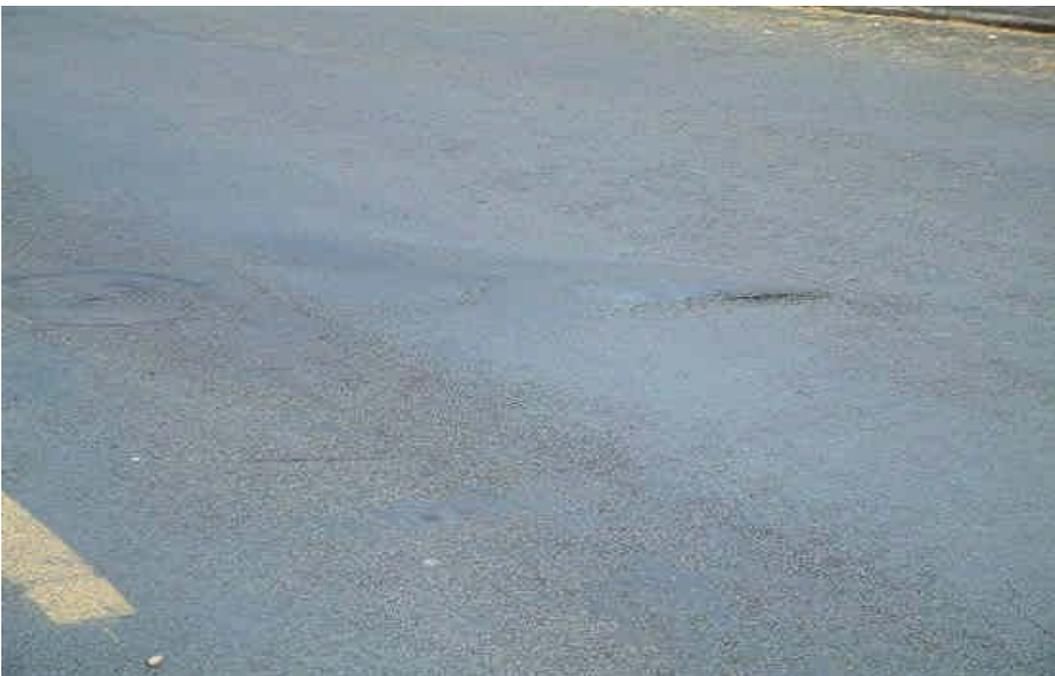
It is not essential to record additional faults such as cracking, potholes and patches within the shoved area.

**Figure 45:** An abrupt shove near a service cover

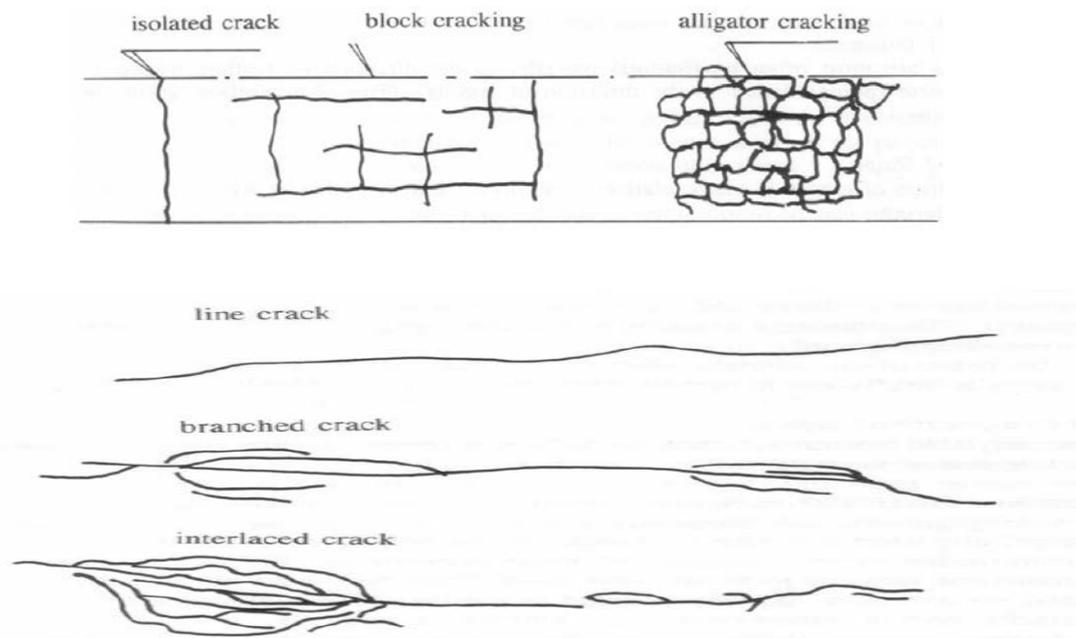
Figure 48 shows examples of some of the most common crack types.

**Figure 46:** Example of some of the most common crack types

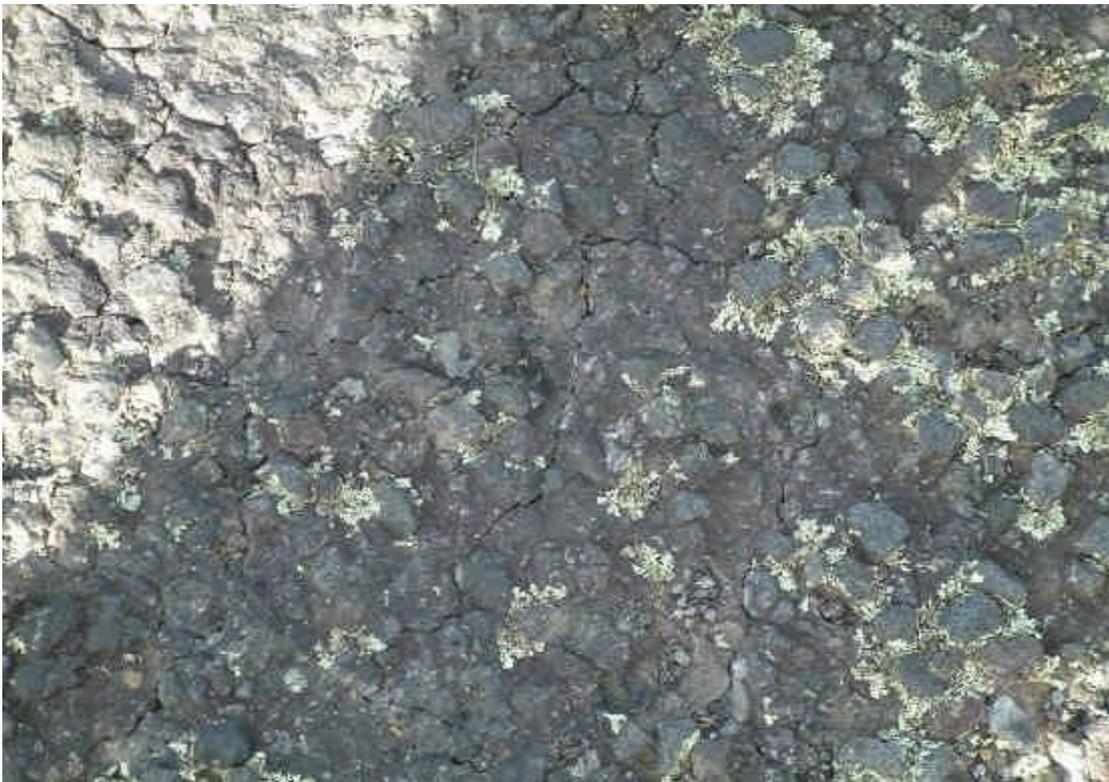
**Figure 48:** Observing fine cracks in shadow

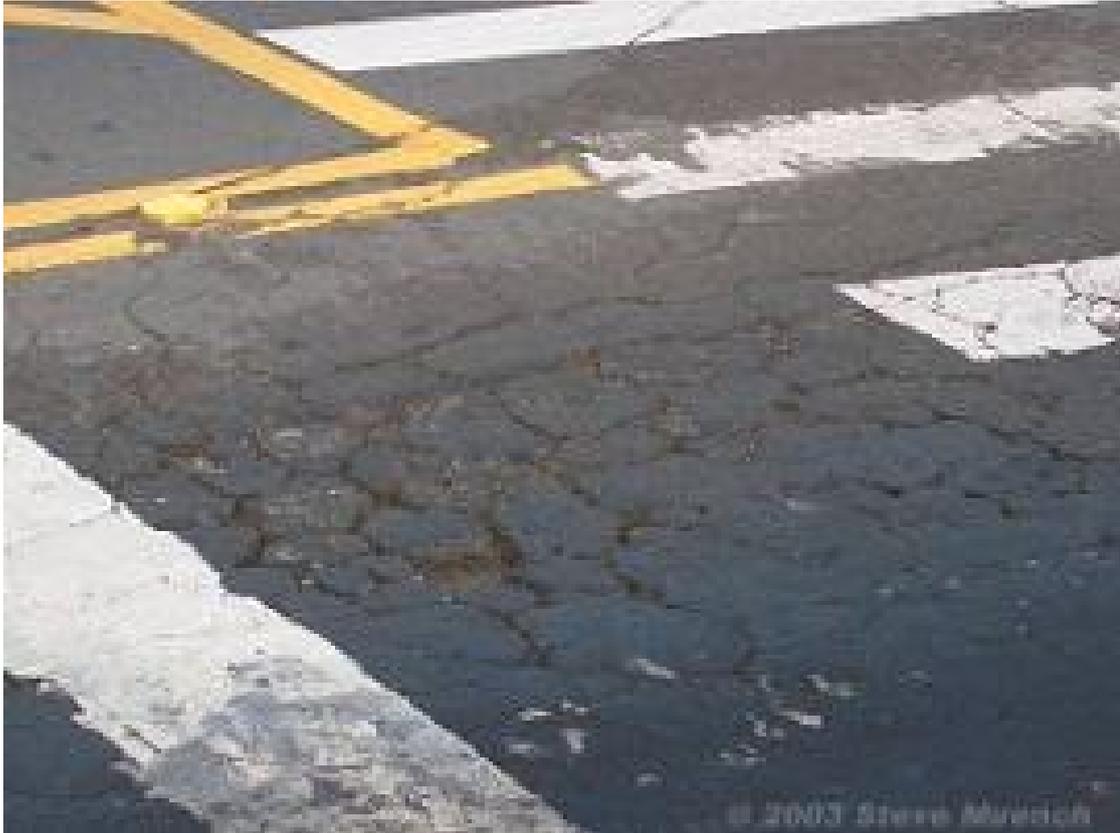
**Figure 49:** Sample of Alligators Cracks

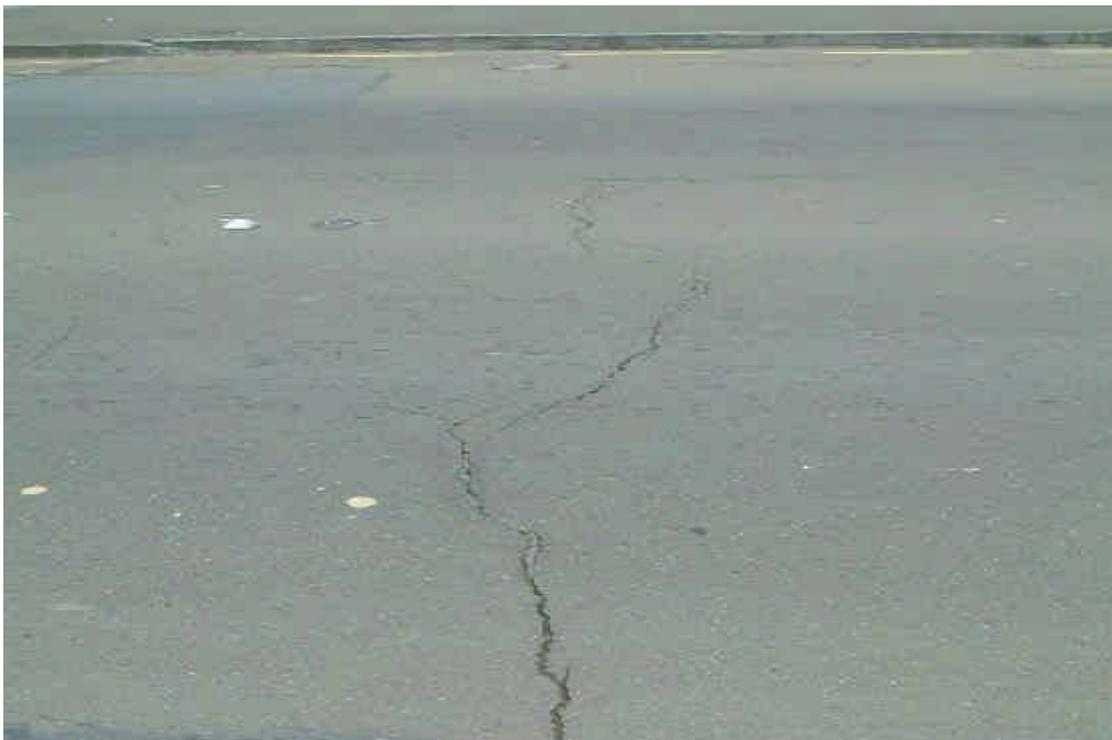
Furthermore, these kind of surface failures also happen on another kind of pavement, for example, concrete pavement, as was indicated in investigations by Jia-liang and Qing-hua (2012). Replacement of the sub grade caused longitudinal cracks on the newly rehabbed joint concrete pavement, more so than rubblisation and break-and-seat, in a project investigated by them. Non uniform compaction of the replaced sub grade, attributable to diversity of replacing materials, inappropriate moisture, and some construction problems, caused plastic deformation, which caused longitudinal cracks.

**Figure 50:** Straight longitudinal and transverse cracks

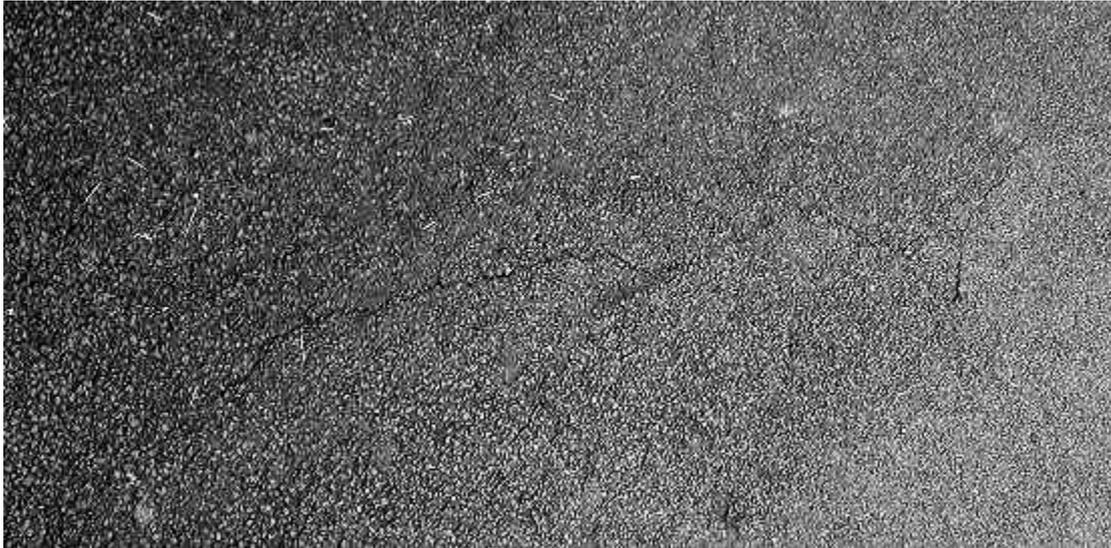
**Figure 51:** A small irregular longitudinal and transverse crack

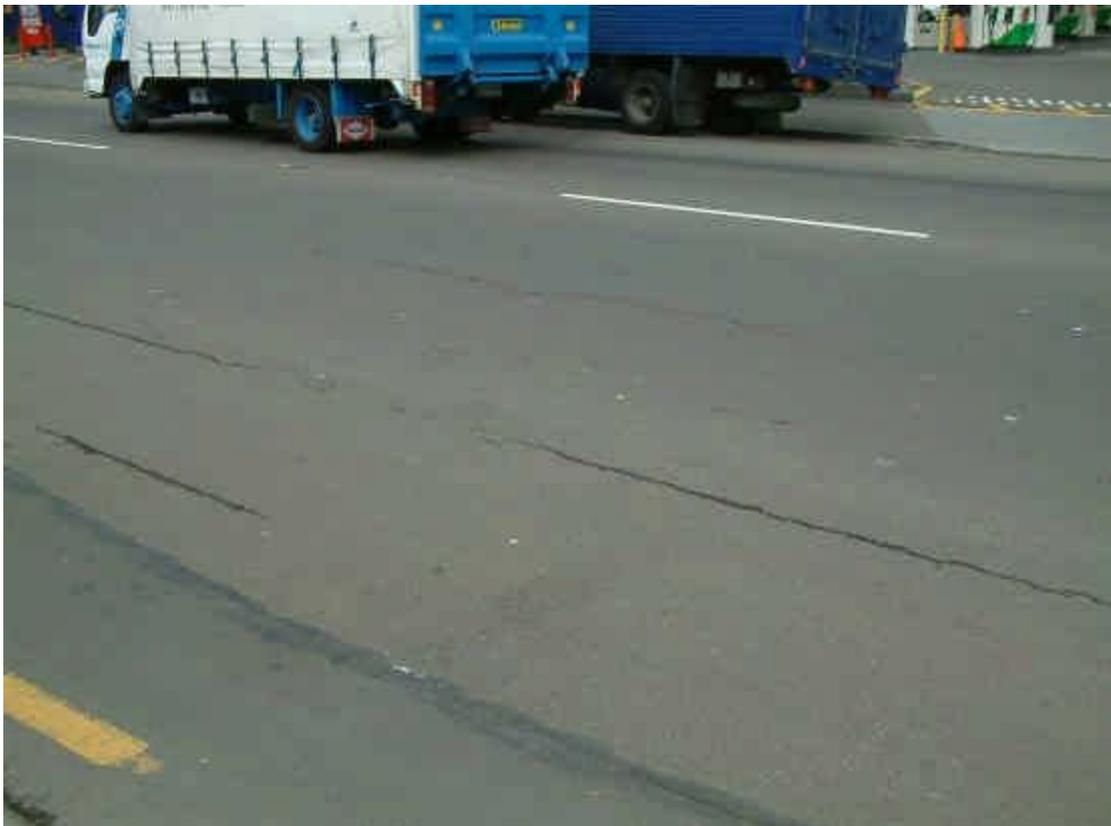
**Figure 52:** Straight longitudinal and transverse cracks

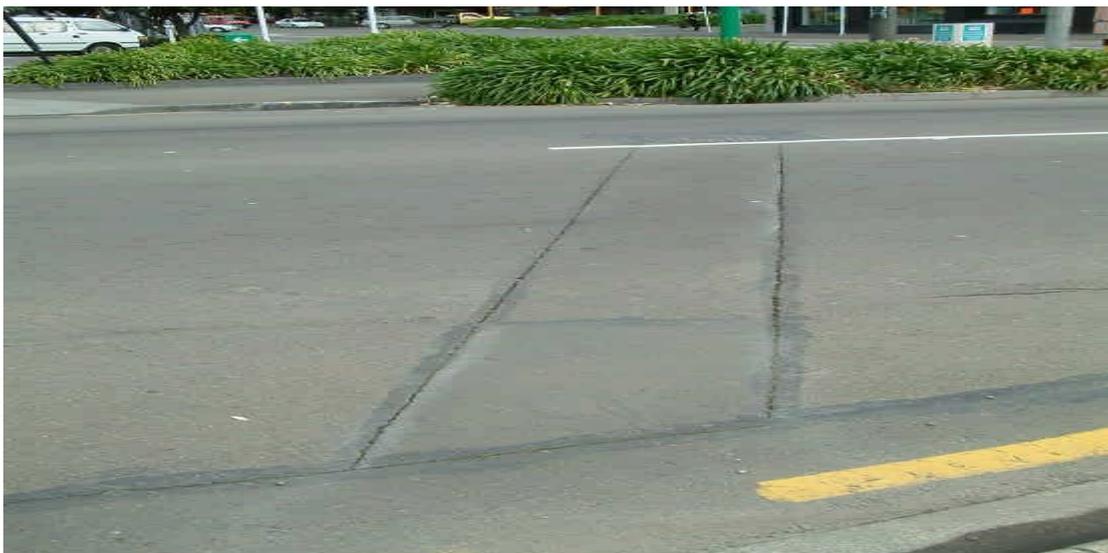
The joint crack will be rated as a L&T crack if it occurs in a continued surface and if it is a visible joint between two different surfaces; the total length of the crack will be recorded for rating purposes.

**Figure 53:** Joints along service trenches

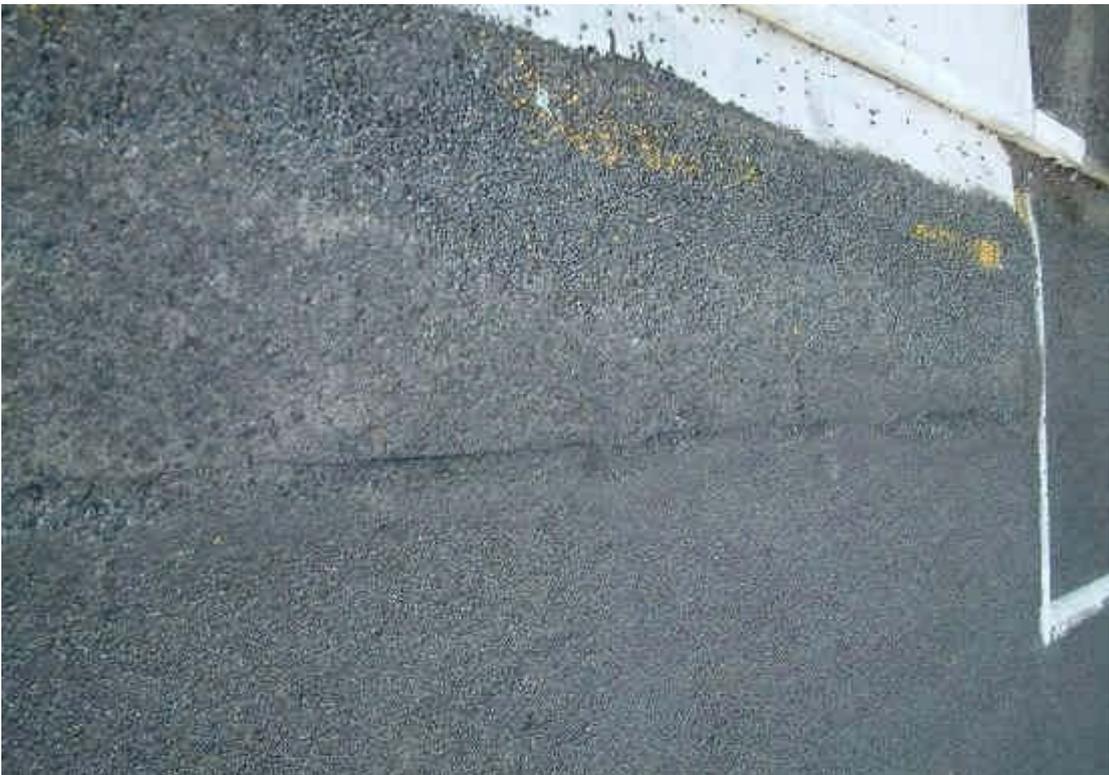
**Figure 55:** Joint crack at the edge of a repair

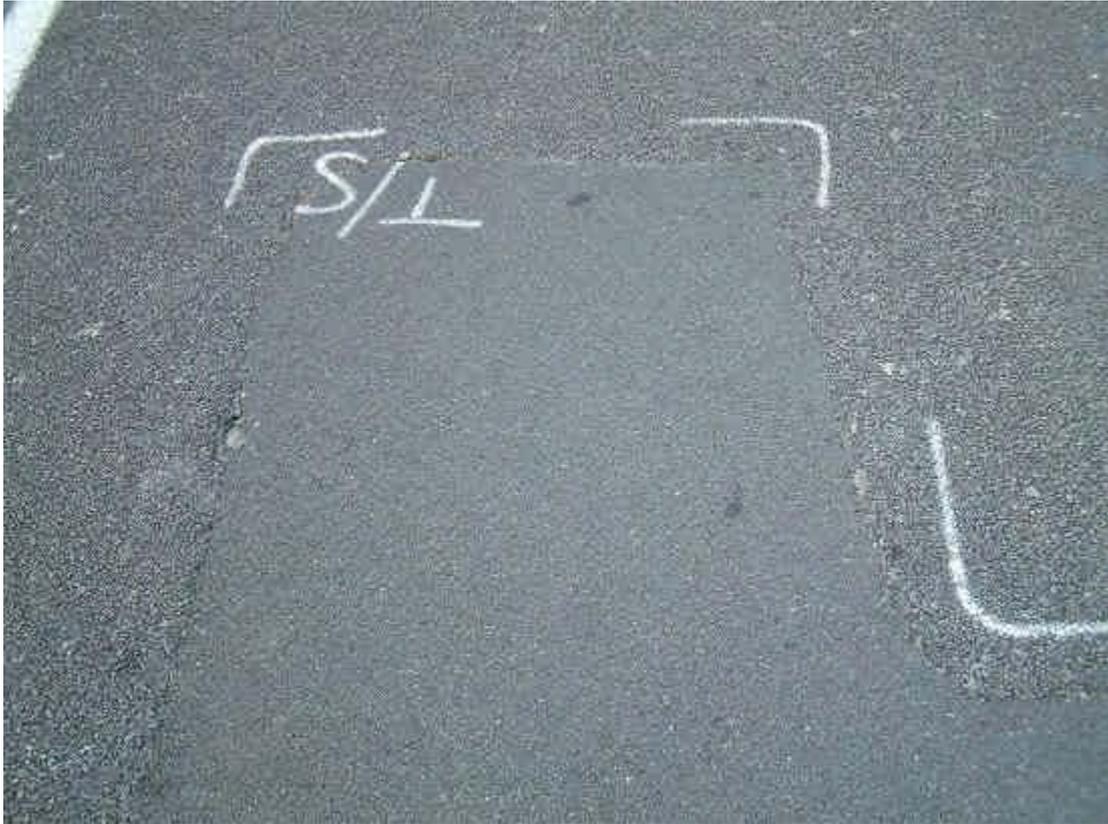
**Figure 56:** Joint cracking around a patch

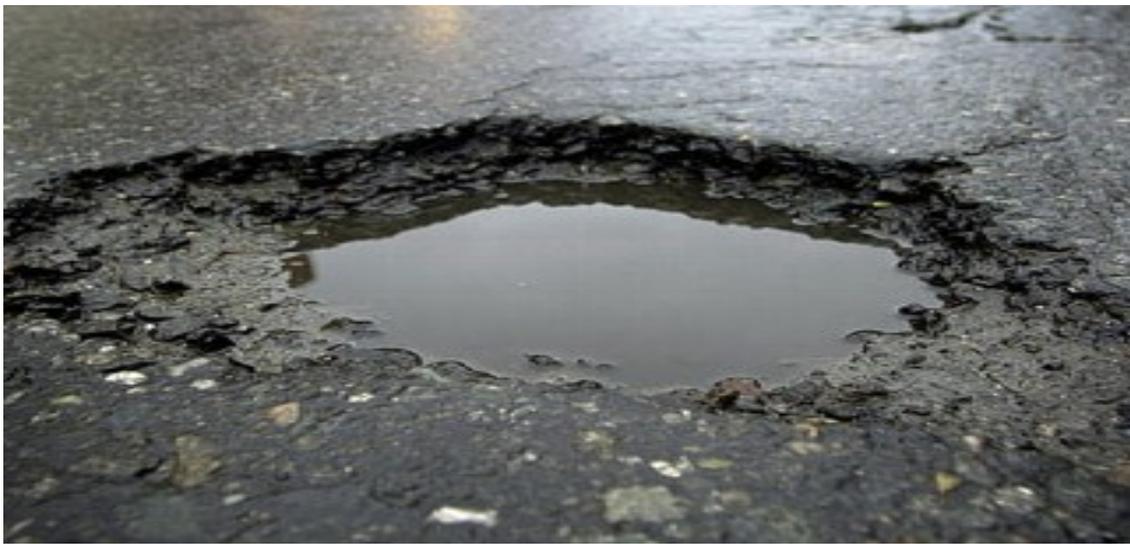
**Figure 57:** Pothole

Small, bowl-shaped depressions in the pavement surface that penetrate all the way through the HMA layer down to the base course. They generally have sharp edges and vertical sides near the top of the hole. Potholes are most likely to occur on roads with thin HMA surfaces (1 to 2 inches) and seldom occur on roads with 4 inch or deeper HMA surfaces. (Roberts et al., 1996)

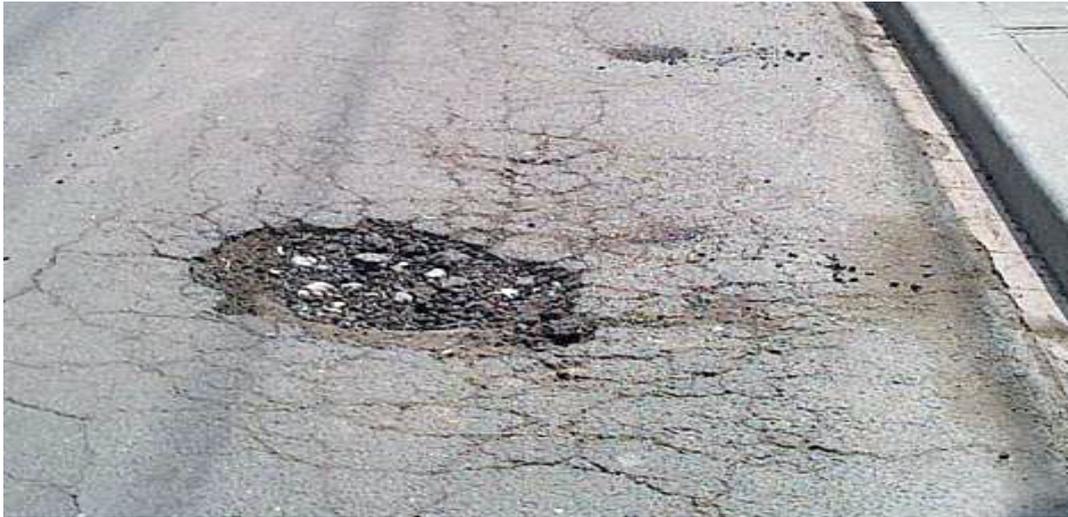
An untreated pothole might cause serious vehicular damage or a crash for crossing cars. Infiltration will also happen on the surface by potholes.

**Figure 59:** A pothole caused by fatigue cracking  
Source: (Transfund New Zealand, 1997)

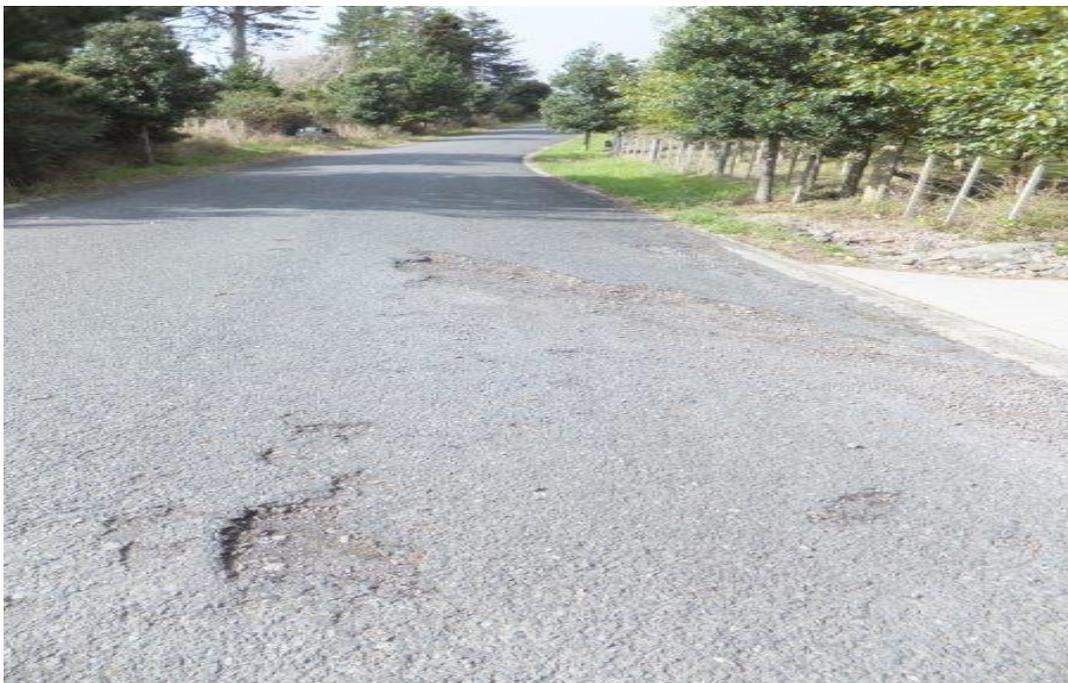
**Figure 60:** Potholes in Smithfield Ave, Paremoremo

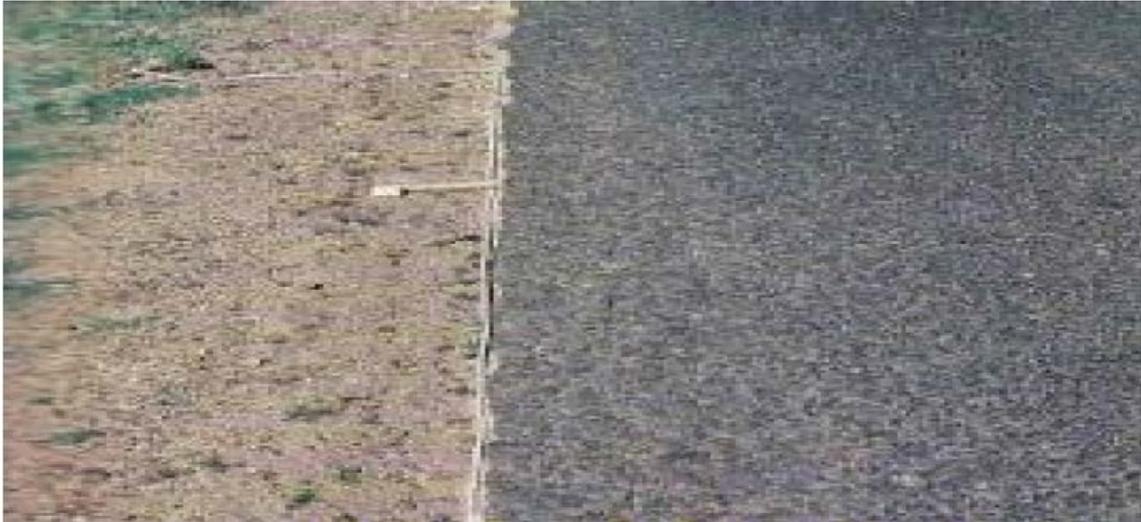
**Figure 61:** Slight edge break

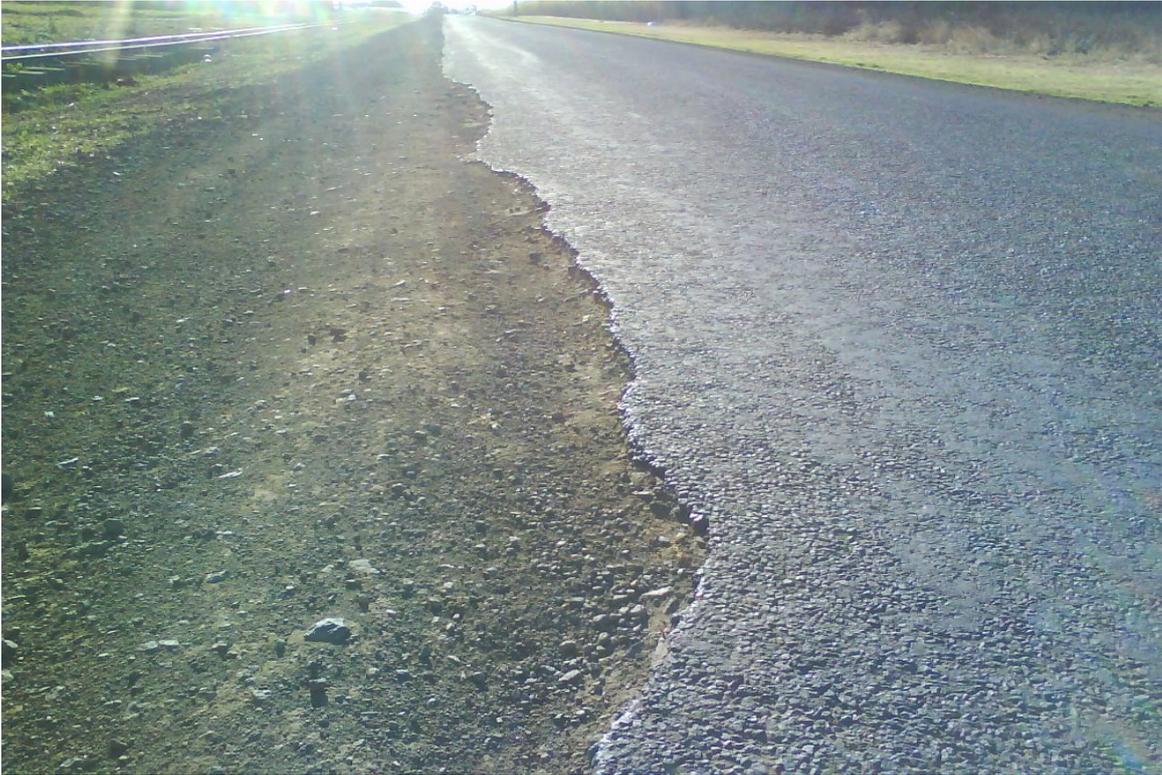
**Figure 63:** Edge break

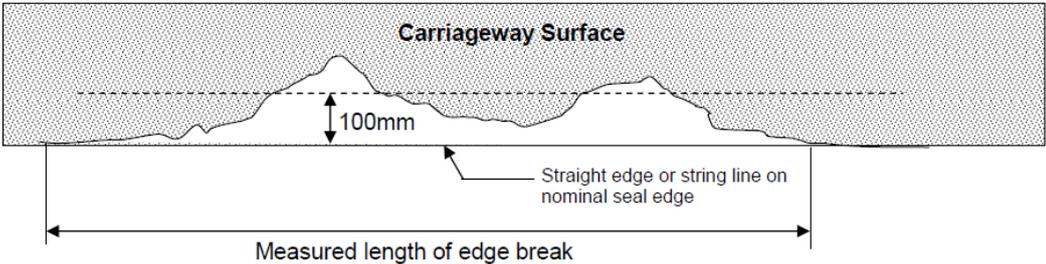
**Figure 64:** Edge break measurement

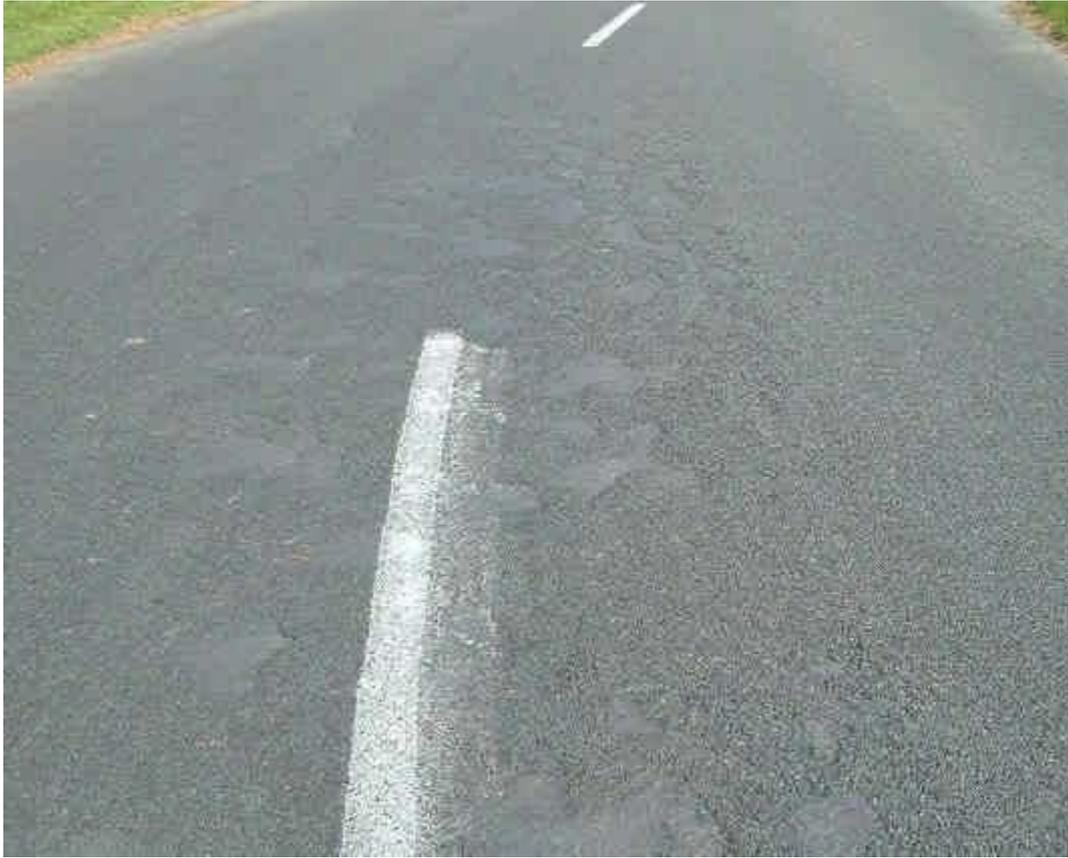
**Figure 65:** A chipseal with greater than 10% chip loss in large areas

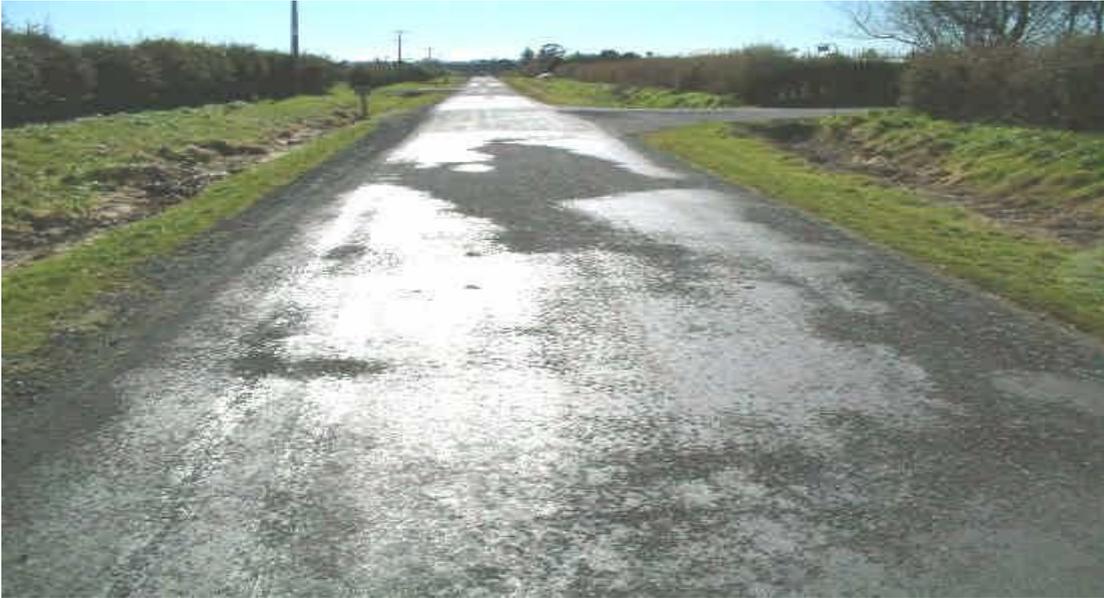
**Figure 66:** Carriageway with extensive flushing on the wheelpath's surface

In the case of chip seal, Ball and Patrick (2005) described that: "there is a maximum compaction level for any particular multilayer chip seal with a corresponding void content; if the total binder content is greater than this, then flushing will eventually occur" (p. 9).

- Excessive asphalt binder in the HMA (either due to a poor mix design or manufacturing problems).
- Excessive application of asphalt binder during BST application.
- Low HMA air void content (e.g., not enough void space for the asphalt to occupy), likely a mix design problem.

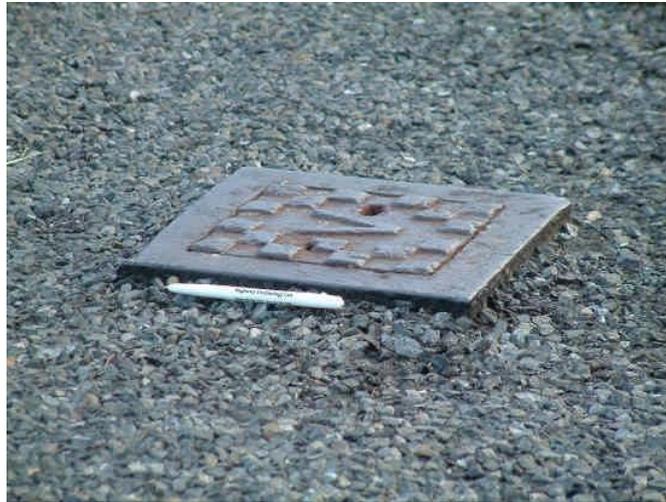
**Figure 67:** High service cover

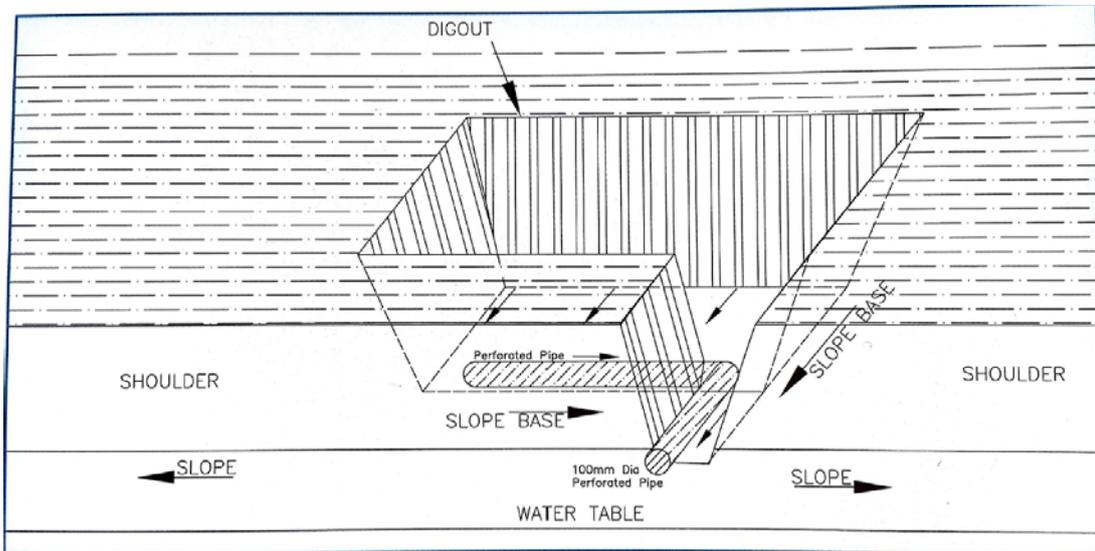
**Figure 68:** Positive drainage, 3D diagram

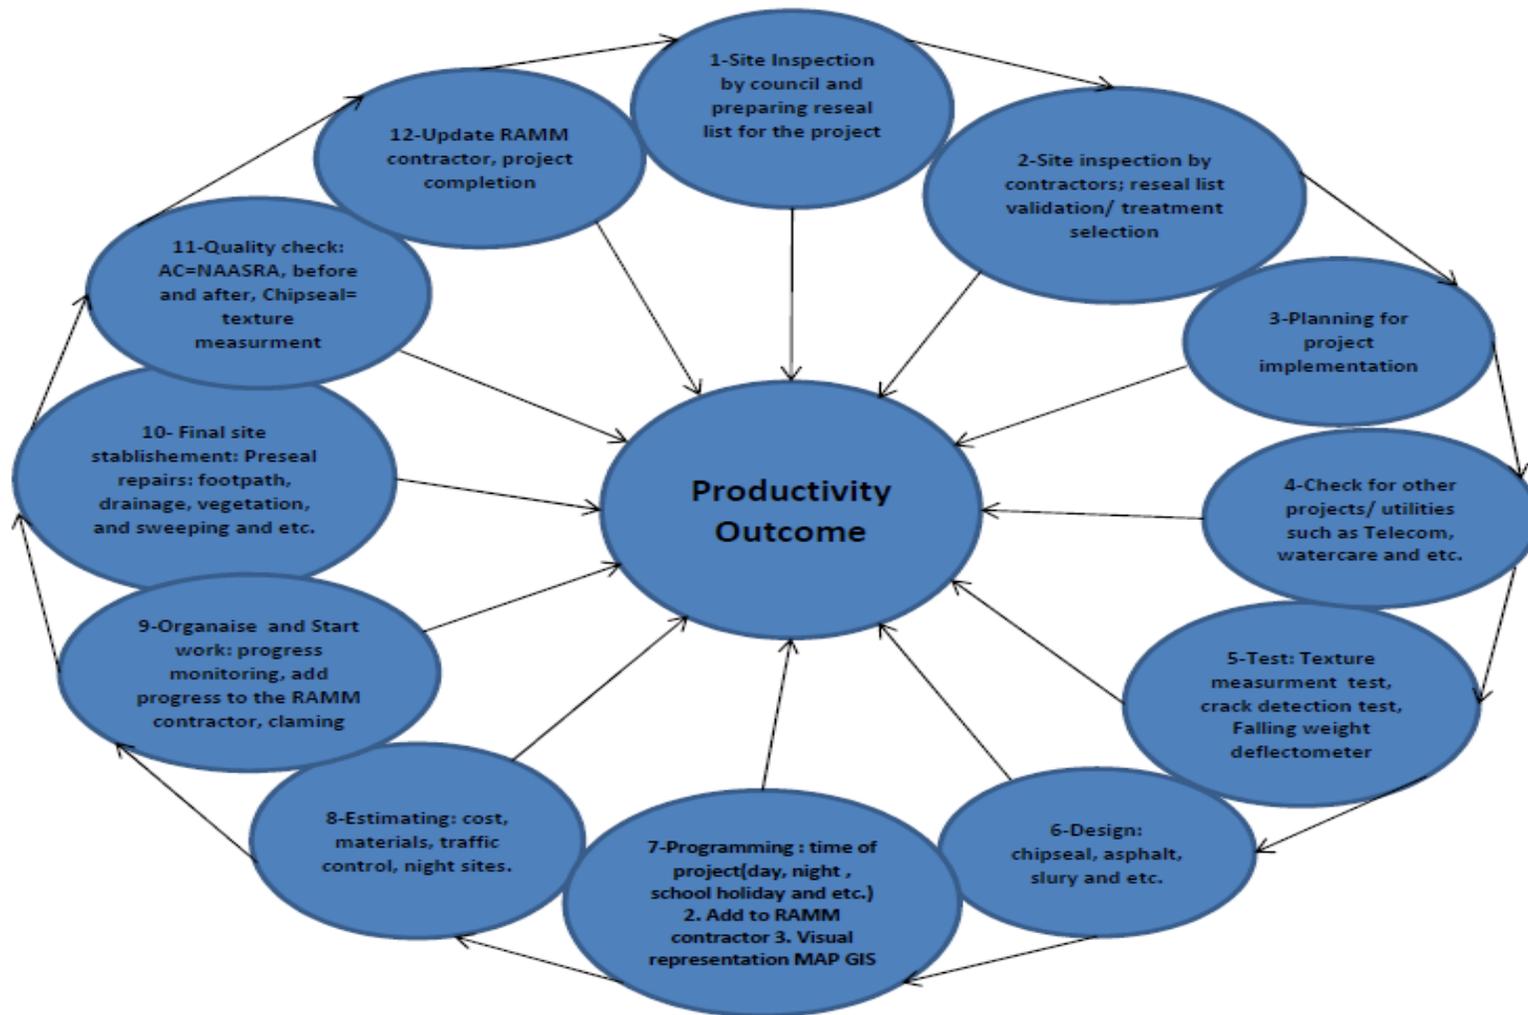
Figure 72: Road pavement maintenance and rehabilitation process in New Zealand

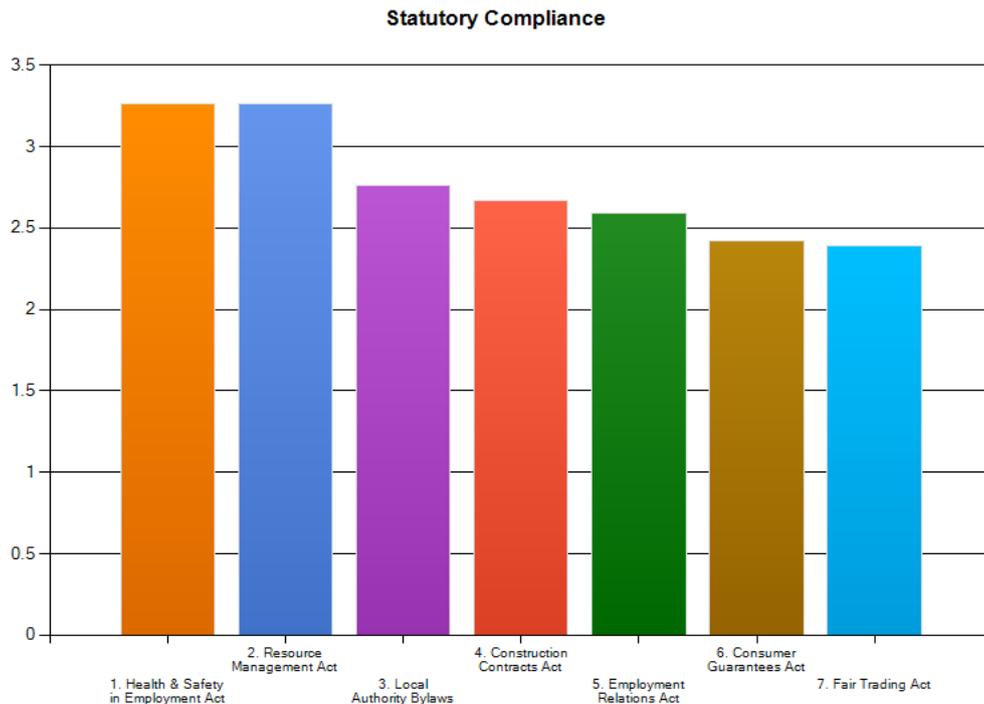
**Figure 82:** Importance of each factor under the category of statutory compliance

Figure 84 provides a summary of the key influential factors under the statutory compliance group.
