**Tsunami evacuation: Lessons from
the Great East Japan earthquake and
tsunami of March 11th 2011**

**GNS Science Report 2012/17
April 2012**

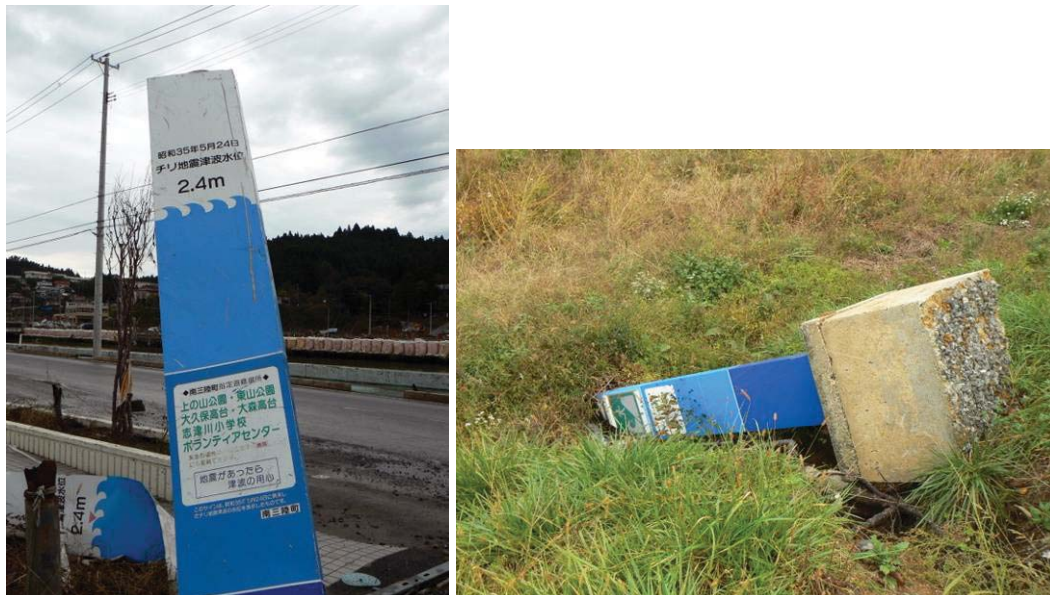
Figure 28 A marker post indicating past inundation height in central Minami-Sanriku Town. The Japanese text gives notification that the Shizugawa hospital is a designated vertical evacuation building. The Japanese text informs people to evacuate to designated evacuation places such as parks, highlands, and Shizugawa elementary school and Shizugawa hospital.

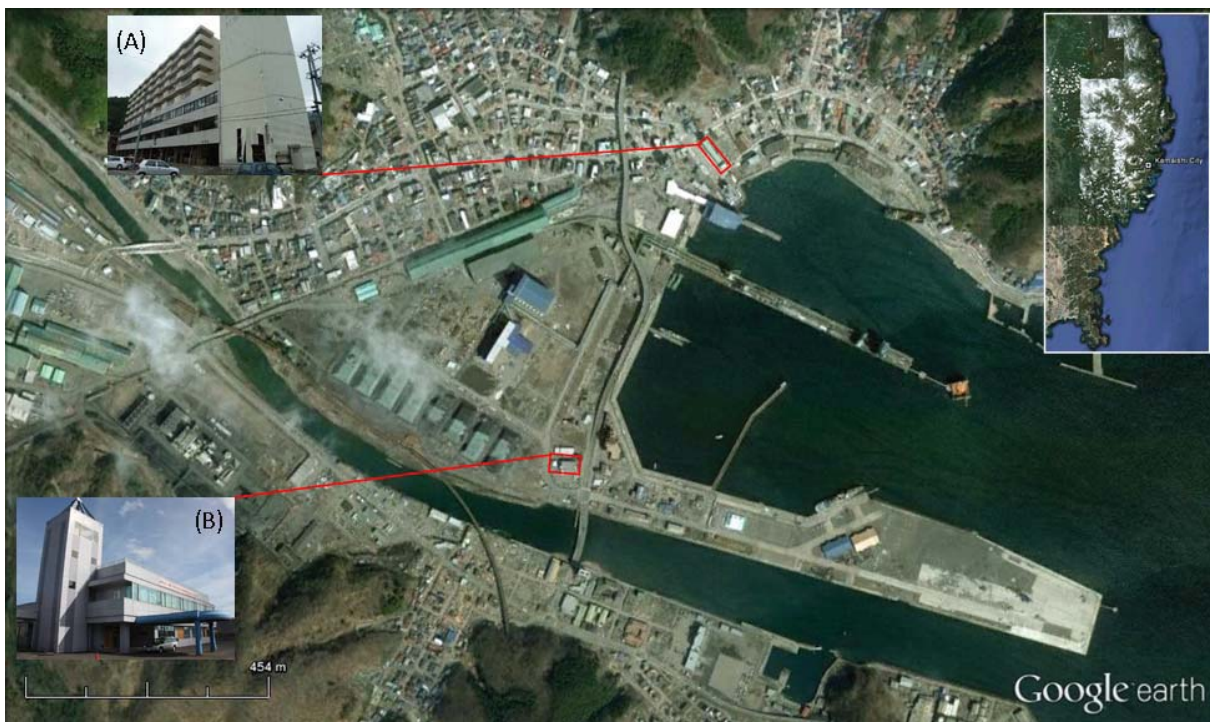
Figure 34 Designated evacuation locations in Kamaishi City. An estimated 50 people evacuated to this apartment block (A) and government offices (B). The entire area shown was inundated; inundation depth was 8 m in the vicinity of building (A).

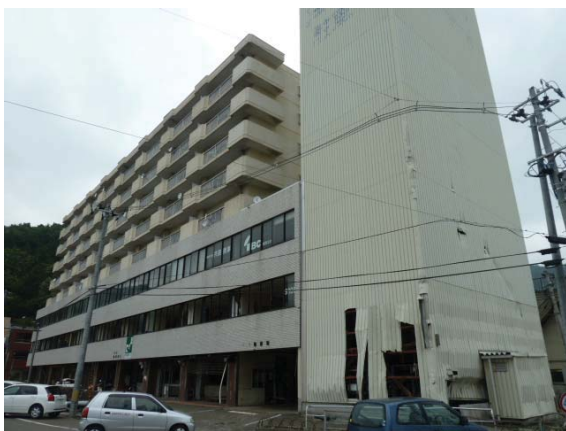
Figure 35 Apartment block in Kamaishi City, which was inundated to the 3rd storey

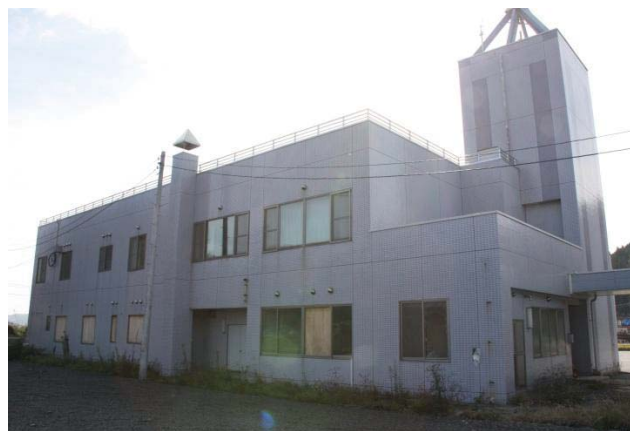
Figure 36 Government offices in Kamaishi City. This building is raised several metres above sea level and sustained damage to only the 1st storey windows

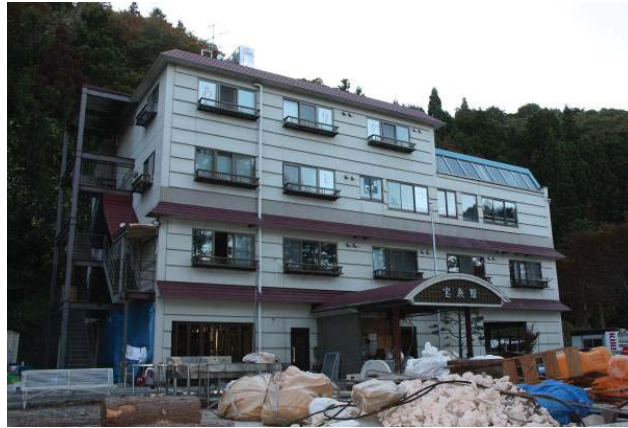
Figure 37 The Hotel Horaikan at Unosumai, Kamaishi City, with official signage displayed at the 3rd floor and very little external damage. The hotel was inundated to the ceiling of the 2nd storey

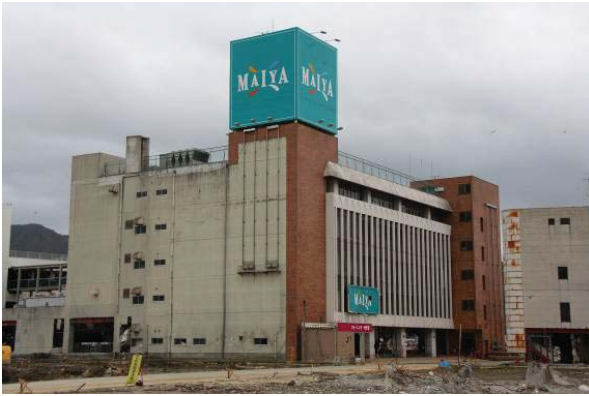
Figure 39 Maiya shopping centre, which was inundated to the 3rd storey

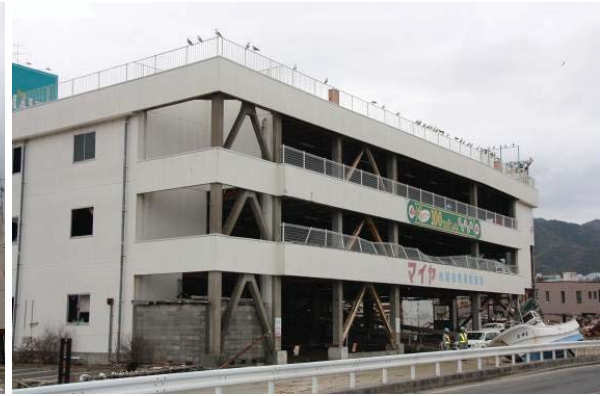
Figure 40 Maiya multi-storey car park showing damaged railing at the 2nd storey.

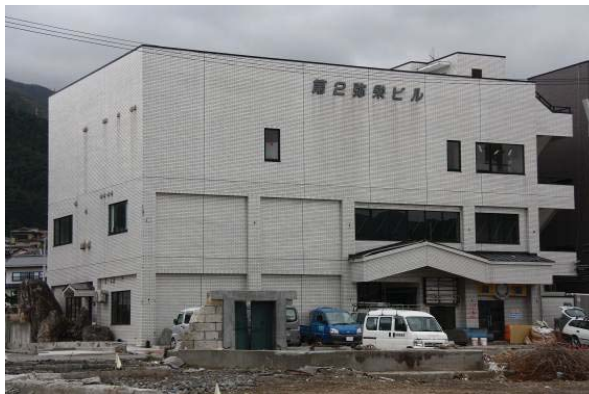
Figure 41 Yasuka private commercial and apartment block number 1 shows very little exterior damage.

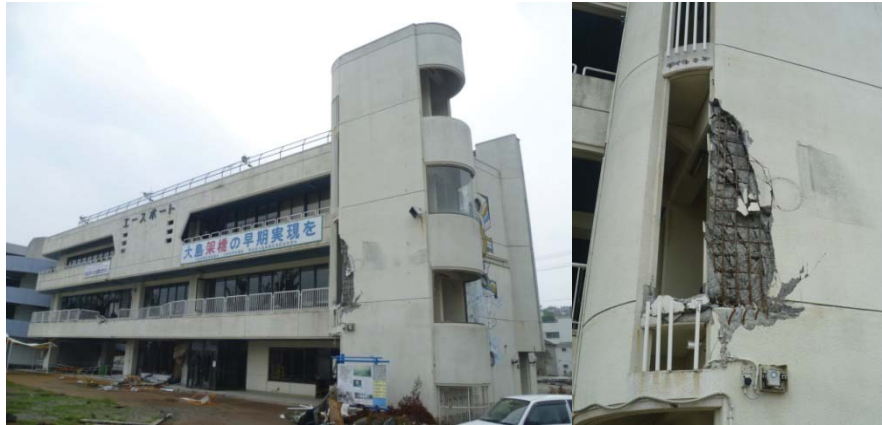
Figure 46 An office building in the inner harbour was unused on March 11th. This building sustained debris damage to the external stairs (front right) which face the harbour. Minor scour occurred along the seaward face of the building, and around the base of the external stairs.

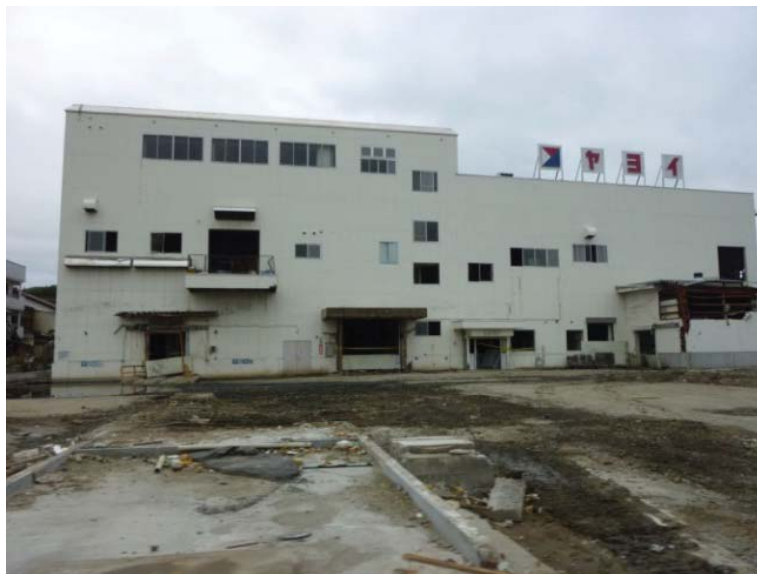
Figure 47 The Yoyoi food factory, where 400 people took refuge. Inundation height was around 8 m here.

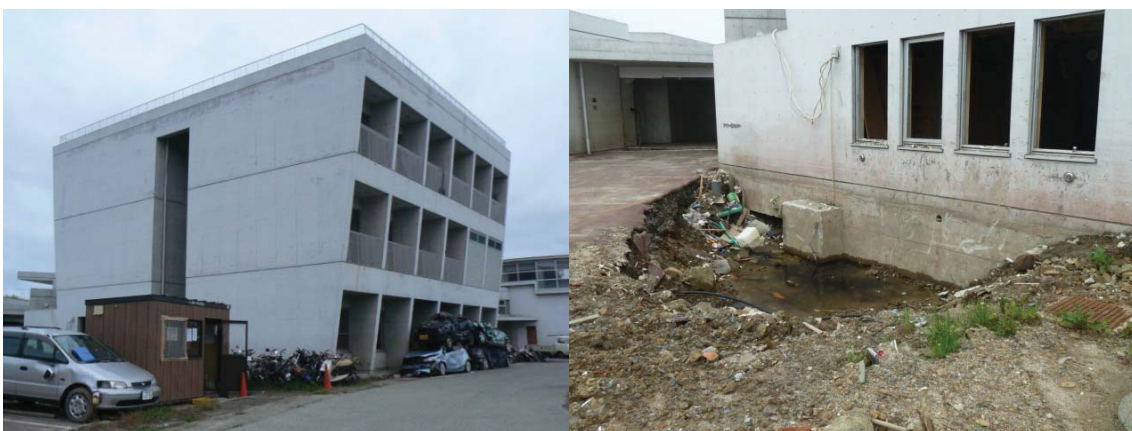
Figure 48 An elderly persons' welfare centre which was inundated to around 8 m height. Scour up to 2 m deep occurred on the near side of the building in this photograph. Extensive damage occurred immediately inland of this building, while 80 survived on the upper floors.

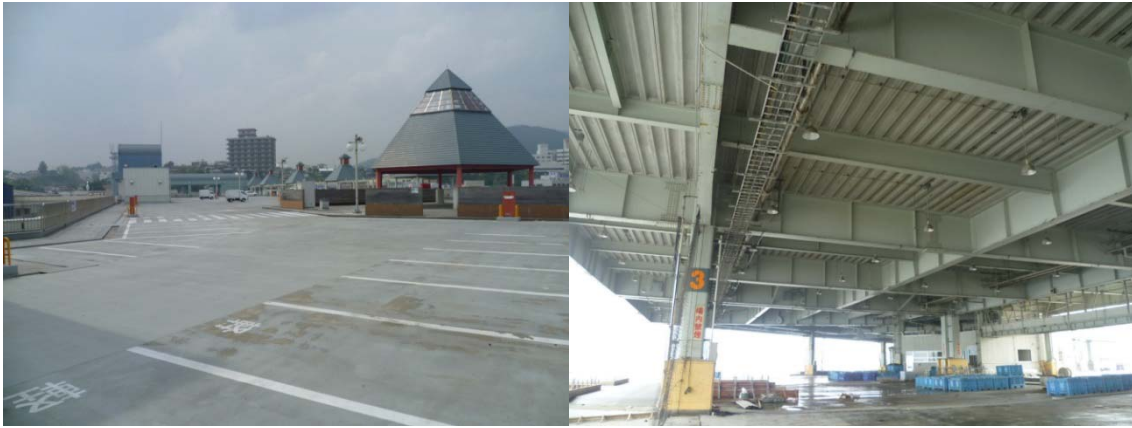
Figure 49 The large open car park roof space above the fish market provided refuge to 1000 people. This structure is at the harbour front and inundation almost reached roof level. The open steel structure enabled tsunami flow at the 1st storey.

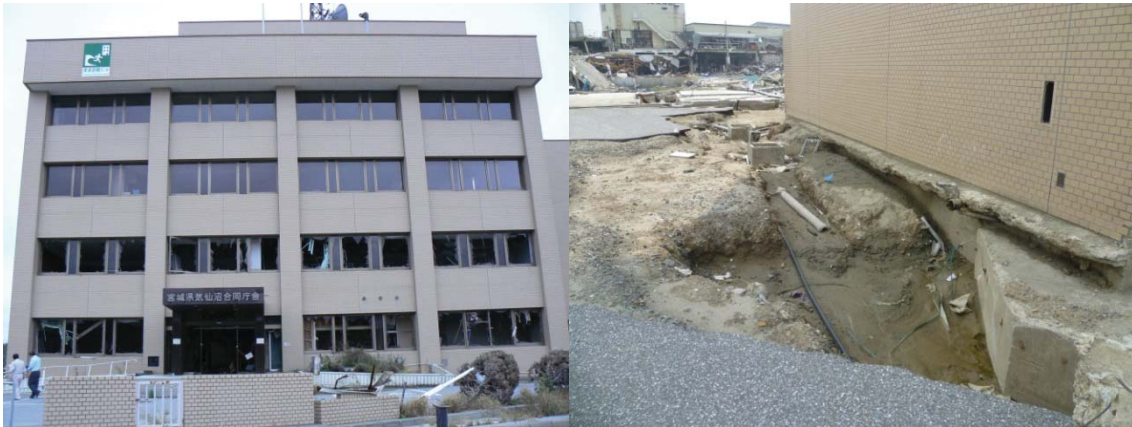
Figure 50 The Prefectural Government offices suffered extensive scour and heavy inundation of 8 m. This building was constructed after 2004 and displays tsunami vertical evacuation signage at roof level. 200 people survived the tsunami in this building

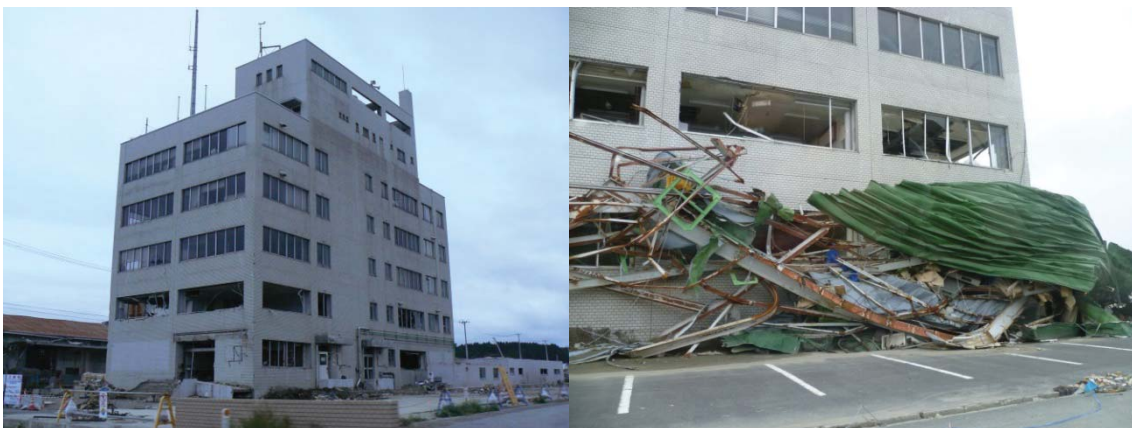
Figure 51 The National Government office, where 120 people took refuge from the tsunami. This building is adjacent to the Prefectural Government offices and was left undamaged when light steel structures were washed into it. The lower two storeys were inundated.

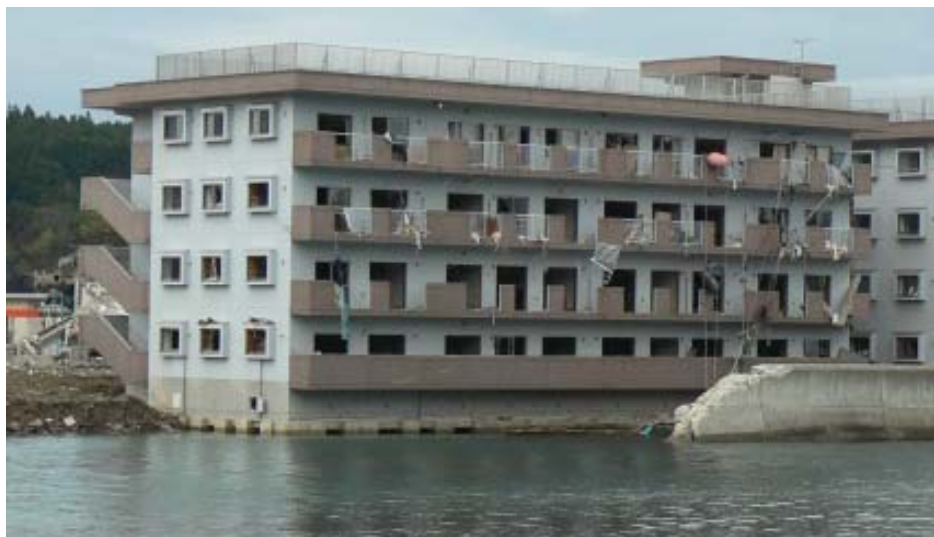
Figure 55 Matsubara apartment block viewed from the seaward side with waterborne debris to the 4th storey. The low seawall has been destroyed in the tsunami return flow and was sheltered in part by the apartment building. The foundations of this building are exposed above the water level due to extensive scour.

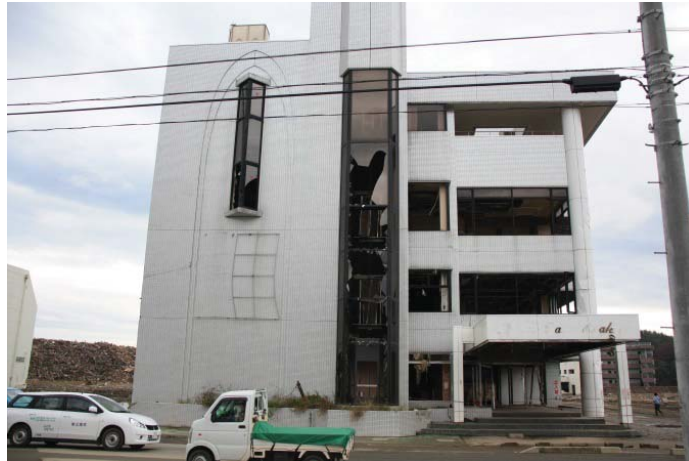
Figure 56 The Takano Kaikan building 160 m inland of the Matsubara apartment block. Little damage aside from glazing was observed here, despite heavy damage and collapse of RC buildings immediately seaward.

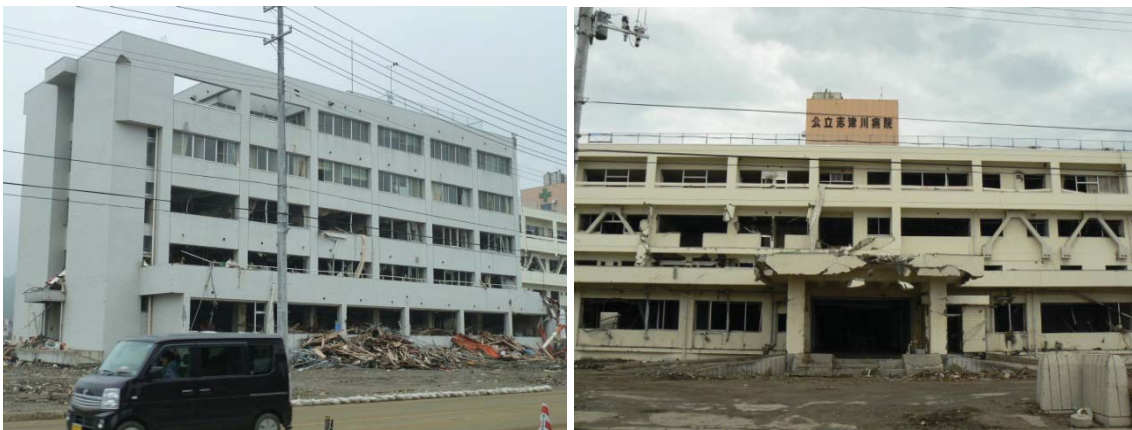
Figure 57 Shizugawa Hospital (west building) – the taller of the 2 hospital buildings at 5-storeys, this section suffered less debris damage than the east building.

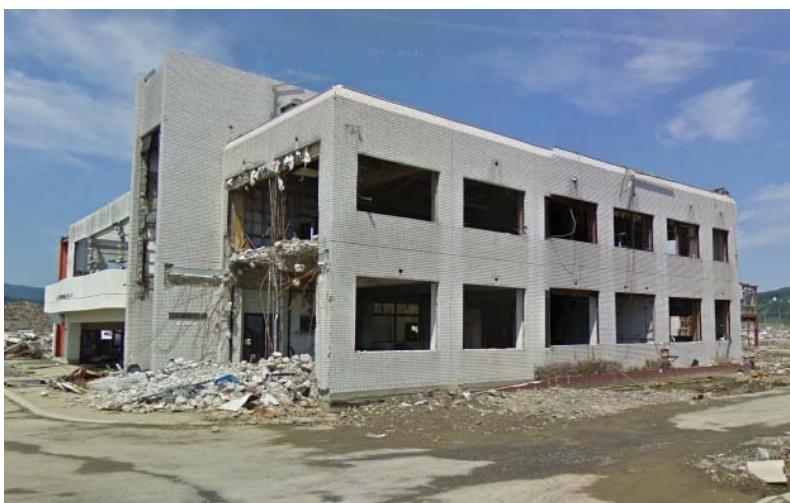
Figure 59 Minami-Sanriku fisheries co-operative building which was overtopped on March 11th. Image credit: Google Streetview, August 2011.

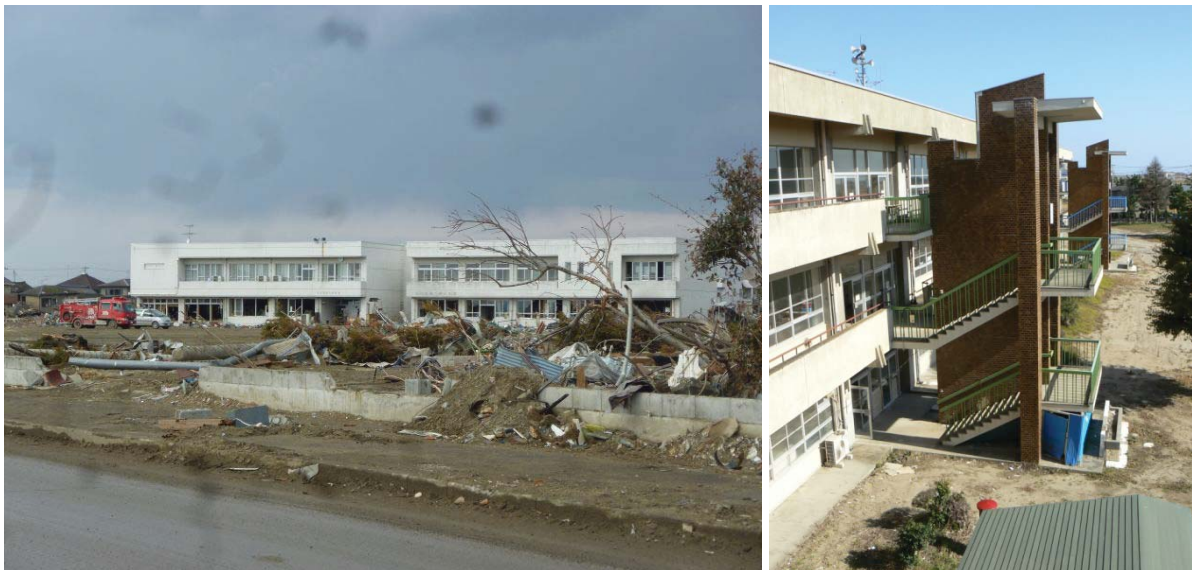
Figure 65 The Yuriage Community Centre was inundated to the 2nd storey but 43 people survived in the building.

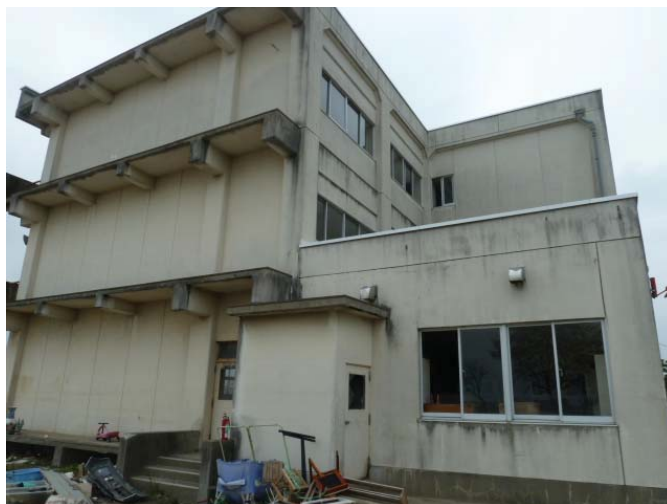
Figure 67 Yuriage Junior High School is constructed on ground which is raised 1.8 m above the surrounding fields. This helped to mitigate damage from the tsunami flow and only contents damage was observed (EEFIT, 2011). 823 people took refuge here.
