DETERMINATION OF PROCEDURES TO ESTABLISH  
PRIORITIES FOR EROSION CONTROL AS  
DETERMINED IN THE SOUTHERN  
RUAHINE RANGES, NEW ZEALAND.

A thesis presented in partial fulfilment  
of the requirements for the degree of  
Masterate in Agricultural Science in  
Soil Science at Massey University.

Peter Robert Stephens.

1975.

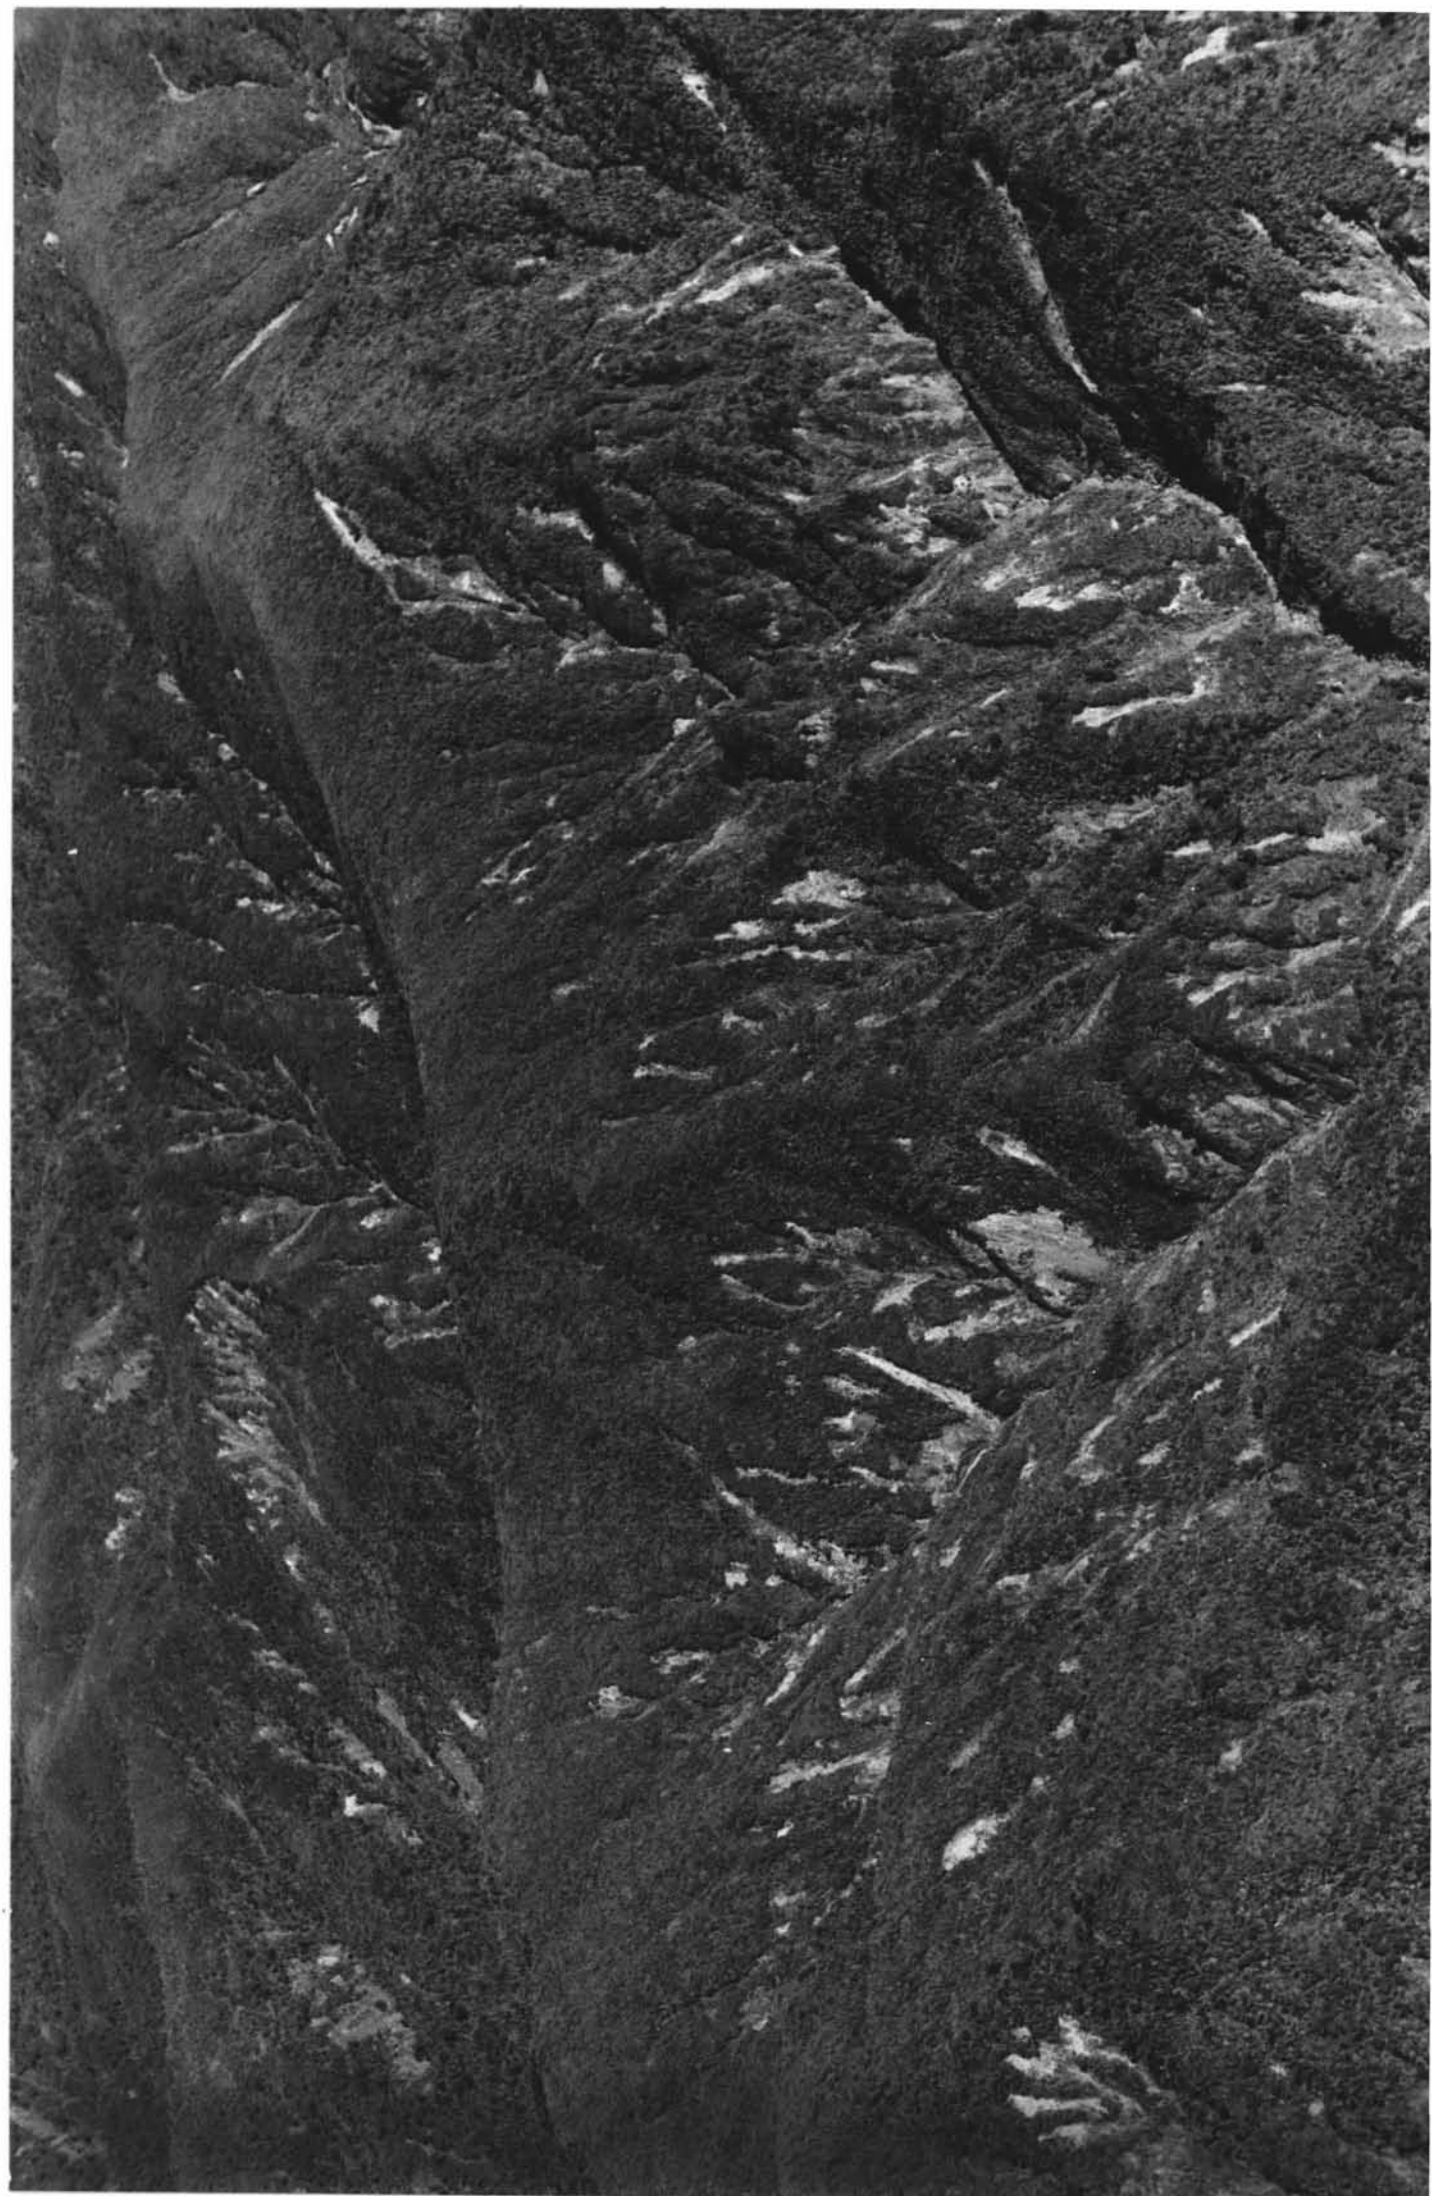
FRONTPIECE. Oblique aerial photograph of the two photographic study areas. Main divide of southern Ruahine Range runs from centre left to top right. No. 1 catchment is in the foreground. The top half of the large slump in the Raparapawai catchment and the many other erosion scars are clearly seen. Date of photography is March 19 1975.
