**THE USE OF A GEOGRAPHIC INFORMATION SYSTEM
TO INVESTIGATE SOIL SLIP DISTRIBUTION AND
THE LAND USE CAPABILITY CLASSIFICATION
IN THE EAST COAST REGION, NEW ZEALAND.**

A thesis presented in partial fulfilment of the requirements
for the degree of Master of Applied Science
in Soil Science at Massey University

SHERYL DENISE HENDRIKSEN

1995

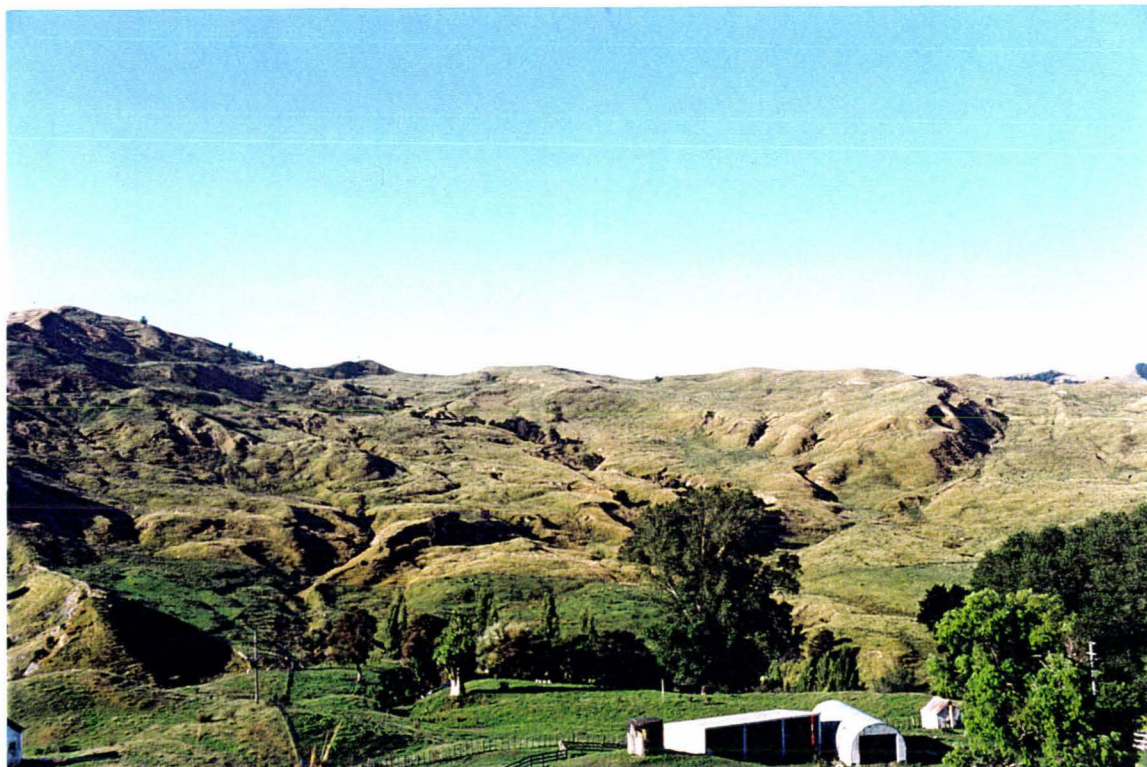
Figure 3.3 The Te Arai syncline in crushed mudstone with jointed mudstone on the right tilted up towards the east

The Te Arai syncline trending NNE-SSW is clearly obvious within a band of crushed mudstone east of the Te Arai River. The jointed mudstone to the east of the syncline is tilted up towards the east (the Rerepe anticline) (Figure 3.3). West of the syncline banded sandstone and mudstone is tilted upwards towards the Waingake anticline, Figure 3.4. Faults were noted in bands of crushed mudstone also to the west of the syncline (Figure 3.5).

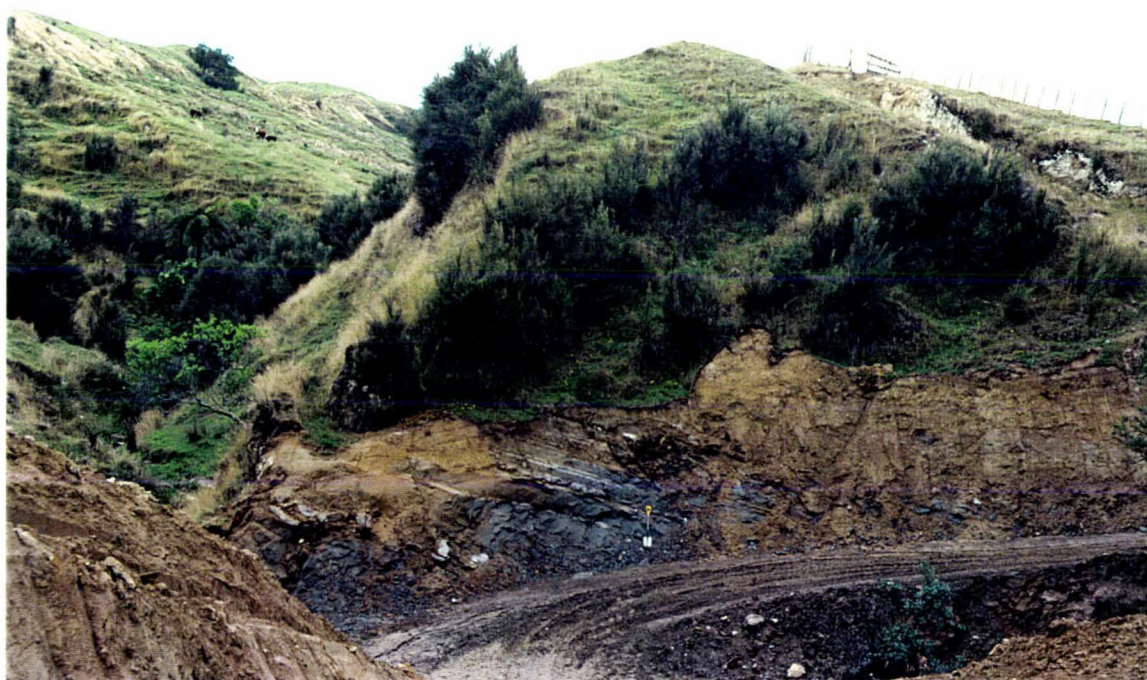
Figure 3.4 To the west of the Te Arai syncline the banded mudstone and sandstone is tilted up towards the west

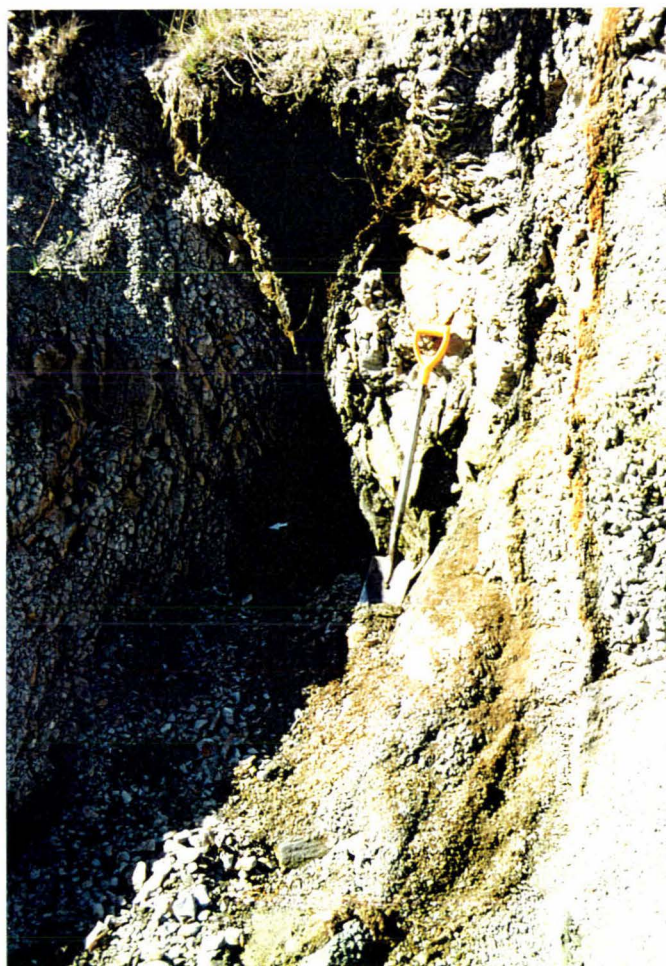
Figure 3.5 Faults are observed in bands of crushed mudstone

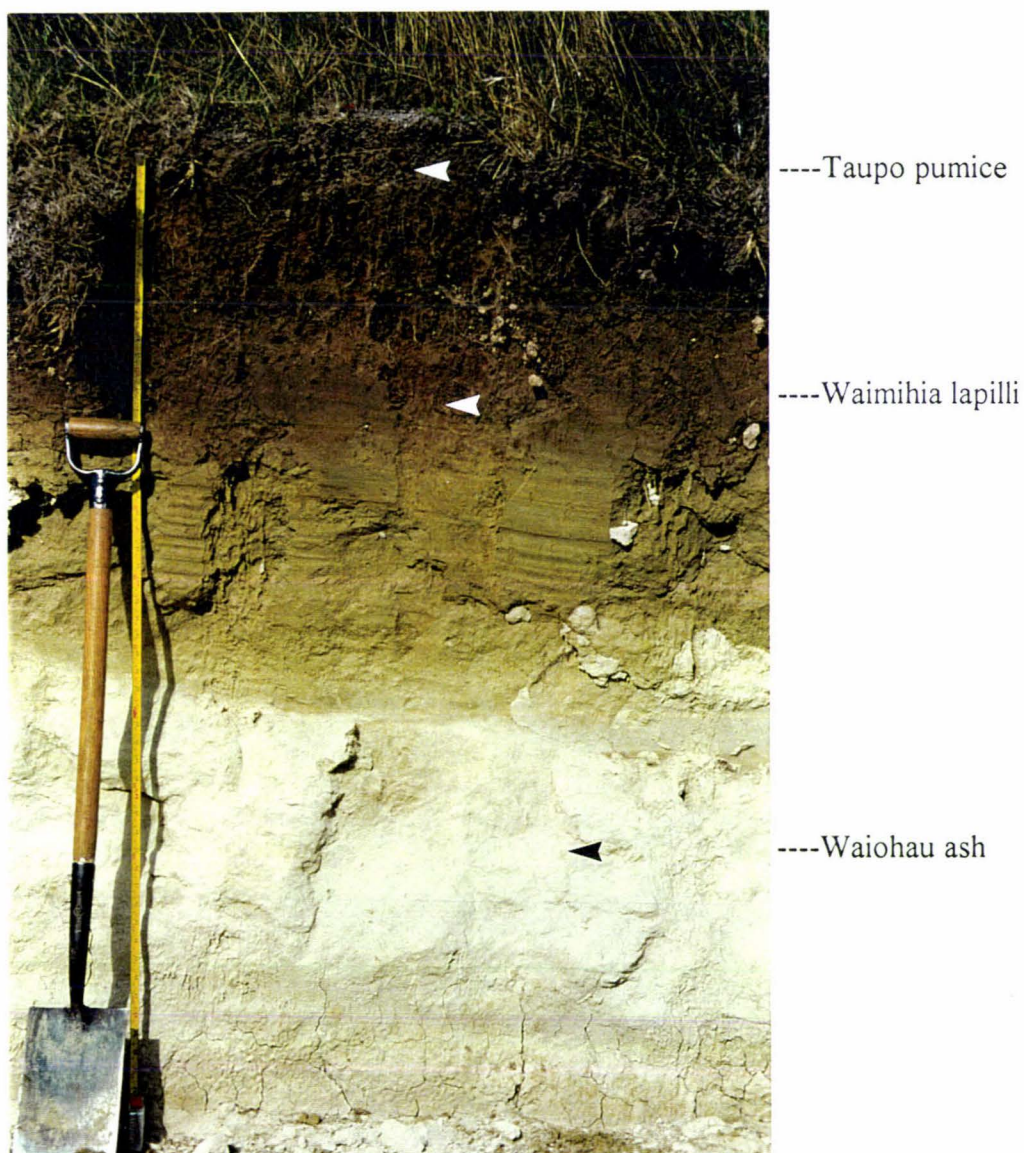
Figure 3.6

Three tephrae are found on the broader ridges and shoulders. The Waiohau ash overlying Mudstone indicates that no soil parent material in the area is older than 11,200 years. The colluvium between the Waiohau and the Waimihia infers the instability of that period.

This study found that three tephras are recognisable on Emerald Hills station. Taupo fine to coarse ash and pumice of up to 15mm in diameter occurs mixed in the top soil; dark orangey, brown Waimihia lapilli underlies the topsoil and overlies colluvium, weathered bedrock or the light yellow cream Waiohau ash deposit (Figure 3.6). These deposits do not occur in a consistent manner.

<i>Ah/Taupo pumice</i>	<i>10-20 cm</i>
<i>Waimihia lapilli</i>	<i>10-30 cm</i>
<i>Waiohau ash</i>	<i>10-30 cm</i>
<i>Cw (bedrock/colluvium)</i>

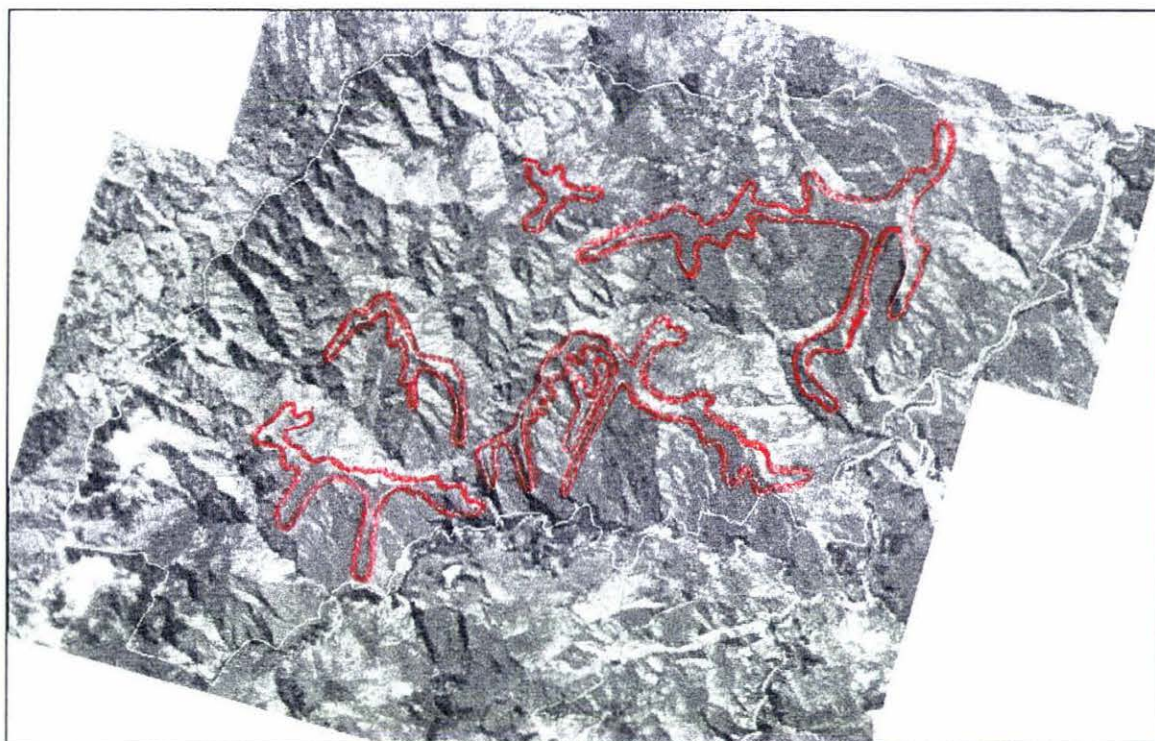
Figure 3.7 Areas on Emerald Hills station where all three tephras may be found.

On the 2,900ha property there are few areas where the tephras are preserved in their true sequence. A field survey revealed that all three tephras are found in only a few stable sites on the broader parts of the ridges delineated in Figure 3.7. Large areas mapped as Mj / Kt or Kt / Mj (jointed mudstone and ash) on the farm plan, are usually the more stable slopes where Taupo pumice occurs mixed in the Ah horizon.

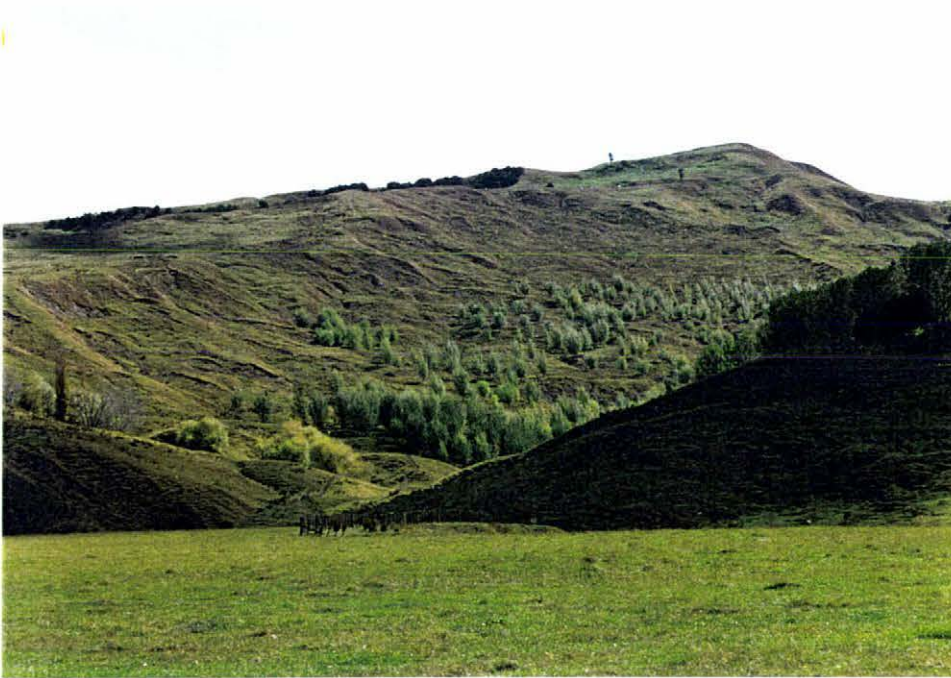
Figure 3.8 Earthflow erosion on Emerald Hills station

Throughout the catchment the physiography reflects historic erosional processes. Large areas have been altered by progressive earthflows, Figure 3.8. Gully erosion is evident along drainage channels and is serious in some places especially in the crush zones associated with faults and the syncline. Poplar and willow plantings, and debris dams protected some, but not all, gullies during Cyclone Bola, Figure 3.9. Stream bank erosion occurs along the Te Arai River and its 3 major tributaries, the Waimata, Kauwaewaka and Waingake Streams. Where these erosional processes remove the toes of slopes, slumping often occurs. The erosion form most obvious in the catchment is the soil slip and sheet erosion induced by Cyclone Bola in 1988, Figure 3.10.

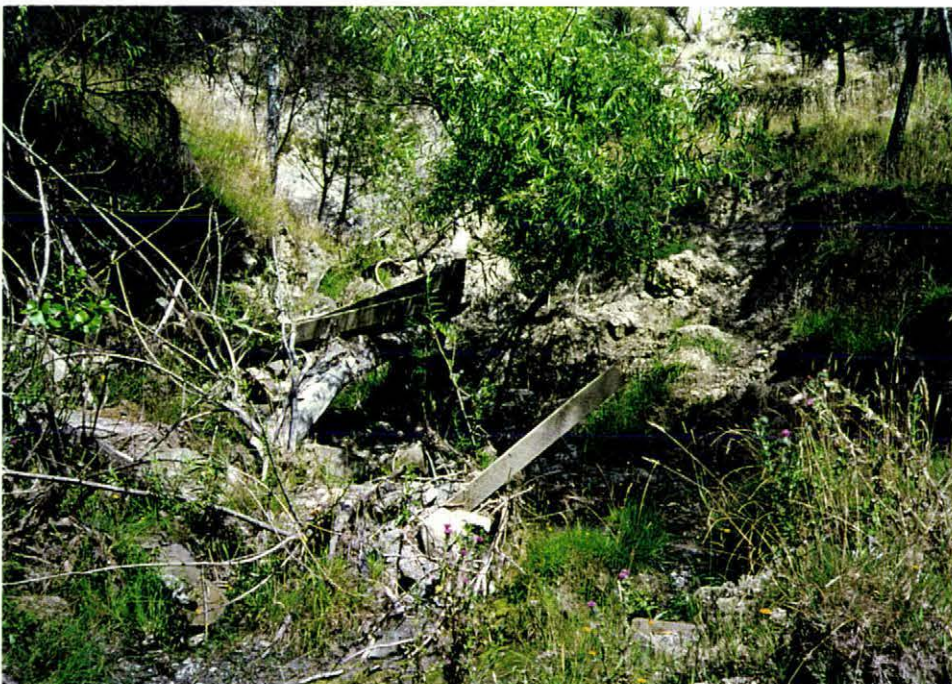
Figure 3.9 Gully infilling following Cyclone Bola

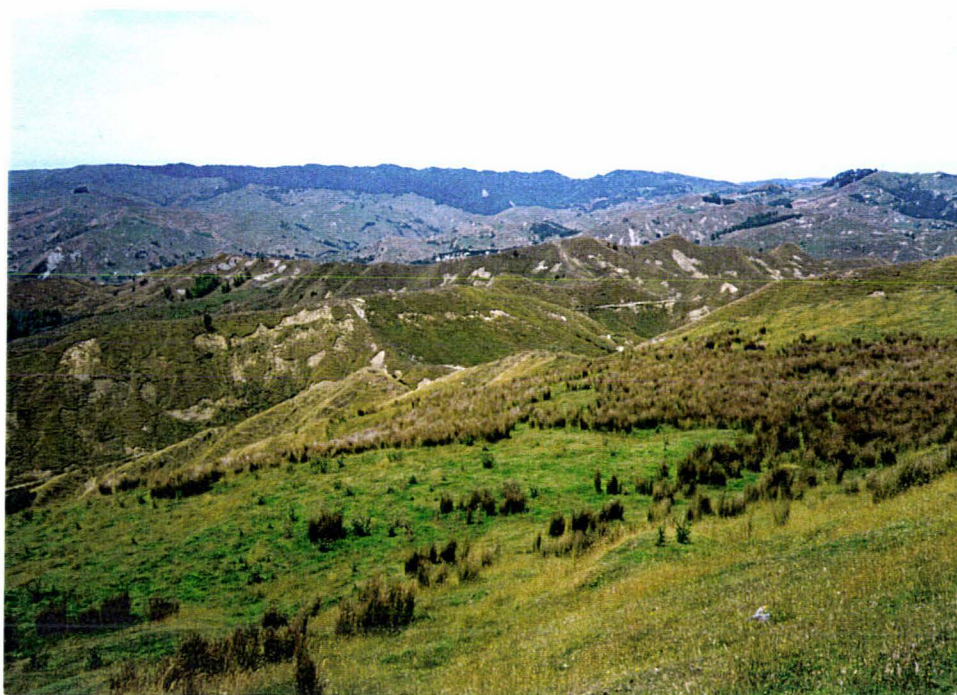
Figure 3.10 Soil slip erosion following Cyclone Bola

Slip scars were estimated to be approximately 5% of the land area (C.M. Trotter, Landcare Research, Palmerston North. *pers com.*). The erosion inflicted by Cyclone Bola appeared to be restricted to pasture land with little evidence of disturbance in the bush reserve or pine blocks, except for deeply incised gullies.

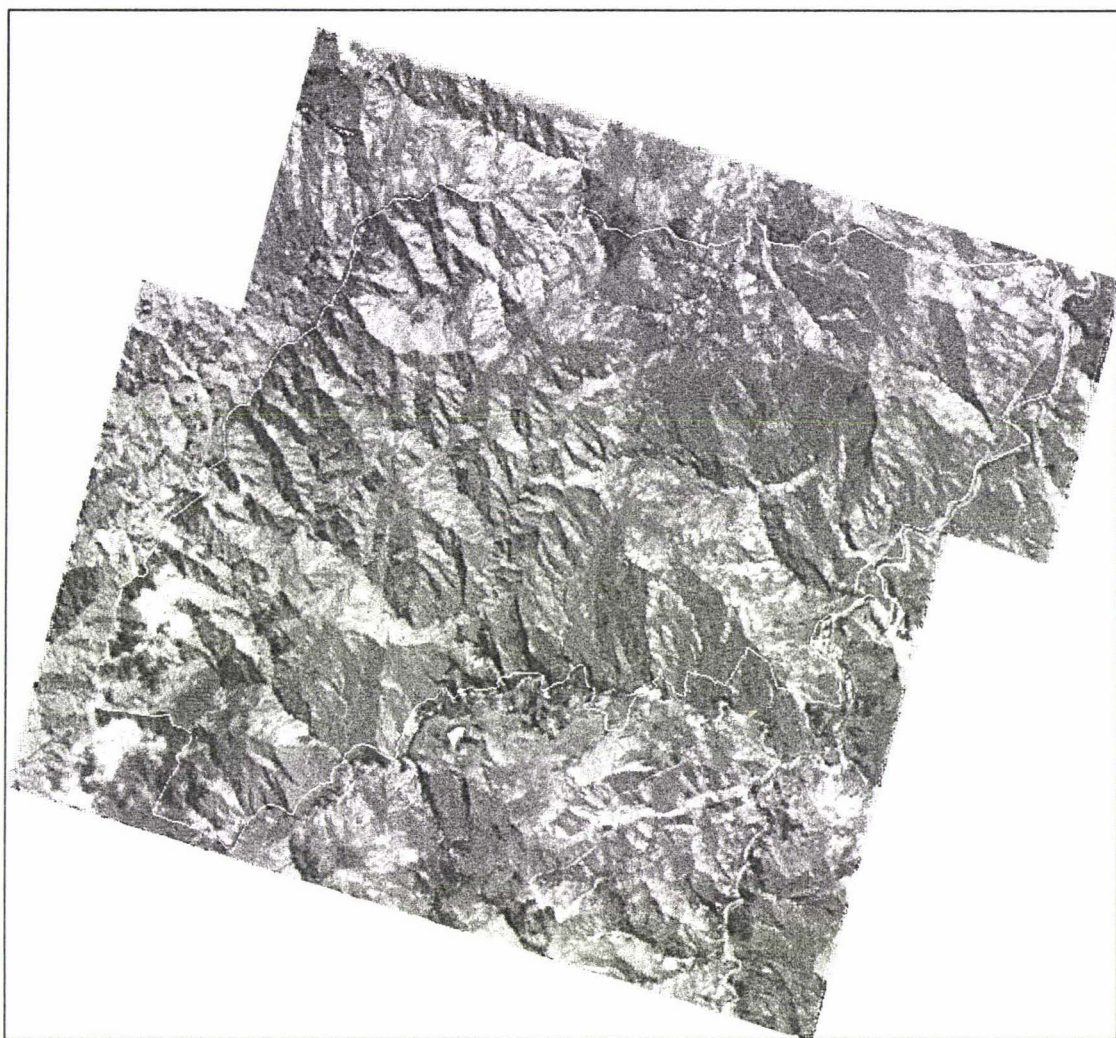
Figure 5.1 Satellite image of Emerald Hills station, registered to the NZ metric grid.

An attempt was made to classify for trees, pasture and bare ground. However, when the image was classified for the three land cover classes the resultant image showed that trees and pasture could not be discriminated. This was due partly to the amount of shading on the image and also to the characteristics of the trees themselves. The trees that were of most interest were space planted poplars and willows which were used for conservation works in eroding areas. These had similar reflectance values to pasture. Being autumn the tree leaf colour would be subdued and it is possible the poplars were affected by rust. Also, where there were only one or two small trees occupying a pixel, which represented 10m by 10m of ground area, the pixel would record the dominant reflectance character which was pasture.

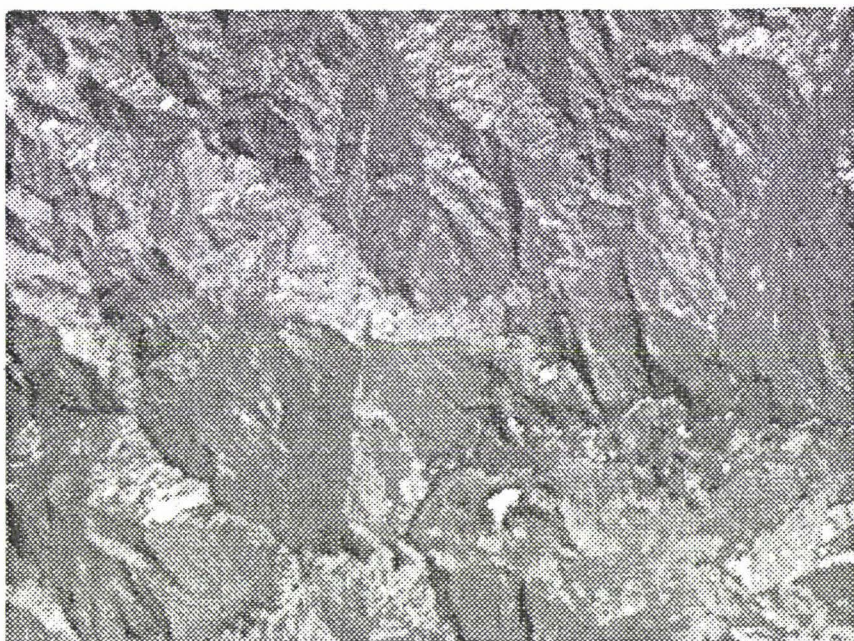
Figure 5.2(a) Sample area from satellite image

The classification procedure involved adjusting the range of reflectance values in the feature signature file until it resulted in a distinct delineation of the land cover classes. This is often referred to as density slicing. The classified image was compared with the original image and the signature ranges adjusted until a satisfactory classification was obtained, Figures 5.2 (a) & (b).

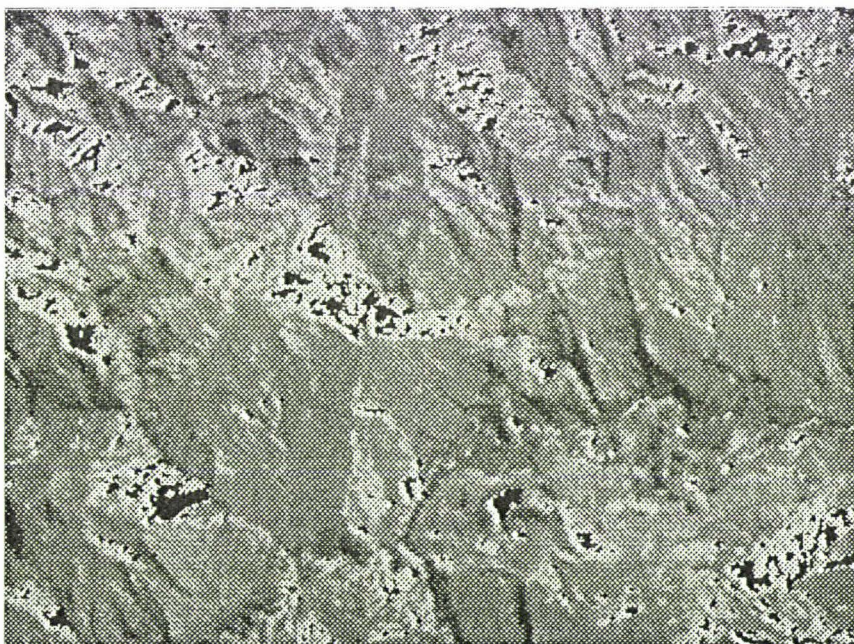
Figure 5.2(b) Satellite image (a) with areas classified as bare ground overlaid

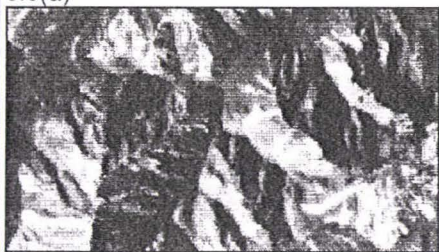
Figure 5.3 Sample area from aerial photograph (a), and the results of classification of the photograph scanned at 10m(b), 5m(c), 1m(d) resolution.

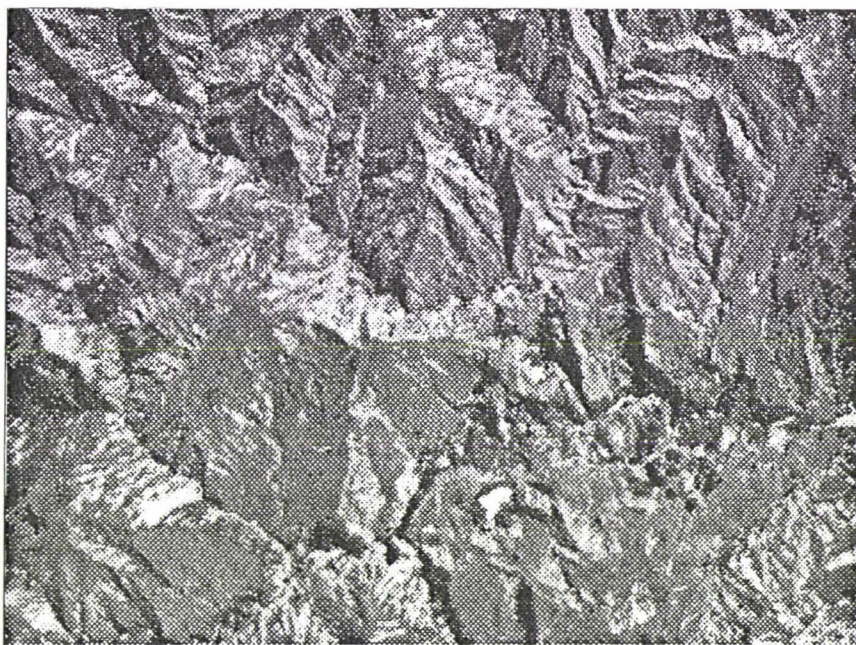
Figure 5.4(a) Sample area from aerial photograph, scanned at 10m resolution

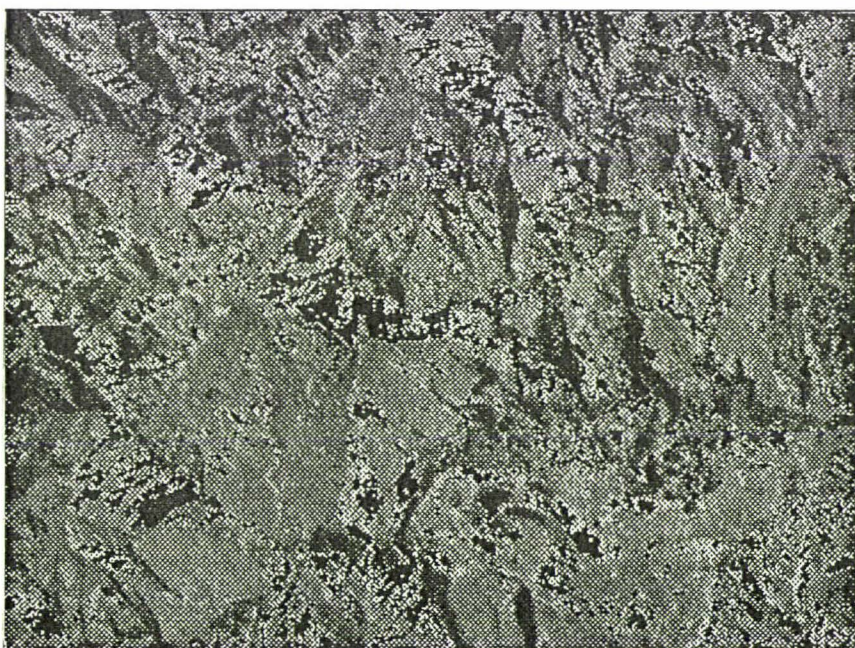
Figure 5.4(b) Aerial photograph (a) with areas classified as bare ground overlaid.

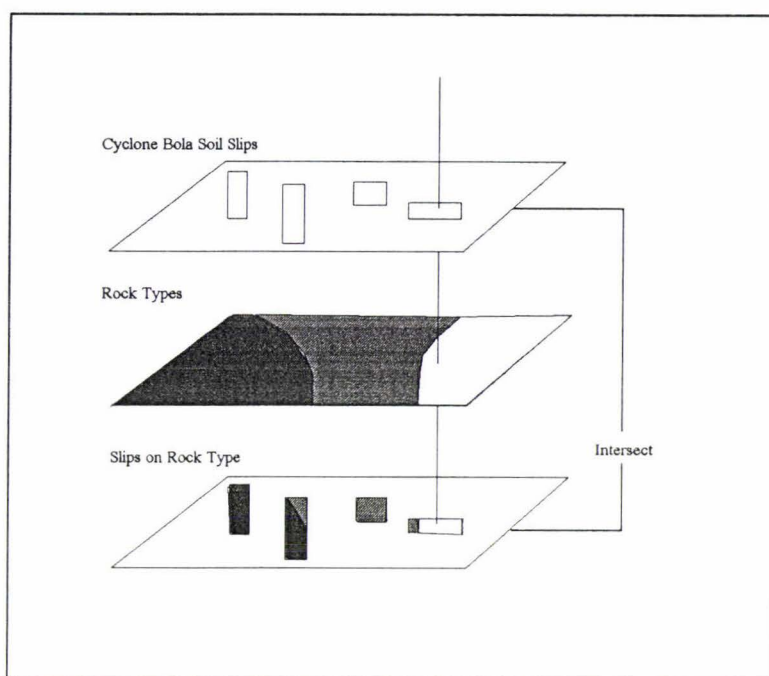
Figure 6.1 Overlay ('intersection') procedures to provide soil slip per landscape feature information.

Multifactor layers were also produced by combining the layers of slope and aspect; slope and rock type; and, rock type and aspect before their intersection with the soil slip layer (Figure 6.2). The database table of the resultant layer contains information obtained from the database tables of both of the original layers.

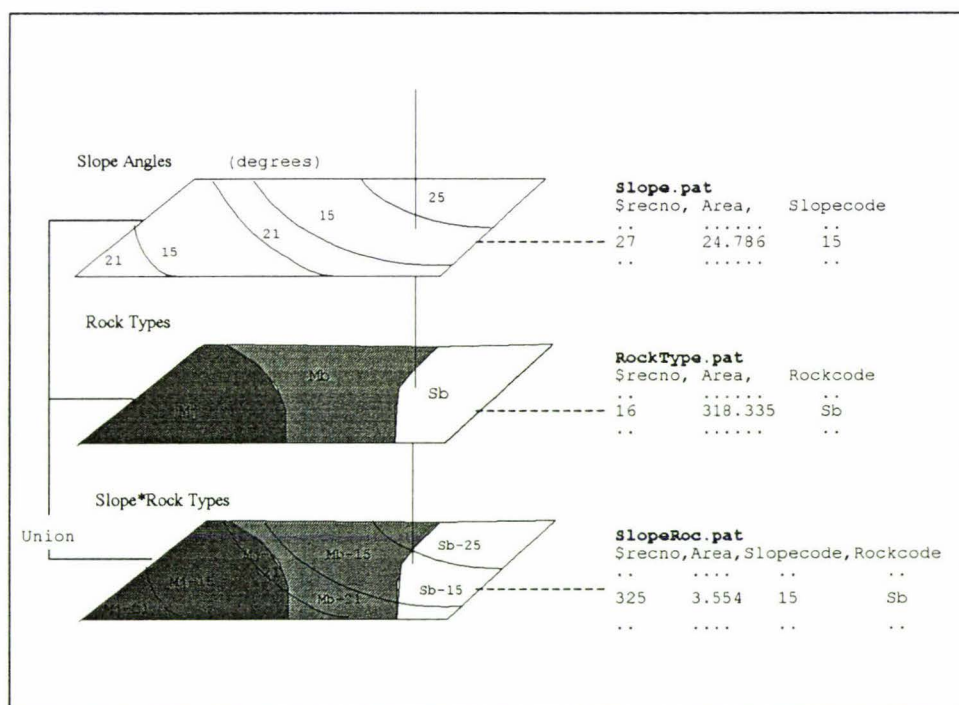
Figure 6.2 Overlay ('union') procedures and associated database polygon attribute tables.

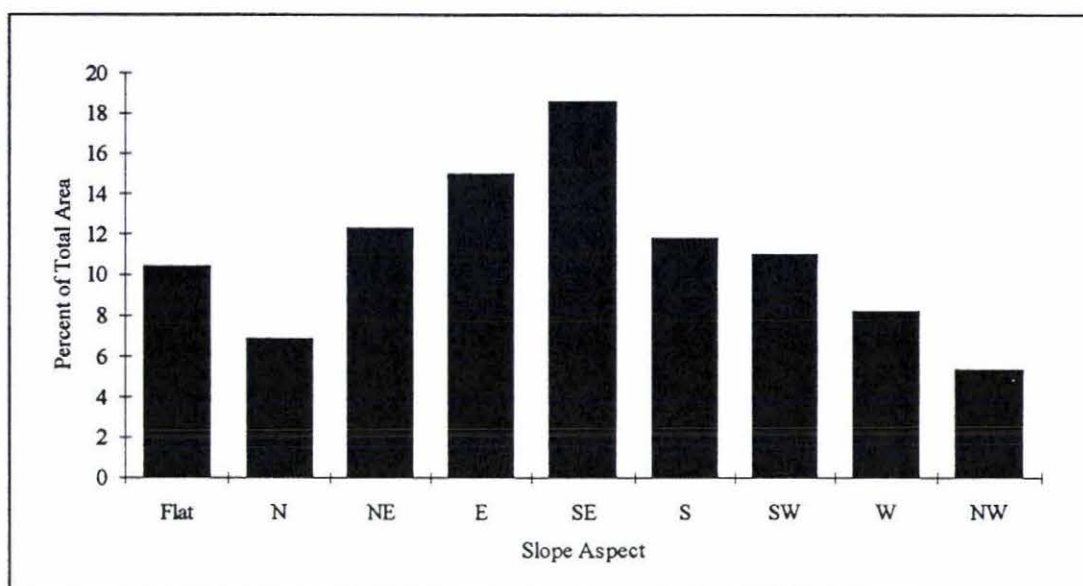
Figure 6.3 The distribution of slope aspects on Emerald Hills station

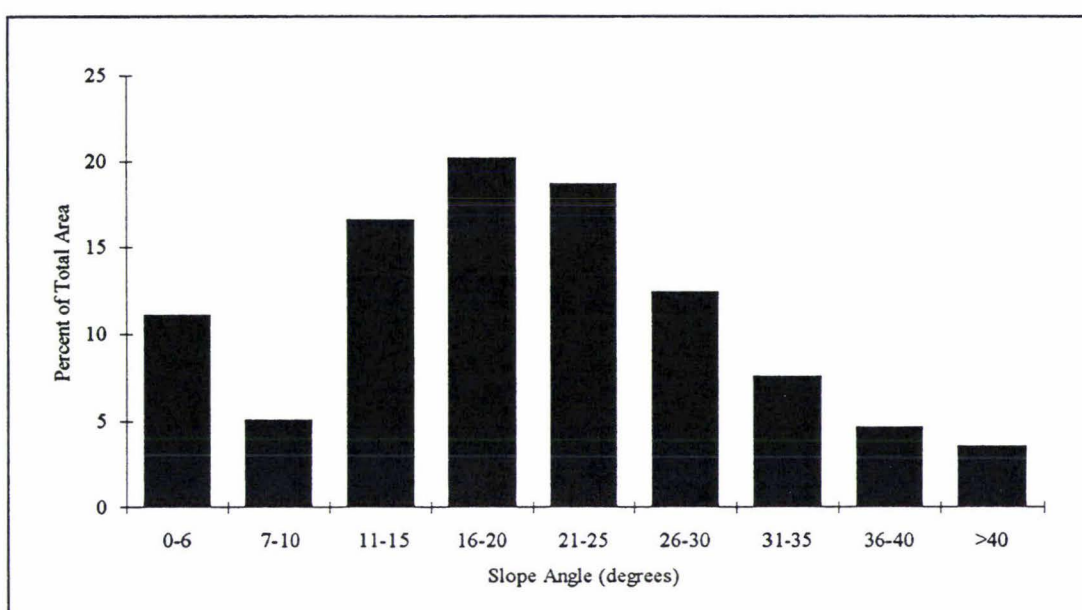
Figure 6.5 The distribution of slope angles on Emerald Hills station

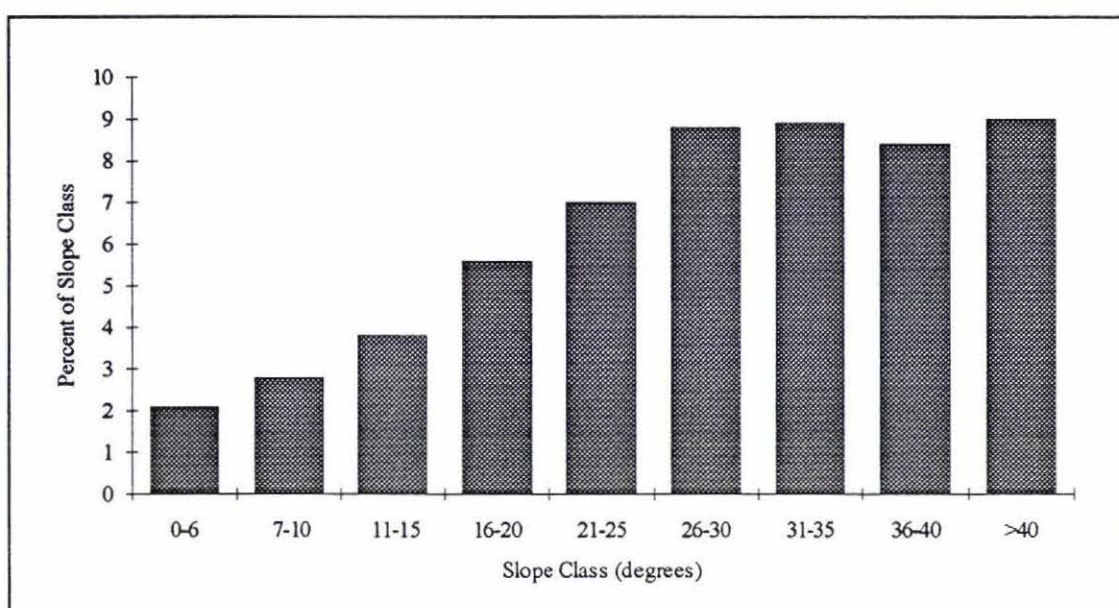
Figure 6.6 The distribution of soil slip per slope angle class

As slope angle increases so does the percentage of soil slip (Figure 6.6). This trend is in agreement with other studies (Eyles *et al.*, 1978, De Rose *et al.*, 1993,). However, where other studies have identified a critical angle below which soil slip does not occur, results from this study show there to be no critical slope angle. Soil slip can occur at any angle. Because of the scale of the contour data (20m) small

changes in slope angle have not been identified. For instance, a slope with a general slope angle of 8-15 degrees may have within it small areas of lesser or greater slope angle. The soil slip recorded in that general slope may in fact be occurring in sites with greater than 15° slope angle. There is a gradual increase in the amount of soil slip as slope angle increases, to a maximum at 27 - 30°. The amount of slip does not increase on slopes over this steepness.

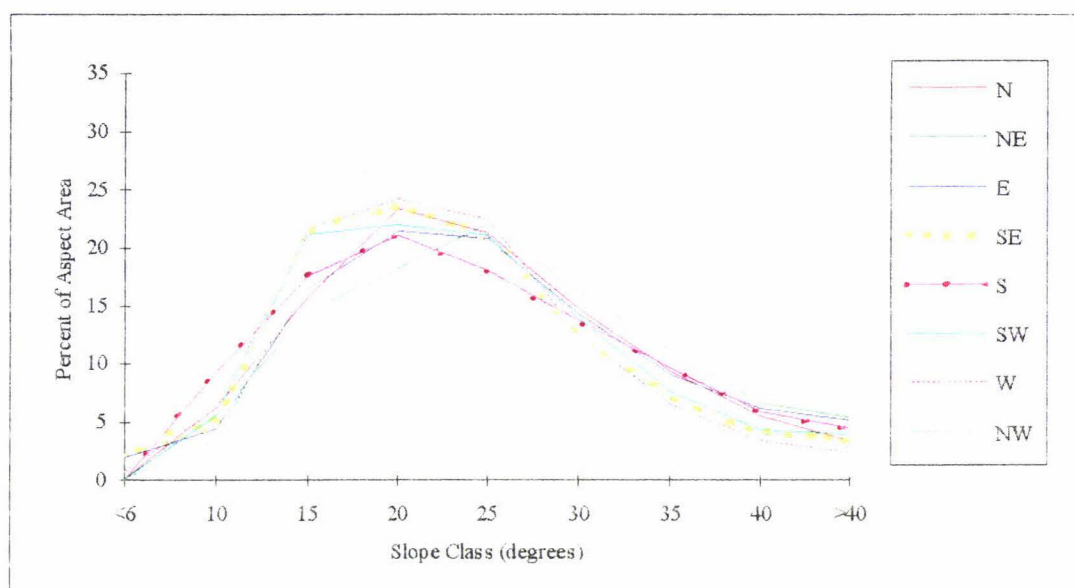
Figure 6.7 The distribution of slope class per aspect

To investigate whether the increased soil slip in the northerly and easterly aspects was a function of the slope angles within those aspects, the two layers were combined. This produced a layer of areas with consistent slope aspect and slope angle. The distribution of slope angle within each slope aspect was then determined (Figure 6.7).

There was little variation in the distribution of slope angle classes across the aspects with the exception of NW aspects which had a higher percentage of strongly rolling slopes (16 - 20°) than other aspects. NE aspects had a lower percentage of rolling to strongly rolling slopes (11 - 20°) than other aspects and a slightly higher percentage of steep slopes.

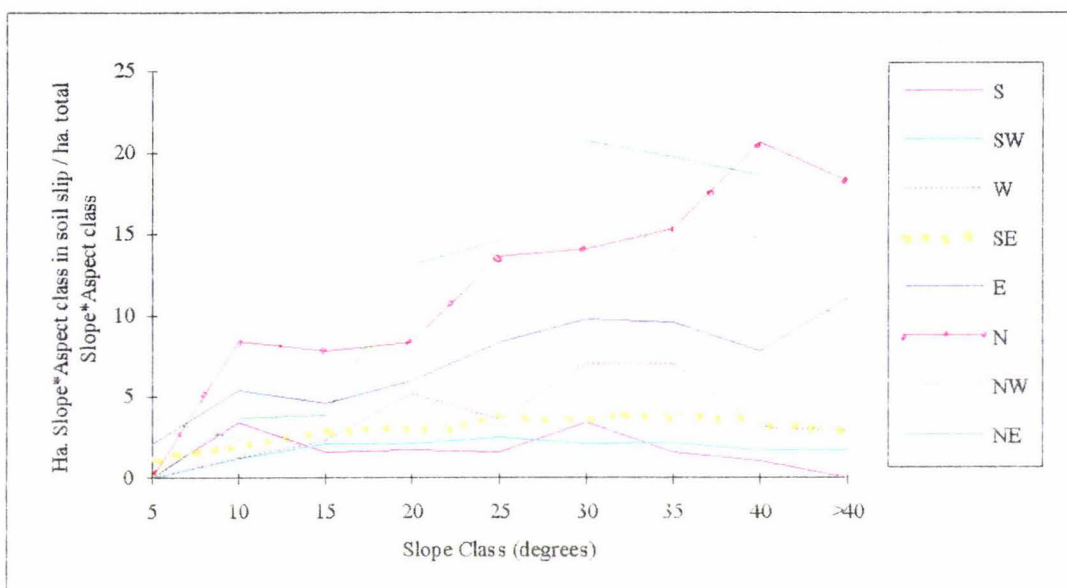
Figure 6.8 The density of soil slip on Slope*Aspect classes

The density of soil slip within each of these units was then calculated by dividing the area of soil slip within each unit by the total area of each unit (slope angle*aspect), and expressing the results as a percentage (Figure 6.8). The density of soil slip is greater on the steeper NE, N, NW, and E aspects than on other aspects which show less variation in the density of soil slip across the units. This reiterates the fact that the greatest density of soil slip occurred on steeper slopes over 20° (Figure 6.6) and on NE, N, NW and E aspects (Figure 6.4). NE, N, NW and E aspects do not have a greater percentage of slopes over 20° than other aspects (Figure 6.7) and therefore, slope angle alone cannot describe the predominance of soil slip on these aspects.

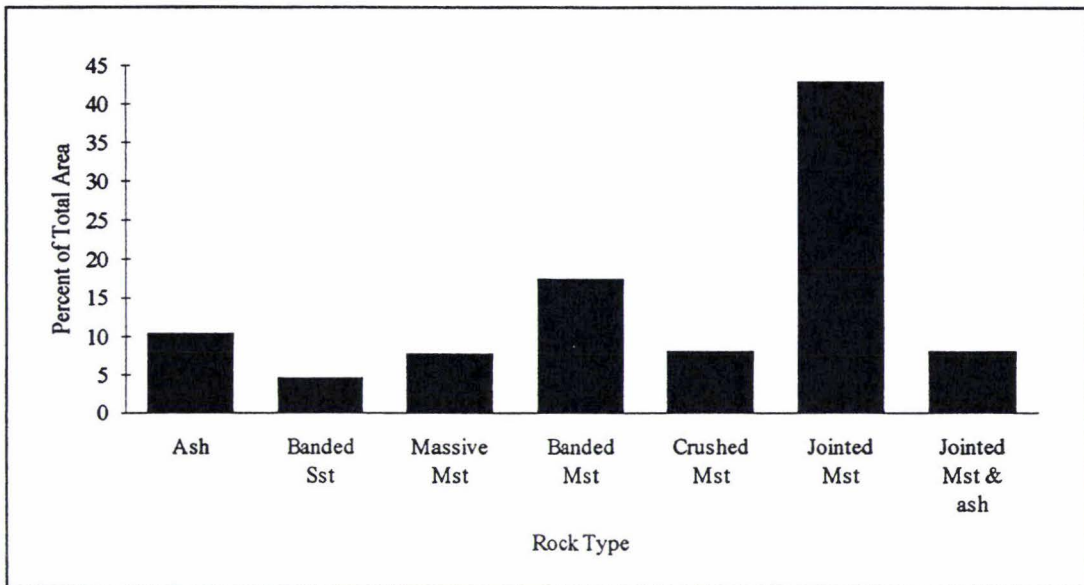
Figure 6.9 The distribution of rock types on Emerald Hills station

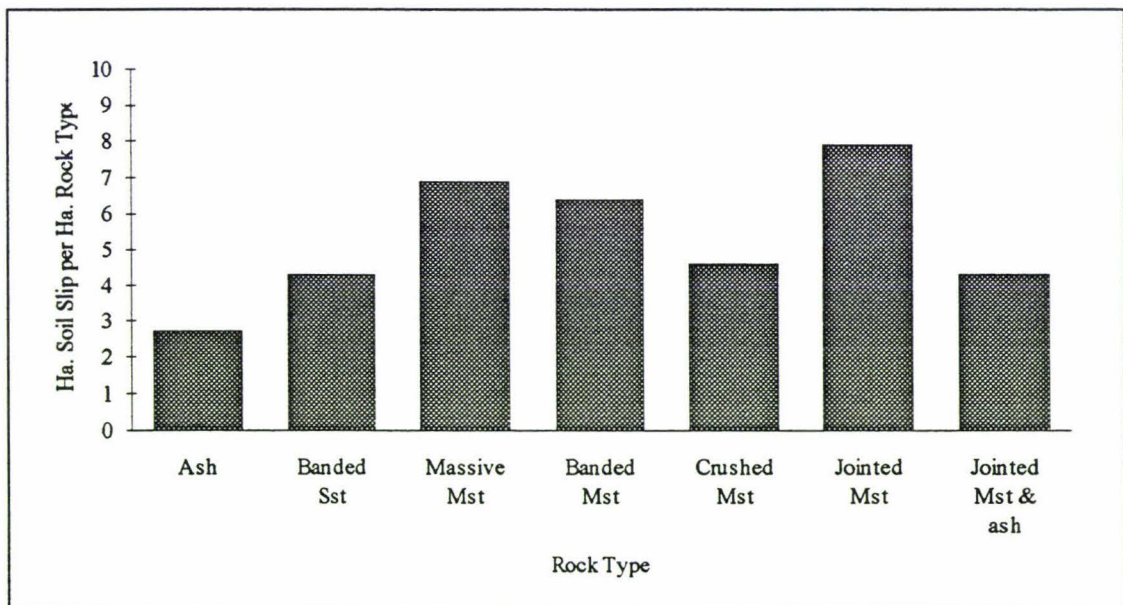
Figure 6.10 The density of soil slip per rock type

Jointed mudstone had the greatest density of soil slip (7.9%), followed by massive mudstone (6.9%), banded mudstone (6.4%), and crushed mudstone (5.2%), (Figure 6.10). The least soil slip was found on areas with a layer of tephra at or near the surface. Areas underlain by banded sandstone had less soil slip than areas underlain by mudstone.

The greatest density of soil slip occurs on NE, N, NW and E aspects (Figure 6.4). The greatest density of soil slip also occurs on jointed mudstone (Figure 6.10) with slightly lesser densities of soil slip on massive and banded mudstone. To investigate whether there was a higher proportion of jointed, massive or banded mudstones on NE, N, NW and E aspects the layers of rock type and slope aspect were combined and analysed. The occurrence of each rock type (%) within each aspect class was determined (Figure 6.12).

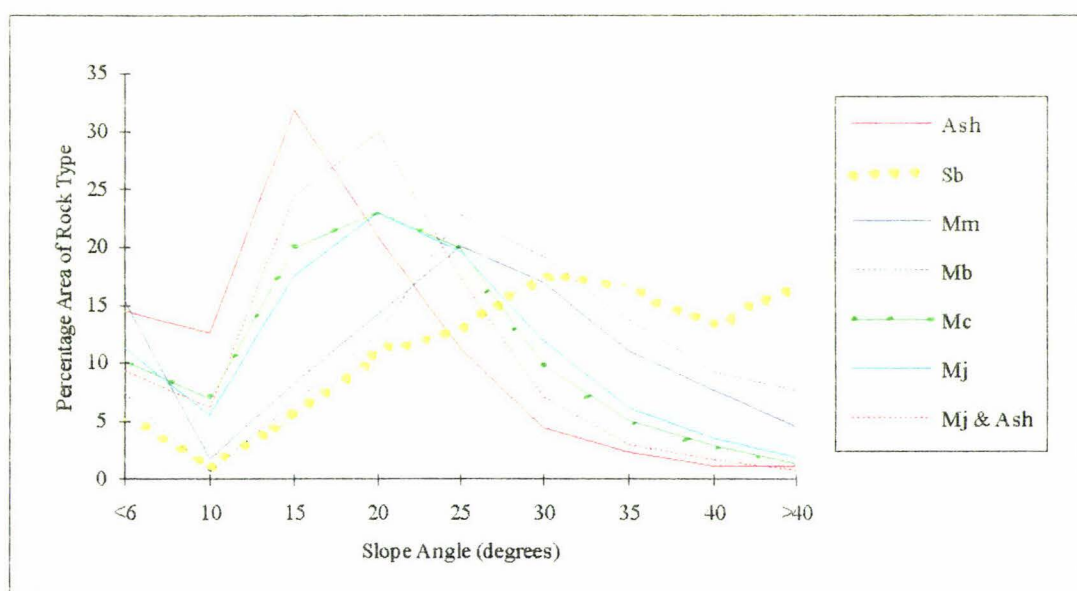
Figure 6.11 The distribution of slope angle per rock type

The distribution of slope angle within each rock type was also investigated to ascertain whether this could account for the variation of soil slip density between rock types (Figure 6.11).

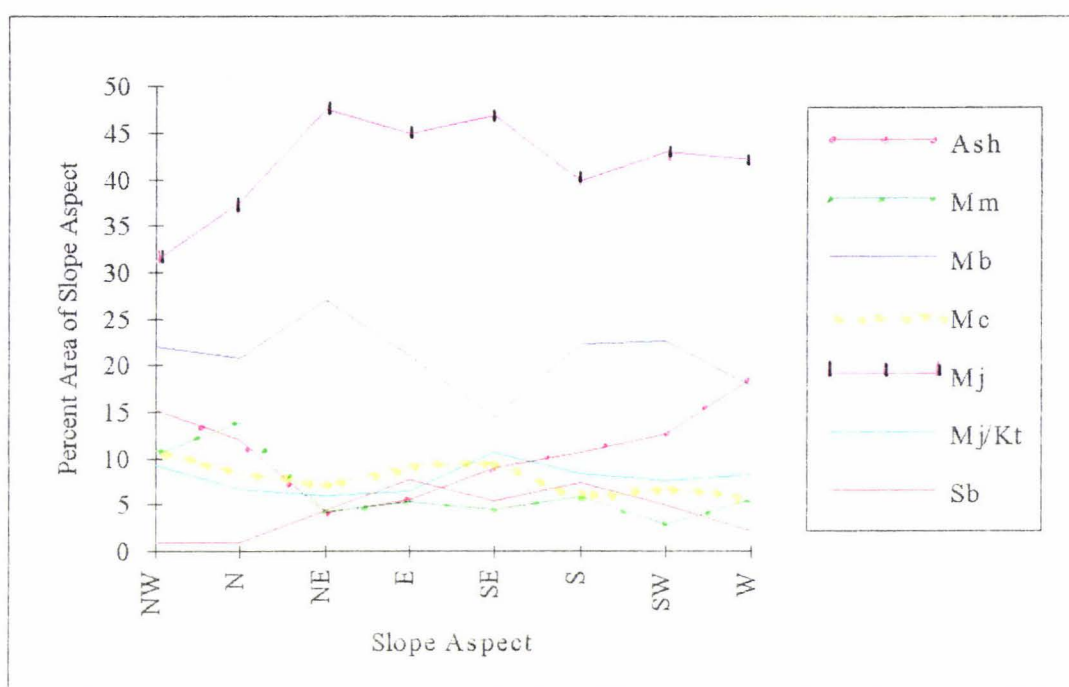
Figure 6.12 The distribution of rock type per slope aspect

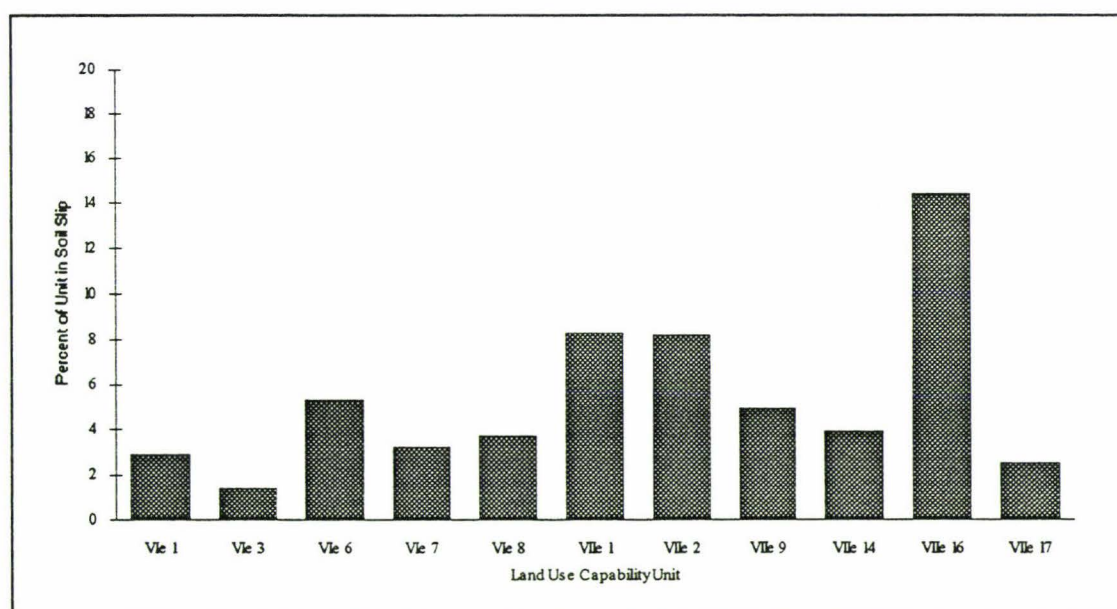
Figure 7.2 The distribution of soil slip per LUC Unit

In Class VII, Units mapped as having a higher degree of limitation (Units VIIe14, VIIe9 and VIIe17) had less soil slip than other Class VII units. Unit VIIe14 contains areas of stream channels with gully erosion but not so much soil slip erosion. These areas were previously considered to be the most problematic in terms of erosion and at the time of Cyclone Bola had mature conservation plantings to protect them. Although a low percentage of bare ground has been portrayed in these areas by the remotely sensed data, ground truthing revealed that the gullies are still eroding in some places beneath the tree cover and that the detritus from the eroded open slopes has infilled many of the stream beds destroying or overtopping the debris dams.

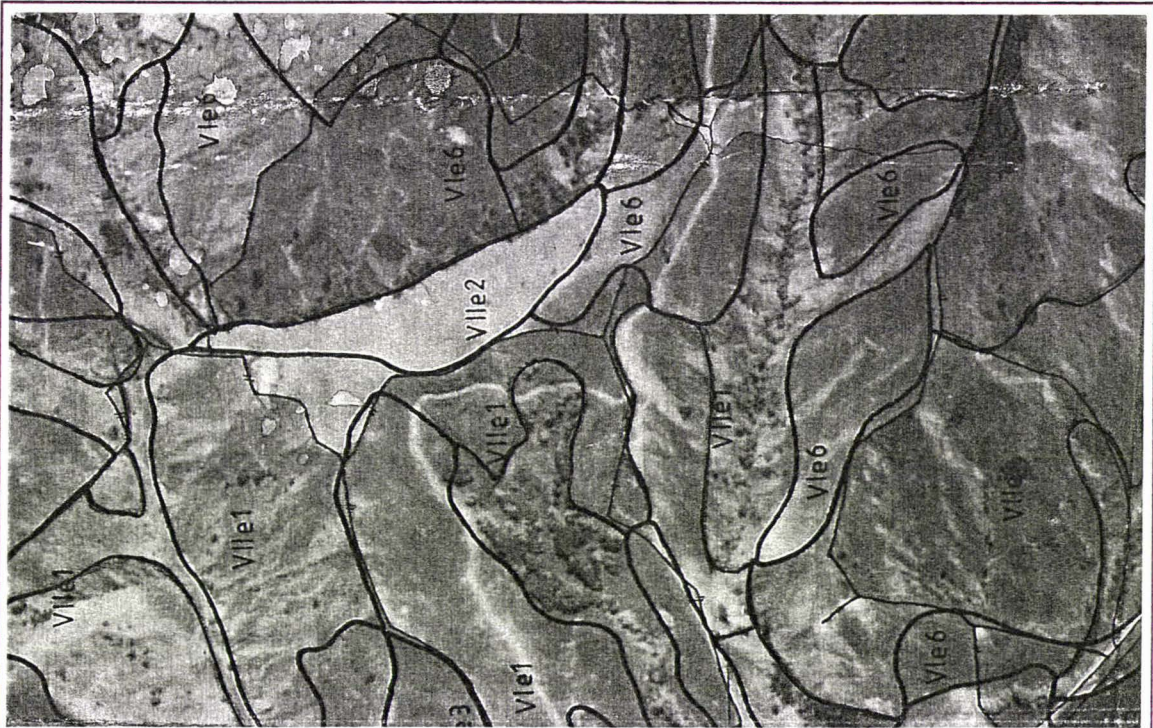
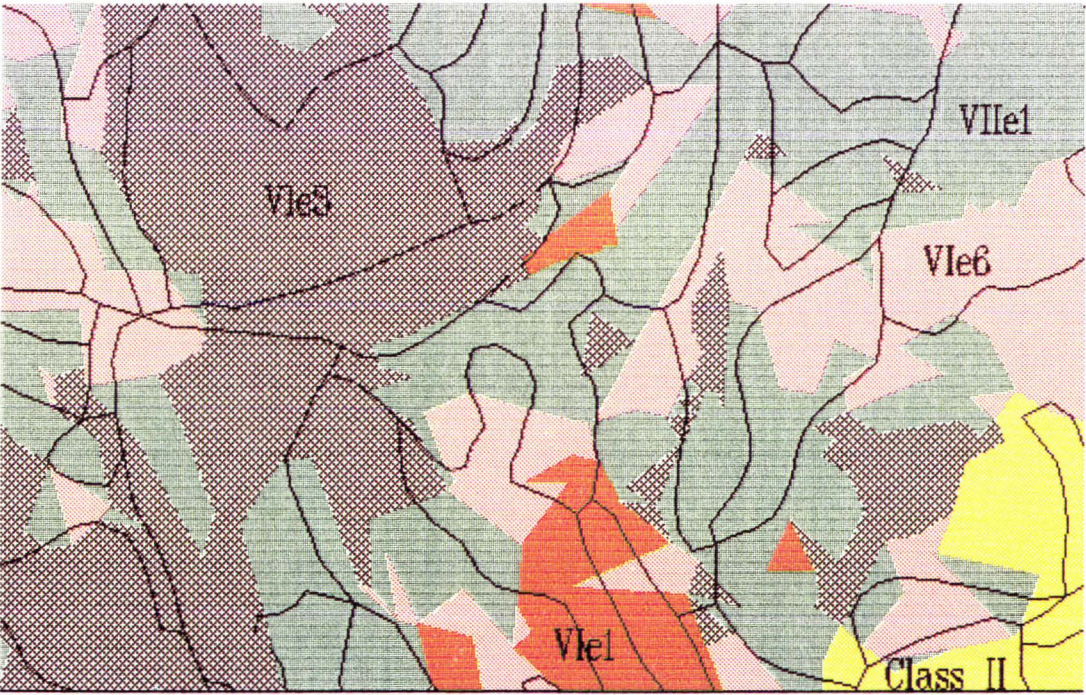
LUC units mapped on conservation farm plan of Emerald Hills station

LUC units mapped from NZLRI inventory and TIN slopes and aspects overlaid with farm plan LUC boundaries

Figure 7.7 GDC farm plan LUC units are assigned in relation to landforms whereas the GIS method assigns them according to set criteria for lithology, slope and erosion.
