DETERMINATION OF PROCEDURES TO ESTABLISH
PRIORITIES FOR EROSION CONTROL AS
DETERMINED IN THE SOUTHERN
RUAHINE RANGES, NEW ZEALAND.

A thesis presented in partial fulfilment
of the requirements for the degree of
Masterate in Agricultural Science in
Soil Science at Massey University.

Peter Robert Stephens.

1975.

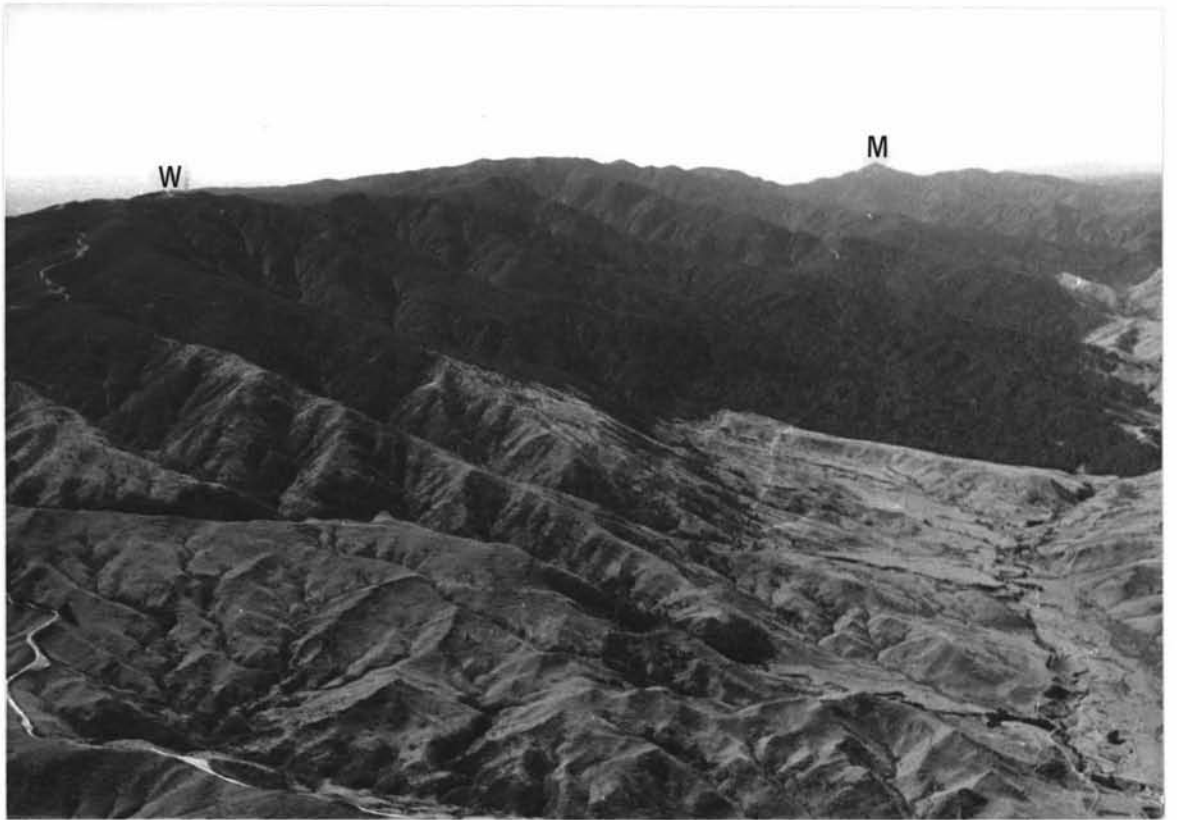
Fig. 2. Oblique aerial photograph of the southern portion of the southern Ruahine Ranges. Prominent peaks Wharite (W), altitude 914 m, and Maharahara (M), altitude 1,096 m are shown.

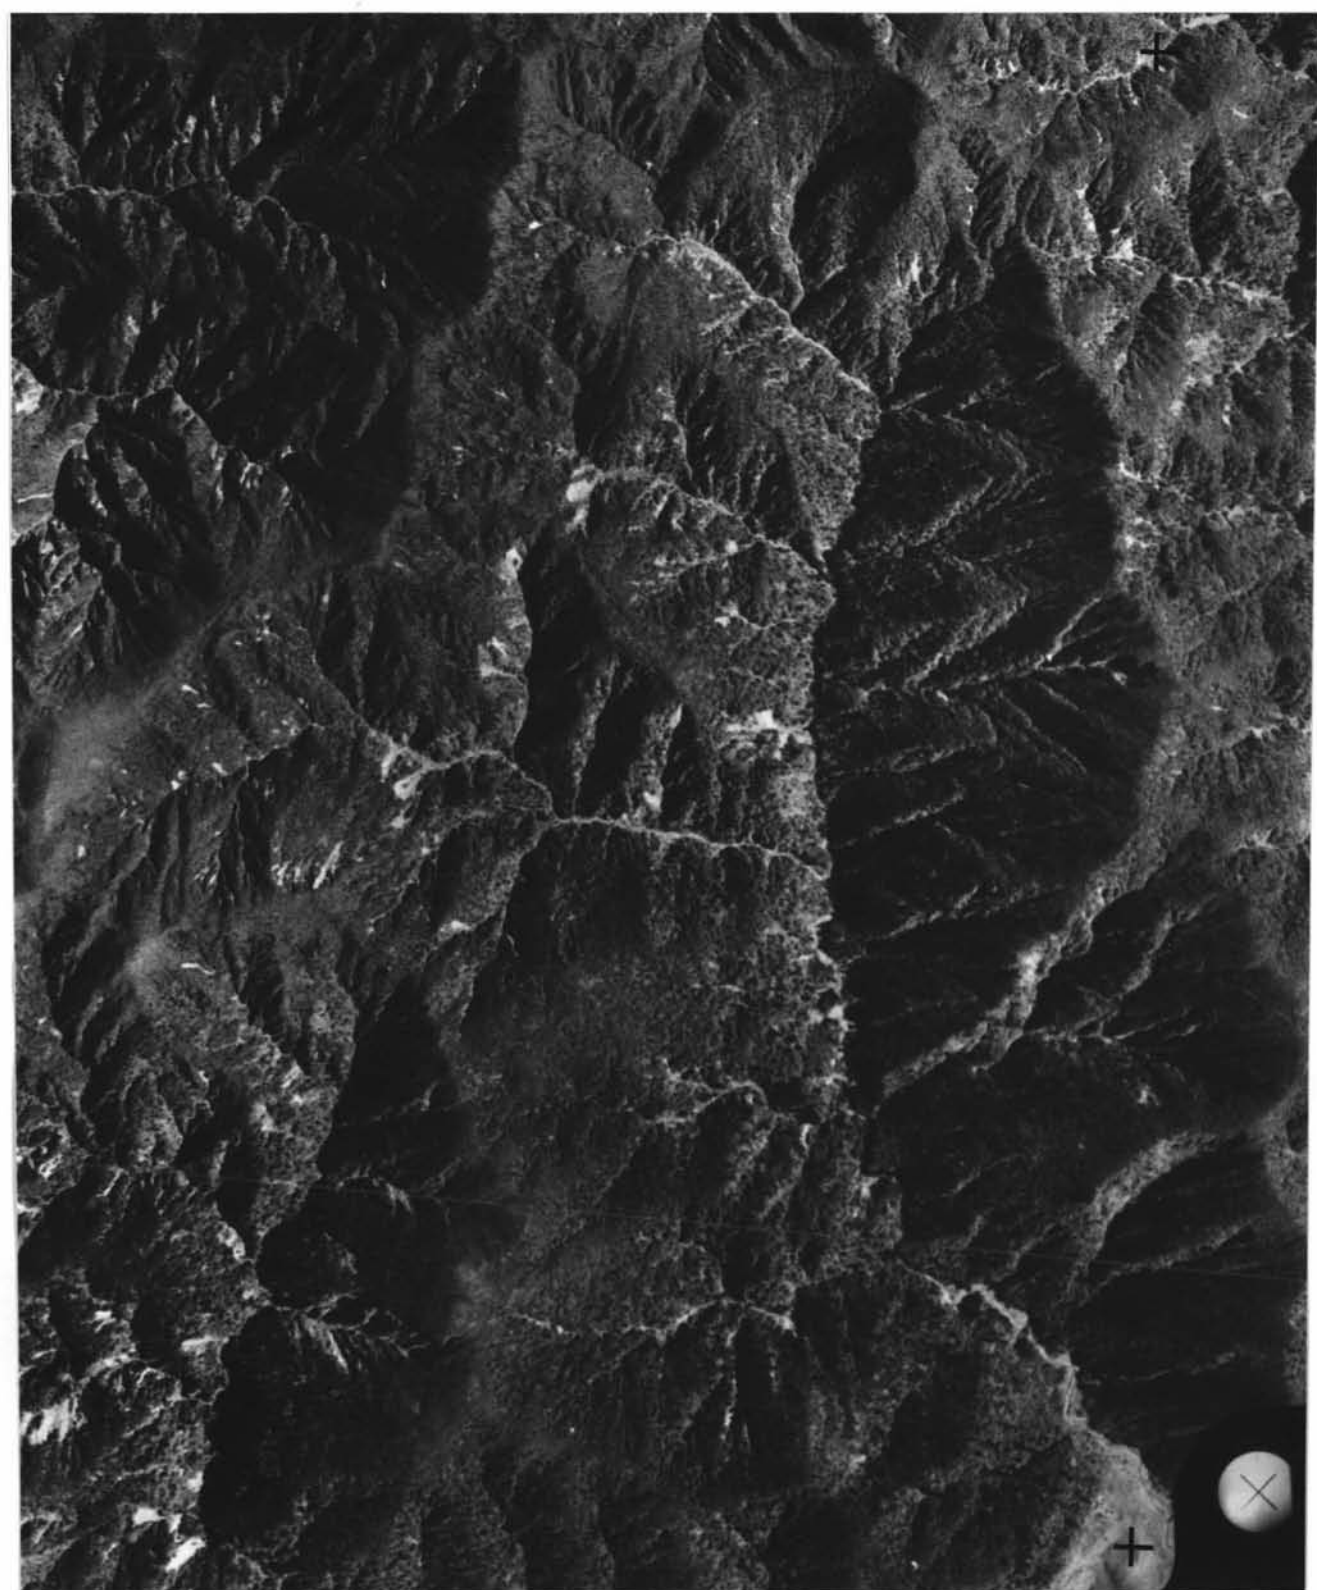
Fig. 3. Vertical aerial photograph of the
Raparapawai catchment. Date of Photography is
December 7 1961. Scale is approximately
1:22,000.

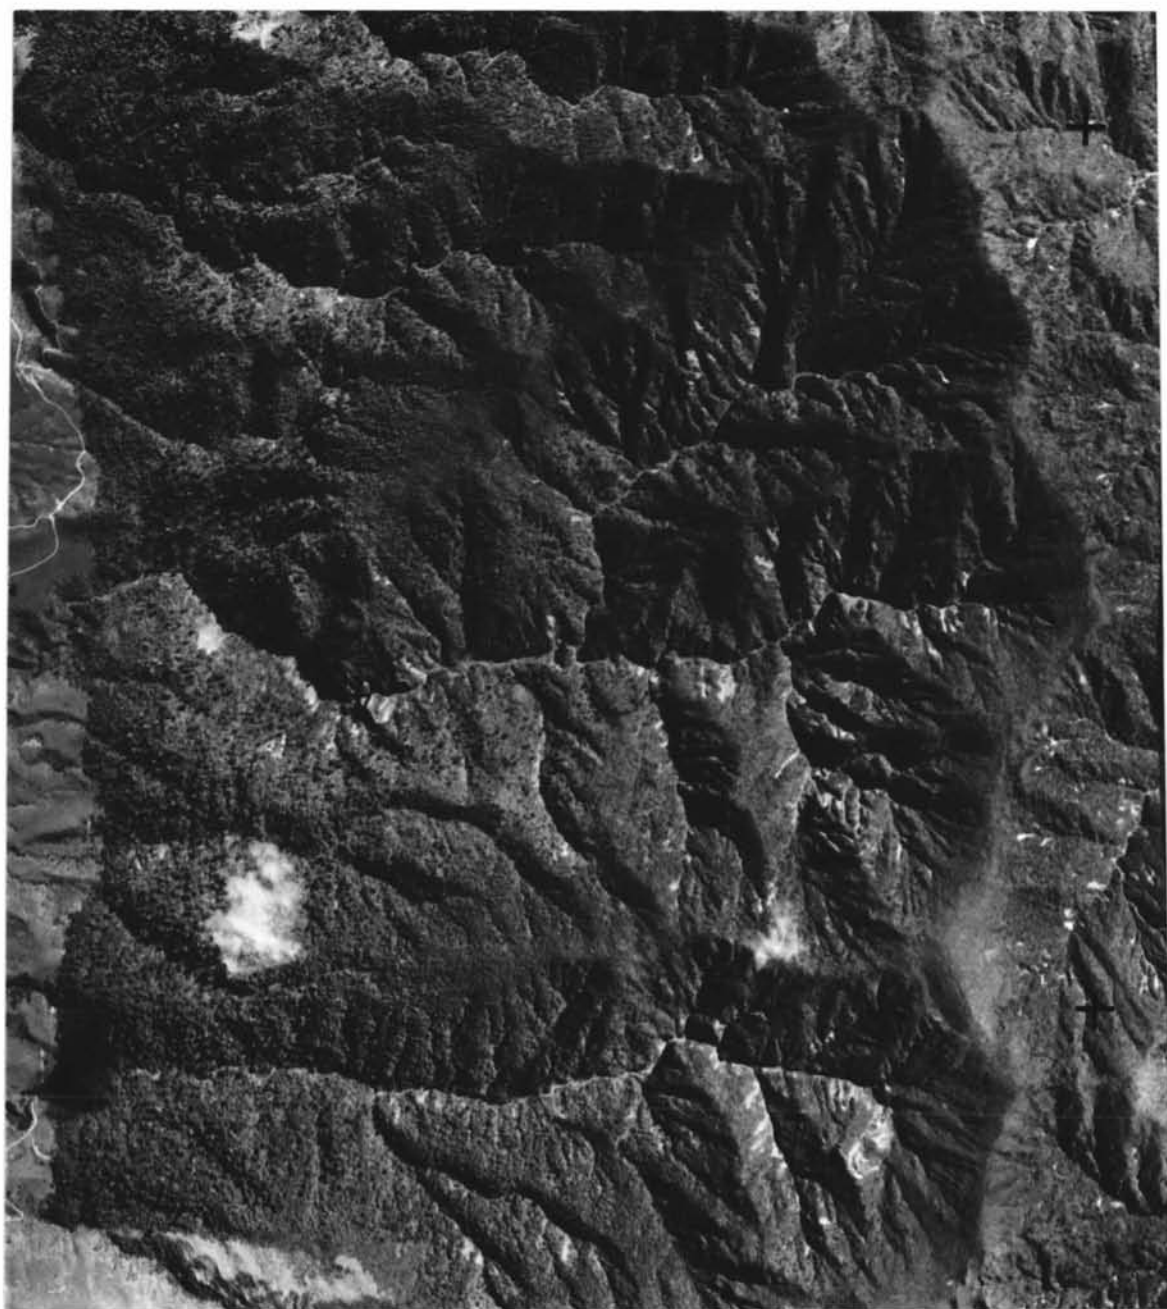
Fig. 4. Vertical aerial photograph of the No. 1 catchment. Date of photography is December 7 1961. No. 1 Line is visible on the centre left of the photograph. Scale is approximately 1:22,000.

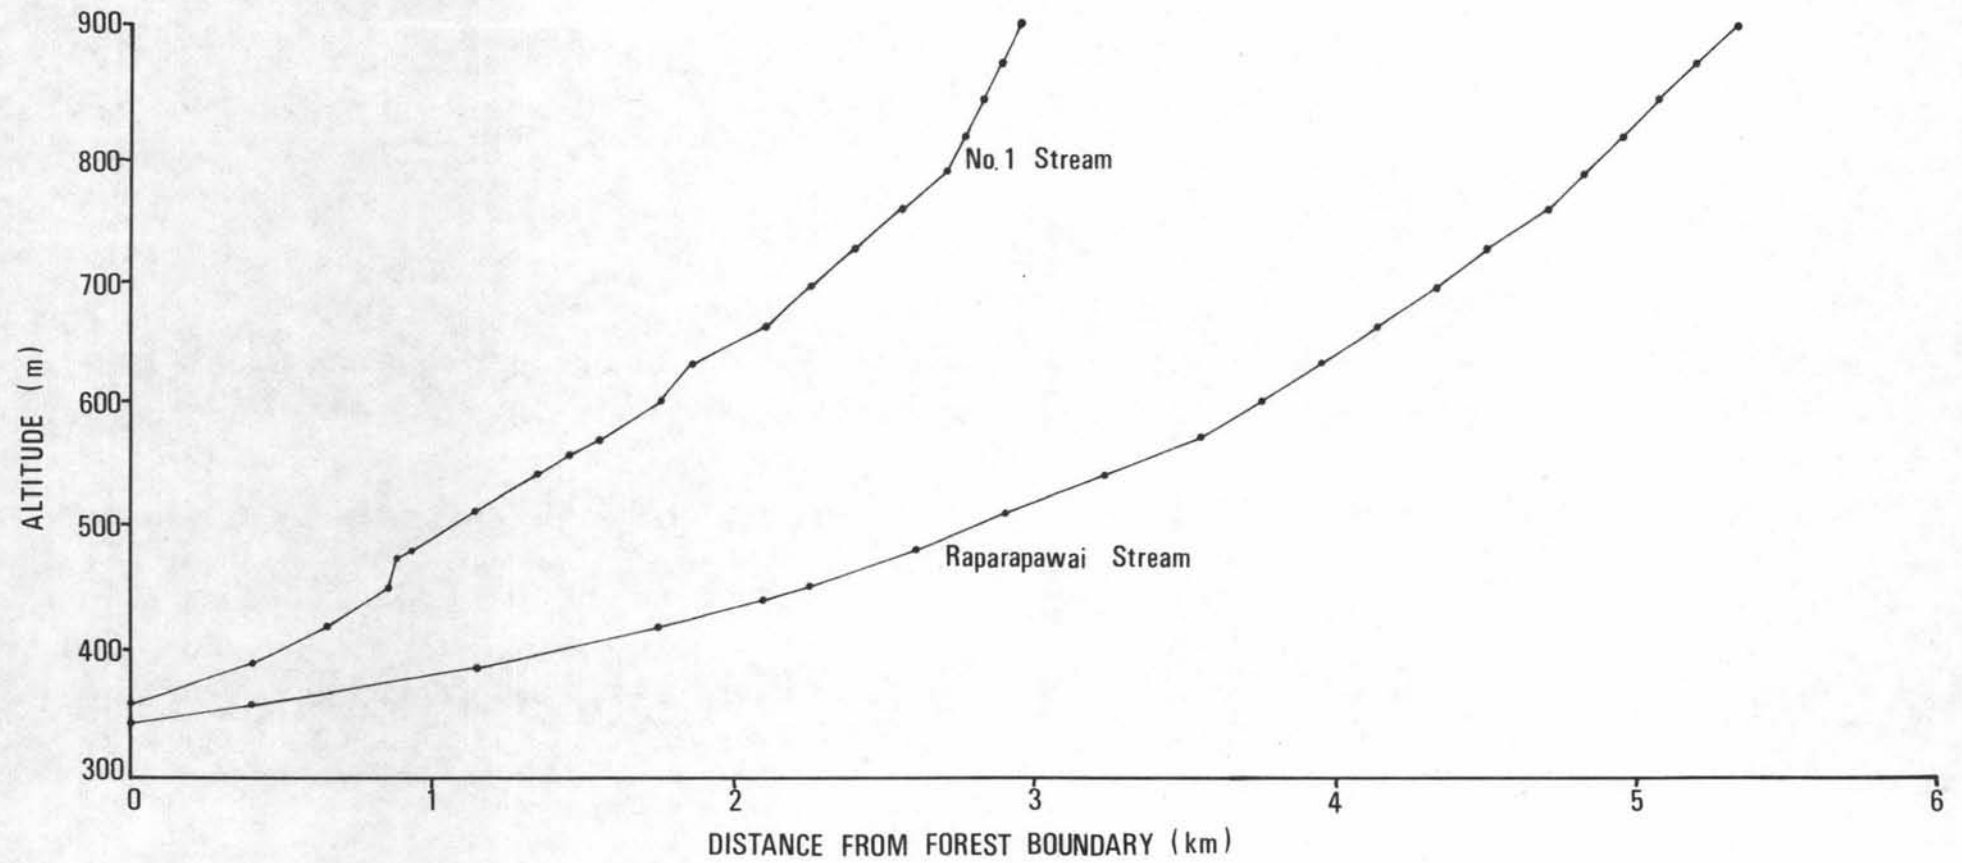
Fig.6. Longitudinal stream-channel profiles.

Longitudinal stream-channel profiles for the two catchments are shown in Fig. 6. This figure illustrates the obvious stream-channel slope differences. The sharp rise in stream-channel grade at 450 m altitude in the No. 1 catchment is due to a series of waterfalls. The average slope of the No. 1 stream-channel is 180 m/km and the average for the Raparapawai is 105 m/km. The easier stream gradient of the Raparapawai Stream, especially in the lower catchment, has

enabled aggradation of the channel. This has lead to the formation of depositional surfaces (see Section 4.7.1). The easier stream gradient also causes water to flow more slowly in its stream bed, thereby causing less undercutting of slopes, and resultant debris slides (see Section 4.7.2).

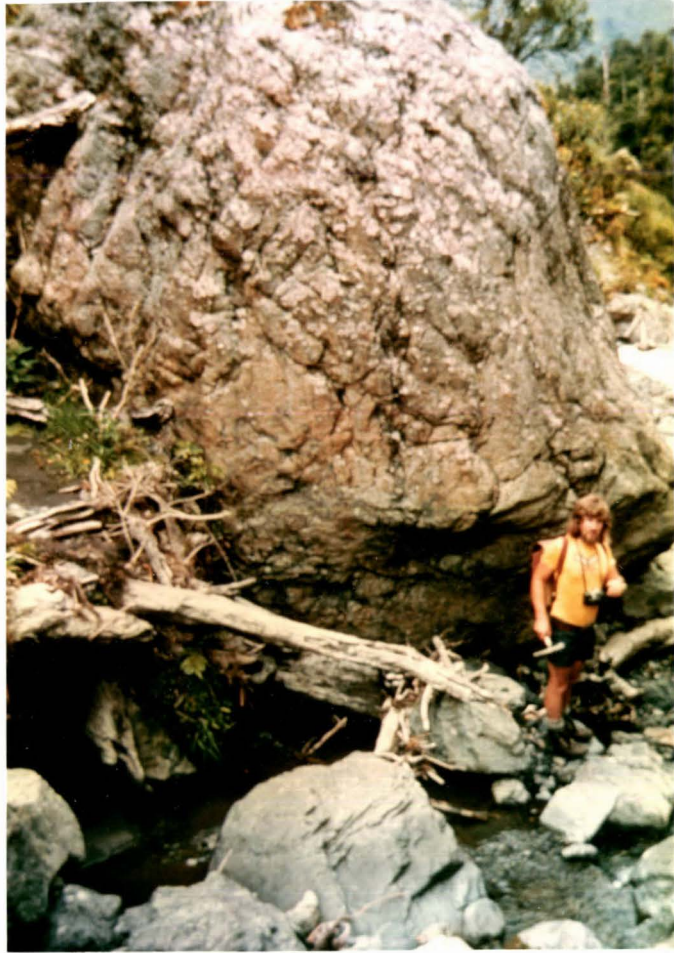
Fig. 9. Showing the largest rounded boulder in the study area. This boulder is located at M44/367535, at the base of Slump A (see Section 4. 7. 2).

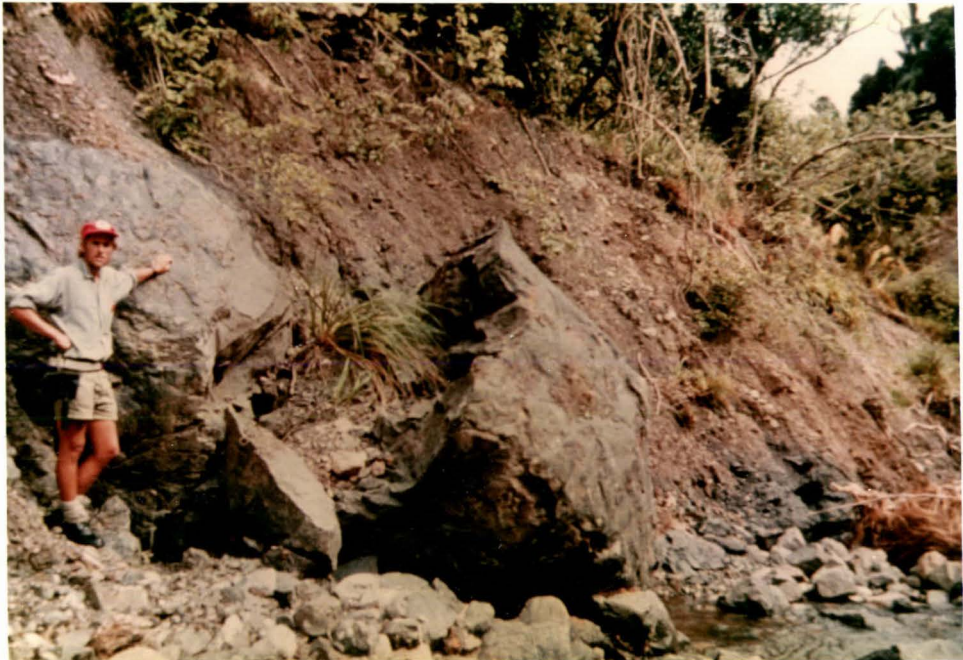
Fig. 10. The author standing beside a recently exposed boulder in the No. 1 catchment. Note that it is split in two and is well rounded. A fault pug is seen in the lower right of the photograph.

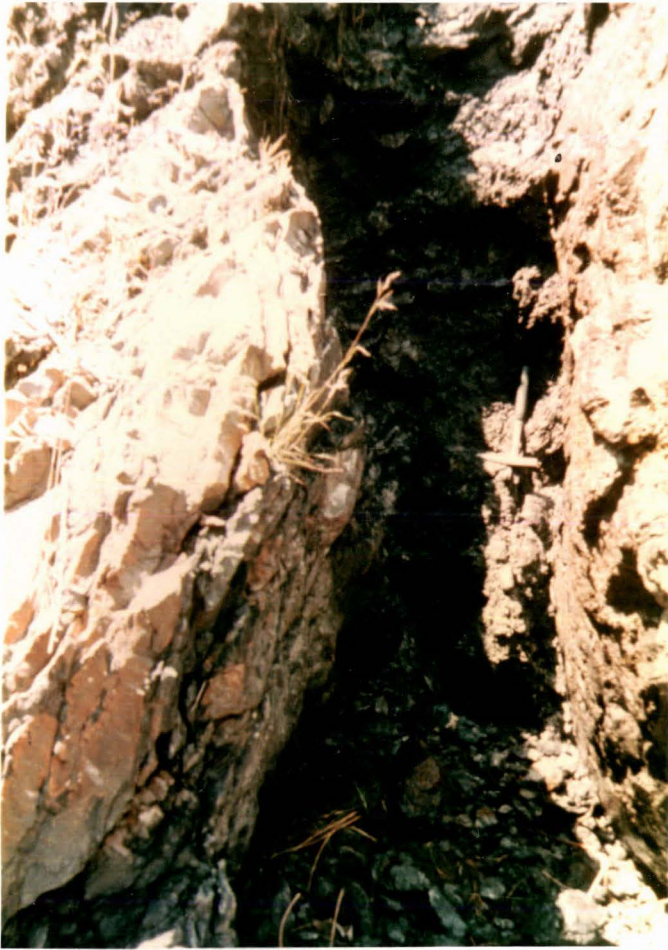
Fig. 12. Showing pug zone on a fault in the No. 1 catchment. Location is at M144/353548, and clay mineralogy is shown in Appendix III. The pug zone has been eroded by high stream flows and seepage waters. Either side of this fault, and of many others, there is a marked change in dip of the sedimentary beds.

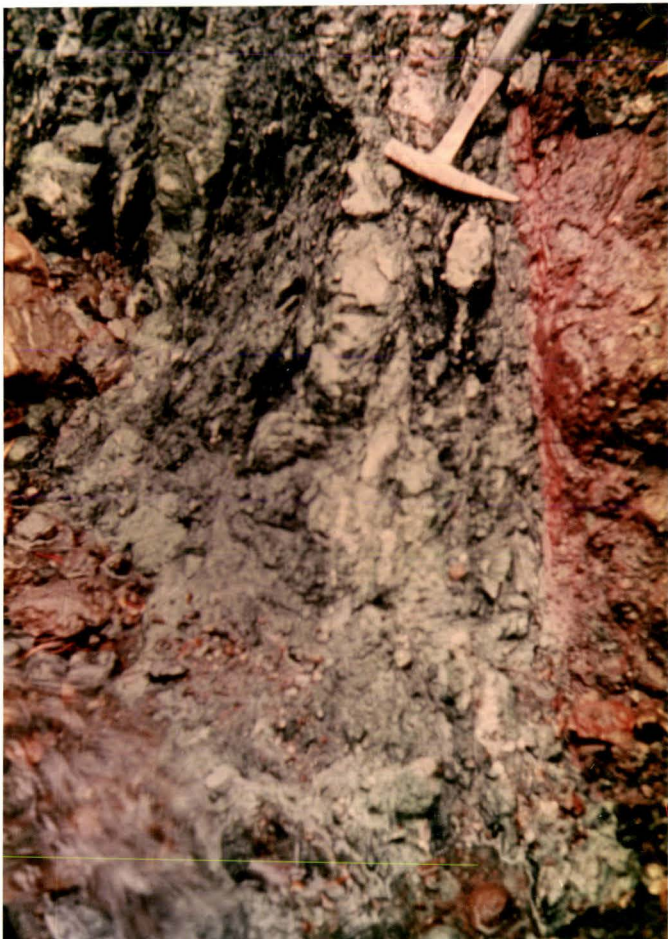
Fig. 13. Fault exposure in Raparapawai catchment at M144/376555. Rock types visible from right to left are red spillite, sticky blue-black clay with some sandstone, and a lense of green argillite.

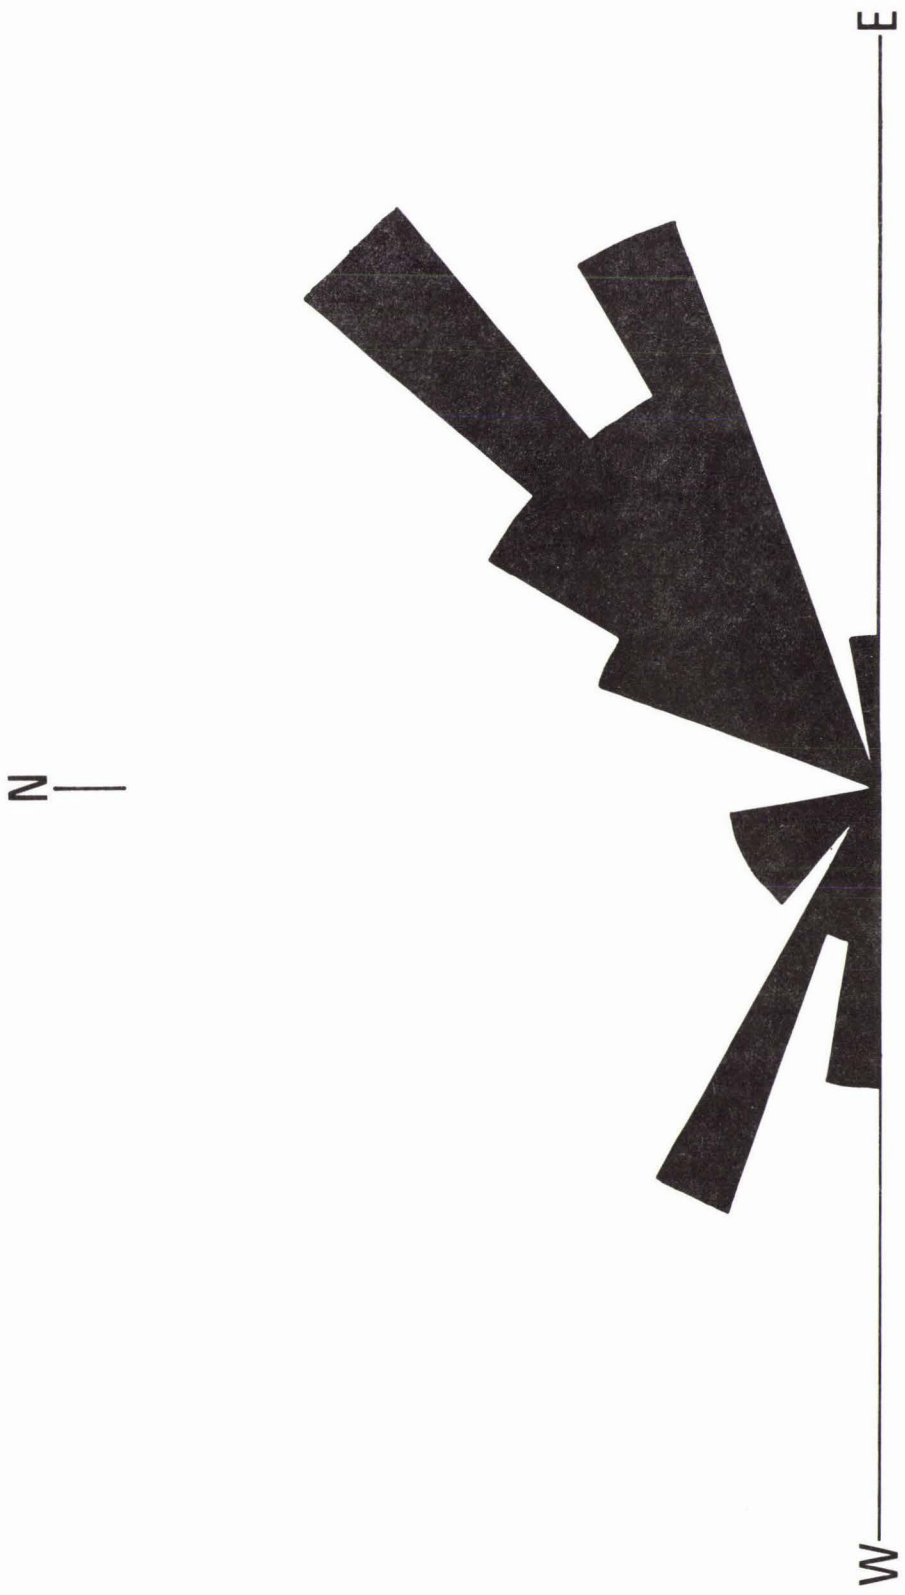
Fig.14. Rose diagram of fault strikes.

Moody and Hill (1956) applied to several Californian hills near the San Andreas Shear Zone. It is tempting to consider that the fault pattern of the study area belongs to this model. The primary wrench being the active transcurrent Mohaka Fault on the eastern margin of the Ruahine Range (see Fig. 8), secondary faults (see Stevens, 1974 a), being first order wrench and second order drag folds.

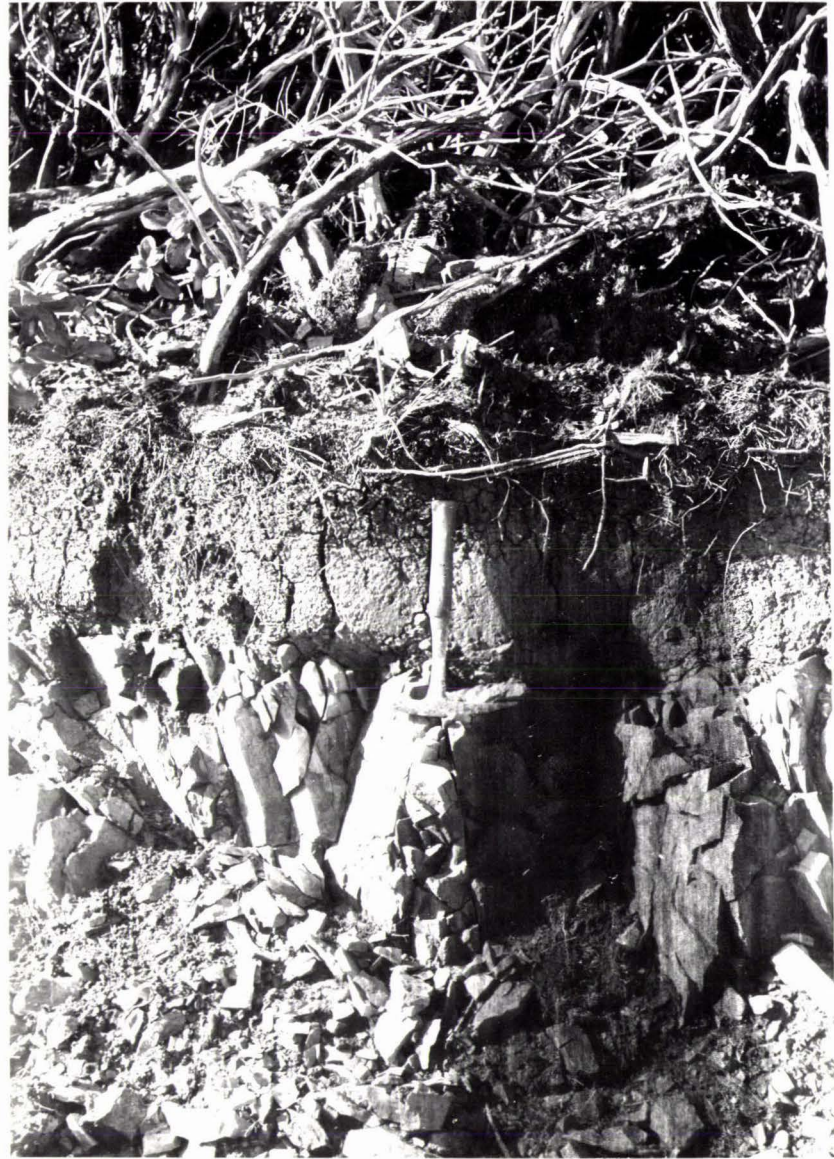
Fig. 15. Showing Takapari peaty loam on sandstone.
Vegetation is leatherwood. Hammer is 30 cm long.
Location is at N145/475648.

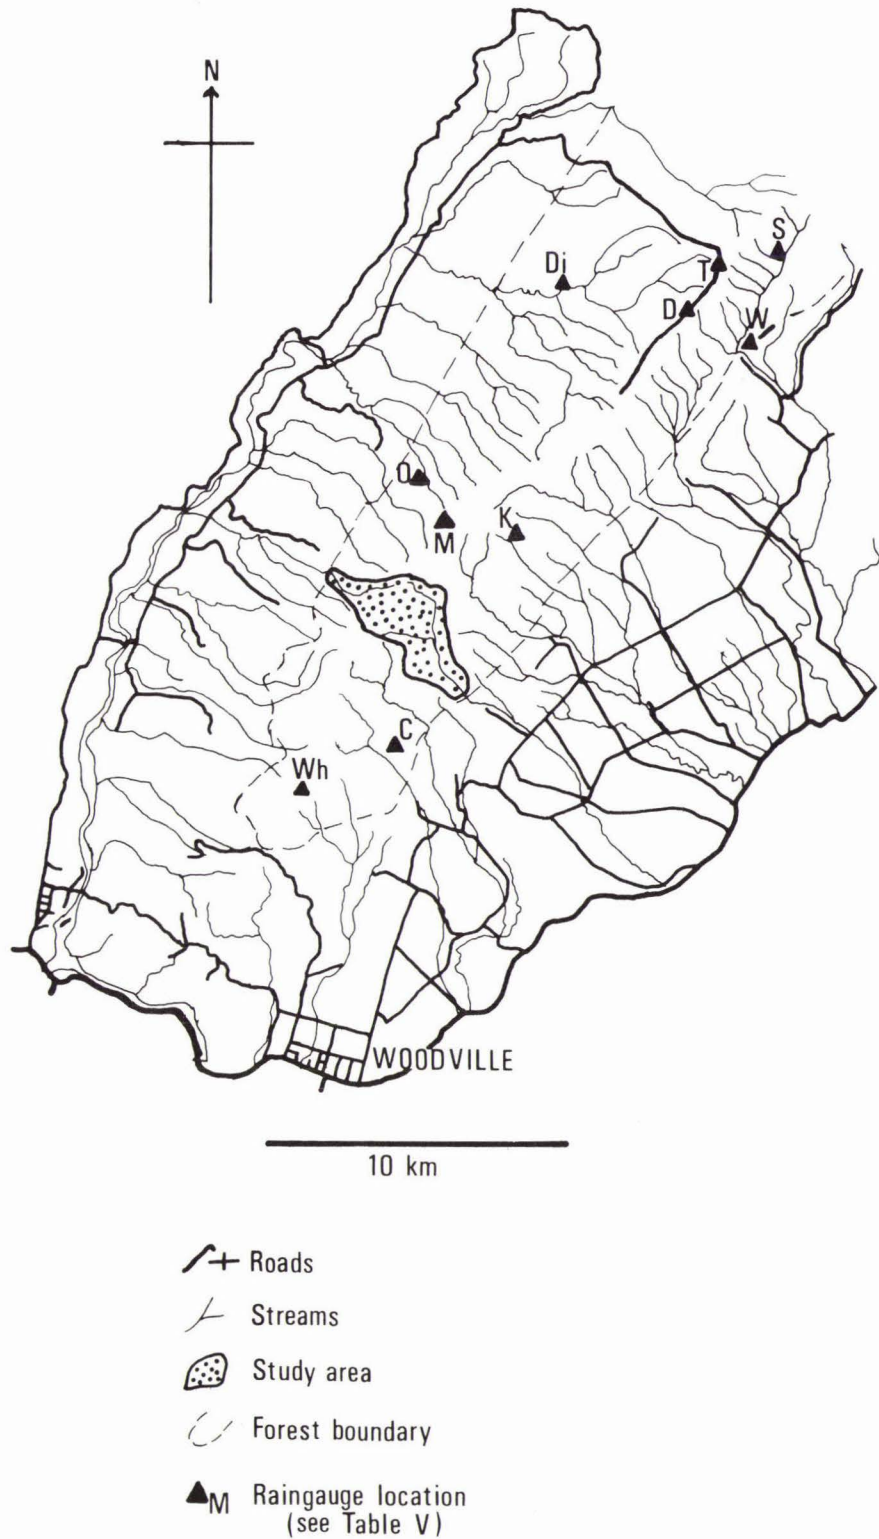
Fig.16. Location of raingauges in southern Ruahine Ranges.

Gauge	Symbol (Fig. 16)	Altitude (m)	Annual rainfall (mm)
Wharite	Wh	914	2,129
Coppermine	C	519	1,780
Kumeti	K	864	2,540
Maharahara	M	925	2,110
Opawe	O	580	1,950
Diggers	Di	464	1,730
Takapari Road	D	1,140	2,920
Takapari	T	1,140	not established
West Tamaki	W	400	not established
Stanfield Hut	S	548	2,800

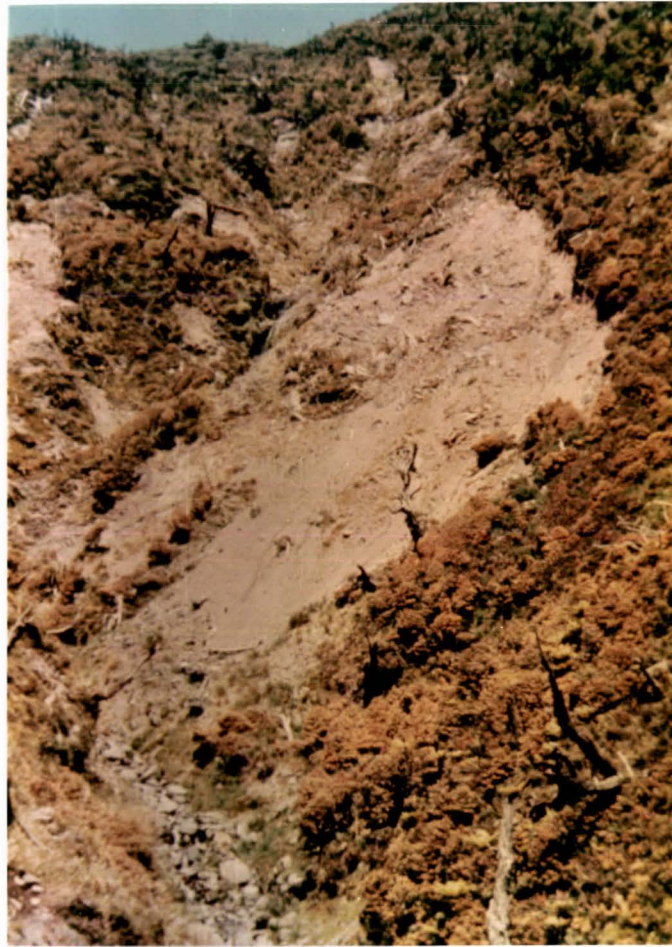
Fig. 19. Debris slide in the peppertree - tree fern dominated zone of the No. 1 catchment. Note the straight fault controlled upper margin of this debris slide. This movement can also be seen on the Frontpiece (slightly left of centre, one third of the way up from the bottom).

(i) Debris slides. These are the most common erosion type resulting from shear failure along one or several surfaces, where the moving mass is greatly deformed, or consist of many small units (Varnes, 1958). Such slides occur in both catchments of the study area. Slope angle range, measured by an Abney in the field, on which debris slides occur is 20 to 60°. The average eroded slope varies between 38 and 42°. Most debris slides are 1 to 2 m deep, the zone of failure being generally within weathered and shattered rock (see Fig. 19). Debris slides are most frequent in the 700 to 900 m altitude zone, although slopes leading into the lower portion of the No. 1 Stream channel are badly eroded (see Section 4.2.3 and Fig. 20). The base of most debris slides occur at stream level. A close relationship between debris slides and their proximity to stream channels in Southern California was described by Rice *et al.* (1969). These workers reasoned that erosion was caused at such

localities by stream undercutting and higher porewater and seepage pressures. It is considered that such factors are partly responsible for increasing shear stress and decreasing shear strength of soil and rock on slopes of the study area. Other factors predisposing slopes to mass movement are discussed in Section 4.7.4.

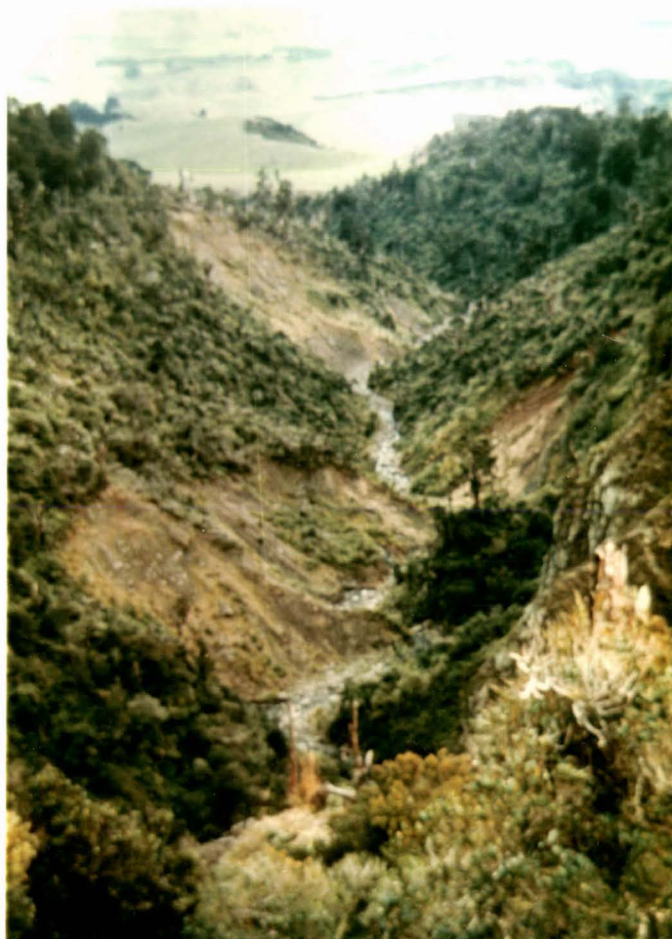
Fig. 20. Debris slides in the lower No. 1 catchment. Farmland can be seen in the background.

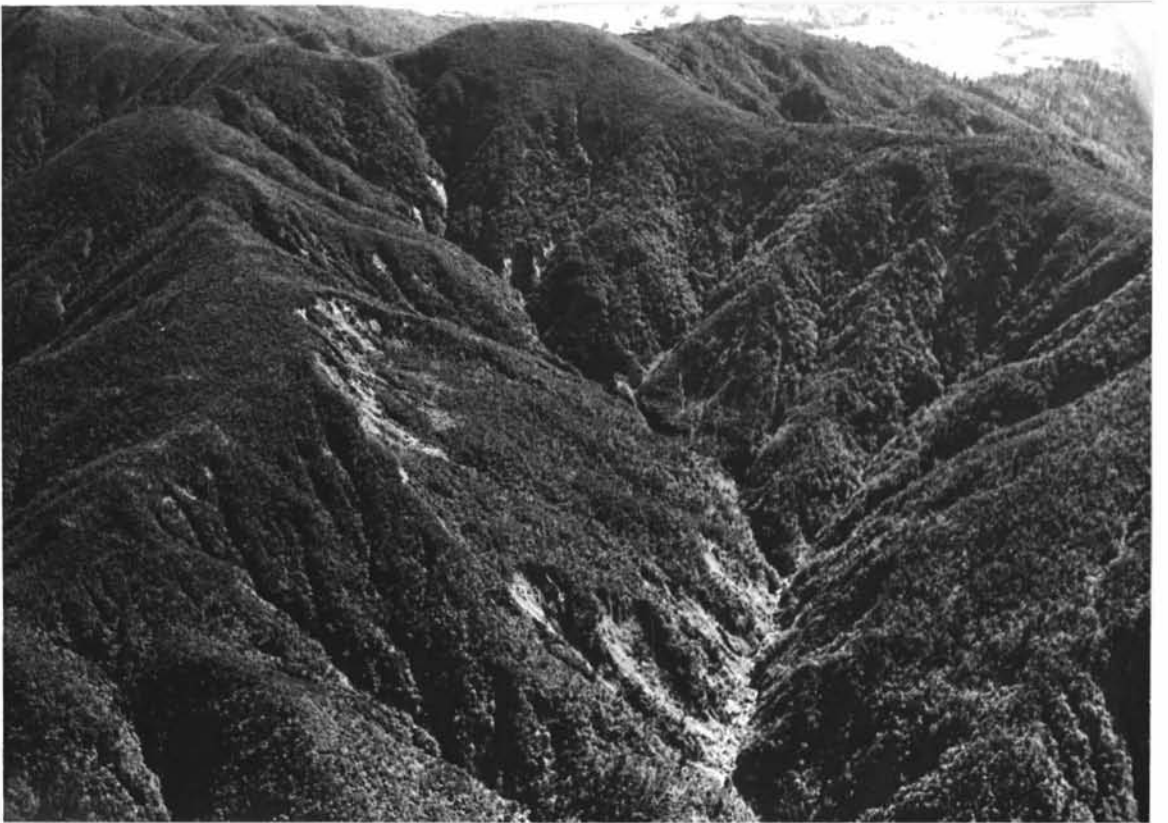
Fig. 21. Oblique aerial photograph of Slump
A. Eroding headscarp and toe slopes are
clearly seen. No. 1 catchment is partly visible
in the top right of the photograph.

Three slumps occur in the study area, two are in the Raparapawai catchment, slump A (N144/367533, see Fig. 21 and Front-piece) and slump B (N144/378552), and the other in the No. 1 catchment (slump C - N144/358543). Slump A occurs in the film type comparison area (see Section 1.4), and its boundary is indicated on transparent overlay 2 (a).

Slump A is elongate, covering an altitudinal range of 214 m with a maximum width of 350 m. The average slope of the headscarp is 55°, while the eroding toe has an average slope of 40°. Below the arcuate headscarp, a depressed ponding area lies between 5 and 15° to the horizontal. Assuming a concave shear plane, slump A has an estimated 1 million m³ of material within it.

The ponding area is fed by a fracture spring (see Fig. 32), situated in a fault zone at the base of the headscarp. The detailed alignment pattern on this slump is shown in Fig. 29 (Section 5.3). Ponding of water in such a position no doubt maintains a constant lubricant for the shear plane. It is considered significant that the ponding of water has only recently occurred, suggesting rotary movement and backward tilting. The 1946 aerial photographs show a uniform vegetation cover over the upper slump area. The author considers that the vegetation at this time (1946) was dominated by kamahi and peppertree on the present ponding area, and leatherwood on the now well-defined headscarp. Present vegetation at the base of the headscarp is dominated by rushes, rautahi (Carex geminata), bush ricegrass, and peppertree (some of which are dying). Numerous dead tree trunks are present. Another plant present is liverwort (Marchantia spp.). Leatherwood is extending down some portions of the headscarp. The extent of the ponding area is shown in Fig. 22.

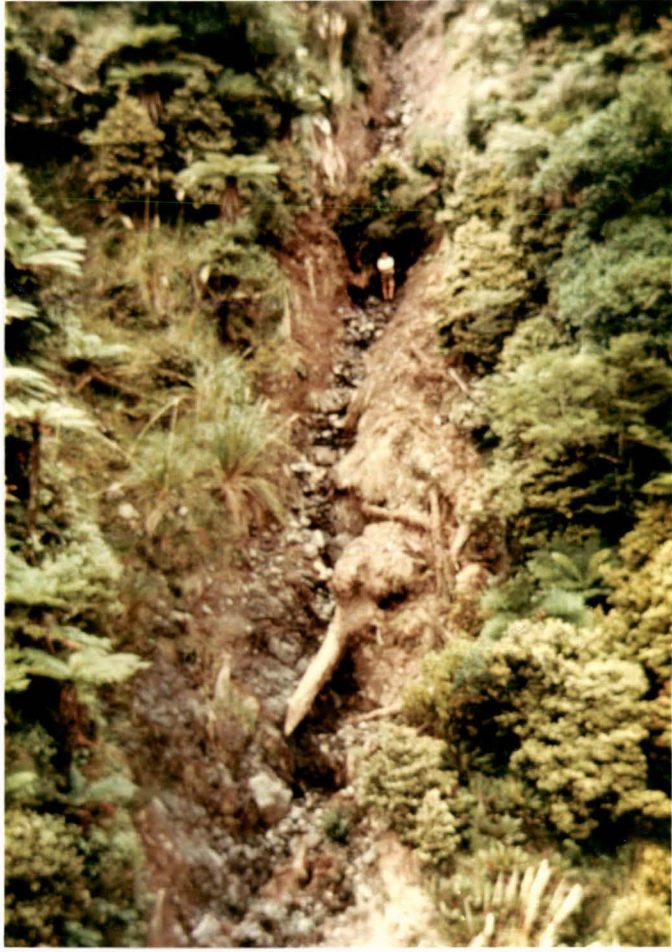
Fig. 23. Debris avalanche which occurred during cyclone Alison (March 11 and 12 1975). Detritus to the right of the small drainage channel is lying on top of 4 m high peppertree vegetation. The figure in the channel gives an indication of scale. Location is N144/357545.

Debris avalanches are characterised by their long narrow shape, often occurring in small fault controlled drainage channels (see Figs. 23 and 24). The longest debris avalanche in the study area is about 200 m in length, with a width of 10 m.

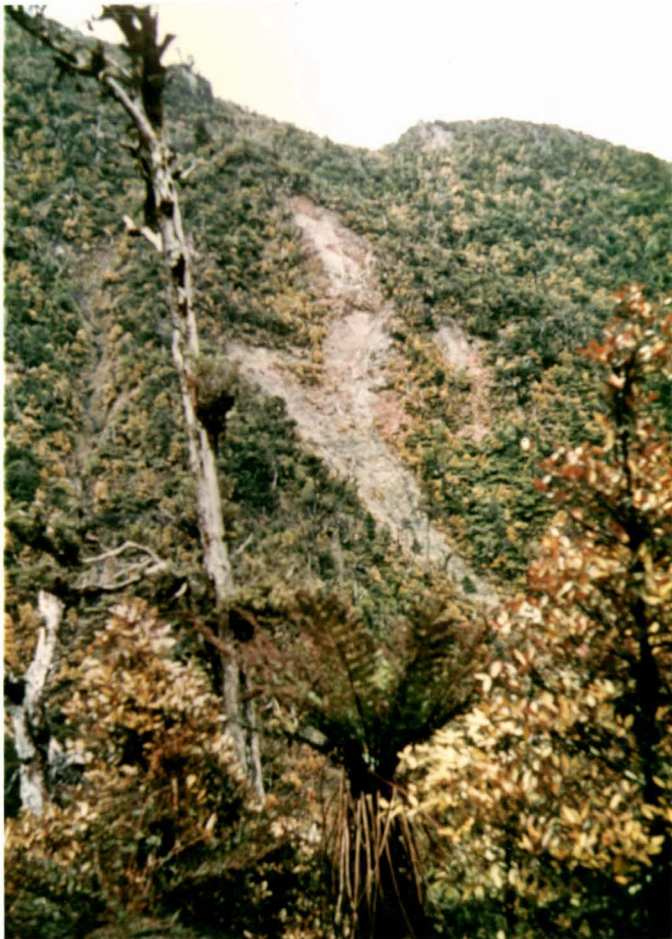
Fig. 24. Debris avalanche on fault line in the No. 1 catchment (N144/365548). Note the depressed ridge on the skyline (fault trench) and remnants of the former vegetation.

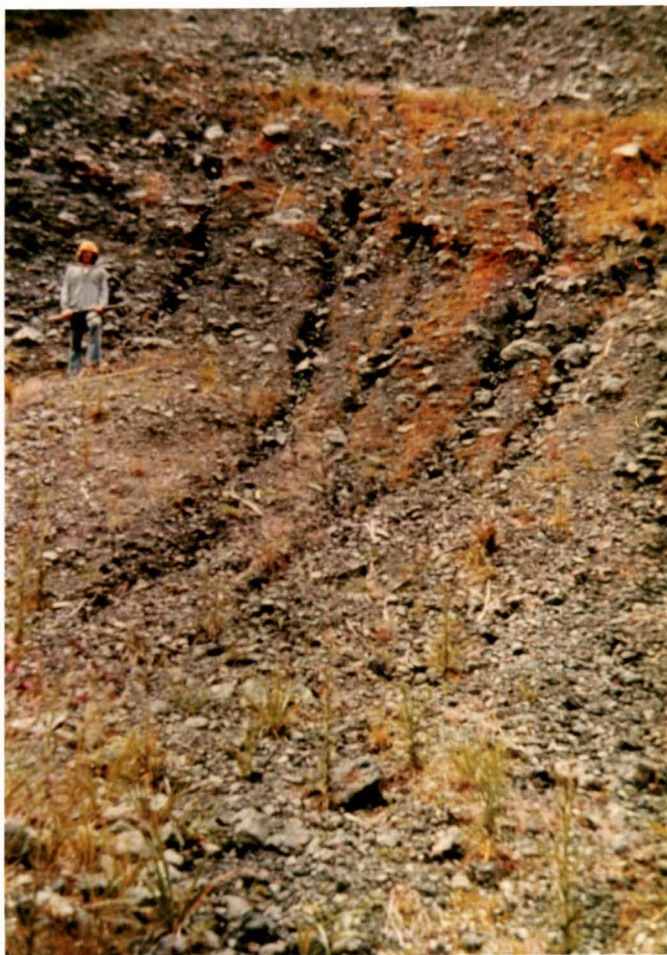
Fig. 25. Showing rill erosion which has occurred in material at the base of a debris slide/slump movement. Location is N144/375533.

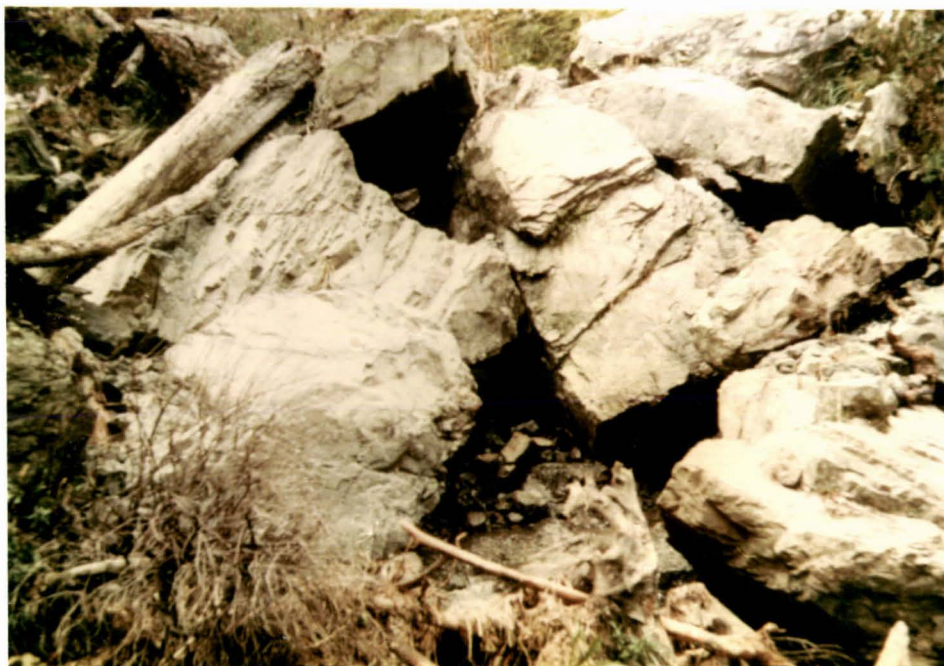
Fig. 26. Showing angular sandstone rocks deposited by a rock fall. The tree trunk in the top left of the photograph has a diameter of 50 cm.

rocks came to rest. Following a snowfall in August 1974, the author saw some small rocks, up to 5 cm in diameter, bounding down poorly vegetated slopes. It is suggested that as the time of observation was 1300 hours, the erosion trigger could be the thawing of soil and rock.

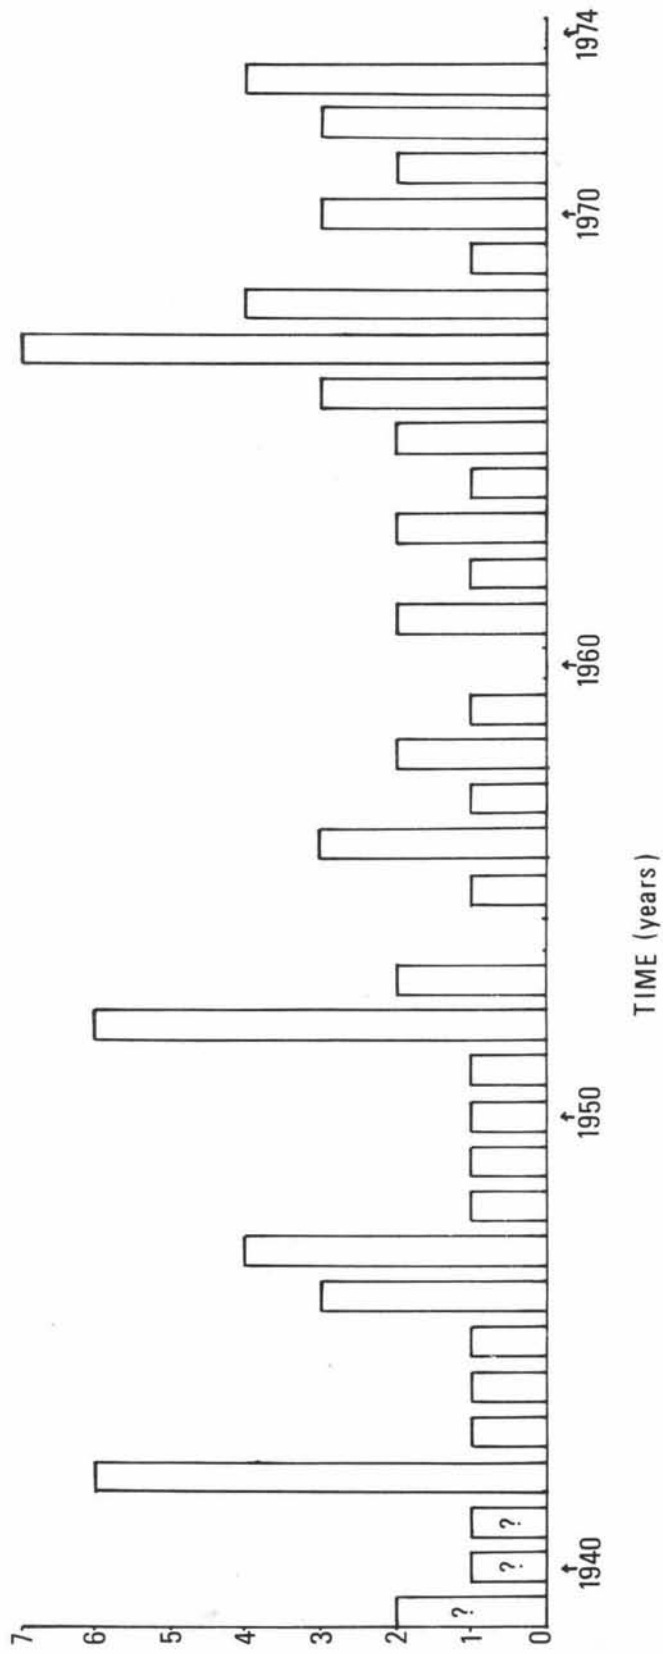
Fig.28. Frequency of earthquakes.

No. OF EARTHQUAKES (MAGNITUDE 5+) WHOSE
 EPICENTRES ARE WITHIN 100 km OF STUDY AREA
 (1970 data not complete)

of magnitude 4 shocks would be roughly 10 times as great as the number of magnitude 5 shocks, and of magnitude 3 shocks, 10 times as great again (G.A.Eiby, pers. comm.). Only four earthquakes shown in Fig. 28 have magnitudes > 6 . In 1942 two earthquakes had magnitudes of 7.0, in 1947 an earthquake had a magnitude of 6.1, and in 1951 there was a 6.2 magnitude earthquake.

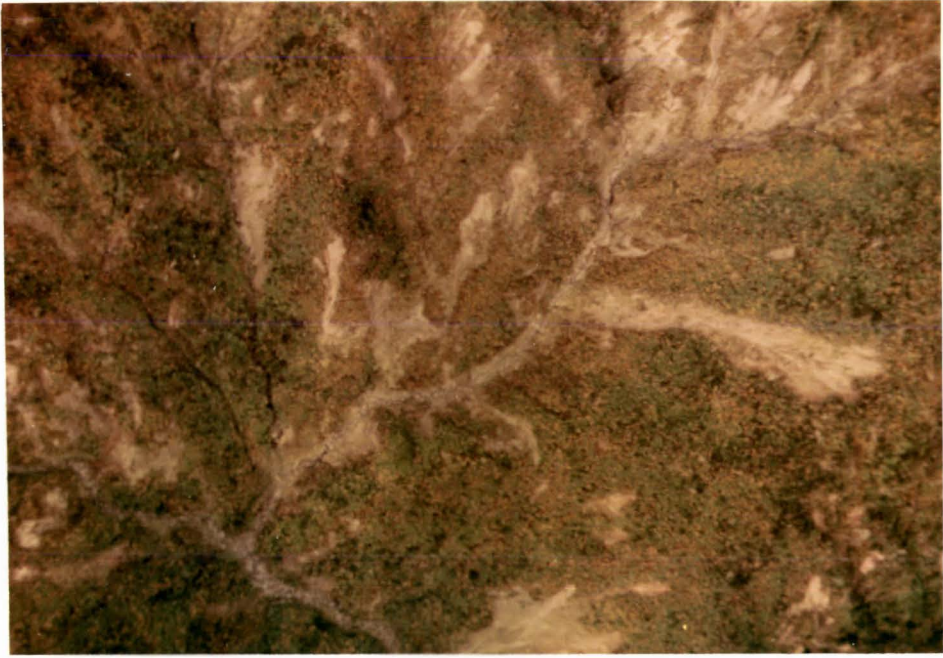
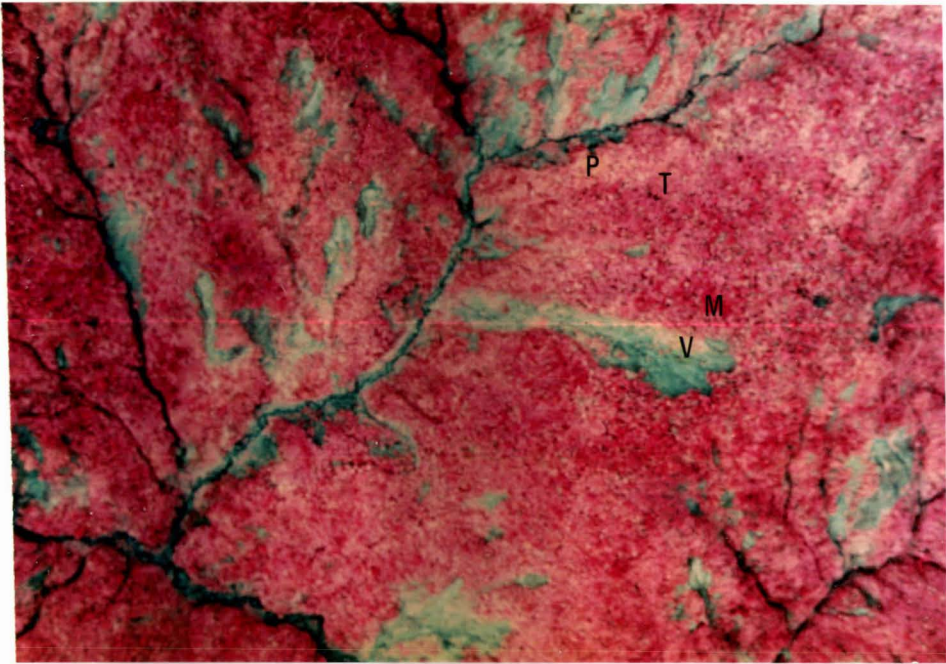
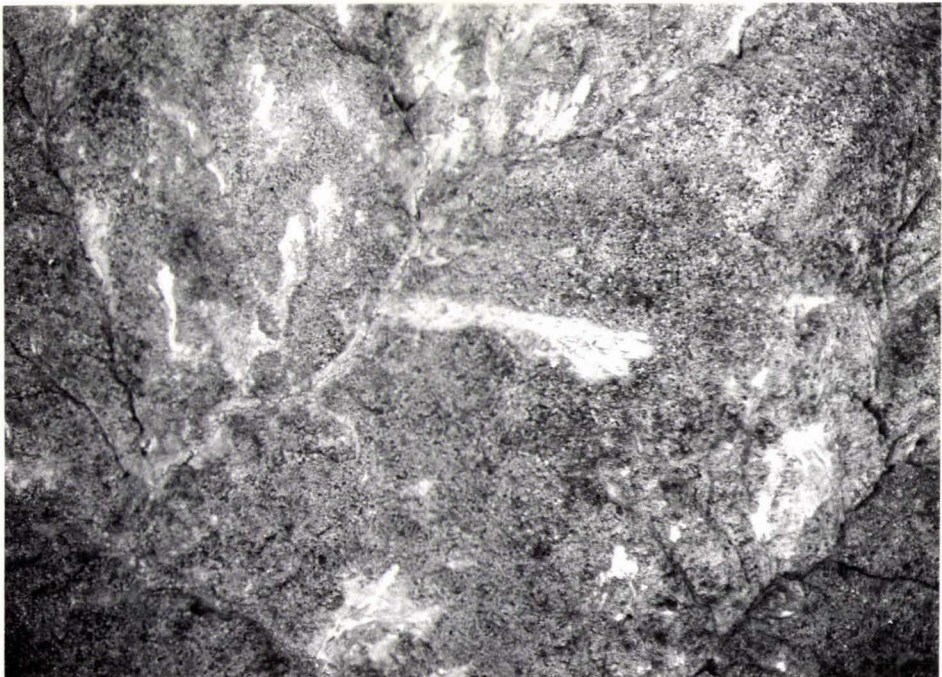
Fig. 31. Vertical aerial photographs of the No. 1 catchment photographic study area using different film types. Top, centre, and bottom photographs are colour, colour infrared, and panchromatic respectively. Date of photography is June 6 1975. Major vegetation types are indicated: peppertree (P), tree ferns (T), and miro (M). Grass and toetoe (V) are clearly visible on the colour infrared photograph, but are difficult to see on the other two photographs. Stream channels and eroded areas are also more clearly seen on colour infrared. Scale is approximately 1:5,000.

using colour infrared alongside colour and panchromatic photographs, pug zones and seepage areas were often not seen on the latter. The recognition of such features on colour infrared generally permitted their recognition on the other two film types.

Water, which reflects some green but very little red and no infrared radiation, is recorded blue-black to blue on colour infrared photographs, depending on the amount of green light reflected (Allum, 1970). Generally, the higher the moisture content of the pug zone or seepage area, the more black is the signature.
