DETERMINATION OF PROCEDURES TO ESTABLISH
PRIORITIES FOR EROSION CONTROL AS
DETERMINED IN THE SOUTHERN
RUAHINE RANGES, NEW ZEALAND.

A thesis presented in partial fulfilment
of the requirements for the degree of
Masterate in Agricultural Science in
Soil Science at Massey University.

Peter Robert Stephens.

1975.

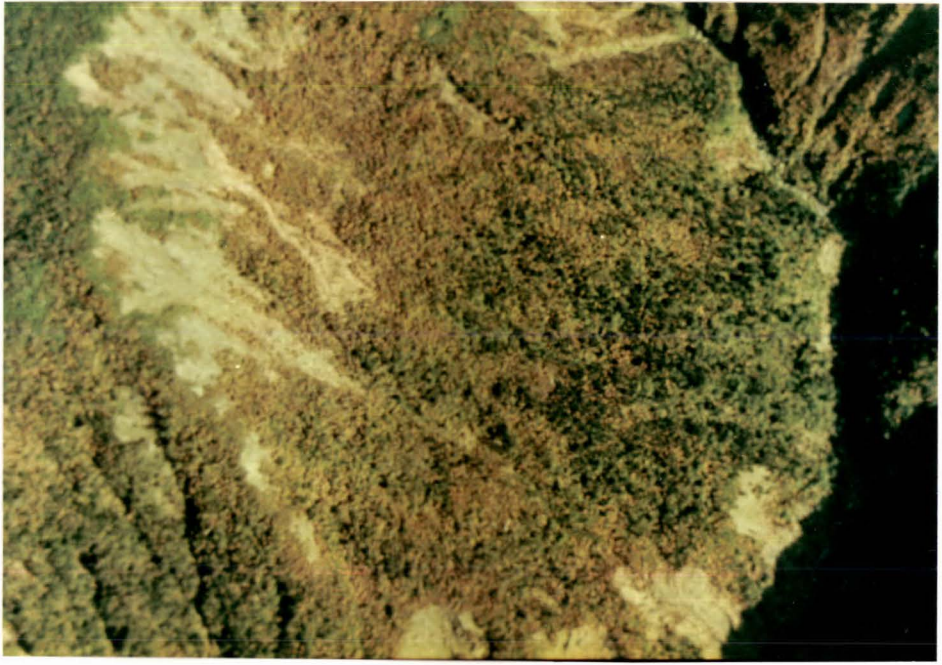
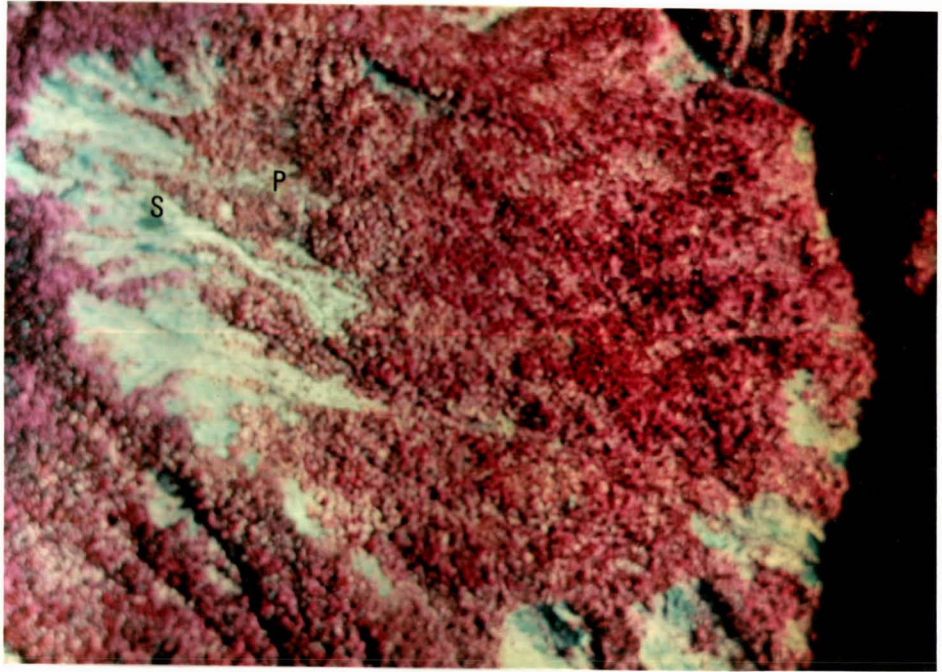
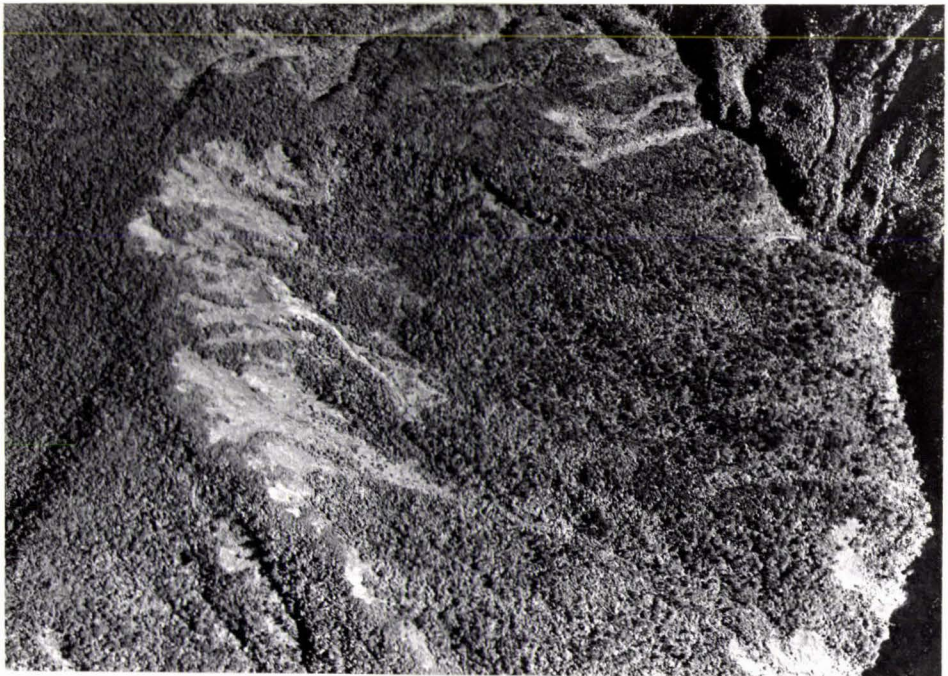
Fig. 32. Vertical aerial photographs of the Raparapawai catchment photographic study area using different film types. This study area also encompasses Slump A (see Section 4.7.2). Date of photography is April 19 1975. Note effect of shadow on right of each photograph. Seepage area on a fault (S) and ponding area (P) in the upper portion of Slump A are indicated on the colour infrared photograph. Note the difficulty of seeing the seepage area on the other two photographs. Scale is approximately 1:5,000.

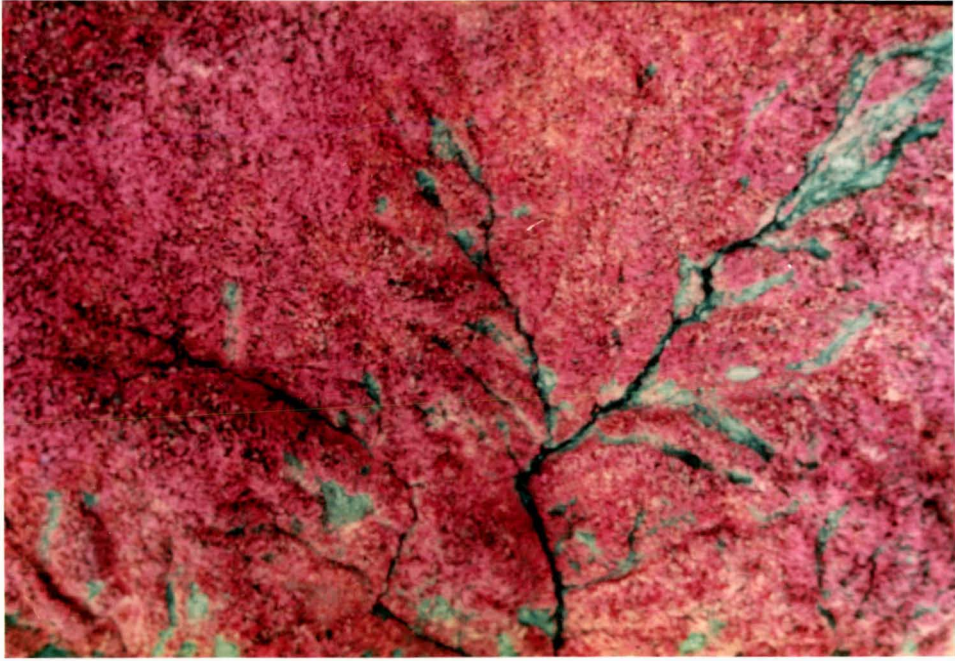
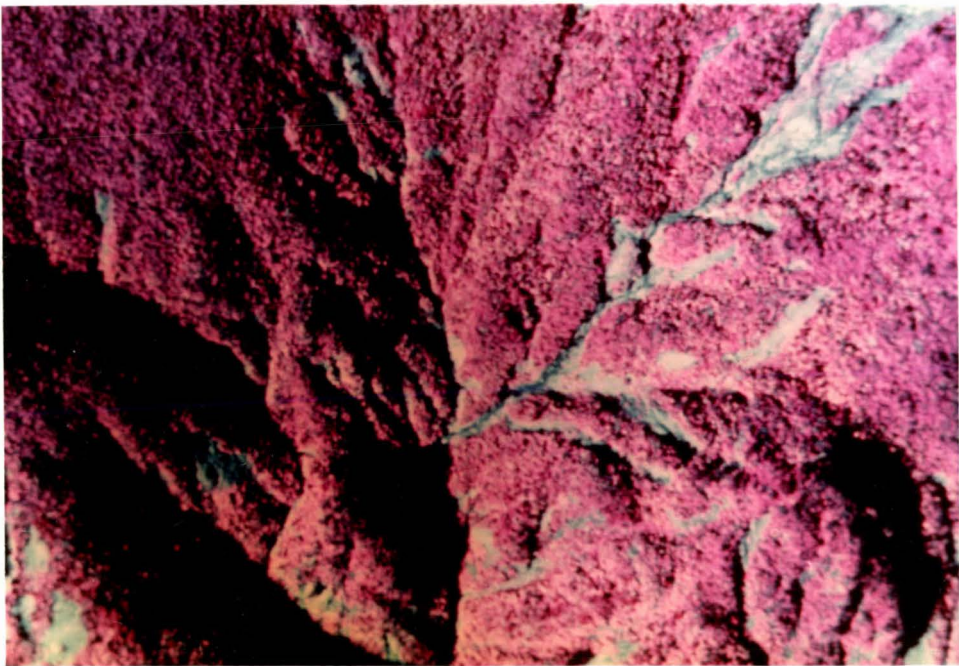
Fig. 33. Showing difference in colour balance of colour infrared film. Date of photography is June 6 1975 (top), and April 19 1975 (bottom). These two photographs of the same area also show the effect of shadow in this mountainous area. The top photograph was taken during cloudy conditions, and is considered to have correct colour balance. Scale is approximately 1:5,000.

pers. comm.) or to poor film storage (J.R. Clouston, Photographic Unit, Massey University; pers. comm.).
