GEOLOGY AND ITS RELATIONSHIP TO EROSION  
IN THE SOUTHERN RUAHINE RANGE,  
NORTH ISLAND, NEW ZEALAND

MICHAEL MARDEN

RELATIONSHIPS BETWEEN GEOLOGY AND EROSION

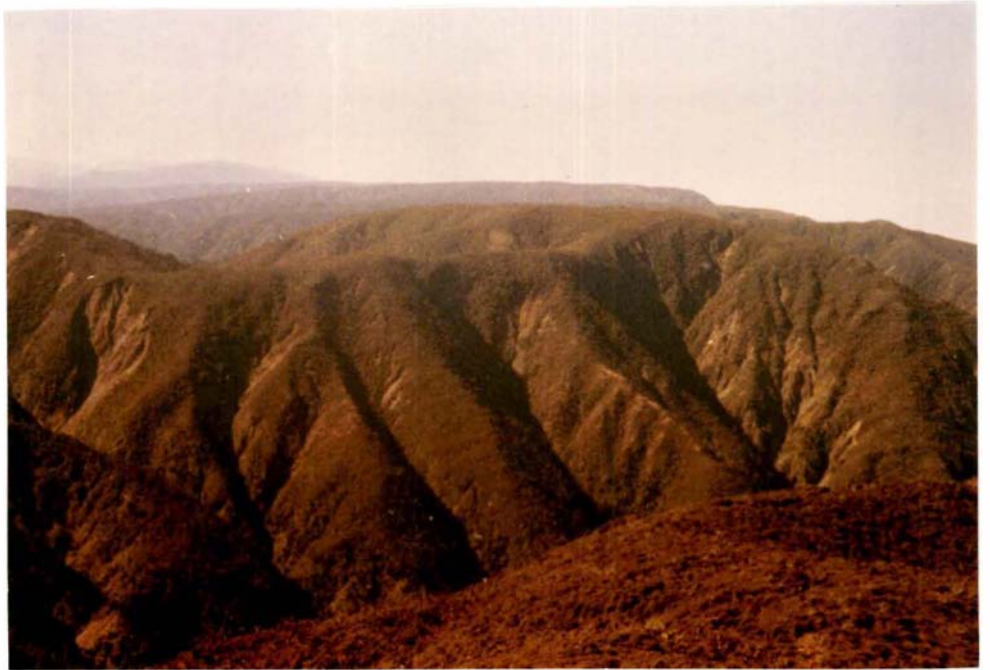
Debris avalanche resulting from failure within bedrock. Height of scarp at head of debris avalanche is 5m.

Note (1) the position of the point of failure (near ridge crest), (2) V-shaped scar, (3) blocky scree deposit at toe of slope, and (4) the difference in stage of seral development between tussock covered debris avalanche scars and the surrounding shrubby vegetation. Photograph taken in Rokaiwhana catchment.

Debris avalanches are the dominant form of slope movement upon steep valley sides of the southern Ruahine Range (Maps 5 and 6). Debris avalanches are characteristically long and narrow scars cut through dense vegetation cover (Fig. 9.1). They may be found at any position on a valley slope but it is more usual for them to originate at a break in slope. Many debris avalanches are found within the outline of large-scale slump movements. The biggest ones result from failure high up near ridge crests and may extend the entire length of a valley side to the stream channel. Often at the head of each debris avalanche is an uphill tapering serrate or V-shaped scar which marks the point of failure (Figs 9.1 and 9.2). Their length is largely dependent upon the position of failure on the slope, slope steepness, and the volume of material involved. The latter two factors determine the momentum of the avalanche which becomes restrained by the forest vegetation through which it flows. The depth to which such avalanches develop is largely dependent upon the thickness of colluvium and the lithological and structural features of the underlying bedrock (see Section 10.1.1). At the toe there is usually a fan-shaped accumulation of coarse blocky detritus, here referred to as scree deposits (Fig. 9.11). Scree deposits are of convex outline in transverse cross-section with the highest point near the longitudinal axis. In the axial region is sometimes a channel that is the site of ephemeral surface runoff from the exposed debris avalanche scar. This channel is bordered by small natural levees. The length of the channel is dependent upon the distance that runoff and transported 'fines' can travel as a high concentration surface flow, before major infiltration into the highly porous scree occurs. A longitudinal profile of a representative scree has a constant steep gradient of 30-40 degrees. The toe slope is usually steeper, being 40-60 degrees, due to the high angle of repose maintained by the coarse, blocky detritus. Once formed, scree deposits remain devoid of vegetation for long periods of time. This is largely due to periodic collapse of the over-steepened margins around the debris avalanche scar (Fig. 9.1).

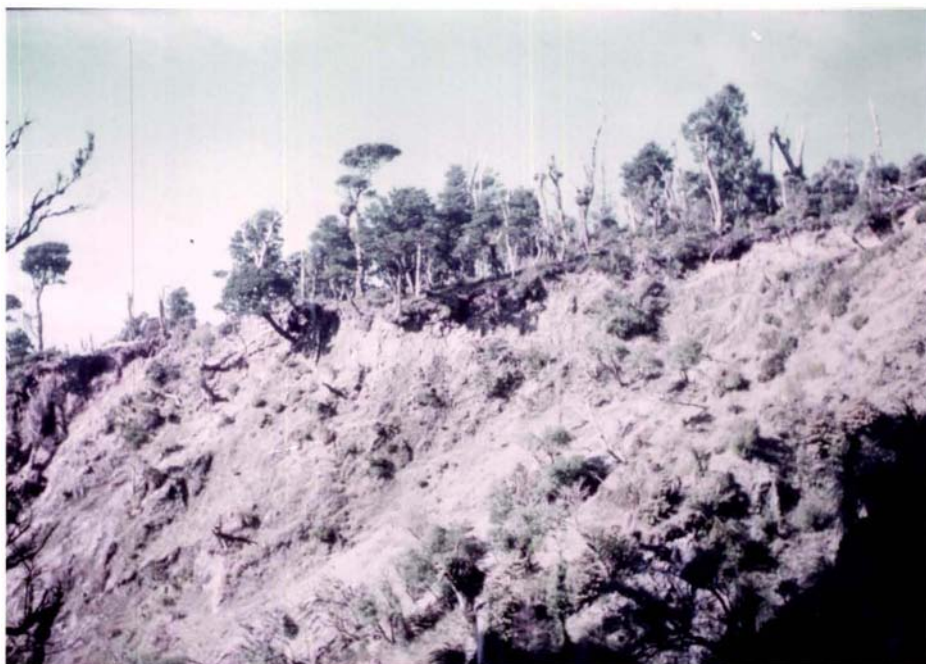
FIGURE 10.1: Extensive debris slide development within South Oruakeretaki catchment. Note the poor condition of the forest vegetation and the large number of dead trees on the surface above the debris slide.

Irrespective of their position on valley slopes the majority of debris avalanches and debris slides resulting from failure within soil or colluvium are of very shallow depth. Whilst some are less than 0.5m deep (Figs 10.1 and 10.2) the majority tend to be up to 1m deep.

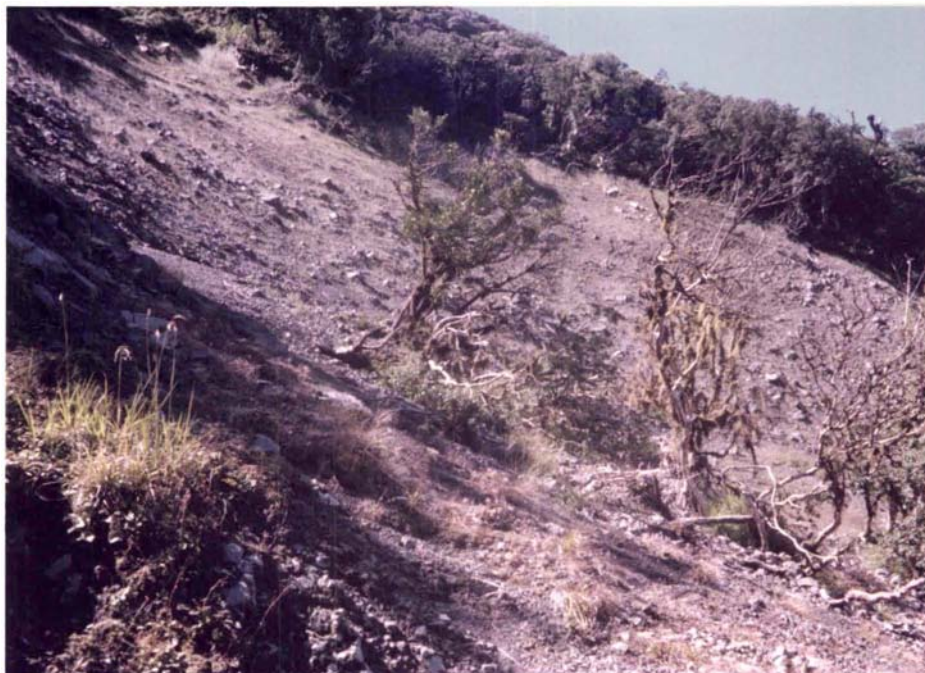
FIGURE 10.2: Close-up of debris slide scar within Mangapuaka catchment. Note: (1) the shallow depth of failure (less than 0.5m) within colluvial slope material; (2) the dense shrubby vegetation (background) adjacent to where the movement occurred; and (3) the shallow root systems of the vegetation on the slide (foreground).

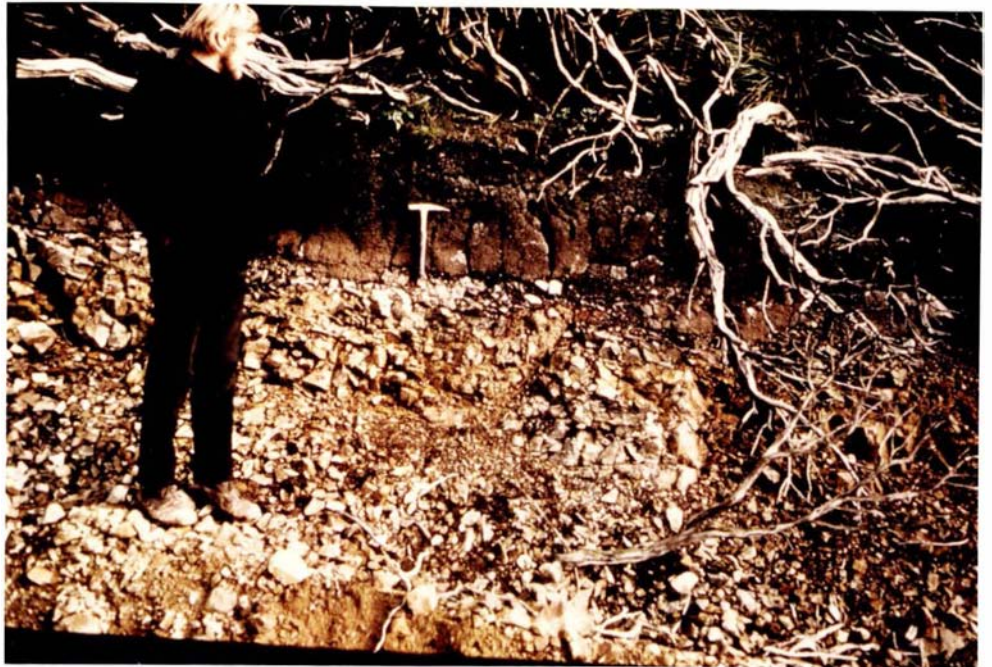
FIGURE 10.3: Torlesse bedrock overlain and in sharp contact with peaty loam. On inclined valley slopes the lubricating affect of water along this contact facilitates slope movement. Debris slides or debris avalanches may occur as a result of failure at this contact.

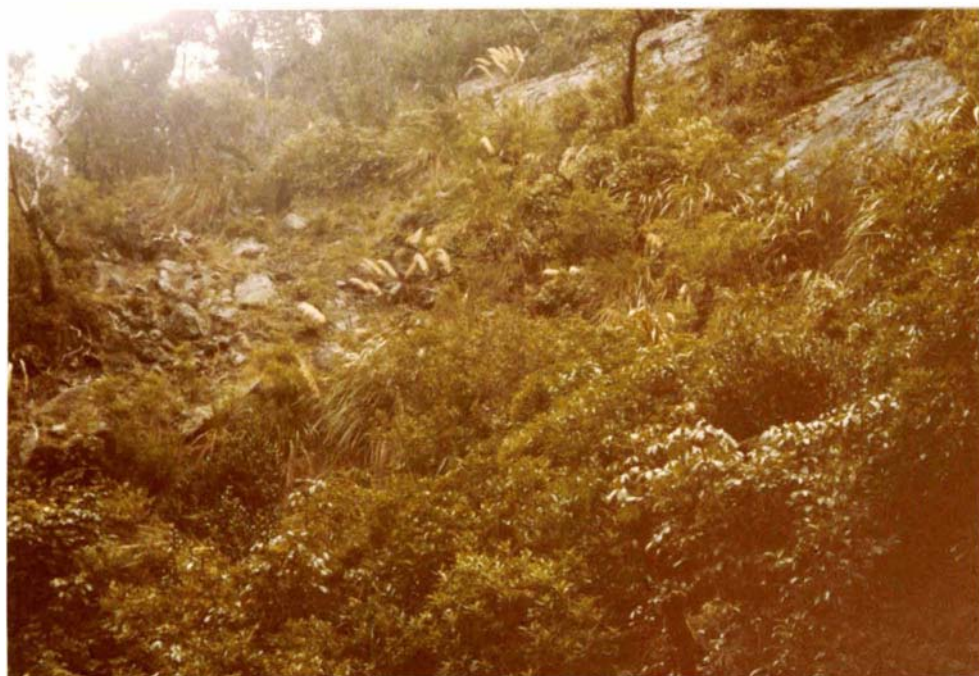
FIGURE 10.6: A rock slide resulting from downslope movement along a bedding plane surface within bedrock comprising the Tamaki Lithotype. The direction of bedding plane dip coincides with topographic slope. Strike of the strata parallels valley slope. Downslope displacement of the moved mass is small hence the rock is relatively undisturbed and the vegetation cover has not been disturbed. *Locality T23/591083.*

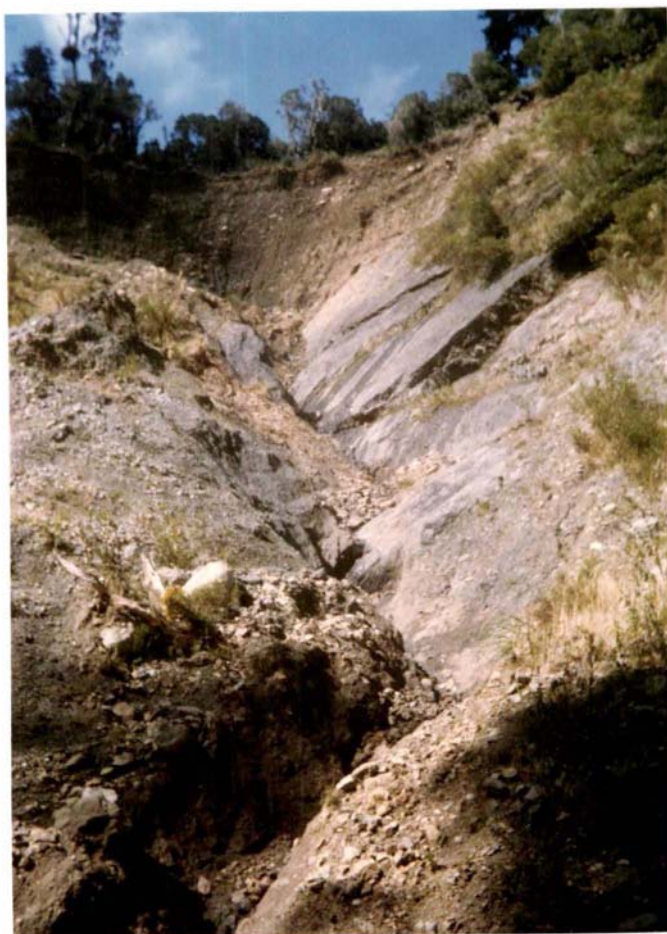
FIGURE 10.7:

An undisrupted rock slide resulting from downslope movement along a lithological contact within bedrock comprising the Wharite Lithotype. Downslope displacement is small. Note the water seep on the exposed sandstone surface.

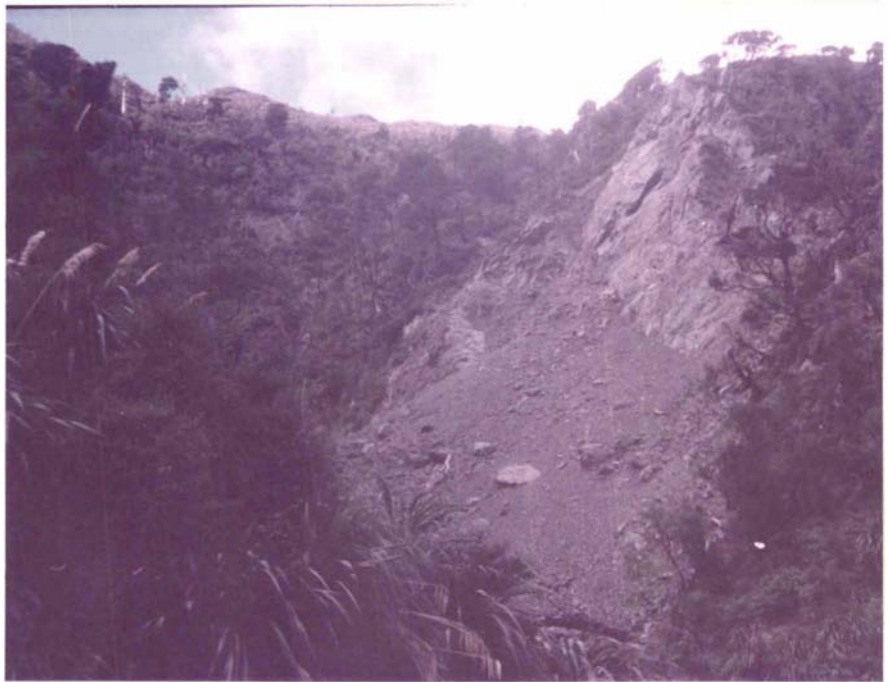
FIGURE 10.11: Rock fall resulting from failure along the north-south trending joint system. The planar joint surfaces dip steeply towards the west (left). Channel at base of rock fall is choked with coarse angular rock fall detritus. Photograph taken in North Oruakeretaki catchment at T23/593091.

rock fall activity. Where the resultant rock-face is planar in appearance, it appears that rock fall activity has been controlled by one dominant set of joints (Fig. 10.11). Sets of filled joints were not found in association with rock fall activity. Consistent relationships between joint size, spacing, open or filled joints and the incidence of rock falls could not be established. Rock fall locations are shown on Maps 5, 6 and 7. Slope movement as a result of rock fall activity is of a small scale and of minor importance in this area.

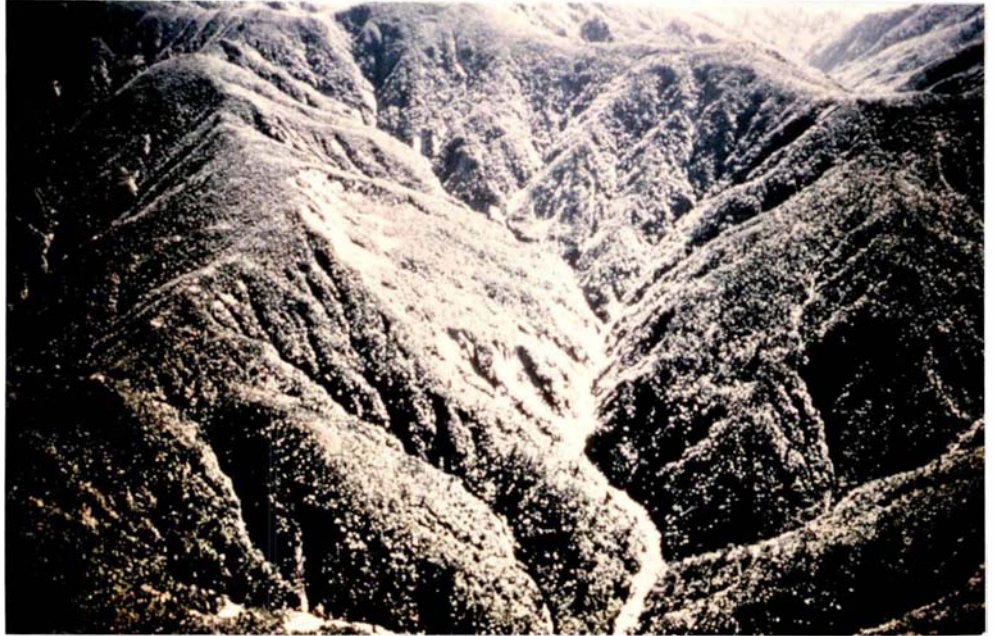
FIGURE 10.17: Large-scale rock slump with well defined lateral and head-wall scarps. Slump movement is towards the north (right). This slump sits astride a 500m wide, northeast striking fault breccia zone mapped as the Ruahine Fault. Note the occurrence of debris slides in the headwall area and gully erosion together with debris slides in the toe area of the slump, much of which has developed since 1946 (see Chapter 11).

*Photograph taken in Raparapawai Catchment at locality T23/563071.*

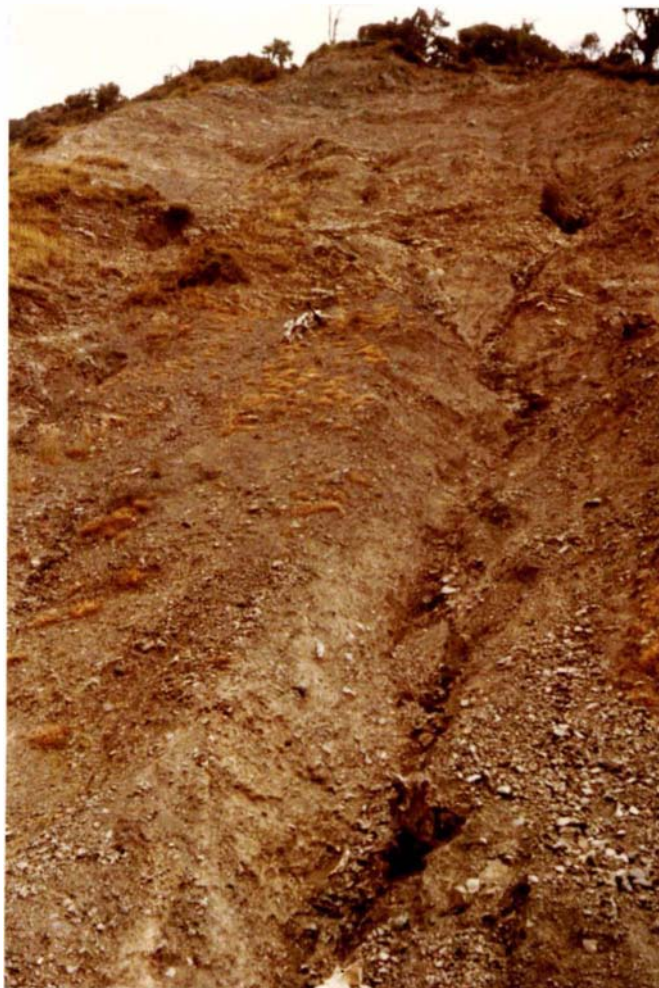
FIGURE 10.21: Rilling within colluvium at the head of a debris slide scar. Note how the smaller rills near the top of the scar merge further downslope into a single master rill. Photograph taken in Otamarahu catchment at locality T23/612107.

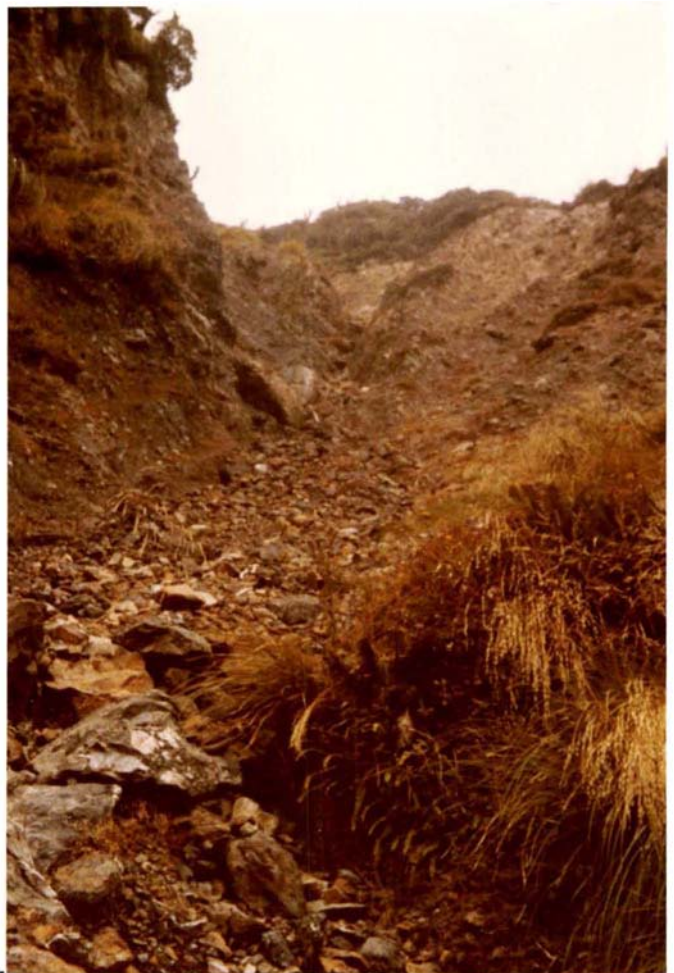
FIGURE 10.23:  
An example of gully erosion within bedrock strata comprising the Wharite Lithotype. This ephemeral gully is bordered by steep sided slopes that are susceptible to mass movement and are consequently bare of vegetation. Photograph taken in Coppermine catchment at locality T23/551041.

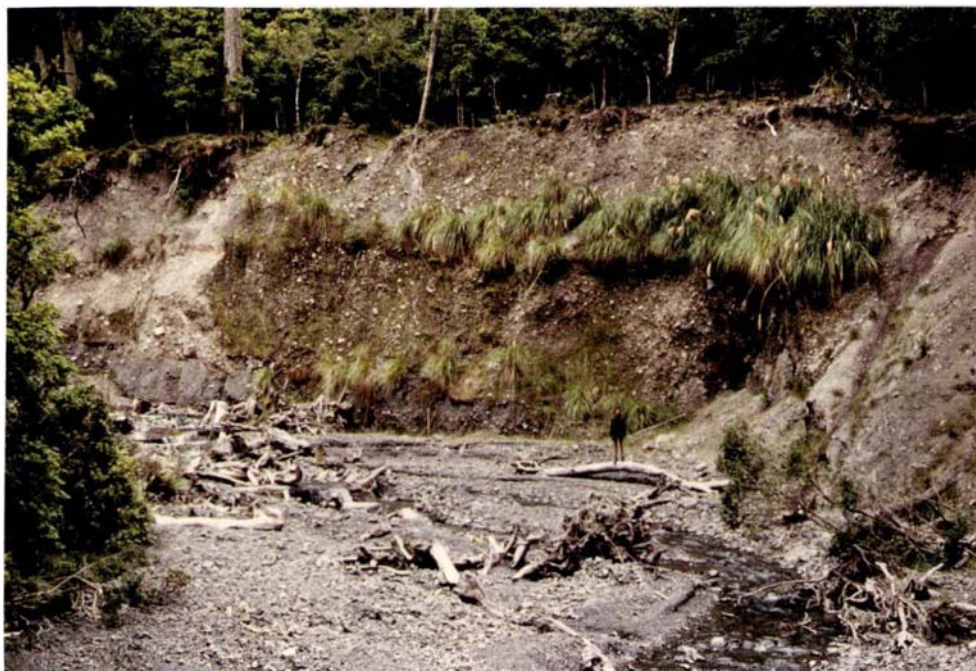
FIGURE 11.1: Whiteywood Creek fan deposit in which at least three levels of gravel aggradation are recorded. The basal gravel (blue-grey colour) and uppermost gravel deposit are undated. The middle level has been dated at  $12\ 150 \pm 150$  years B.P. Each level of gravel aggradation is separated by a thin accumulation of fine gravel and silt. Here, emergent water seeps and hydrophilic vegetation highlights the boundaries between successive gravel deposits. The terrace surface supports a thick stand of *Dacrydium cupressinum* dated by tree ring dating as being approximately 450 years old. Figure is 2m high. Locality T23/698191 on the left bank of West Tamaki River.

At the base of this alluvial fan at locality T23/698191, on the left bank of West Tamaki River, is a buried soil which overlies an undated gravel deposit which in turn overlies greywacke bedrock (Fig. 11.1). Above the buried soil is a second gravel horizon from which wood identified as *Griselinia littoralis* (broadleaf) has been radiocarbon dated (NZ 4314B) at  $12\ 150 \pm 150$  years B.P. (Appendix Vb), suggesting that active deposition was occurring on the fan about 12 000 years ago. A 2m thick layer of fine gravel and silt mark the end of this second period of gravel aggradation. A seepage zone, highlighted by the line of *Cortaderia fulvida* vegetation (Fig. 11.1), indicates the position of this layer of fine gravel. The third period of aggradation is represented by the upper gravel unit upon which a mature stand of rimu has grown (Fig. 11.1). Tree ring dating of

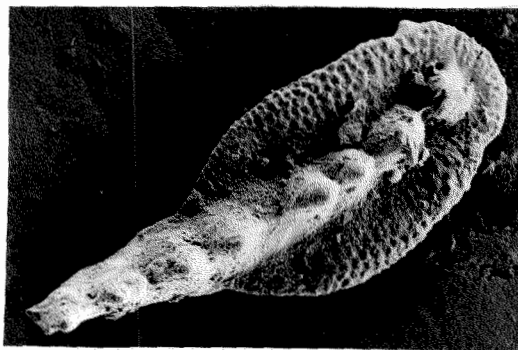
B. top view

- A. *Gondolella navicula*. Top and lateral views, x 100.  
 B. *Gondolella polygnathiformis*. Top and lateral views, x 140.  
 C. *Gondolella navicula* juvenile, x 160.  
 D. *Prioniodina excavata*, x 110.  
 E. *Enantiognathus zieglerei*, x 100.  
 F. ? *Hindeodella suevica*.
