**Physical and social impacts of past and future
volcanic eruptions in New Zealand**

**A thesis presented in partial fulfilment of
the requirements for the degree of
Doctor of Philosophy
in Earth Science**

DAVID MOORE JOHNSTON

**Massey University
Palmerston North
New Zealand**

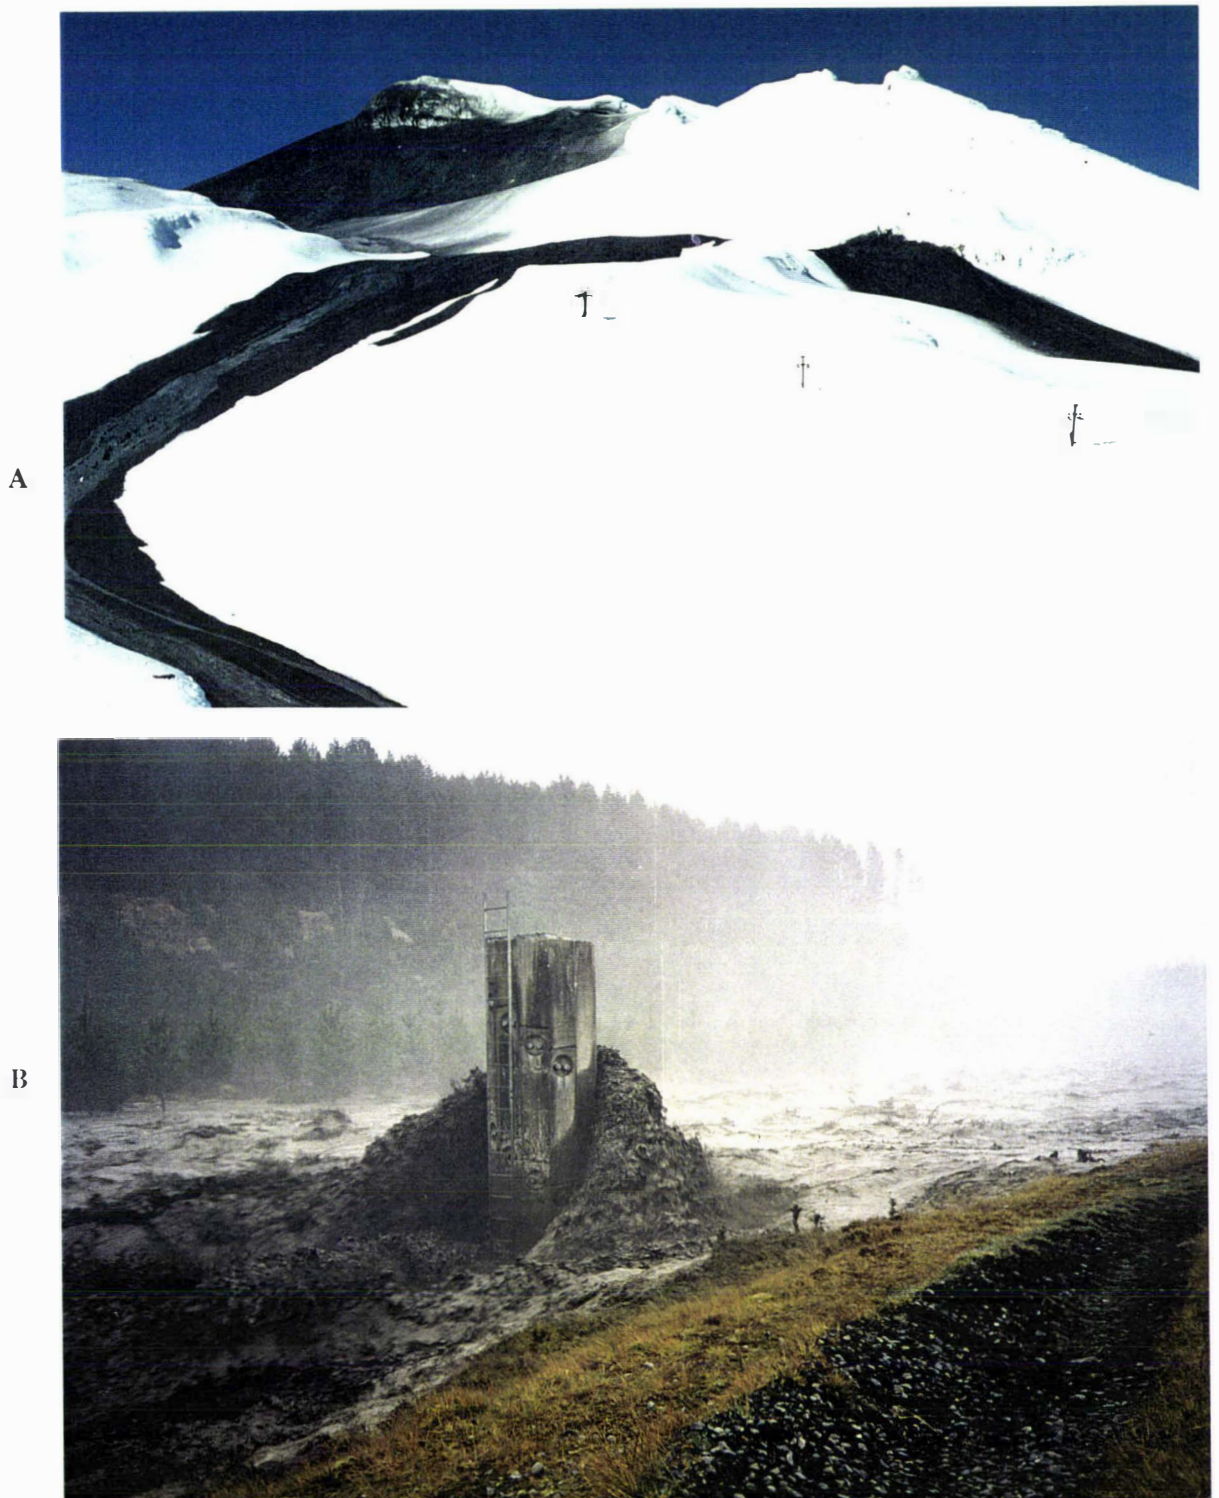
FIGURE 2.3 Lahar impacts from 1995 eruptions.

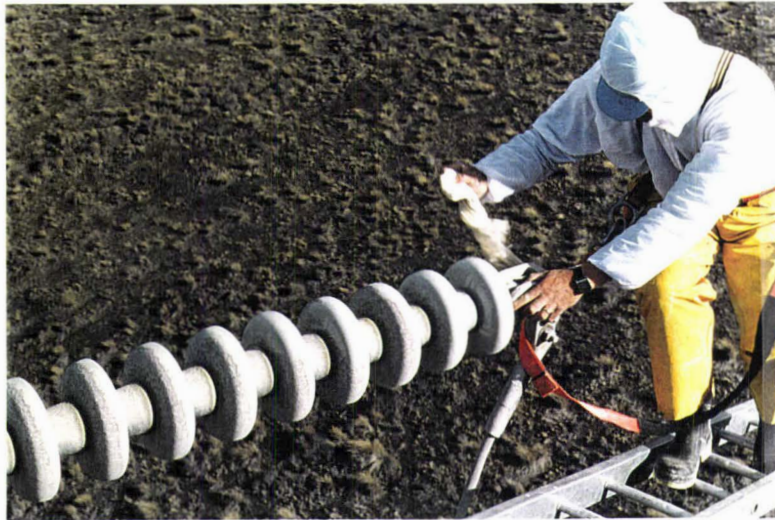
Bunnythorpe – Whakamaru A and B Lines, Volcanic Ash

After ash falls electricity generation and supply companies routinely cleaned ash from affected substations. On 17 June 1996 electricity supplies were disrupted in parts of Rotorua city after an explosion at a local substation caused by ash and water settling on a transformer due to a resident's hosing ash from the roof of a neighbouring building (*Daily Post*, 19 June 1996).

Cleaning using dry cloth, effective but slower

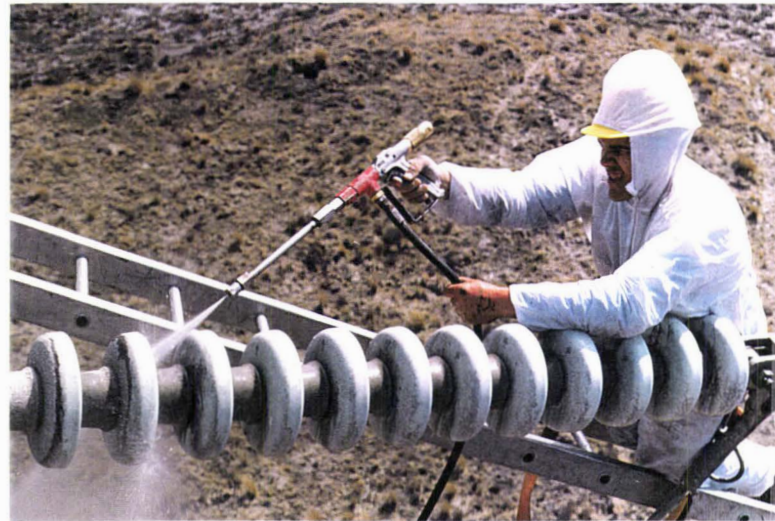
Bunnythorpe – Whakamaru A and B Lines, Volcanic Ash

Water blaster (1500psi approx)

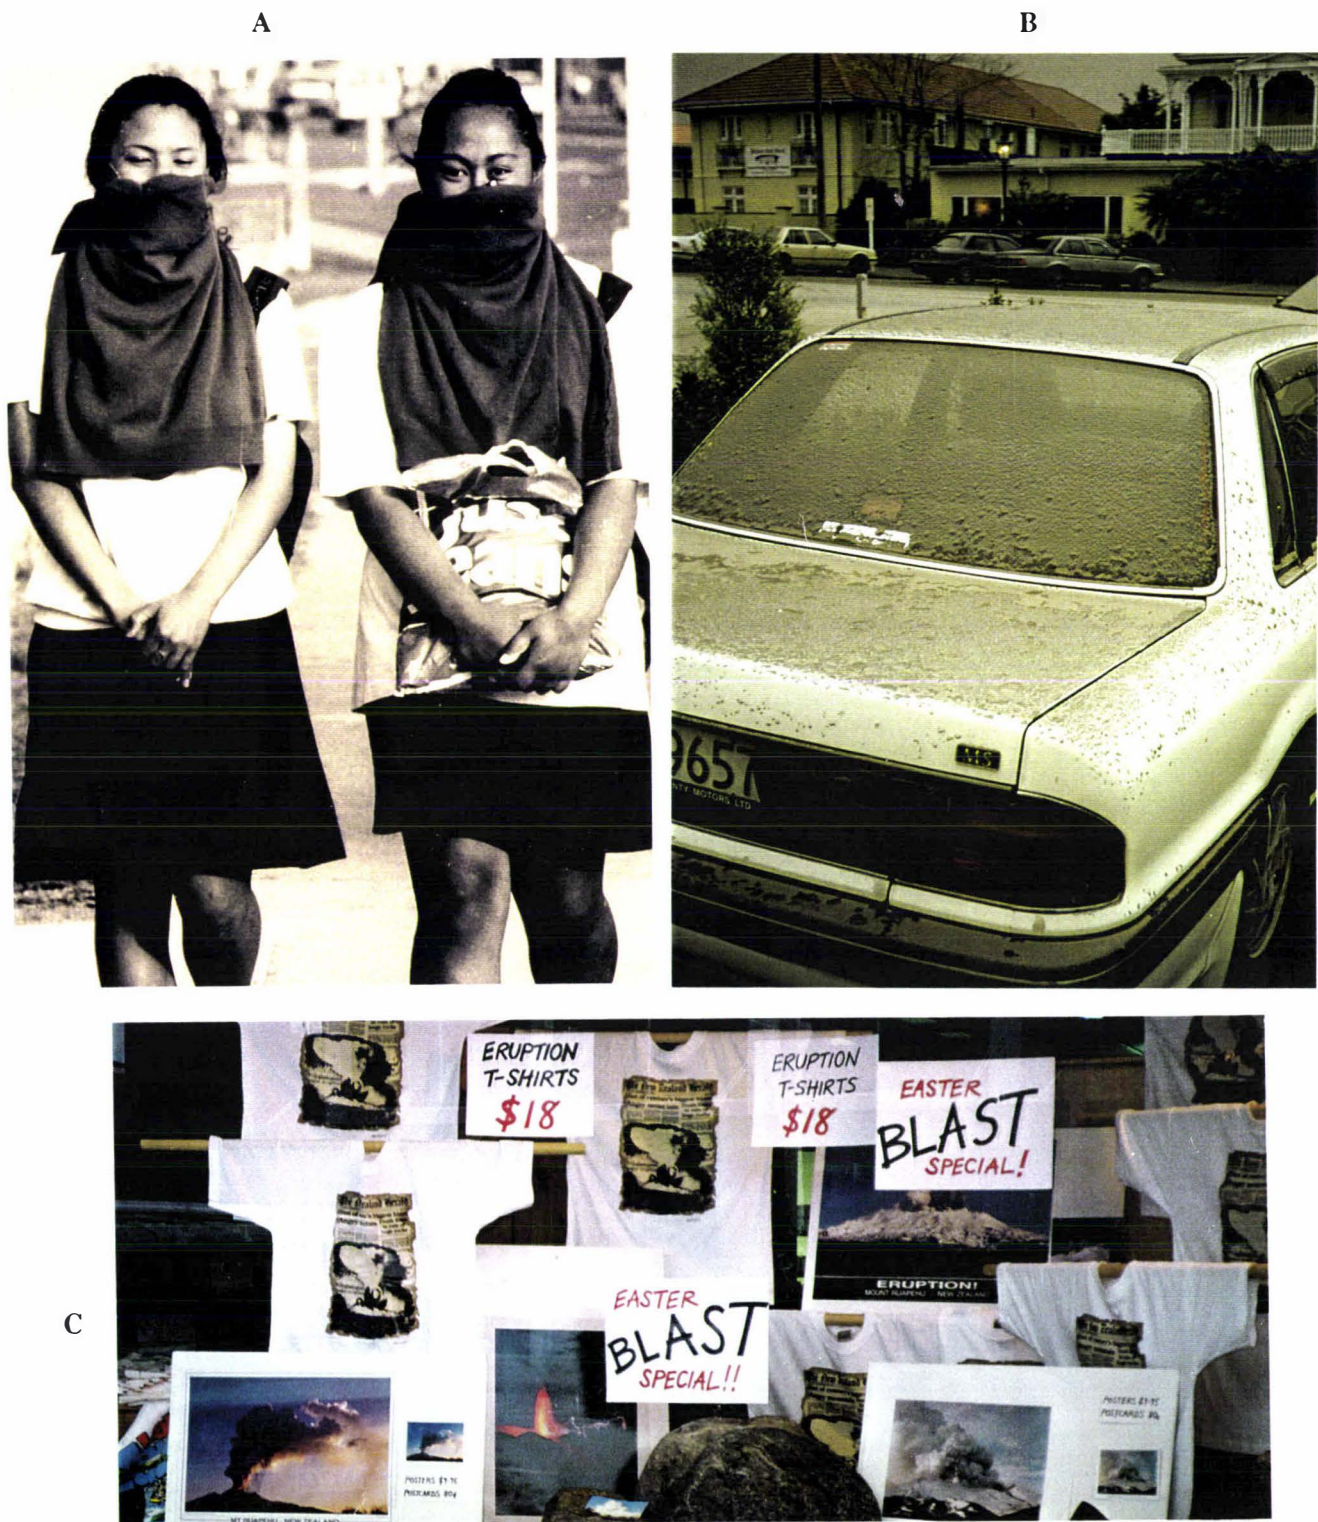
FIGURE 2.6 Examples of impacts of the 1995-1996 Ruapehu eruptions.

- A. Sweatshirts being used as impromptu gas masks to cope with the ash in Gisborne on 12 October 1995.
- B. Ash covered car in Rotorua on 17 June 1996. Many people report minor abrasion damage to paintwork and windscreens
- C. Shop window in Taupo. Some local businesses rapidly adapted to the opportunities supplied by the 1995-1996 eruptions.

Some local businesses have capitalized on the eruption with a range of volcanic products and the promotion of their communities as a safe place to "volcano watch" (Fig. 2.6). Despite slight increases in summer visitors, tourism operations report that the gains do not make up for their losses which resulted from the premature termination of the ski season in September 1995 and the limited season of 1996.

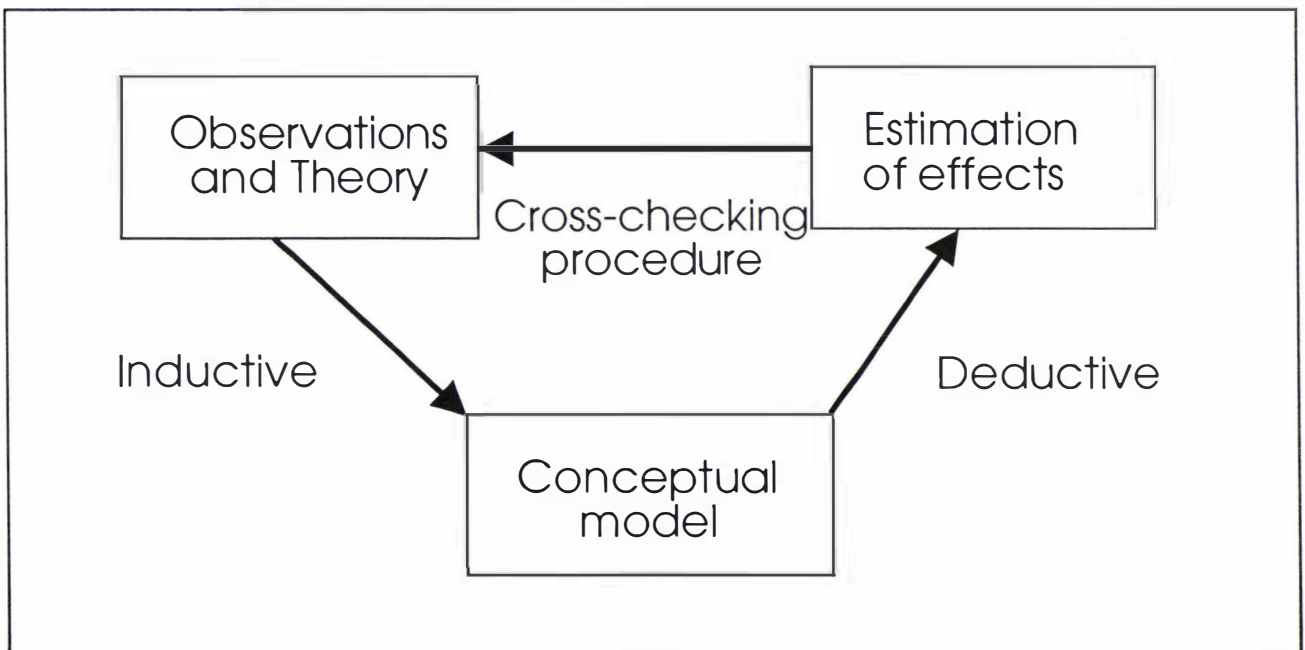
FIGURE 3.1 An approach to estimating the effects of volcanic hazards on community 'lifelines'.

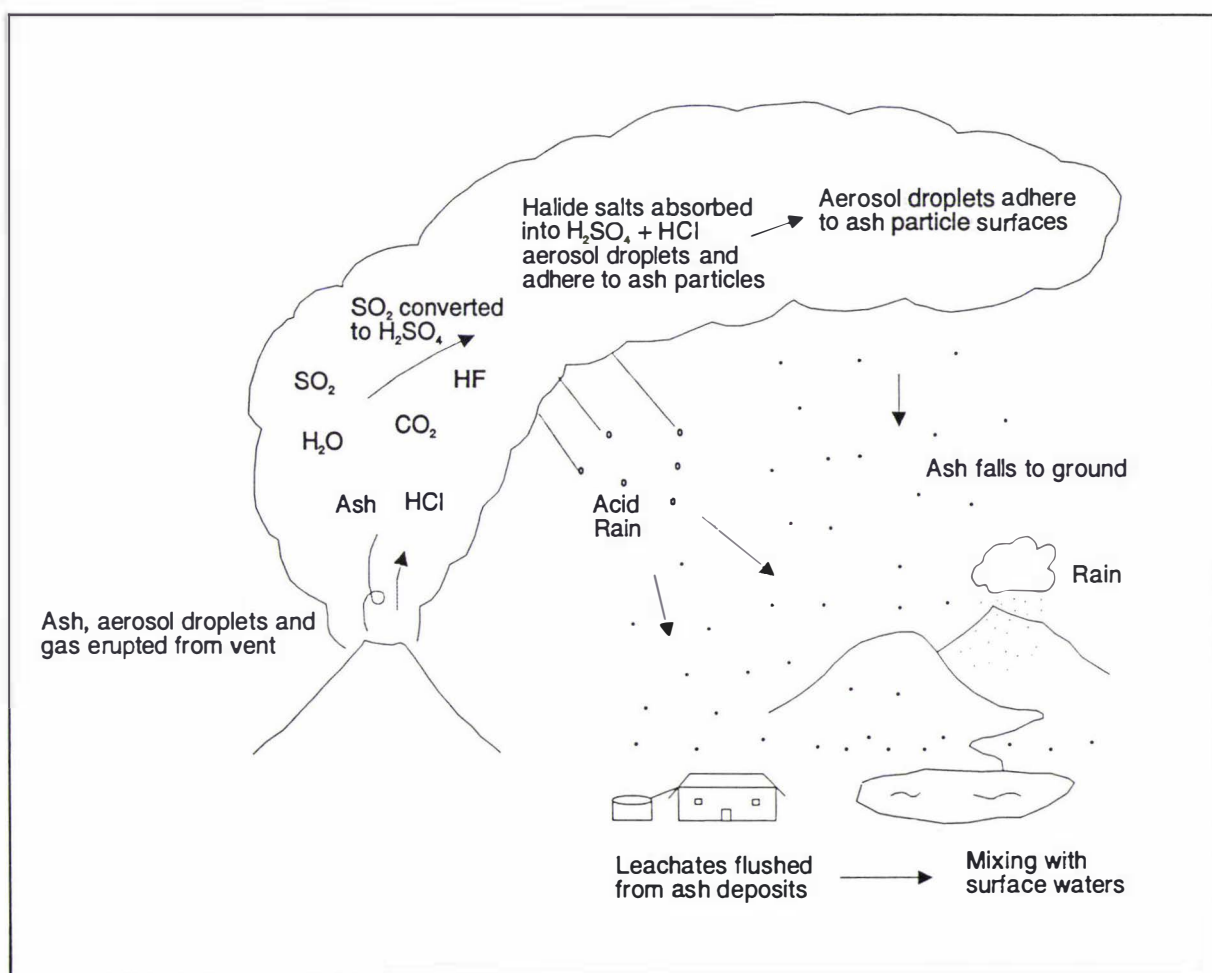
FIGURE 3.3 Volcanic eruptions inject water vapour (H₂O), carbon dioxide (CO₂), sulphur dioxide (SO₂), hydrochloric acid (HCl), hydrofluoric acid (HF) and ash into the atmosphere. HCl and HF will dissolve in water and fall as acid rain whereas most SO₂ is slowly converted to sulphuric acid (H₂SO₄) aerosols. Ash particles may absorb these aerosol droplets onto their surfaces providing an acid leachate after deposition.

Soluble components: Freshly fallen ash grains commonly have surface coatings of soluble components (salts) and/or moisture (Rose 1977). It is these components that make ash mildly corrosive and potentially conductive. These soluble coatings are derived from the interactions in an eruption column between ash particles and aerosols which may be composed of sulphuric and hydrochloric acid droplets with absorbed halide salts (Fig. 3.3). This process is most active close to a volcano (i.e. <50 km), although the amount of available aerosols varies greatly even between eruptions of similar volumes (Bernard & Rose 1990). The release of soluble components (leachates) can also result in changes to local water chemistry and hence quality (refer to 3.2.6).

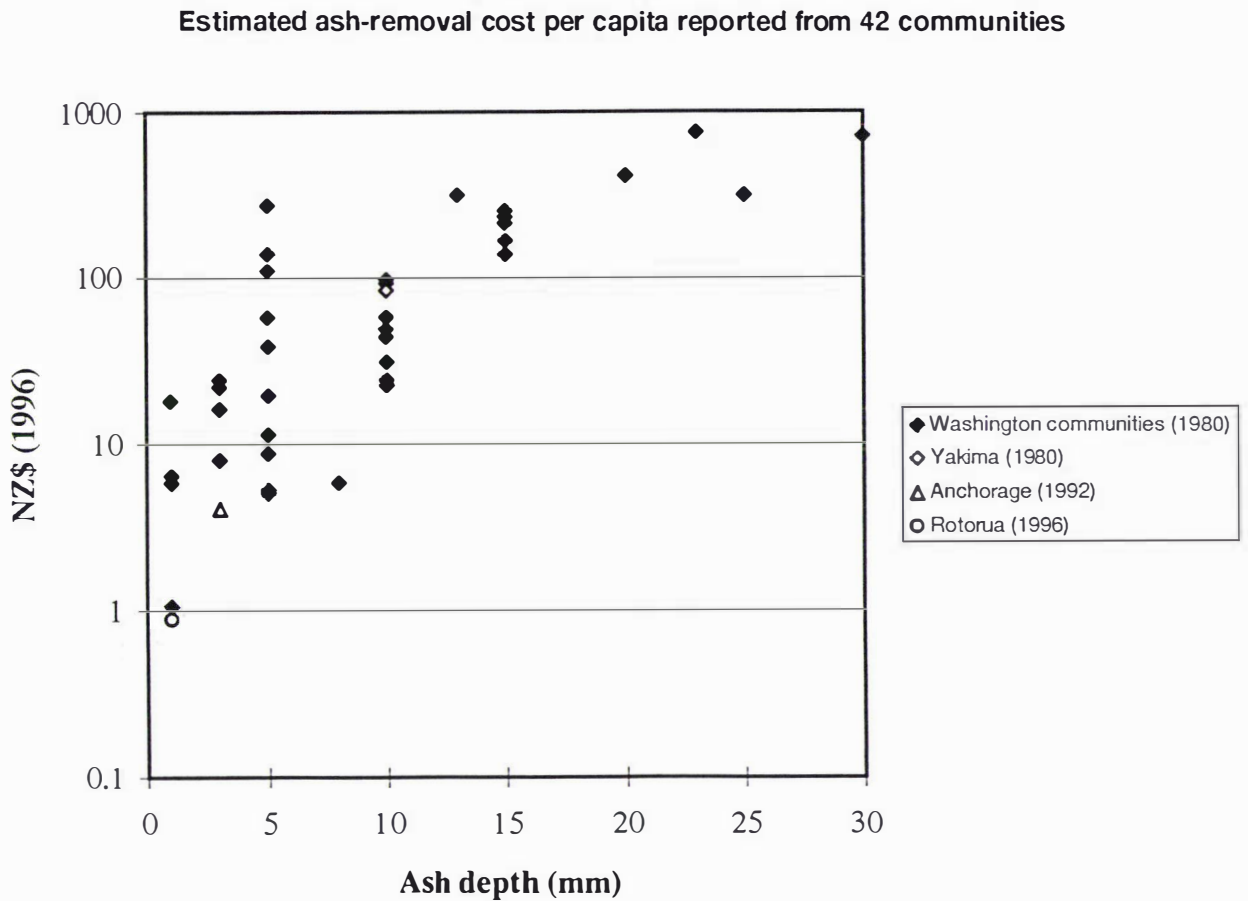
FIGURE 3.5 The estimated ash-removal cost per capita versus ash depth reported from 42 communities (includes removal from road and sewage/stormwater systems). The 1980 ash clean-up in Yakima and other Washington communities resulted from the 18 May 1980 eruption of Mount St Helens (reported by Warrick *et al.* 1981). The 1992 Anchorage ash clean-up was a consequence of the 18 August 1992 eruption of Mt Spurr and the 1996 ash clean-up in Rotorua was a result of the 17 June 1996 eruption of Ruapehu. See Chapter 2 and Appendix 3 for further details. The costs have been adjusted to 1996 values by using the U.S. consumer price index and converted at \$1NZ = \$0.7US.

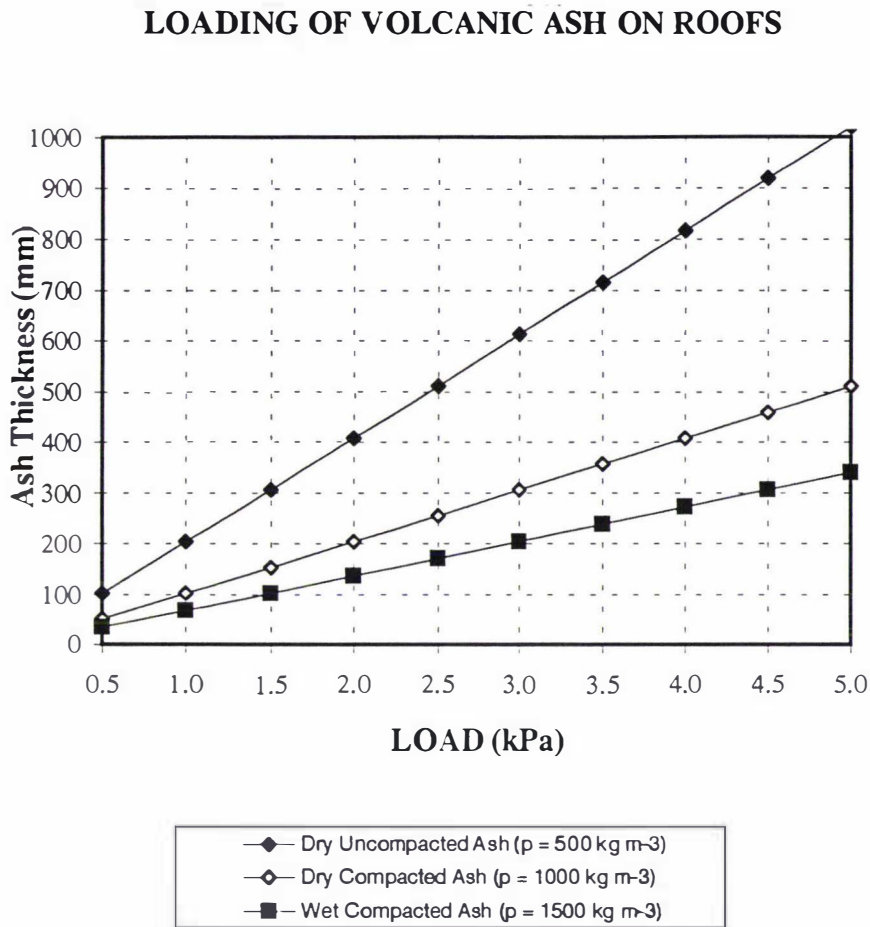
FIGURE 3.9 Loading of tephra on a roof for (a) wet compacted ash, and (b) dry uncompacted ash. The uncompacted ash is assumed to have a density of 500 kg m^{-3} . The wet ash is assumed in this example to have a dry (compacted) density of 1000 kg m^{-3} and a saturation of 50% water by volume and therefore a wet density of 1500 kg m^{-3} .

Compaction increases the density of an ash cover but not its weight. Loading caused by ash depends on its thickness, density and whether it is dry or wet. Densities range from about 500 kg m^{-3} for dry uncompacted ash to more than 2000 kg m^{-3} for a compacted very wet ash (Fig. 3.9). There are strong similarities to problems with loading by snow but the effects of ash accumulation are much more severe (Table 3.14). New Zealand building codes (New Zealand Standard 4203) make allowances for snow, ice and rain water load but not loading by volcanic ash. The snow loading codes will afford some protection against ash but this is highly dependent on the location of structures because snow load levels vary with altitude and geographic position. As seen in Figure 3.10 the northern half of the North Island is not subject to snow loading codes.

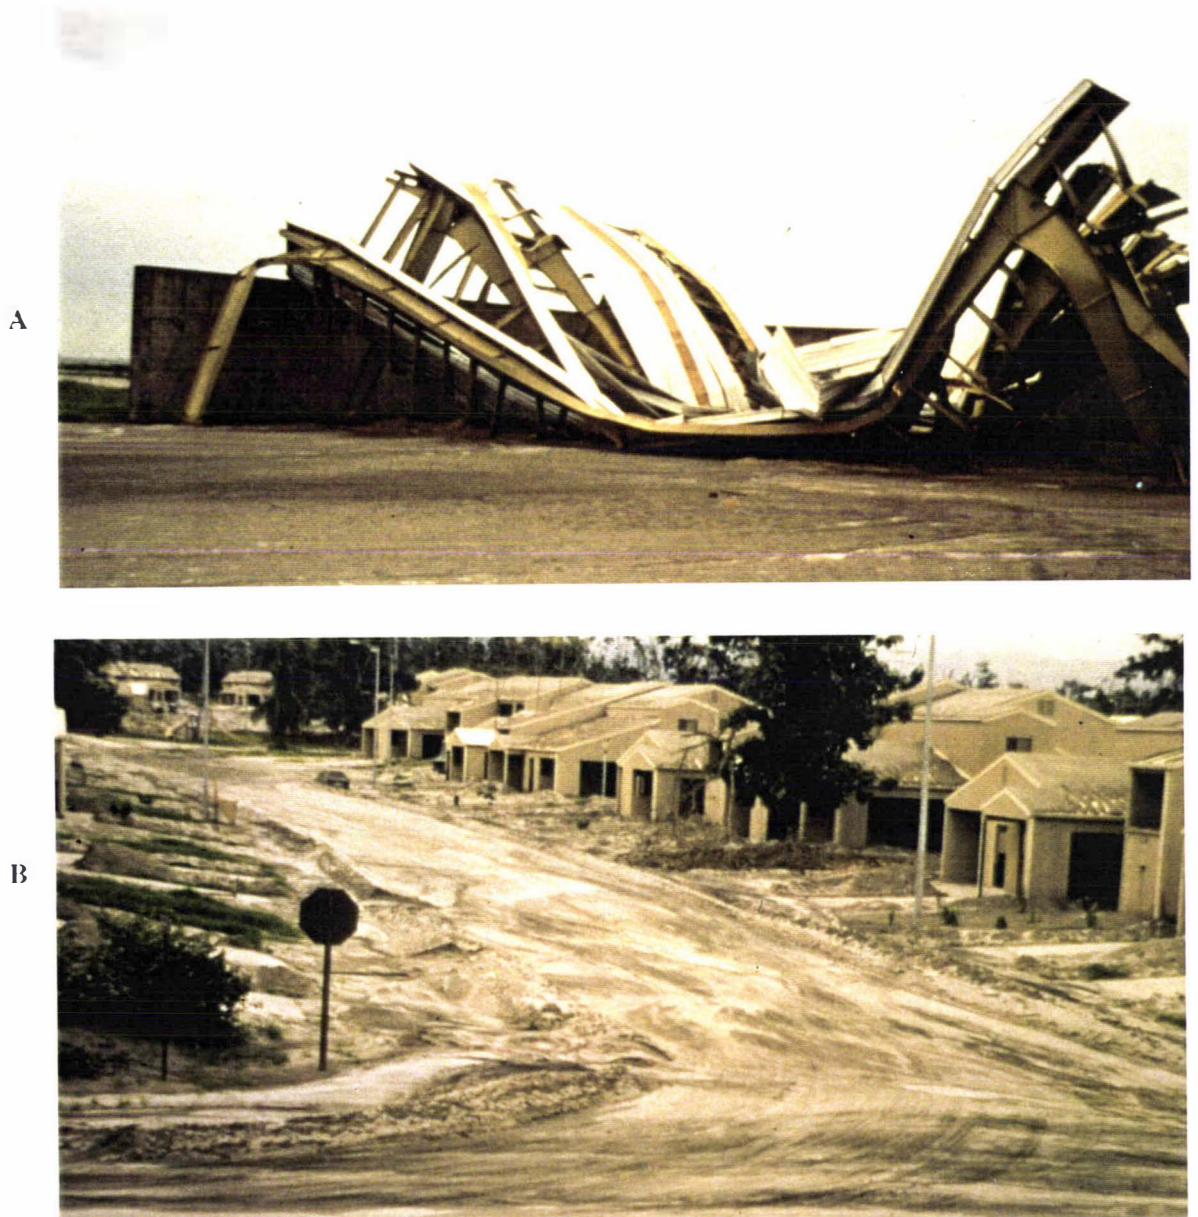
**FIGURE 3.11**

FIGURE 3.11	A comparison of the damage caused to buildings receiving ~ 150 mm of ash from the 1991 Pinatubo eruption.	78
FIGURE 3.12	Corrosion of metal roofs by volcanic ash and acid rain droplets	81

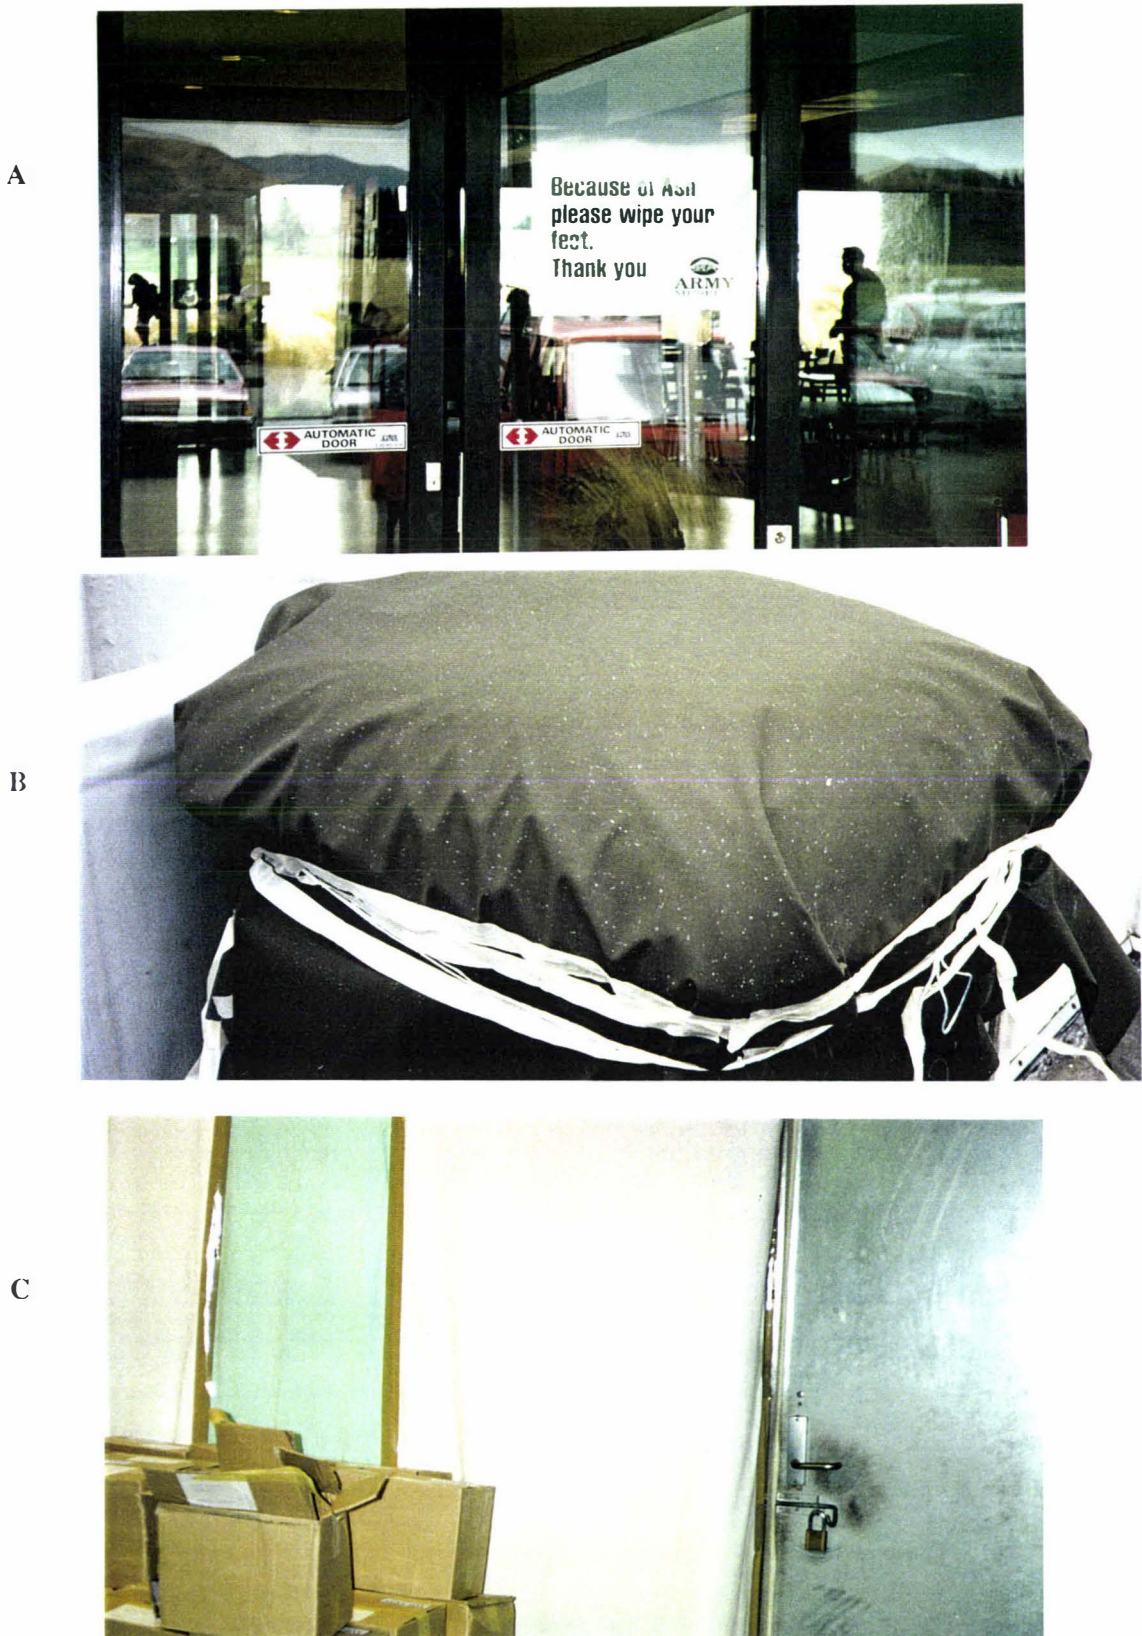
FIGURE 3.15 Examples of simple ash fall mitigation measures used at the Army Museum, Waiouru from September to November 1995, as a result of the Ruapehu eruption.

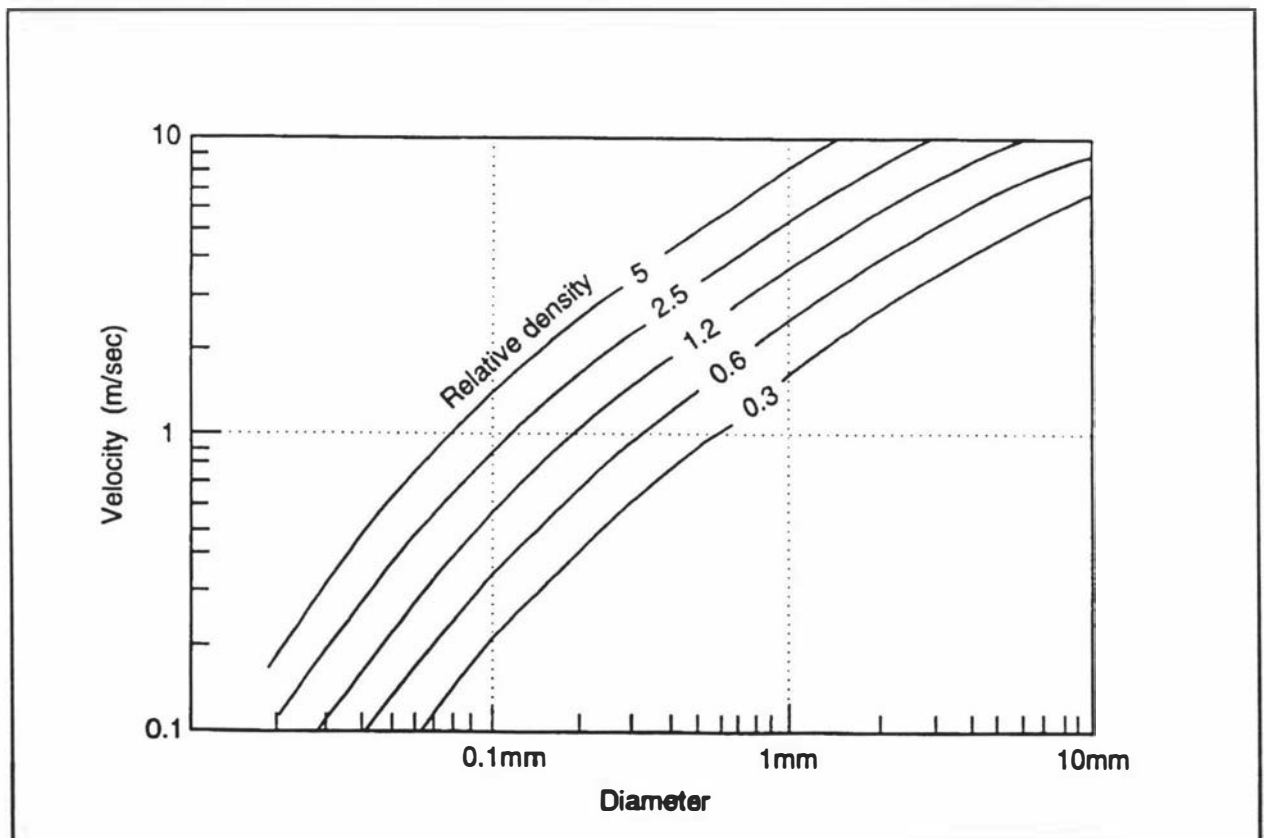
FIGURE 5.1 Settling (terminal) velocities of volcanic ash of various sizes based on modelling by Walker *et al.*(1971).

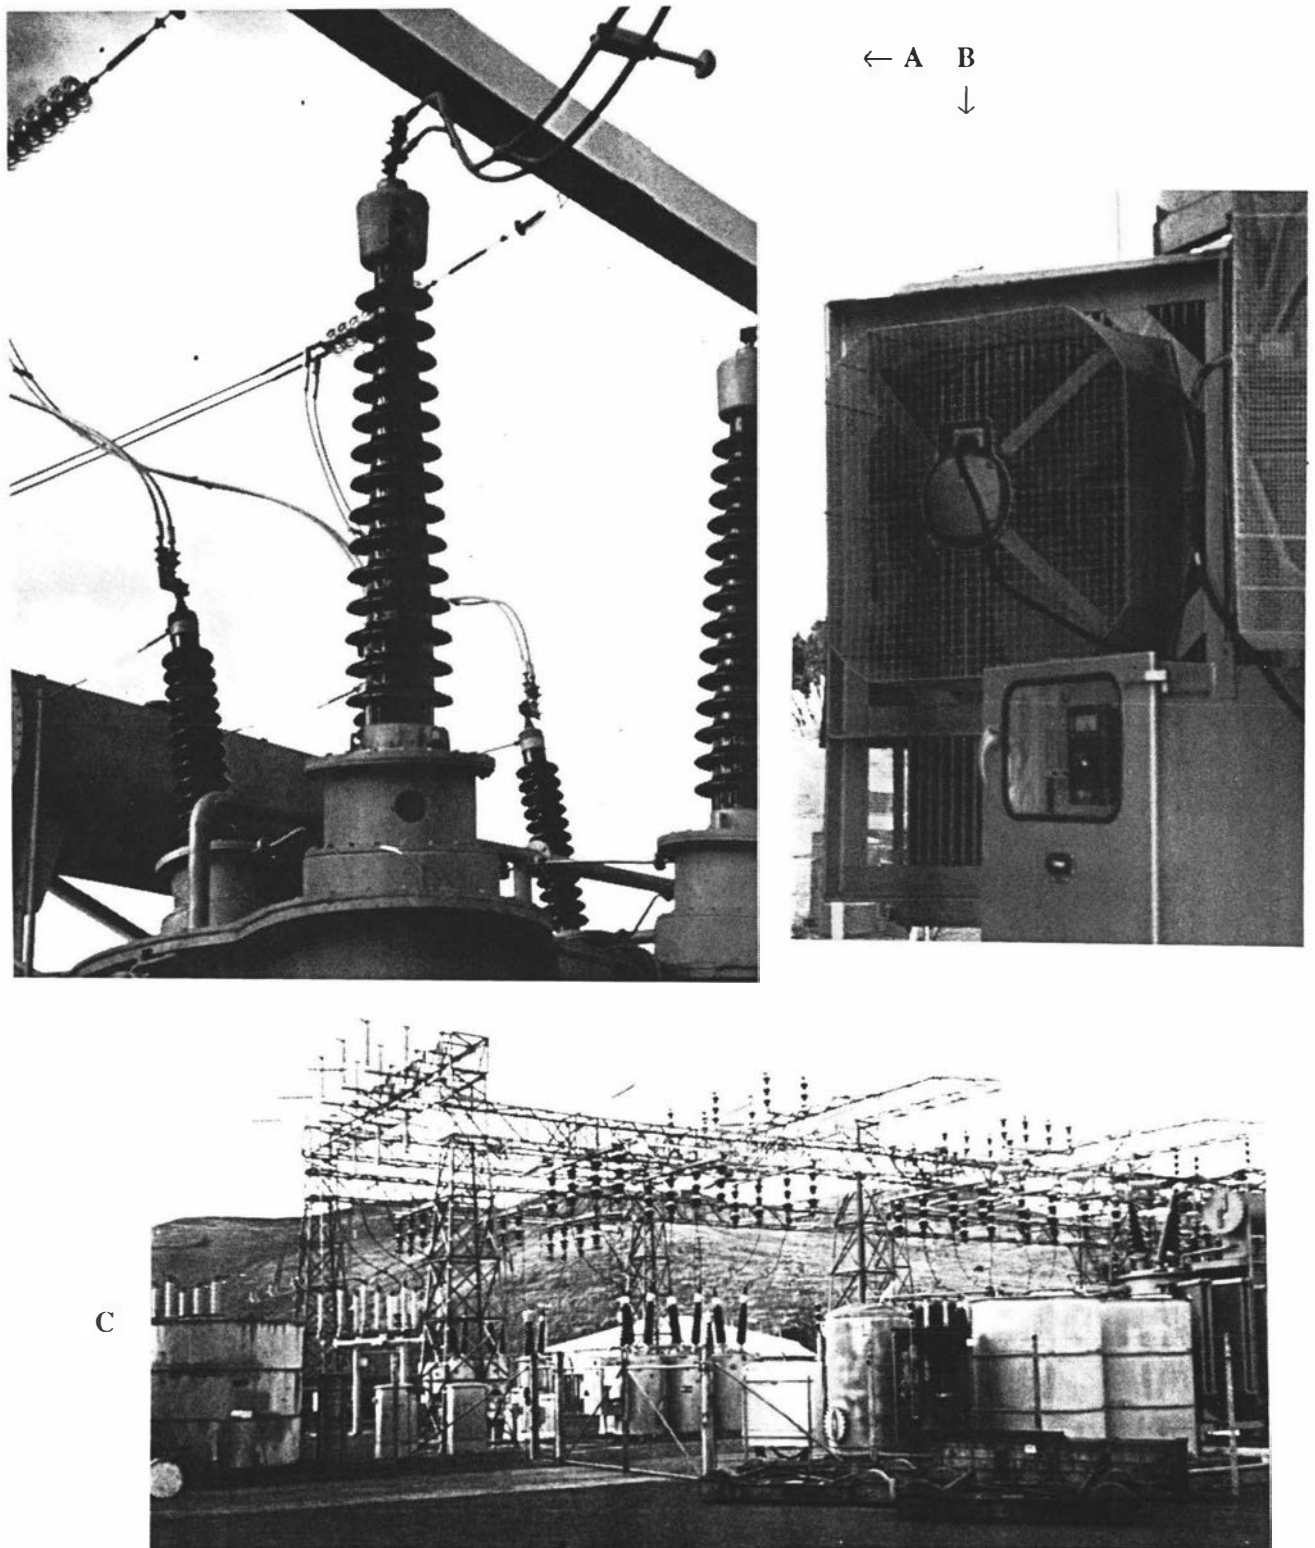
FIGURE 6.6 Example: Redclyffe substation (33 kV \rightarrow 11 kV).

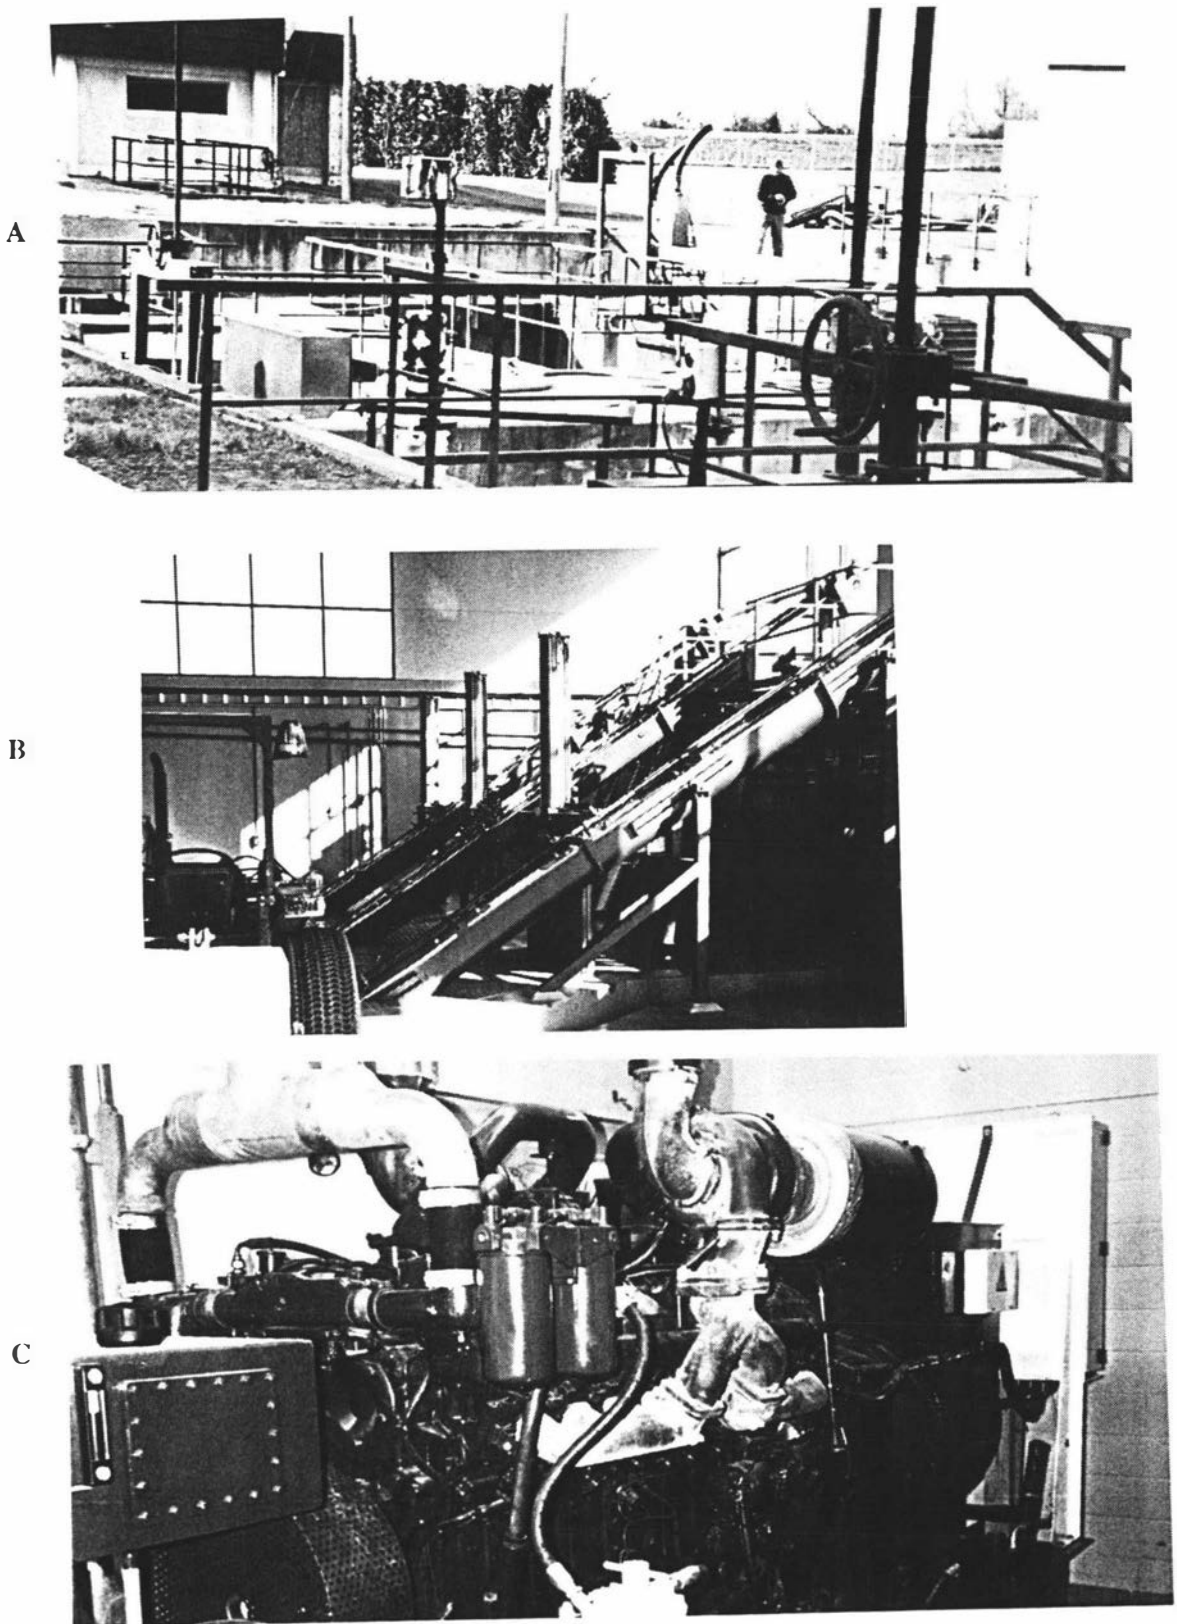
FIGURE 6.10 East Clive sewage treatment plant (see Fig 6.6 for location).

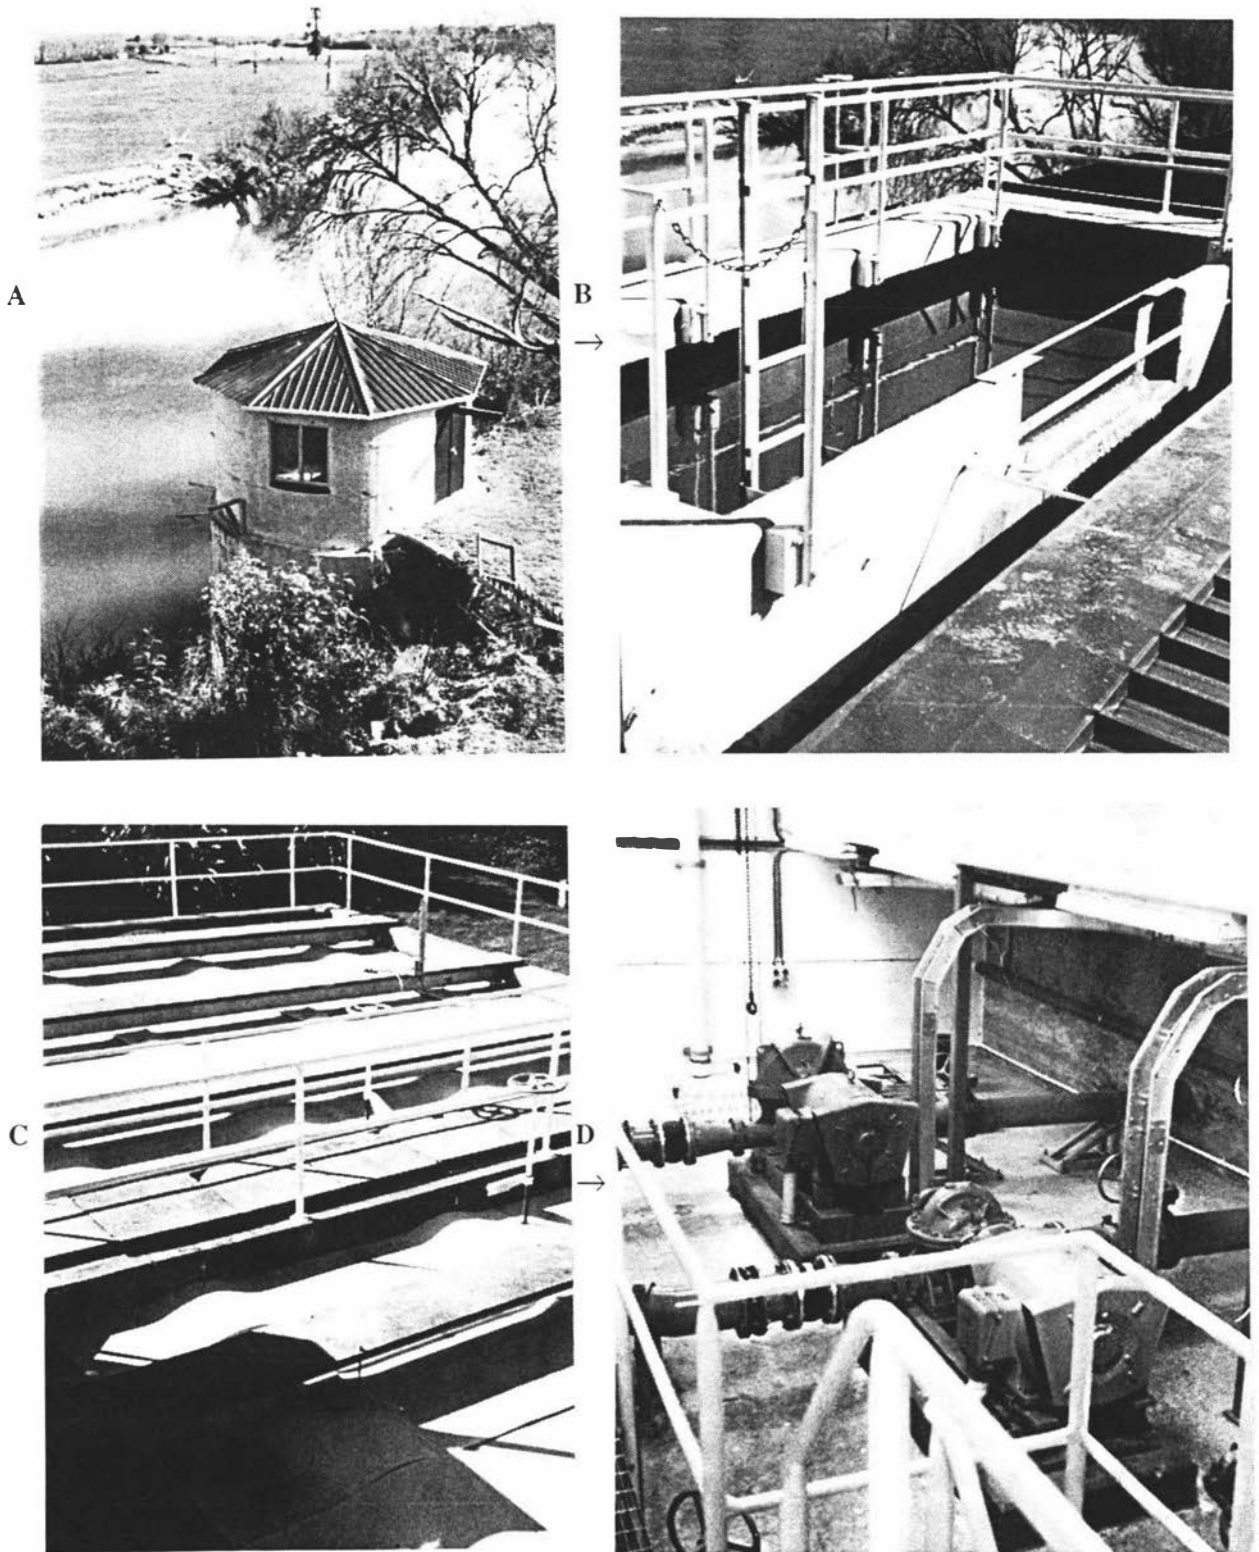
FIGURE 7.10 Whakatane Water Treatment Plant

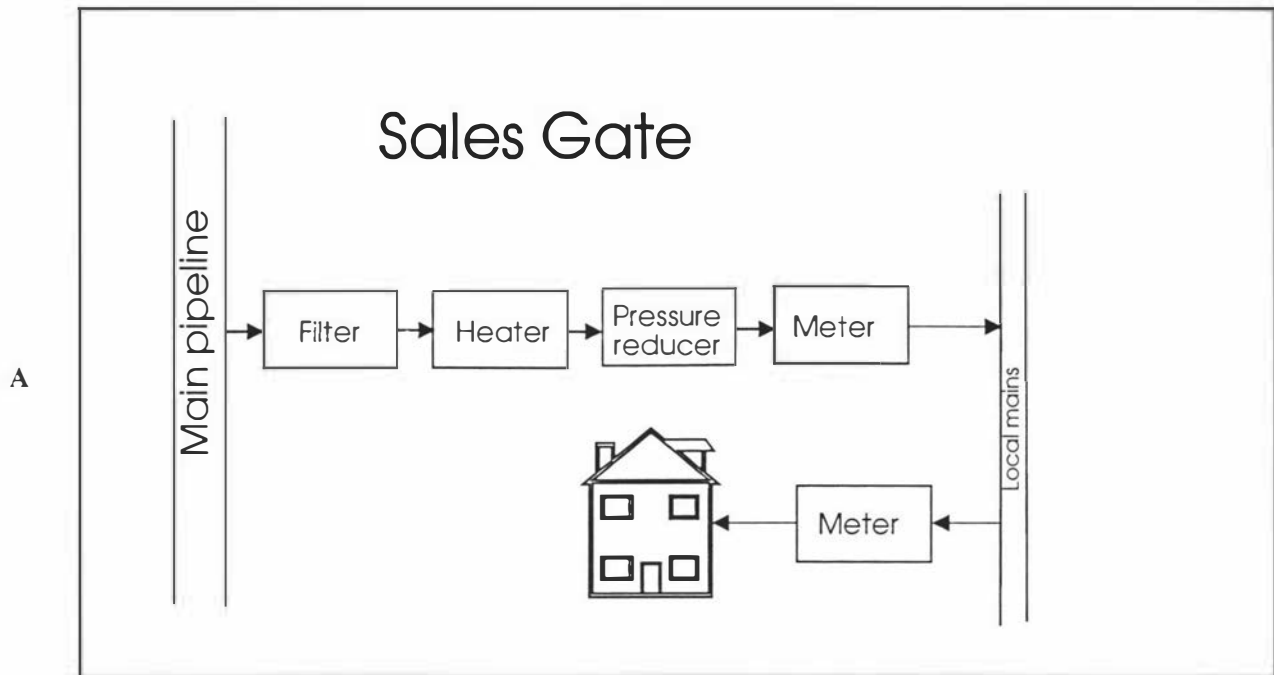
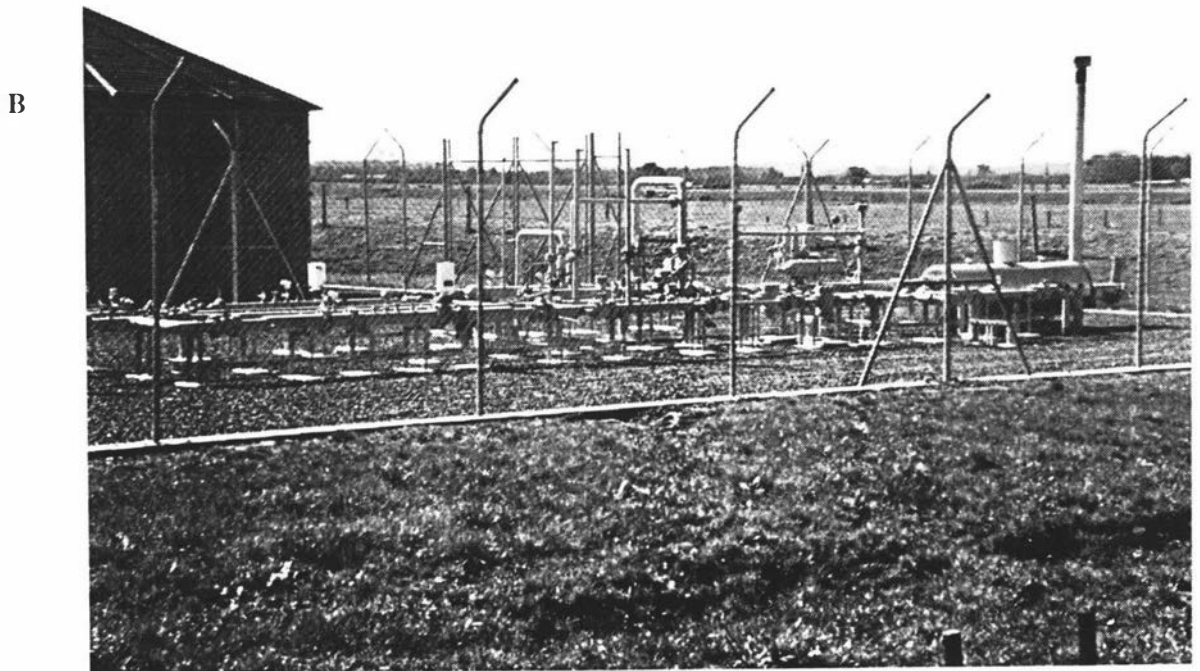
FIGURE 7.16 Gas supply sales gate.

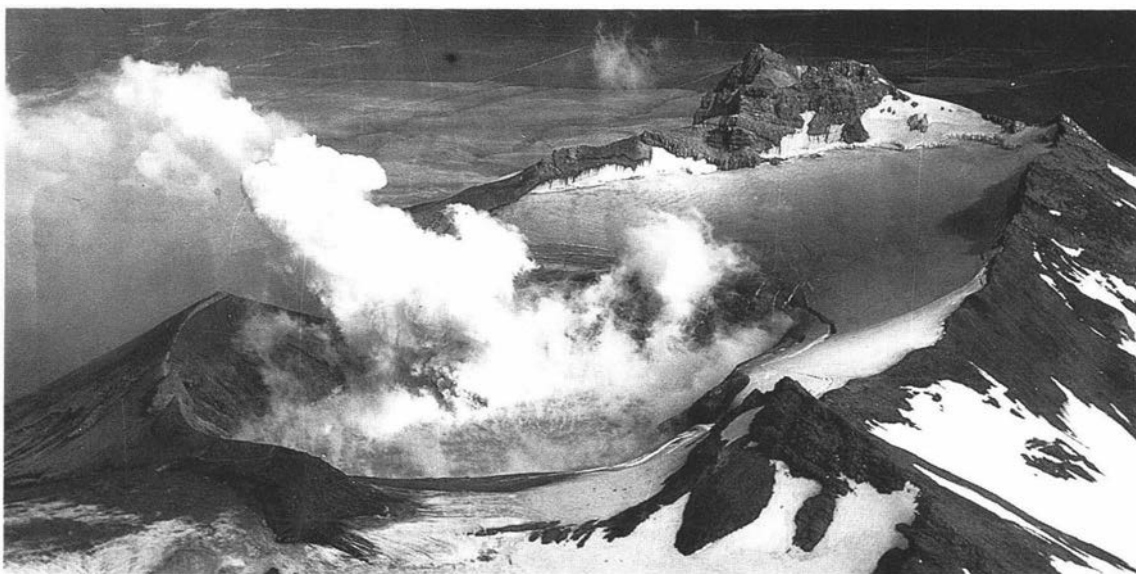
Photo: Aerial view of the crater lake of Ruapehu on 9 March 1945, showing for the first time that year steam issuing from the lake surface. (Photo: RNZAF Collection)
