**Physical and social impacts of past and future
volcanic eruptions in New Zealand**

**A thesis presented in partial fulfilment of
the requirements for the degree of
Doctor of Philosophy
in Earth Science**

DAVID MOORE JOHNSTON

**Massey University
Palmerston North
New Zealand**

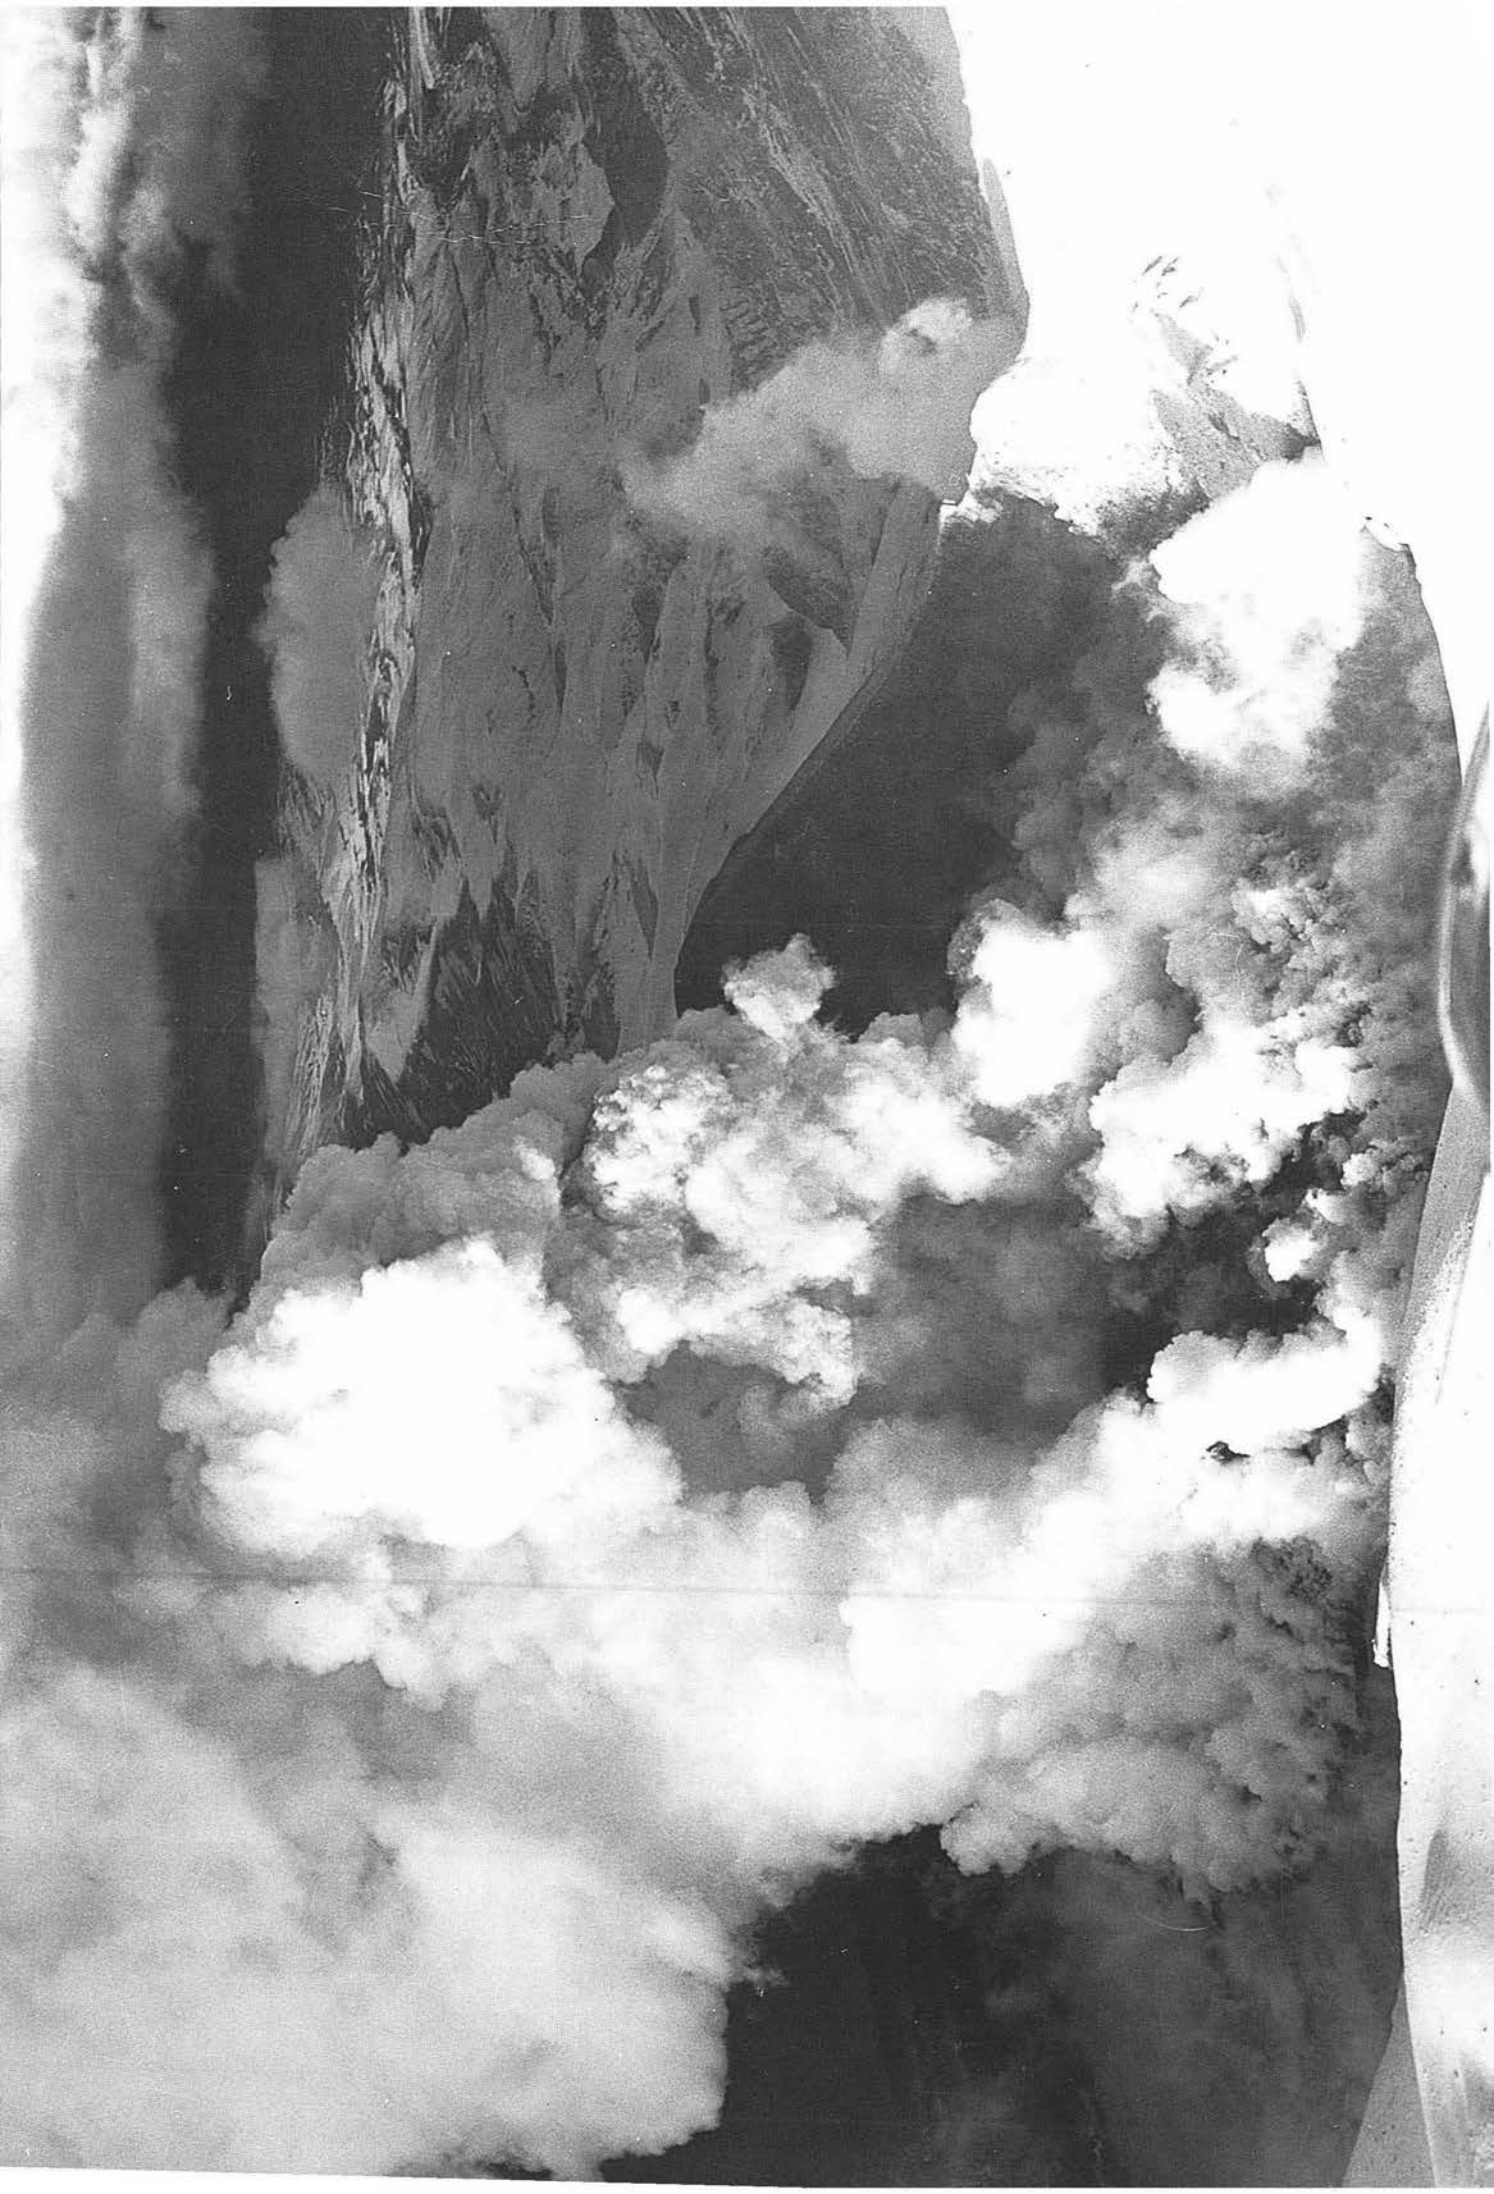
Right Photo: The second lava dome steaming in the crater of Ruapehu on 27 June 1945. Note the remnant of the crater lake to the left of the lava dome. (Photo: RNZAF Collection)

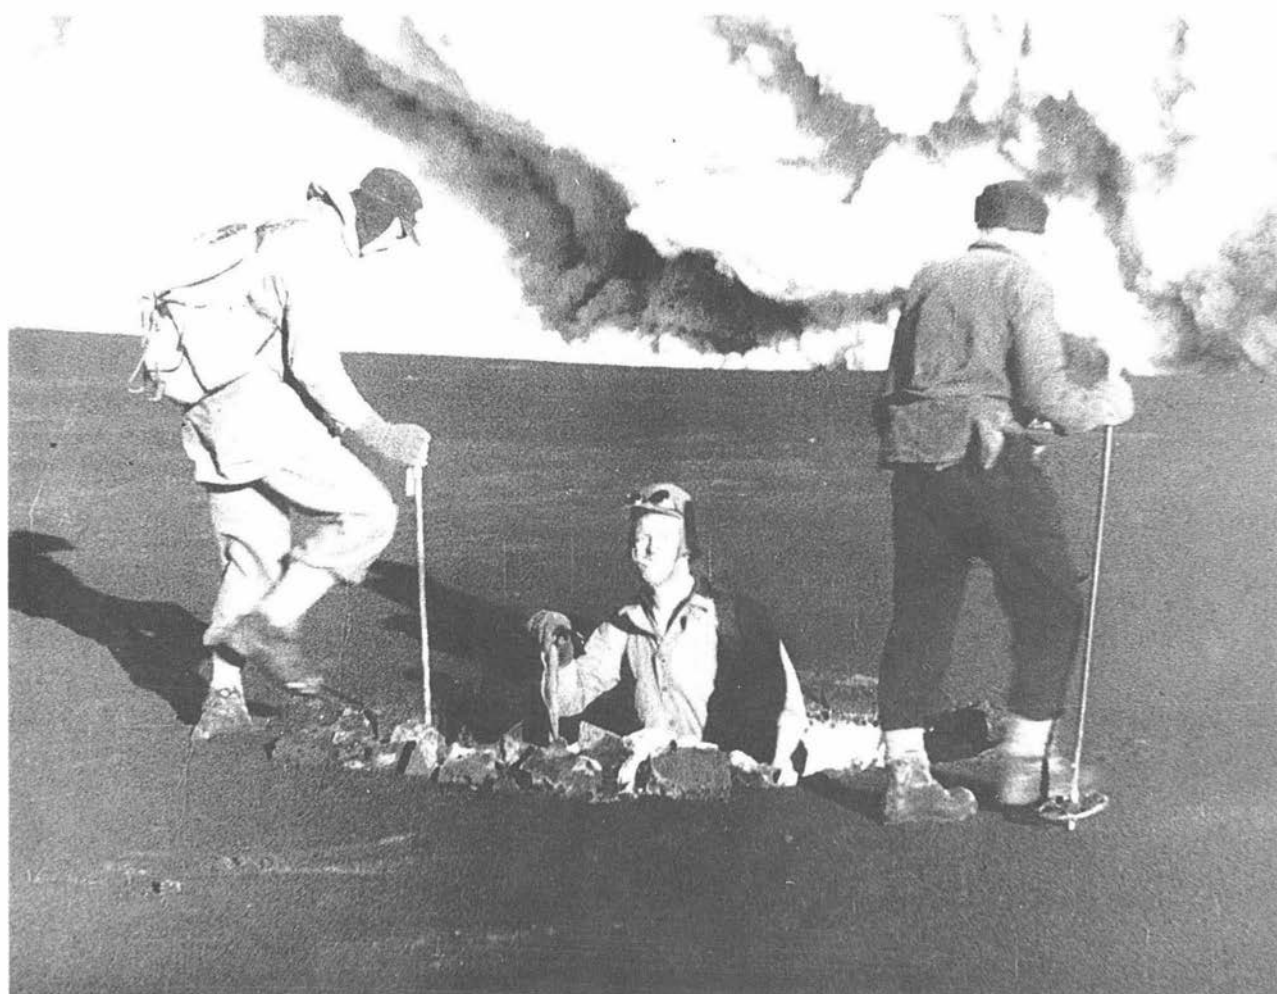
Above Photo: A large hole in the Whakapapa Glacier formed by the impact of an ejected block from the active vent in August 1945. Note the thick ash layer on the surface of the glacier. (Photo: Frame still from the item "Vulcanism...CAMERA ON RUAPEHU" in the National Film Unit film "Weekly Review No.211" (1945). Reproduced with permission of the Director and Chief of National Archives).

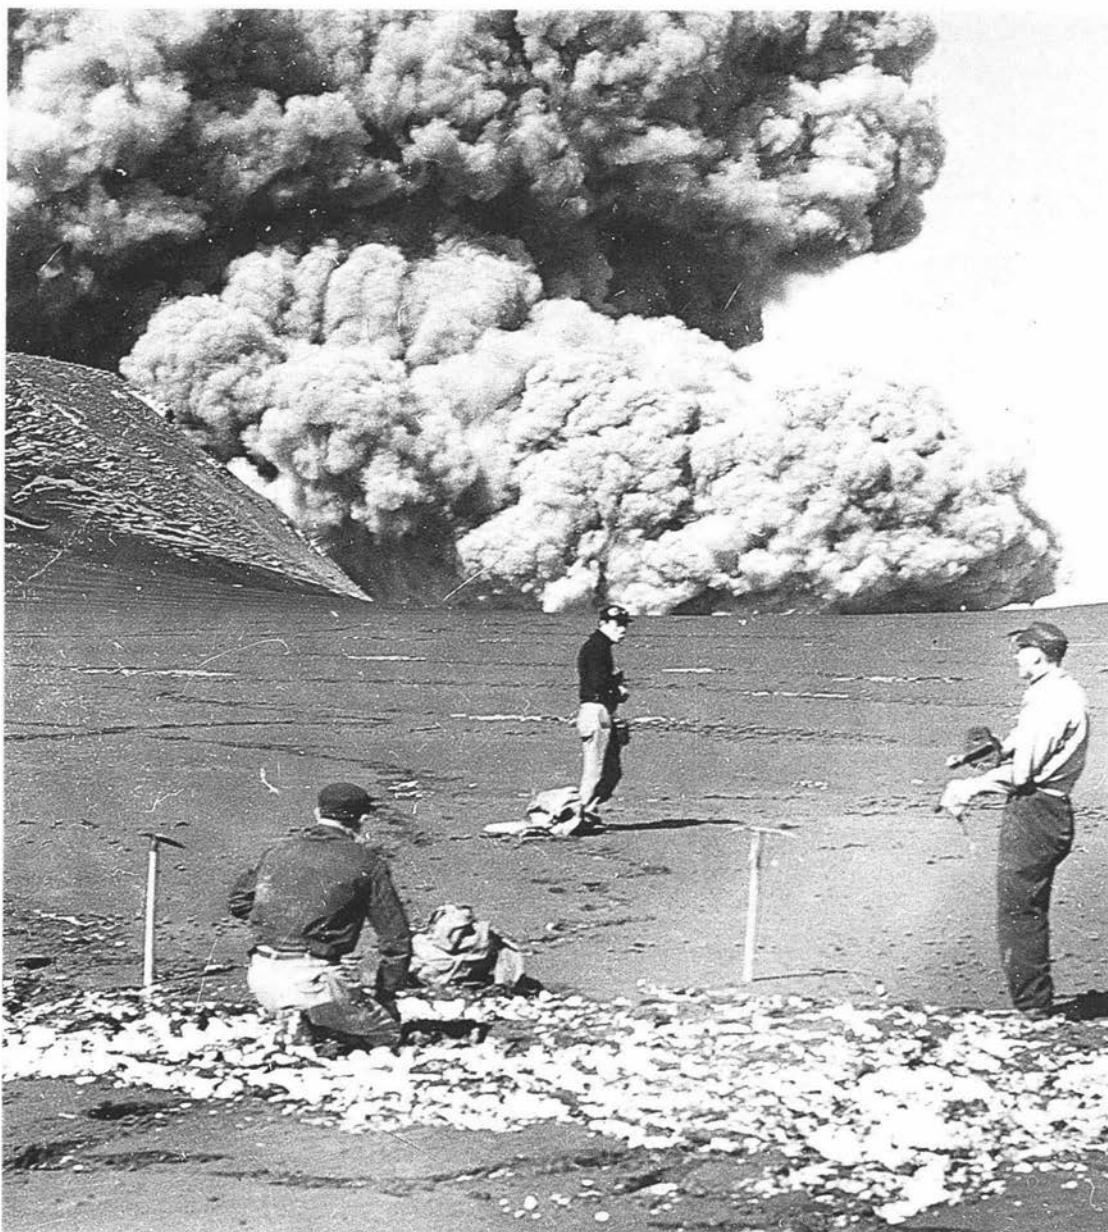
Above Photo: View of the ash and steam clouds issuing from the crater in August 1945. Photo taken from the col between Dome and Paretetaitonga. (Photo: GNS Collection)

Visitors to the crater area on 17 August described three vents: a main vent towards the eastern rim of the crater, emitting ash and steam, and two smaller steam vents to the west (see page 21). Intermittent explosions were observed ejecting ash, rocks and steam in columns that rose several thousand metres above the crater, often with lightning discharges within the rising plume. Activity appeared to reach a climax on 21-22 August.

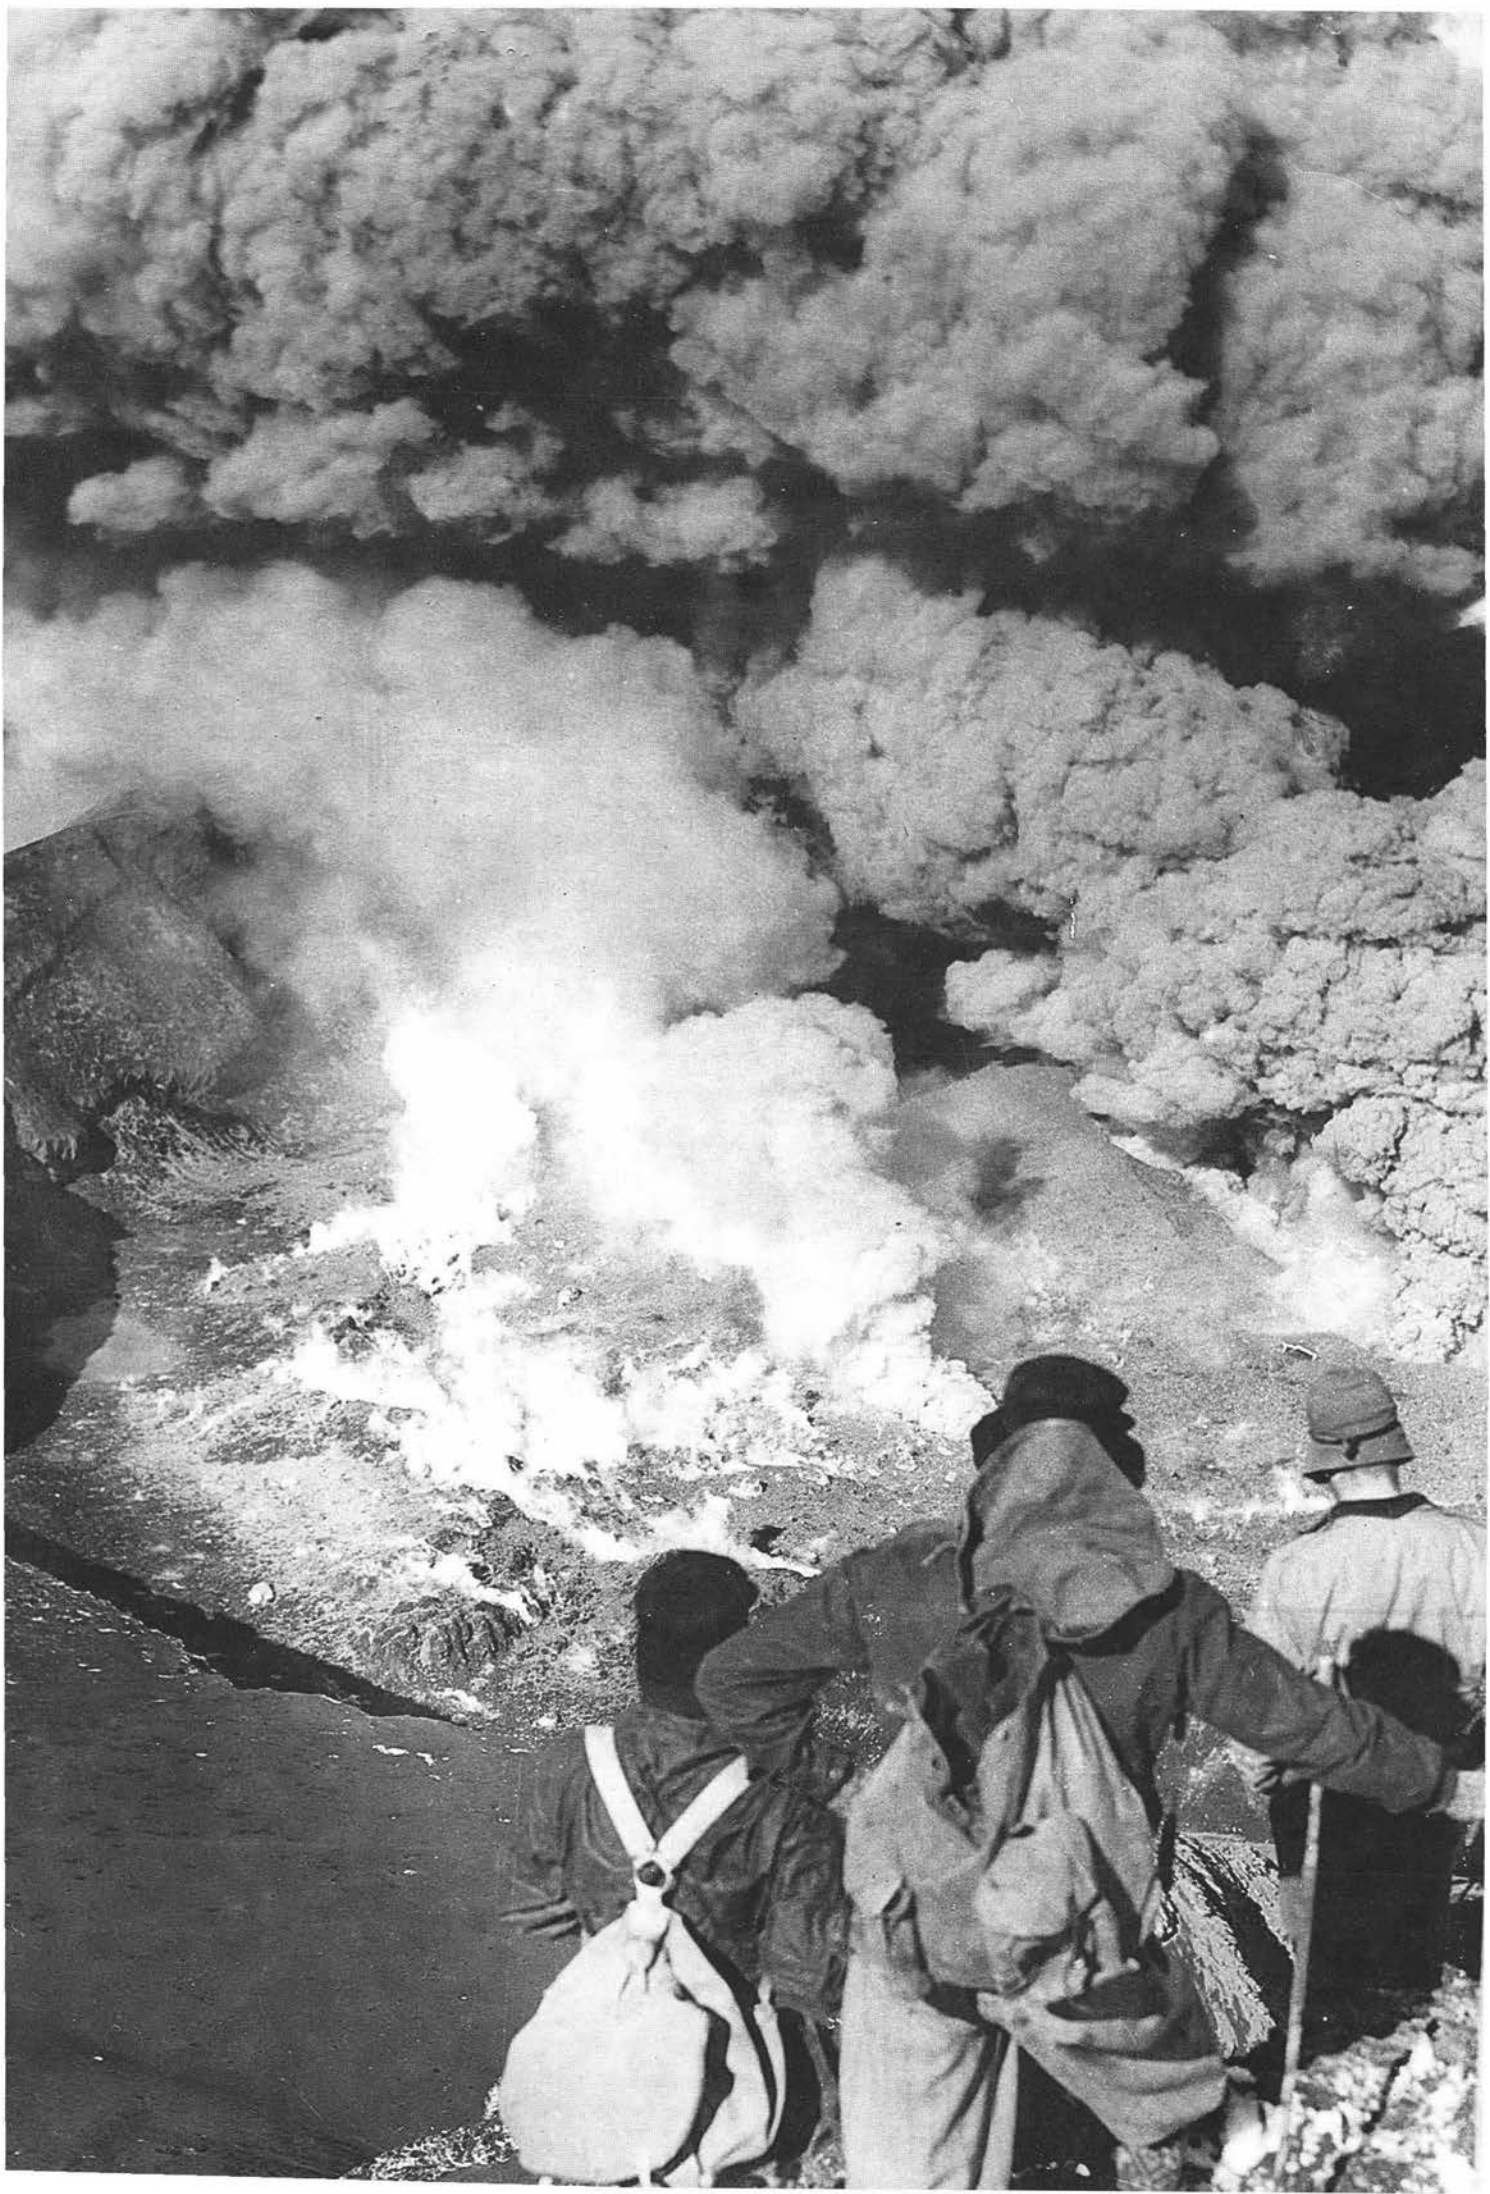
Right Photo: Climbers viewing the active crater of Ruapehu from the summit of Paretetaitonga in August 1945 (? 17 August). Note the large eastern vent (right) from which most of the ash and steam is being erupted. (Photo: GNS Collection)

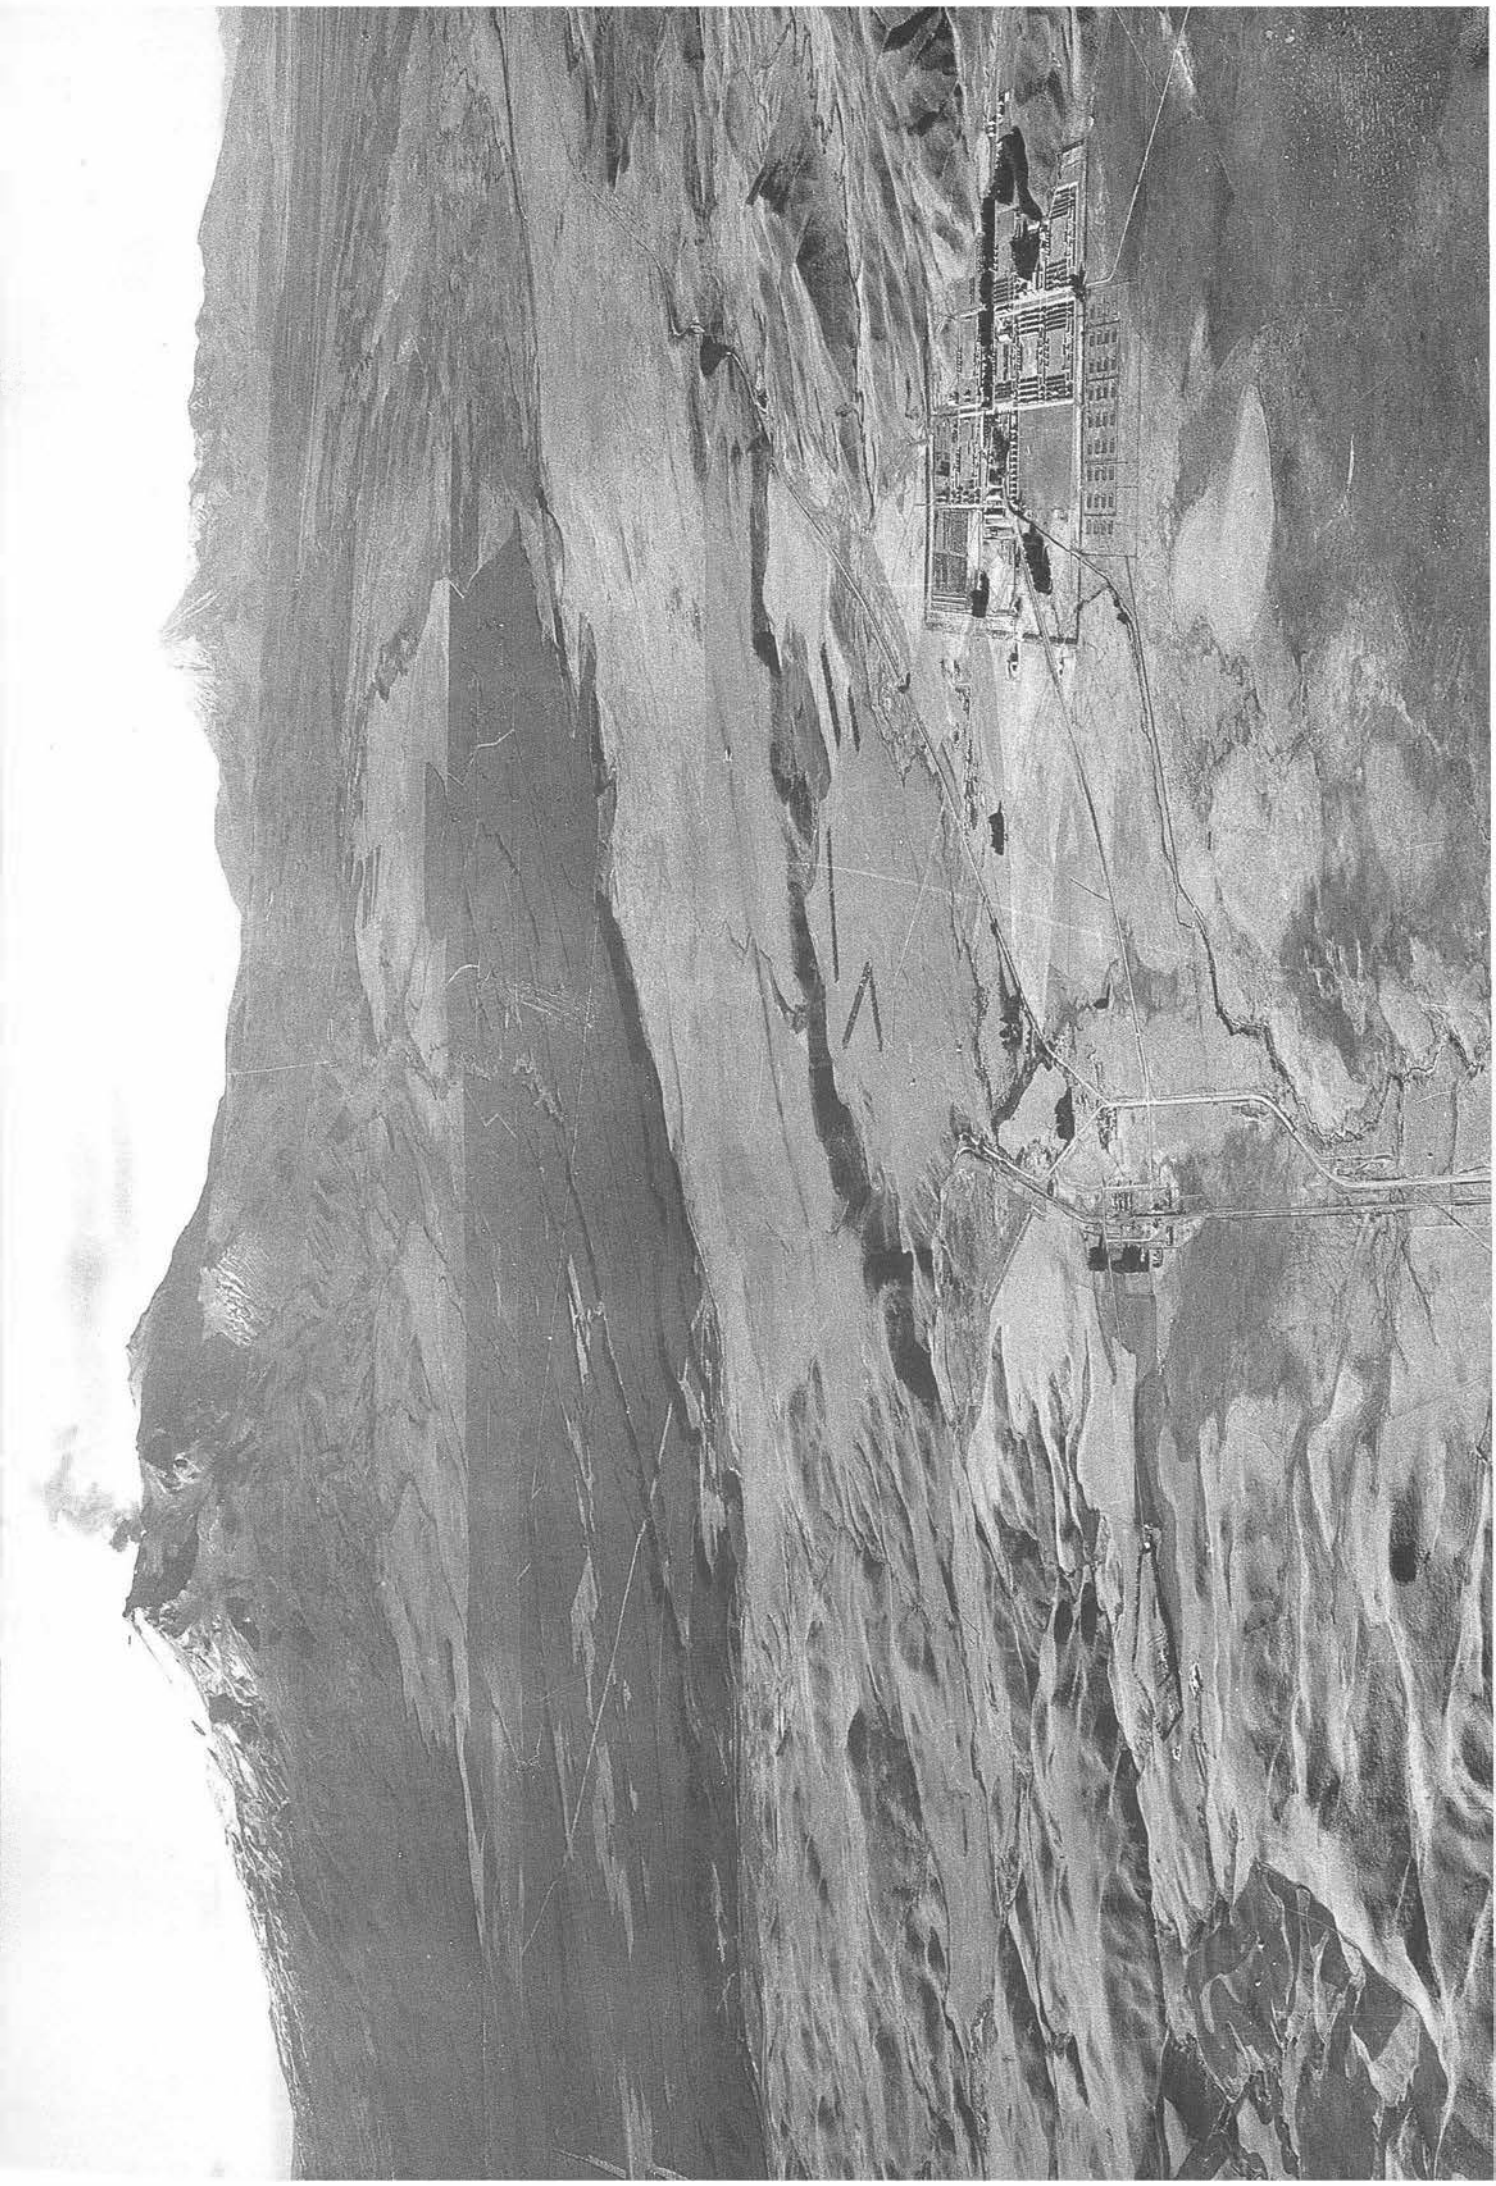
Right Photo: Ash and steam plume from Ruapehu on 16 October 1945 drifting to the northeast. Waiouru Military Camp is in the foreground. (Photo: NZ Aerial Mapping)

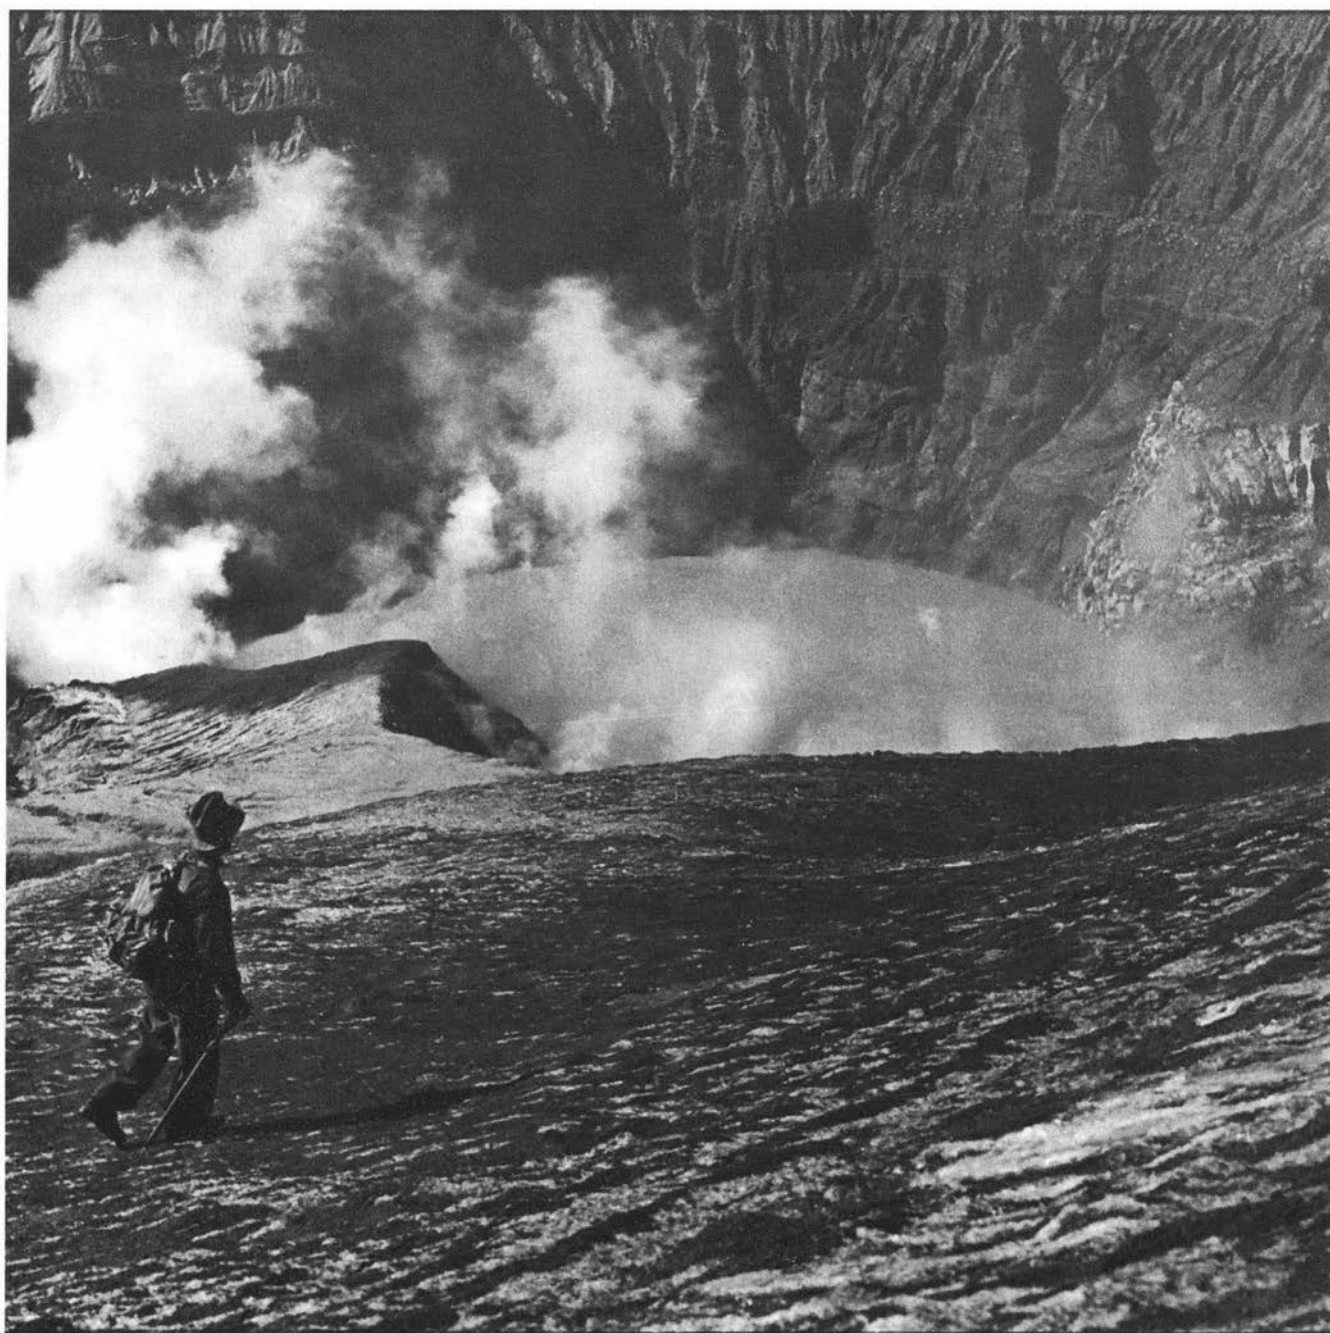
**Above Photo: Climber descending into the crater of Ruapehu on 30 March 1947.
(Photo: J.M.S. Beale Collection).**

When explosive activity ended the crater consisted of a steep-walled vent about 300 m deep, occupied by a boiling lake. The crater lake gradually refilled, and by 1949 it had returned approximately to its previous level.

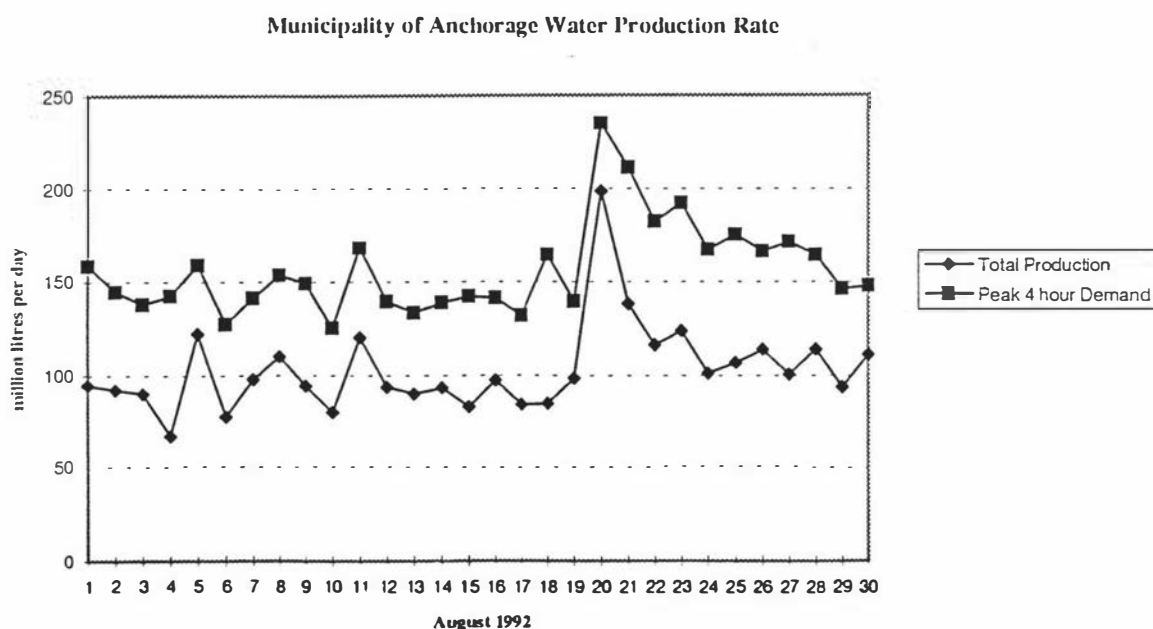
FIGURE A3.3 The August 1992 water production rate for the city of Anchorage. (Source: unpublished Anchorage Water and Wastewater Utility (AWWU) data)

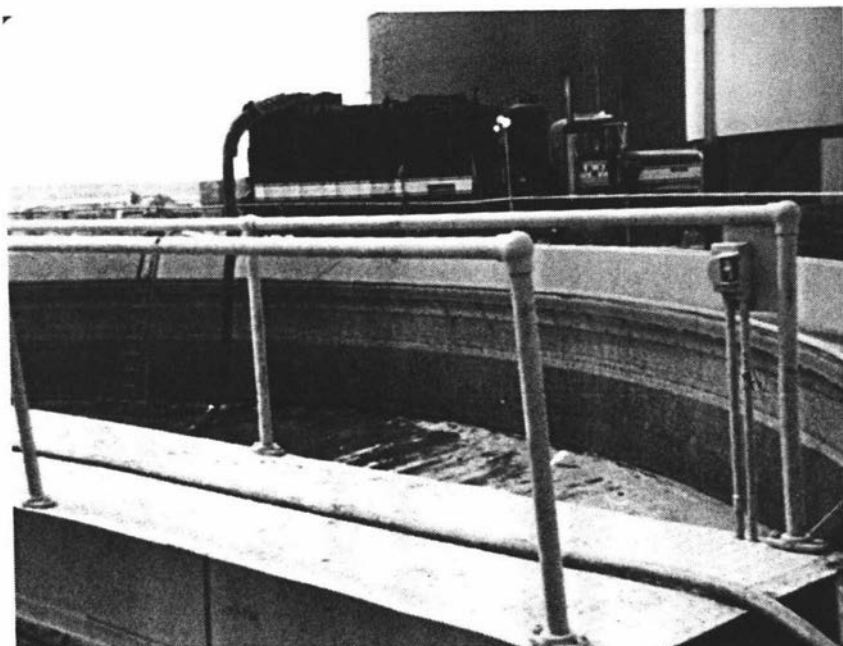
FIGURE A3.7 Ash being removed from the Yakima Sewage Treatment Plant
(*photograph: Public Works, City of Yakimay*)
