A HYDROLOGICAL COMPARISON BETWEEN TWO WATERSHEDS
IN POHANGINA COUNTY

A Thesis Submitted in Partial Fulfillment
of the Requirements for the Degree of
MASTER OF AGRICULTURAL SCIENCE
IN SOIL SCIENCE
at
MASSEY UNIVERSITY

by
Shirley Jean Rolston
1973

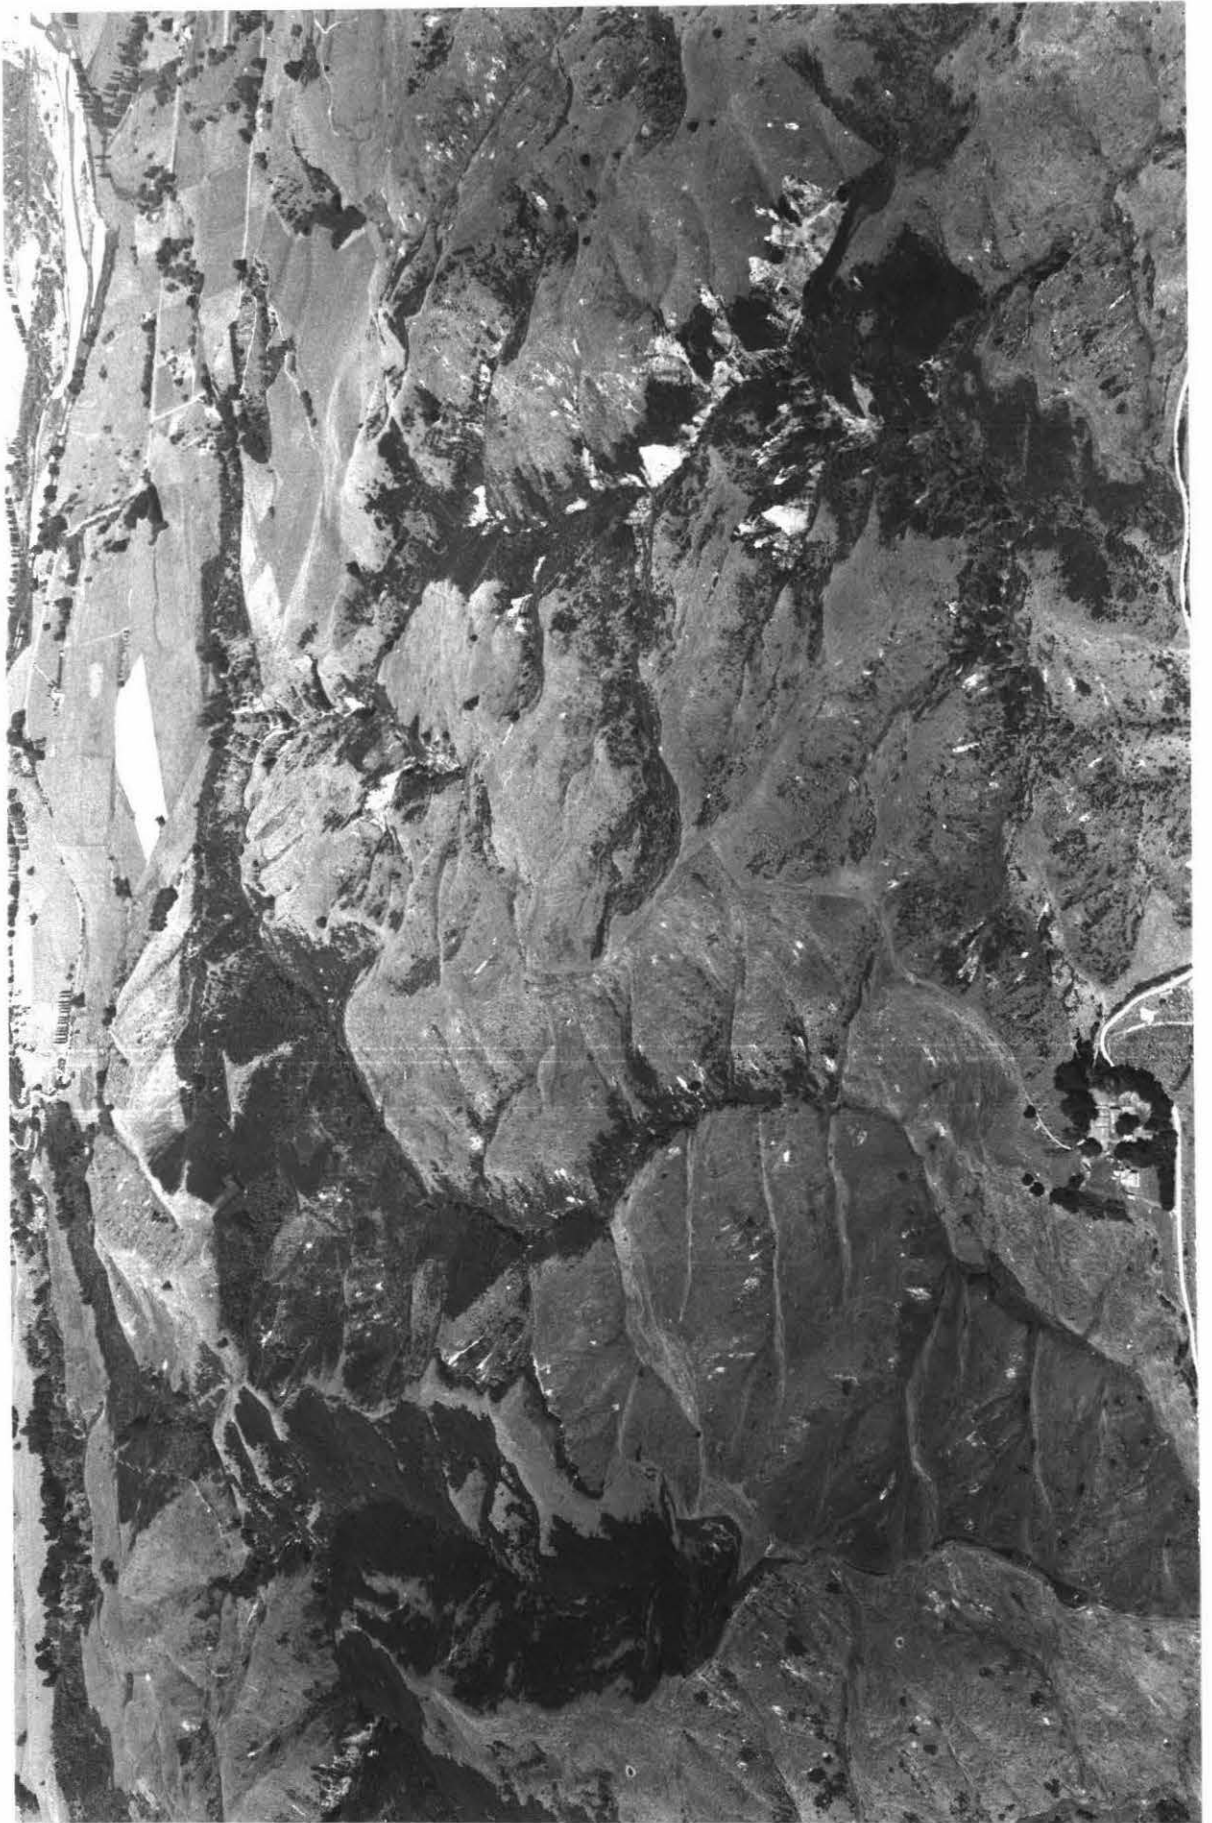
FRONTISPIECE - PLATE 1

Oblique Aerial View of Study Catchments from Ridge Road Looking
towards the Pohangina River
