Tsunami damage to coastal defences and buildings in the March 11th 2011 M_w 9.0 Great East Japan earthquake and tsunami

Stuart Fraser · Alison Raby · Antonios Pomonis ·
Katsuichiro Goda · Siau Chen Chian ·
Joshua Macabuag · Mark Offord · Keiko Saito ·
Peter Sammonds

Received: 8 September 2011 / Accepted: 8 March 2012
© Springer Science+Business Media B.V. 2012

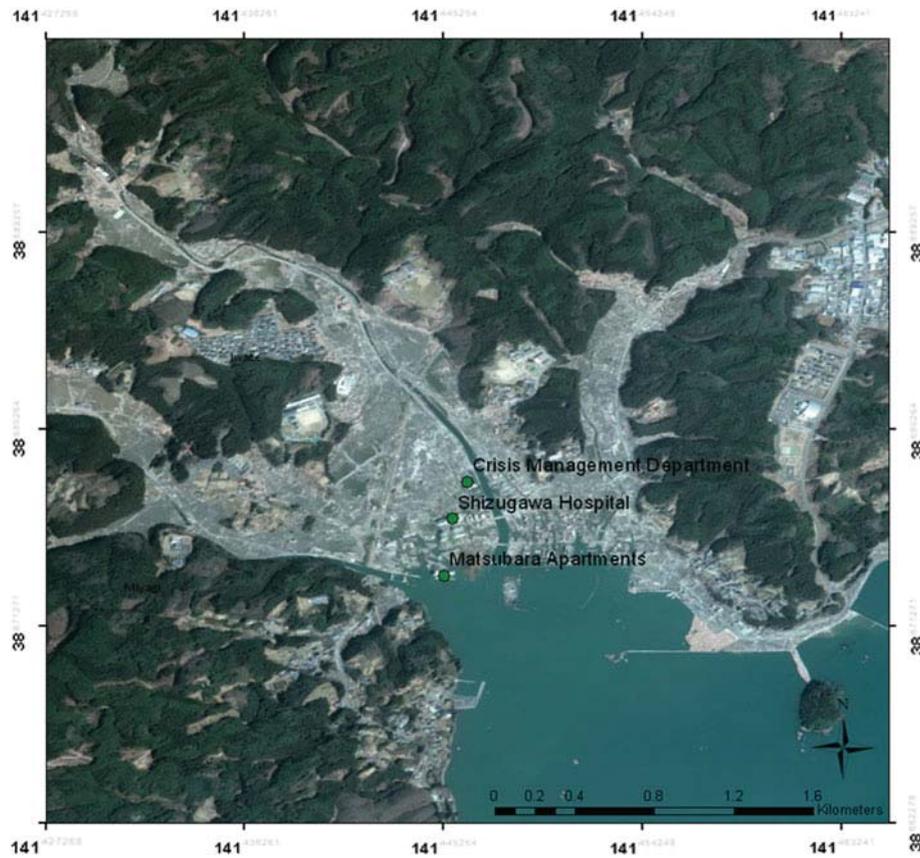
Minami-Sanriku Town is in a south-east facing bay at the junction of 3 river valleys (Fig. 10). The bay is broad, the mouth measuring 1.7 km across with little narrowing to the harbour front (1.1 km across) and further inland, where urban development extends to 1.5 km inland up the rivers. Despite less opportunity for wave amplification in this bay compared with some of the more narrow rias, tsunami height at the shore was estimated at 16 m (Take and Yamaya 2011) and observed by EEFIT to be at least 11 m at Shizugawa Hospital, 300 m inland. Inundation heights and inundation extent here far exceeded those experienced during the 1960 Chile event, or that expected from the anticipated offshore Miyagi-ken-oki earthquake (around M 7.4 with recurrence interval of <40 years). More than 82% of the town's population resided within the area that was inundated and the fatality rate in this area was 6.9% (Table 2; Geo-Spatial Information Authority of Japan 2011b; Japanese Ministry of Internal Affairs and Communications 2011).

The coastal defences in this town consisted of a sea wall and two flood gates across the two river channels; the concrete pillars of these gates remain standing although the attached steel operating components were washed away. Long sections of the tsunami wall collapsed and evidence of inadequate interlocking of adjacent blocks in the concrete sea walls was observed, with the blocks relying on self-weight for stability.

Steel frame buildings sustained heavy damage and EEFIT observed collapse of several 2- to 3-storey RC buildings from debris impact and significant scour. The 3-storey steel frame Crisis Management Department (CMD) building (38°40' 40.06" N, 141° 26' 46.82" E; 470 m from the harbour front) remained standing with heavy damage after being inundated to its roof at 10 m above ground level (Fig. 11).

Fig. 10 Satellite image showing Minami-Sanriku town in its coastal situation. Key buildings discussed in the text are marked: Crisis Management Department, Shizugawa Hospital and Matsubara community housing apartment block, also designated as a vertical evacuation building

Several large RC buildings, including vertical evacuation structures, survived but sustained moderate to heavy damage. In the area up to 500 m from the port front, almost all timber frame structures suffered collapse and many steel frame and RC structures sustained moderate to heavy damage (D2–D3). Several RC structures within 300 m of the coast suffered collapse due to extensive scour and/or debris strike (Fig. 12). The 4-storey RC Matsubara community housing apartment block at the harbour front ($38^{\circ} 40' 25.10''$ N, $141^{\circ} 26' 42.93''$ E; Fig. 13), constructed in 2007, was designated for vertical evacuation. The structure was built parallel to the harbour front in the longitudinal direction, which did not appear to have affected its structural performance despite inundation to the 4th storey and scour of the piled foundations to at least 2 m below previous ground level. The building was protected on the seaward side by a sea wall, which failed during the tsunami return flow; directly in front of this building this wall remained intact, but had failed where it was not sheltered in the return flow. Shizugawa Hospital ($38^{\circ} 40' 34.44''$ N, $141^{\circ} 26' 44.99''$ E; Fig. 14) is a 4-storey RC shear wall construction with steel bracing, and showed significant non-structural damage from debris impact including parts of the steel bracing.

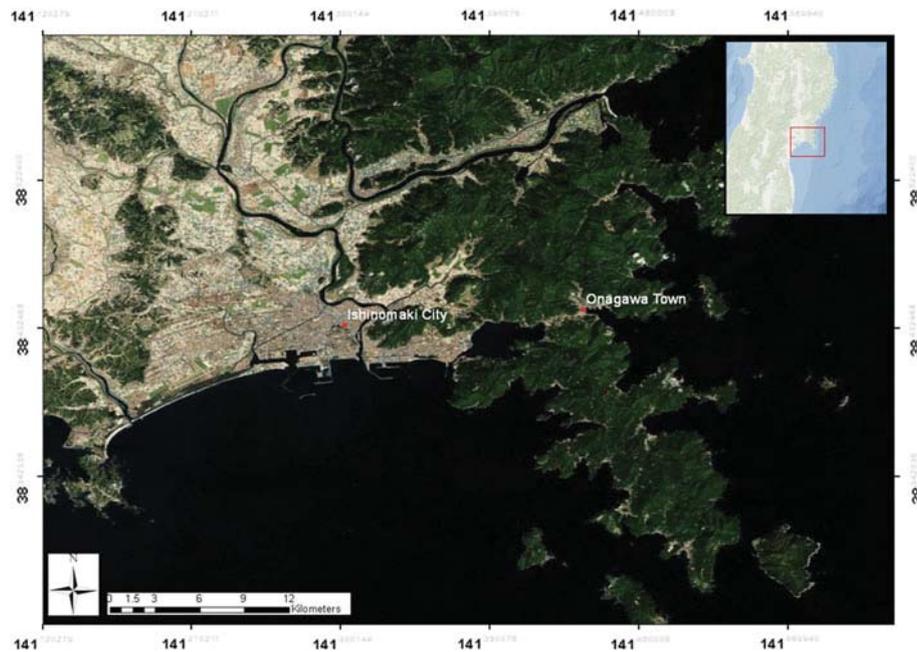
Onagawa Town is situated in a narrow valley exposed to the Ocean to the east, with an estuary at the western end of the valley (Fig. 15). Maximum inundation depths here exceeded 16 m due to flow from the east. The town suffered a high fatality rate (11.9% of the population living in the inundated zone, see Table 2), which was greater than the rate in Minami-Sanriku for a similar level of population in the inundated area, and similar magnitude of tsunami inundation height. These figures suggest important differences in evacuation response between these towns.

Onagawa Town provided some of the most unexpected observations of this event: 5 RC shear wall buildings and 1 steel frame building, all of 2- to 3-storeys height, were overturned and moved from their original positions during the tsunami (movement indicated by arrows in Fig. 16). This type of failure had not been previously observed for RC shear wall or steel frame buildings subject to tsunami loading. The aspect ratio of these buildings may have been

Fig. 15 Satellite image showing Onagawa Town and Ishinomaki City, showing the transition between plains coastline to the west and rias to the east. Figure 16 shows a close up of the eastern harbour of Onagawa Town

higher than other nearby buildings and all had a small building footprint. Some had piled foundations, others were on raft foundations—descriptions of each building are provided below. Witnesses described that the 1st incoming wave knocked over these buildings (Read 2011). Potential explanations for the overturning of these structures are offered below.

Ishinomaki is the 2nd-largest city in Miyagi Prefecture and has approximately 12 km of south-facing coastline (Fig. 15), much of which is dedicated to warehouses and industrial sites associated with the fishing port and commercial port. Inland of the ports, the densely built-up urban area extends 4.8 km inland at its furthest point; the 400 m closest to the harbour is commercial and industrial land use, with residential and smaller commercial land use further inland. The death toll in Ishinomaki City was the highest of all tsunami affected cities and towns and as of August 25th 2011, stood at 3,158 dead and 849 missing (Fire and Disaster Management Agency of Japan 2011). This was a relatively low fatality rate of 3.6% relative to the population living within the inundated area, when compared to other locations which also had 70–80% of the population was living in the inundated area (i.e. Rikuzentakata, Ōtsuchi, Onagawa, and Minami-Sanriku).
