**GRAPPLING WITH COMPLEXITY:
FINDING THE CORE PROBLEMS BEHIND
AIRCRAFT ACCIDENTS**

A thesis presented in partial fulfilment of the requirements for the degree of
Doctor of Philosophy in Aviation

Dmitri Victorovitch Zotov

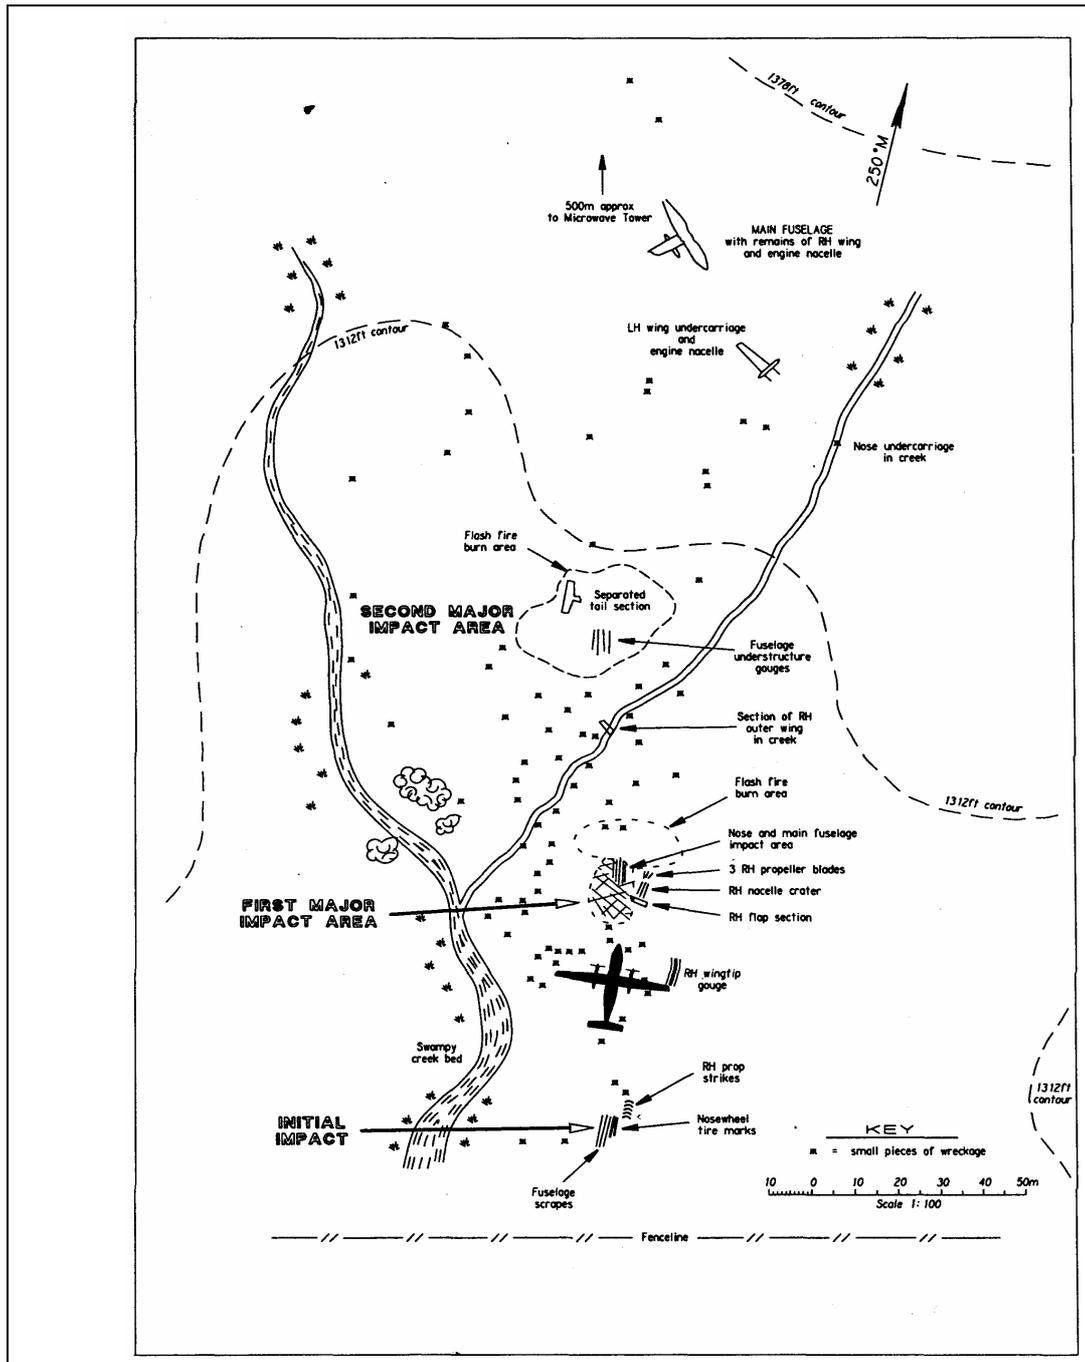
Figure 22. Ansett Dash 8 impact diagram. Source: TAIC. (1995). *De Havilland DHC-8, ZK-NEY controlled flight into terrain near Palmerston North, 9 June 1995* (Aircraft accident report No. 95-011). Wellington: Transport Accident Investigation Commission.

Some 42 metres further on, the right wingtip gouged the ground for 7 metres; 28 metres further yet, the fuselage and right engine nacelle struck a terraced spur which had a local upslope of 30 degrees (see Figure 22). The aircraft lofted, and there was a flash fire. Some 60 metres further on, the aircraft struck the ground again. About half way between the two major impact sites, a portion of the outer part of the right wing was found on the centreline of the wreckage trail, and the empennage was found adjacent to the second major impact site.

During the second major impact the entire left wing assembly separated from the fuselage and slid inverted a further 200m. The fuselage and loosely attached right wing root and nacelle "continued uphill until brought to rest against a bank on the hillside, having traversed a total distance of about 235 metres from initial impact. The fuselage was slewed through some 150 degrees, and lay across the slope on a heading of 040 degrees magnetic partially rolled on its side, at an elevation of 1345 feet amsl." (1.12.17, p. 36).

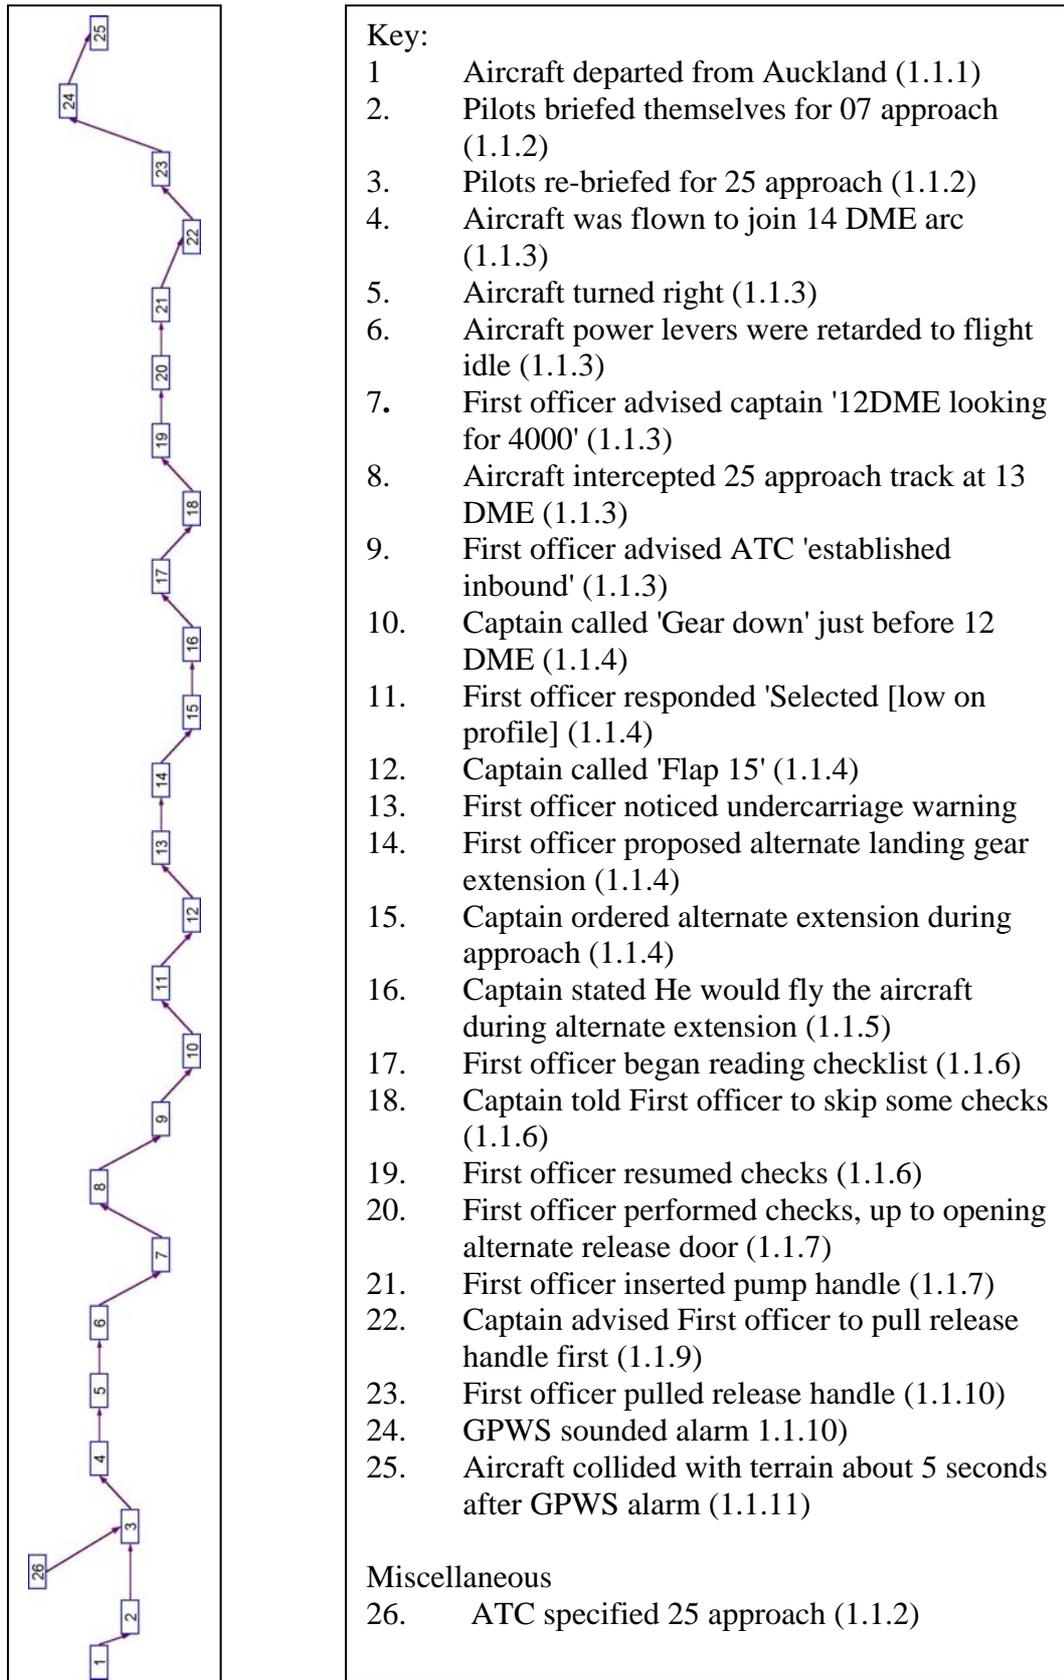
Figure 23. Events from 1.1 (History of the flight)¹³

The ambiguity which can arise from compound words is evident ("the pilots briefed themselves": in reality, one briefed the other, as indicated in the CVR transcript (TAIC, 1995 (Annex B), Appendix C, p. 111 et seq.)), but it could be argued that at this point, precisely what happened during the briefing sequence is immaterial. However, the ambiguity arising from the use of passive tense could potentially be relevant at other times, for example "the aircraft power levers were retarded" raises the questions "by whom?" and "was this the normal power setting?" Certainly the aircraft was not the actor, nor did the levers retard themselves. The 'mental movie' is incomplete at this point. (It would be reasonable to infer that the Captain retarded the throttle levers, as he was the handling pilot, and he gave no instruction to the co-pilot to do so).

Constructing the graph also brings to light out-of-sequence statements in the report: 1.1.3 (p. 7) "The aircraft...intercepted the final approach track." "During the... turn ... the aircraft's power levers were retarded ". While there is no ambiguity, out of sequence statements make the report harder to read.

In the sequence relating to the undercarriage malfunction, the Captain's call of 'gear down' did not result in the First Officer's warning 'low on profile', and the Captain's call for 'flaps 15' did not cause the First officer to notice an undercarriage warning (refer Figure 23). As with the section relating to the GPWS, additional information must be sought. The nosewheel was down at impact (1.12.11, p. 35), indicating that the First Officer not only responded to the Captain's call, but also selected the undercarriage lever to the down position. However, the First Officer's warning 'low on profile', was unrelated to his action of lowering the undercarriage.

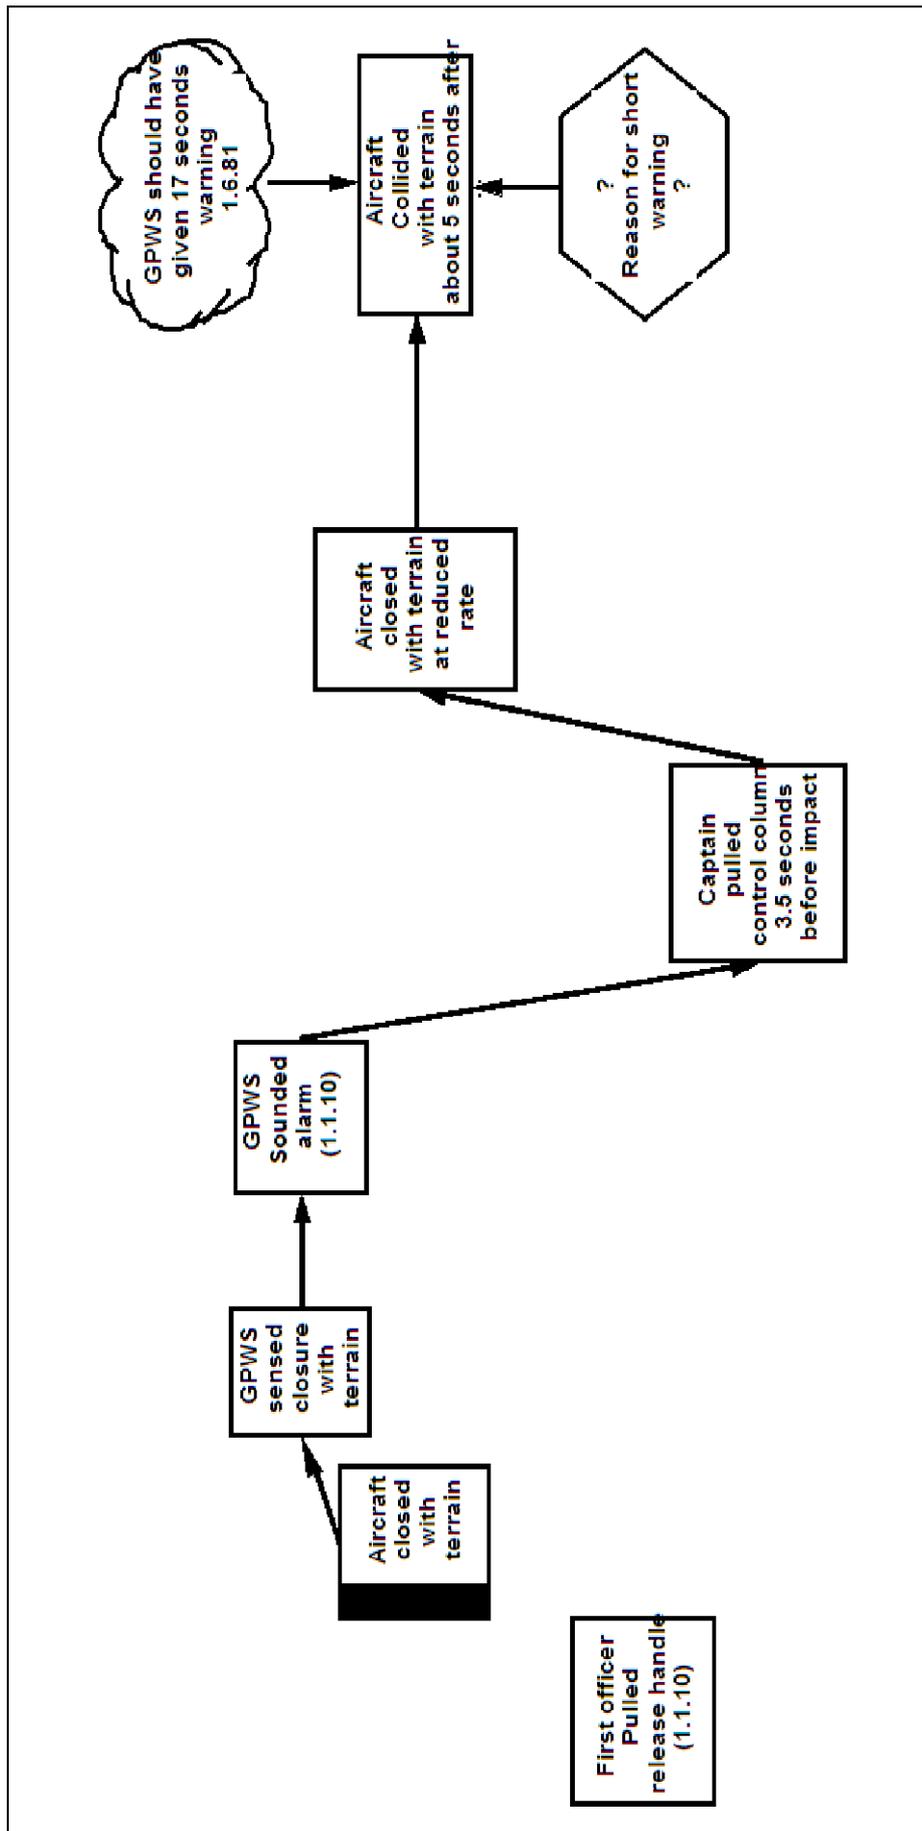
Figure 24. Ground proximity warning.

The GPWS operated in a variety of modes depending on the aircraft configuration, using inputs from the air data computer and radio altimeter, and if applicable the glidepath indication (not relevant in this case) (1.6.67, 68 (p. 20)). The mode applicable in this case was Mode 2A, excessive rate of closure with terrain, and 17 seconds of warning should have been provided in the particular circumstances (1.6.81, p. 23). The cockpit voice recorder (CVR) showed that terrain warning occurred about 5 seconds before impact (1.6.69, p. 21), and the digital flight data recorder (DFDR) showed that 3 1/2 seconds before impact there was a nose-up elevator input and corresponding change of pitch attitude (1.6.70, p. 21).

The captain was the handling pilot, and in view of the very rapid response to the GPWS warning it may be inferred that it was he who applied the nose-up input. So the final section of the MES graph may be re-drawn as in Figure 24.

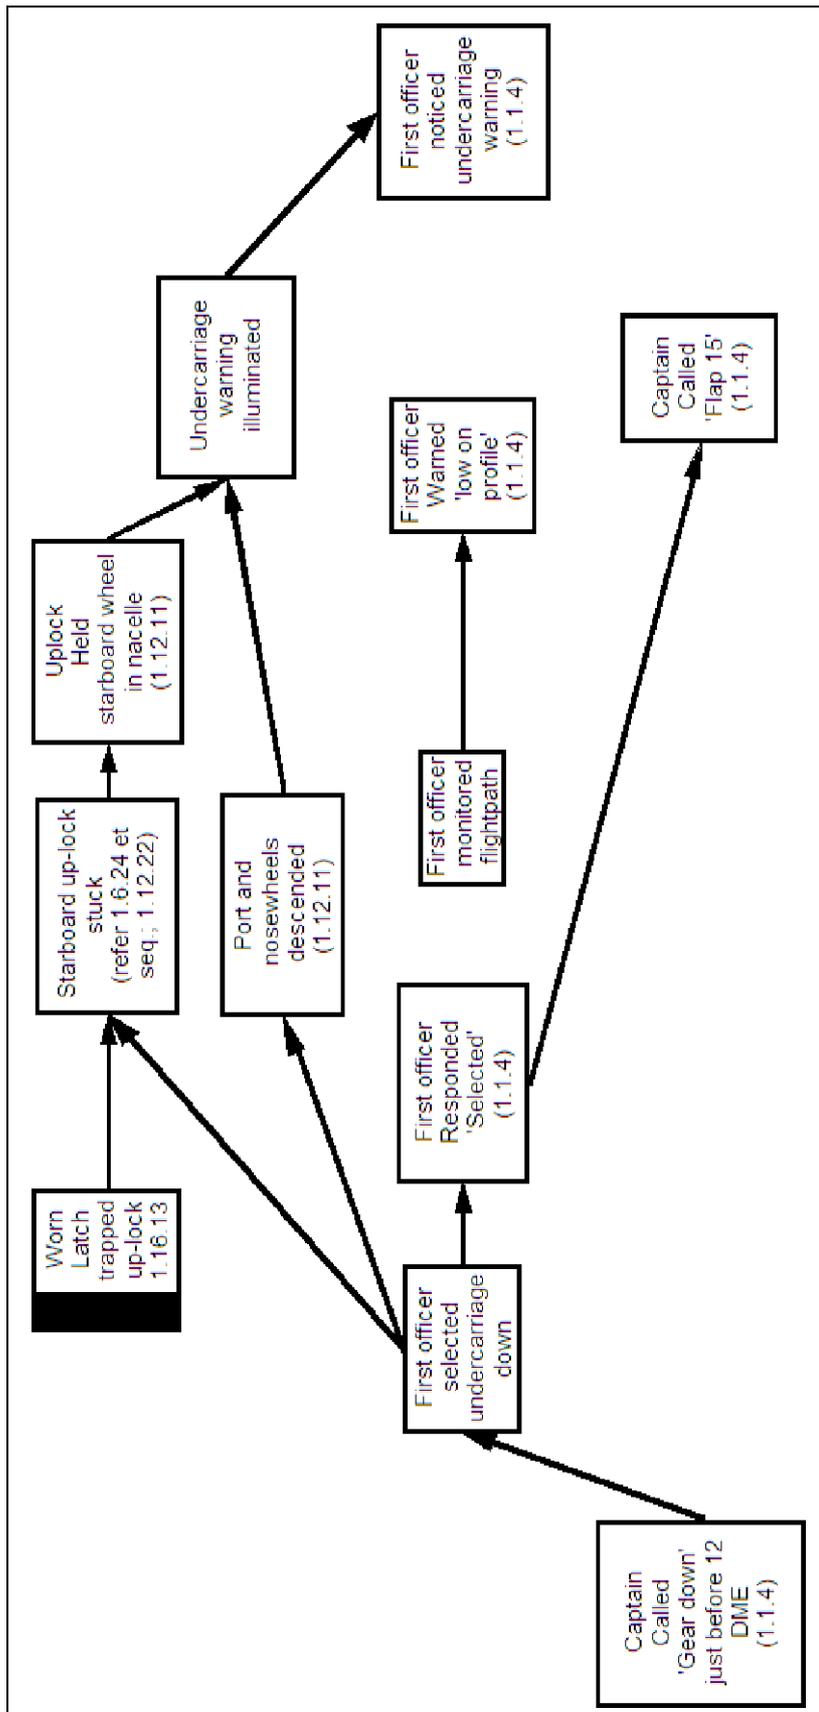
Figure 25. Undercarriage malfunction.

It implies that he was monitoring the approach path, and that the aircraft had descended below the optimum descent path at this point. The Captain's call for 'flaps 15' (i.e. select 15 degrees of flap deflection) was the logical consequence of the First Officer's response to the 'gear down' call, because this was the next action required to configure the aircraft for landing. But again, the detection of the undercarriage warning by the First Officer is unrelated to the 'flaps 15' call; it is a consequence of the right undercarriage leg remaining retracted after the undercarriage had been selected down. This section of the graph is shown in Figure 25.

From Figure 25, it can be seen that there were four streams of events going on in parallel: hence '*Multilinear* Events Sequencing'. Although 'left and nose wheels' is a compound actor, this does not give rise to any ambiguity. The EBBs and linkages now meet the logical requirements.

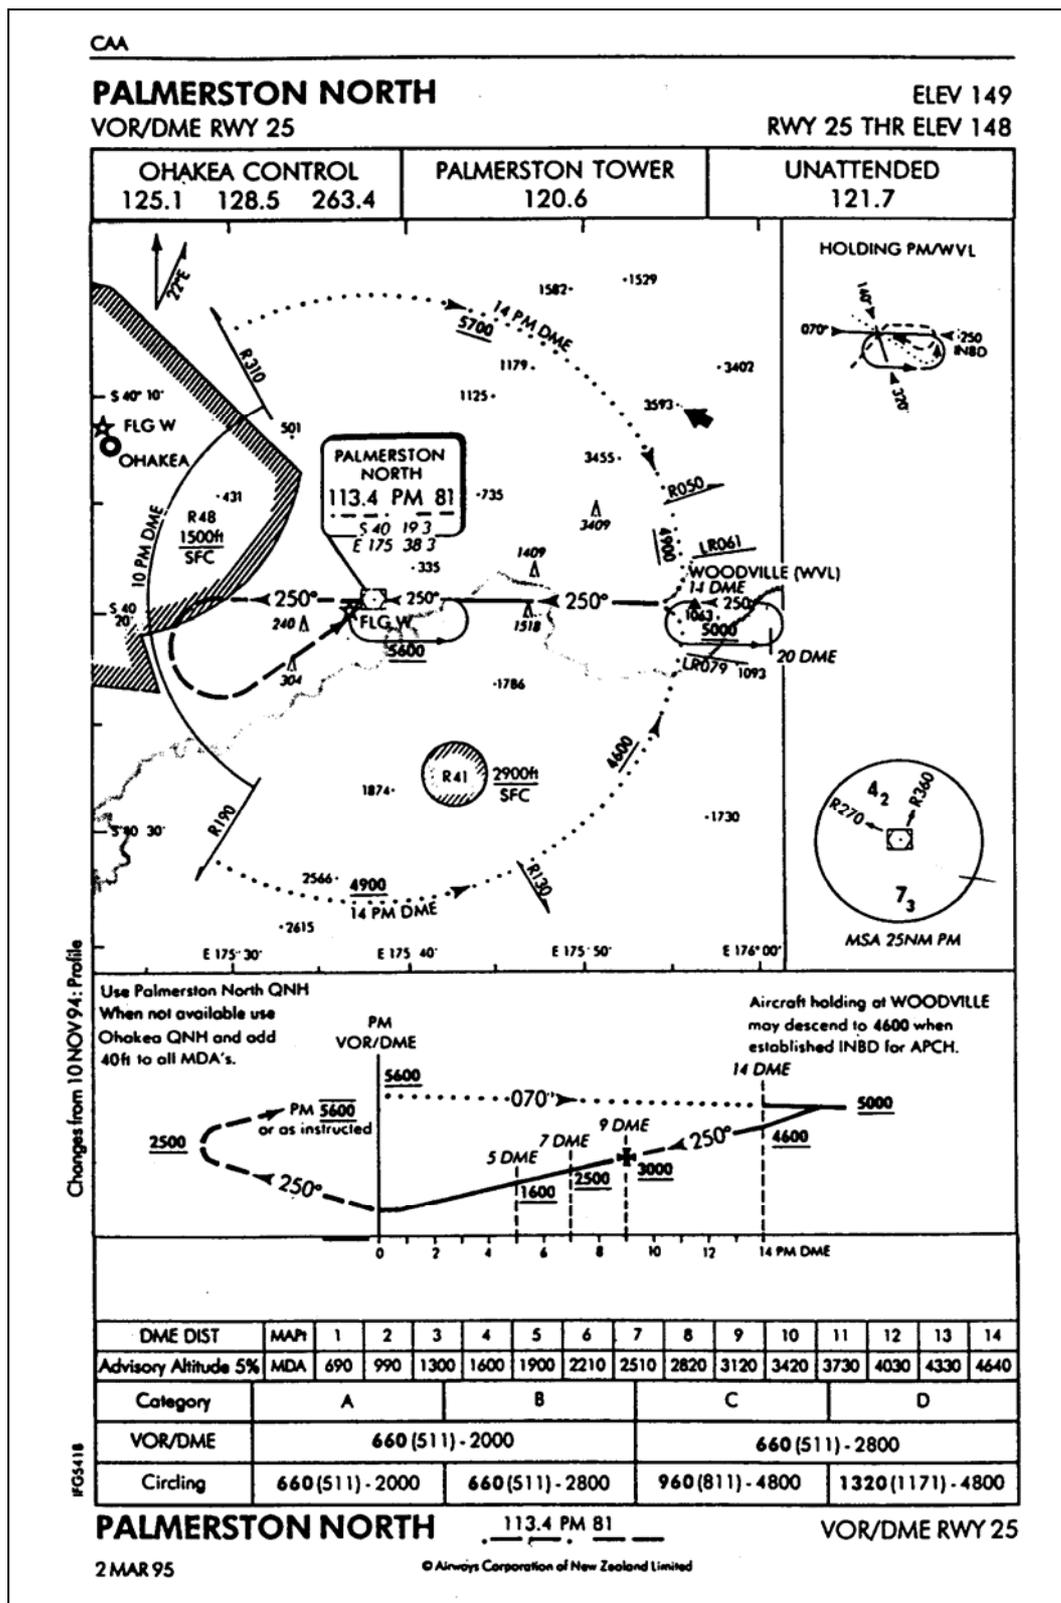
Figure 26. Palmerston North Approach Plate. Source: TAIC. (1995). *De Havilland DHC-8, ZK-NEY controlled flight into terrain near Palmerston North, 9 June 1995* (Aircraft accident report No. 95-011). Wellington: Transport Accident Investigation Commission.

However, according to the vertical profile shown in the Report (Fig. 3, p. 28) the aircraft was at 3100 feet at ten miles DME. According to the Palmerston North Approach Plate (Figure 26) the optimum height at 10 DME was 3420 feet, so the aircraft had just crossed the optimum descent path. 3120 feet was the optimum height at 9 DME. While the First Officer was correct in saying the aircraft was 'a fraction low', the reference to 4000 feet had the potential to be confusing. (The consequences of this will be discussed later, when examining the Why-Because Analysis of this accident). The next stage in the sequence was the attempt to lower the right wheel by means of the alternate procedure.

However, according to the vertical profile shown in the official report (Fig. 3, p. 28) the aircraft was at 3100 feet at ten miles DME. According to the Palmerston North Approach Plate (Figure 26) the optimum height at 10 DME was 3420, so the aircraft had just crossed the optimum descent path. 3120 feet was the optimum height at 9 DME. While the First Officer was correct in saying the aircraft was 'a fraction low', the reference to 4000 feet had the potential to be confusing. If the Captain's attention was focussed on the 'hundreds of feet' hand, he may have believed the aircraft to be one thousand feet higher than in fact it was.

Why did the approach require an initial steep descent? The final part of the DME arc up to the lead-in radial had a minimum altitude of 4900 feet (Figure 26). Assuming the turn onto final approach could be completed and the aircraft established inbound by 12 nautical miles (n. m.) DME, where the glidepath altitude was 4030 feet, the aircraft needed to lose nearly 900 feet while making the turn. The aircraft reached the lead-in radial at 4900 feet (Figure 3, p. 28 in the official report), and so was on profile at this point. However, during the turn the descent was stopped at 4700 feet, and the aircraft was some 500 feet high on completion of the turn. Why did the pilot stop the descent, and so find himself above the glidepath? The reason appears in the CVR transcript at 09:11:42 (p. 116), where the crew were re-briefing themselves for the (unanticipated) approach to runway 25:

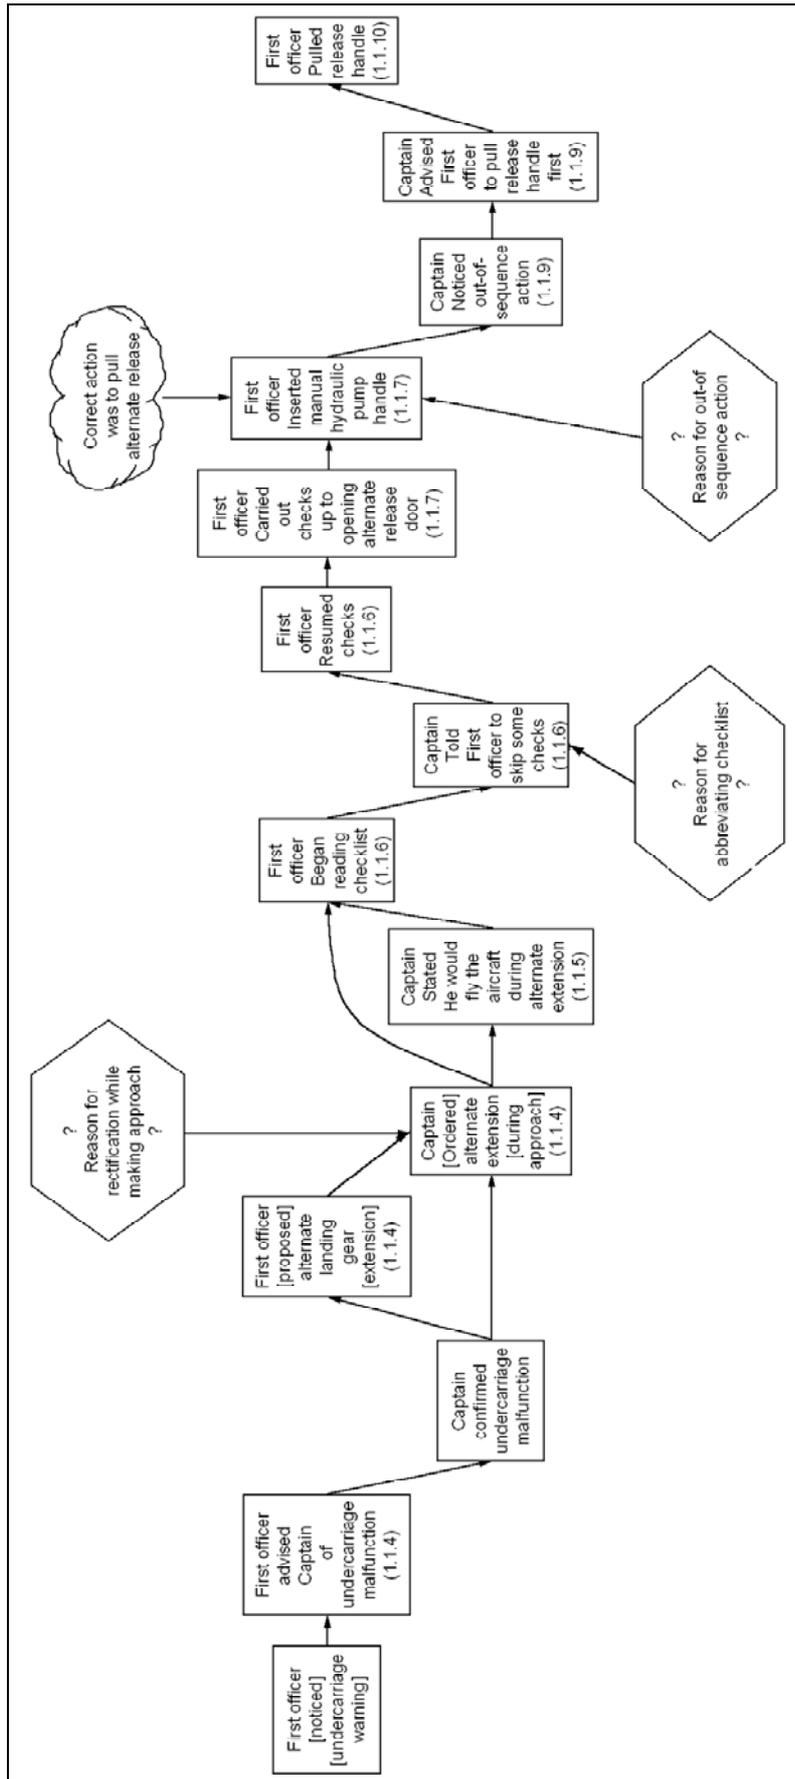
Figure 27 Alternative Undercarriage Selection.

While the EBBs in the sequence relating to the use of the alternate undercarriage extension method follow logically from one to the next in Figure 23, some additional information is necessary. It is necessary to know why the Captain ordered the First Officer to omit some checks, and why the First Officer performed actions out of sequence. Also, it would be helpful to know why the Captain decided to attempt to rectify the problem while continuing the approach (see Figure 27).

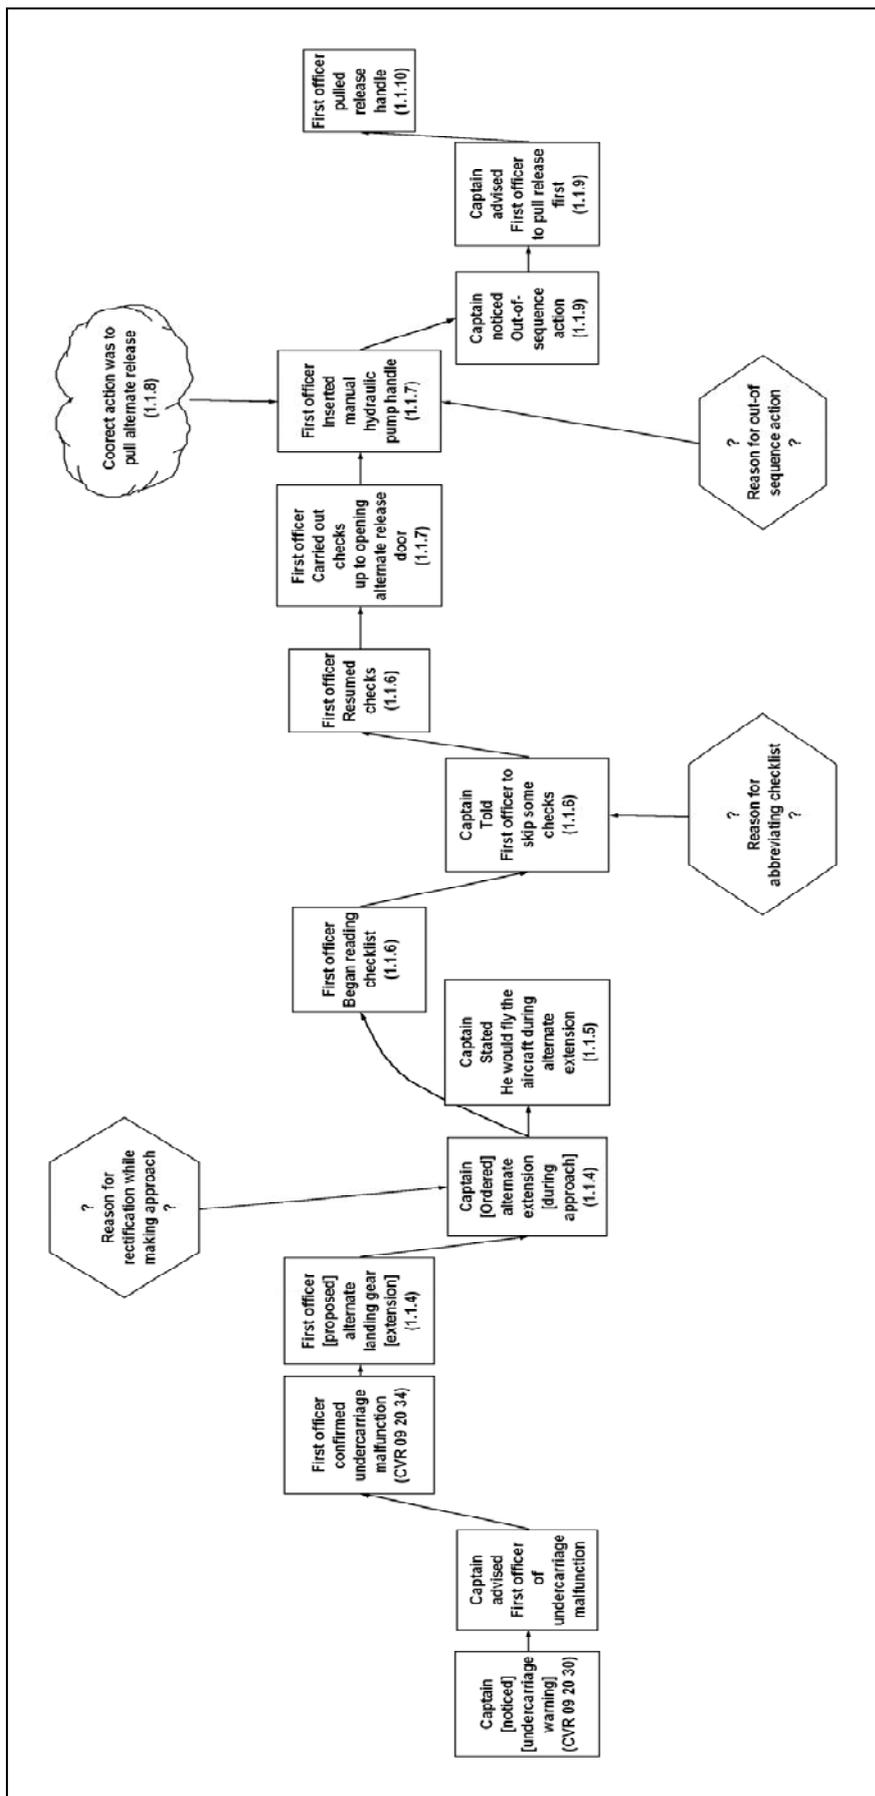
Figure 28. Alternate undercarriage selection (modified).

The first and third boxes in the time sequence have no paragraph references; they are necessary inferences from the material in the report, rather than direct references. However, supporting evidence should be available in the CVR transcript, Appendix C. Appendix C (p. 128; 09:20:30 et seq.) shows that the sequence in 1.1.4 (p. 7) is misleading. It was the captain who observed the undercarriage warning ("Oh #") and then whistled, before the First Officer noticed it. So the MES graph must be modified as in Figure 28.

Although a minor matter, this change illustrates the use of MES as a quality control measure for checking an existing report. MES would function in exactly the same way if used to check the work during the preparation of a draft.

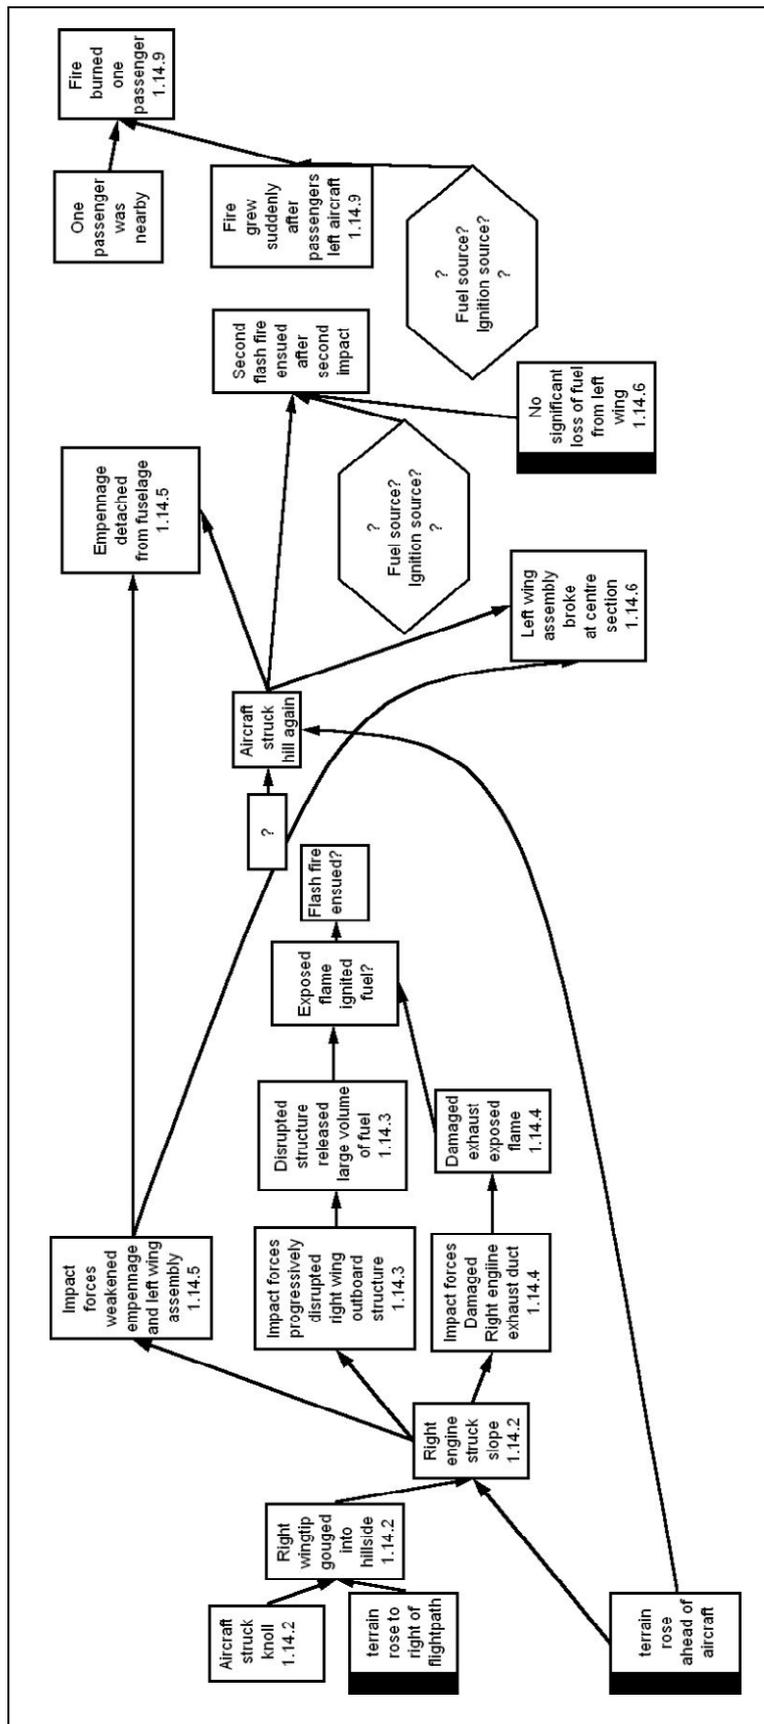
Figure 33. Fire sequence.

The fire sequence is shown, in MES format, in Figure 33. Three weaknesses in the report are evident from Figure 33 relating to weakening of the structure, burns to a passenger, and the second flash fire.

A further limitation in the report is shown by the inconsistency between Figures 32 (the impact sequence) and 33 (the fire sequence). Figure 32 indicates that, for a short period after rebounding from the knoll, the right wing tip scraped the ground, and then the aircraft struck the ground again with the fuselage and the right engine. This is not at all the same as the progressive impact described in Figure 33 - right wing tip, right wing and engine - producing the progressive disruption of the right wing structure alluded to in 1.14.3 (p. 39). While the impact description in section 1.14 would account for the disruption of the integral tanks and so the flash fire, Figure 5 in the report (the wreckage diagram) shows that the description in Figure 32 is accurate. Accordingly, the impact sequence in Figure 33 is wrong. The scrape by the right wing was a transient affair; loads on the wing would have been minor and in-plane, and unlikely to have caused significant damage. The subsequent impact was taken by the right engine, and the belly of the aircraft. Although the engine struck the ground sufficiently hard to damage the engine, the underside of the outer right wing, found further along the wreckage trail, did not display evidence of a major impact. The detachment of the wing, and the fire, remain to be explained. Further evidence must therefore be sought. This will be discussed later, in 'evidence from the wreckage'.

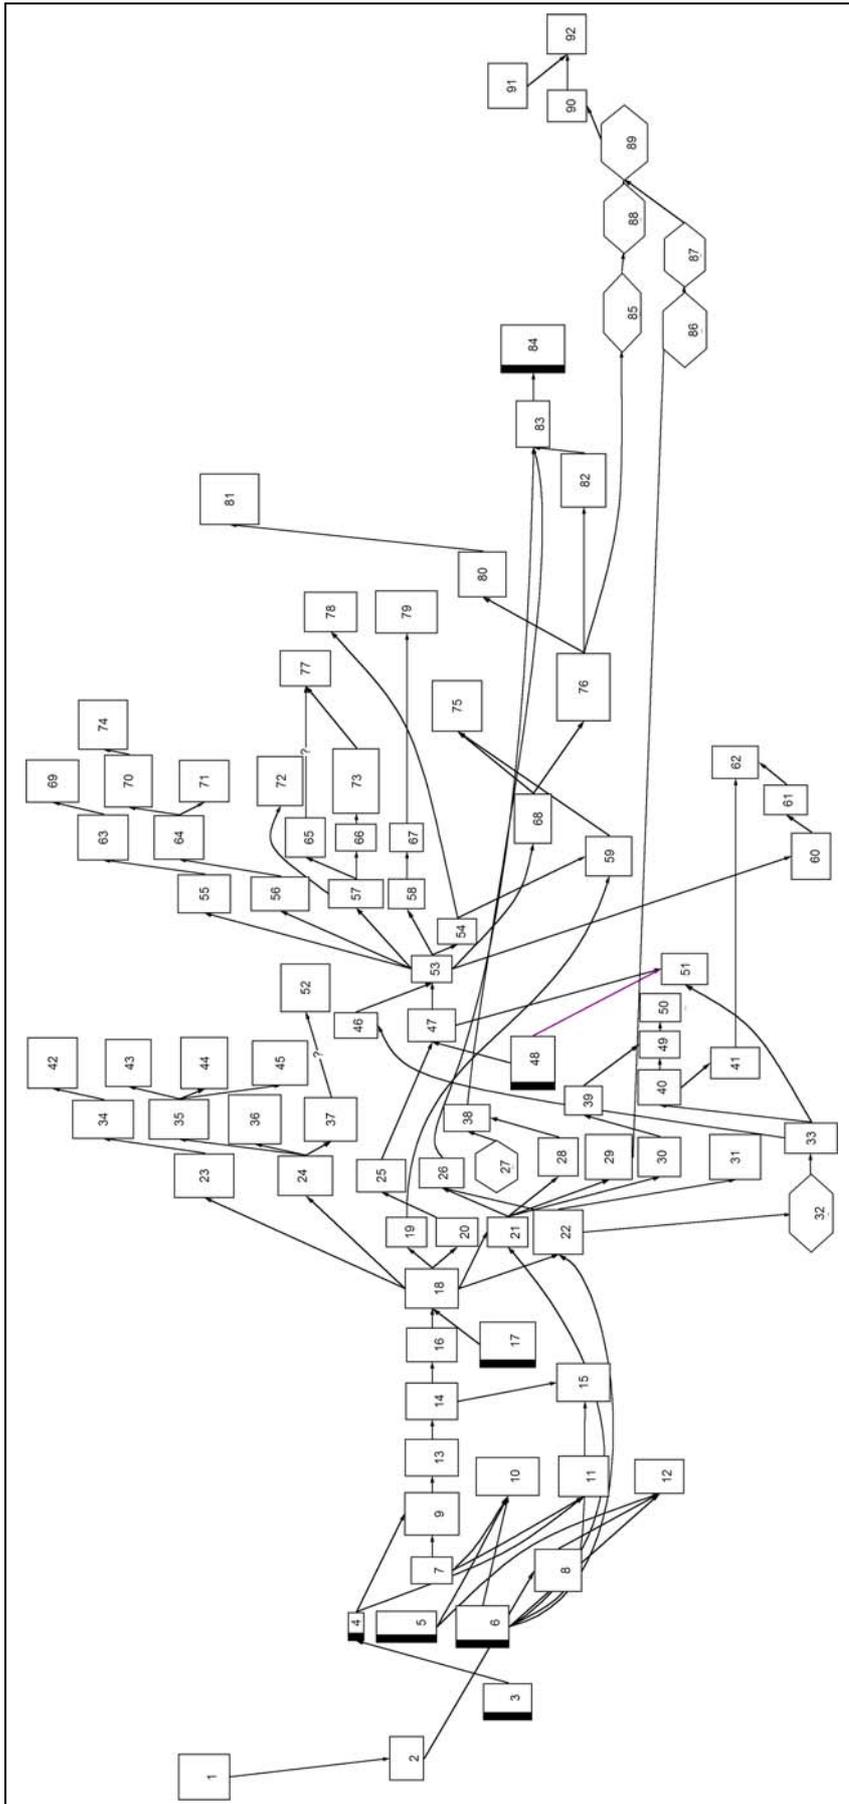
Figure 46. Complete MES Graph using all available information.

The completed MES graph, showing the overall picture of the impact sequence, is shown in Figure 46. It is formed by correcting the various boxes with the information derived from the evidence already discussed. For example, the box containing 'upright impact' in Figures 32 and 37 is amended to 'inverted impact' in Figure 46, and concomitant changes to the causes of injuries follow.

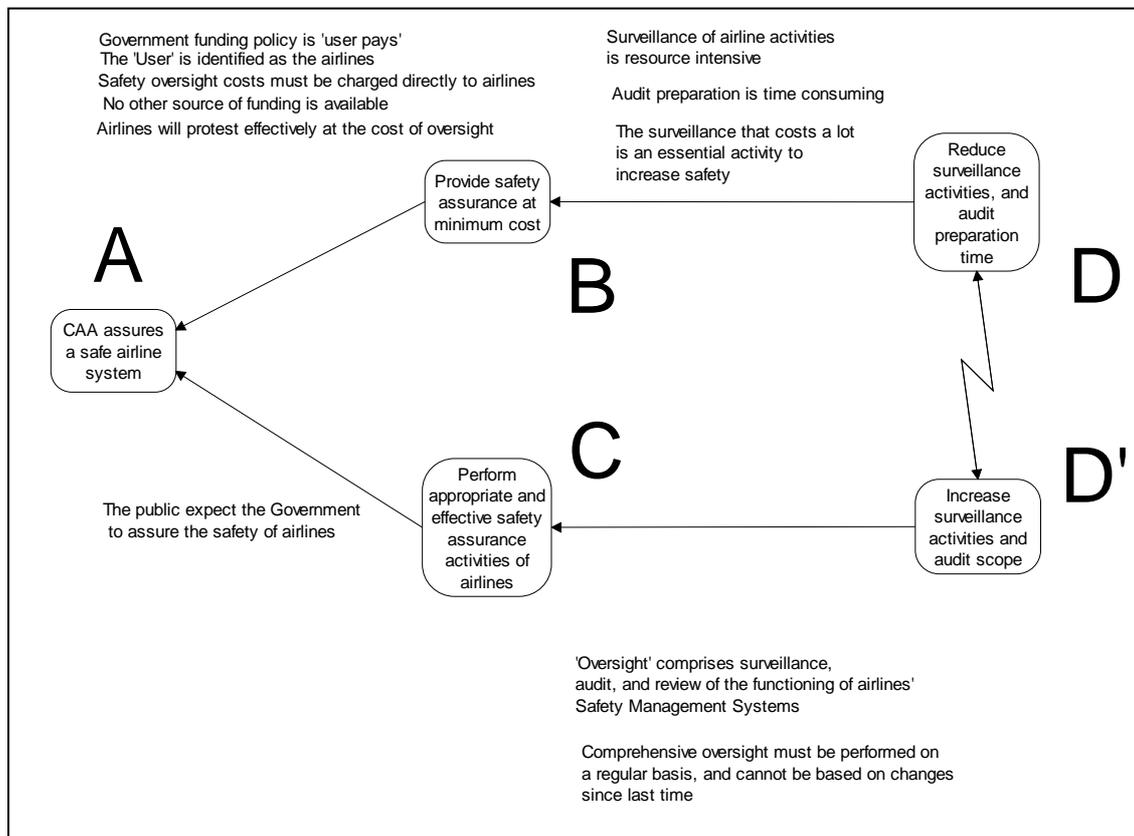
Figure 90. Conflict Resolution Diagram from CAA CRT.

Surveillance of airline activities requires a sizeable staff of highly qualified Inspectors (ICAO, 1995), and audit preparation requires a thorough review of the airline's manuals which takes appreciable time. The assumptions B-D are therefore valid. Likewise, the activities required for safety oversight (C-D) are well established (ICAO, 1999, 1995; Swedavia AB & McGregor and Company, 1988; Flight Safety Foundation, 1998). Public expectation that the Government will assure airline safety (A-C) has been demonstrated by requirements for Inquiries after a disaster (see, for example, the Erebus Royal Commission, Mahon, 1981). If the assumptions at A-B are valid, the CAA's dilemma is clear: it is required to do those things necessary to assure airline safety, but must remain within funding constraints dictated by airline pressure. It cannot do both effectively.

Since there is a feasible alternative source of funding for the CAA, the assumptions at A-B that safety oversight must be charged to airlines, and no alternative funding is available, are not valid. The conflict (D-D') is therefore broken:

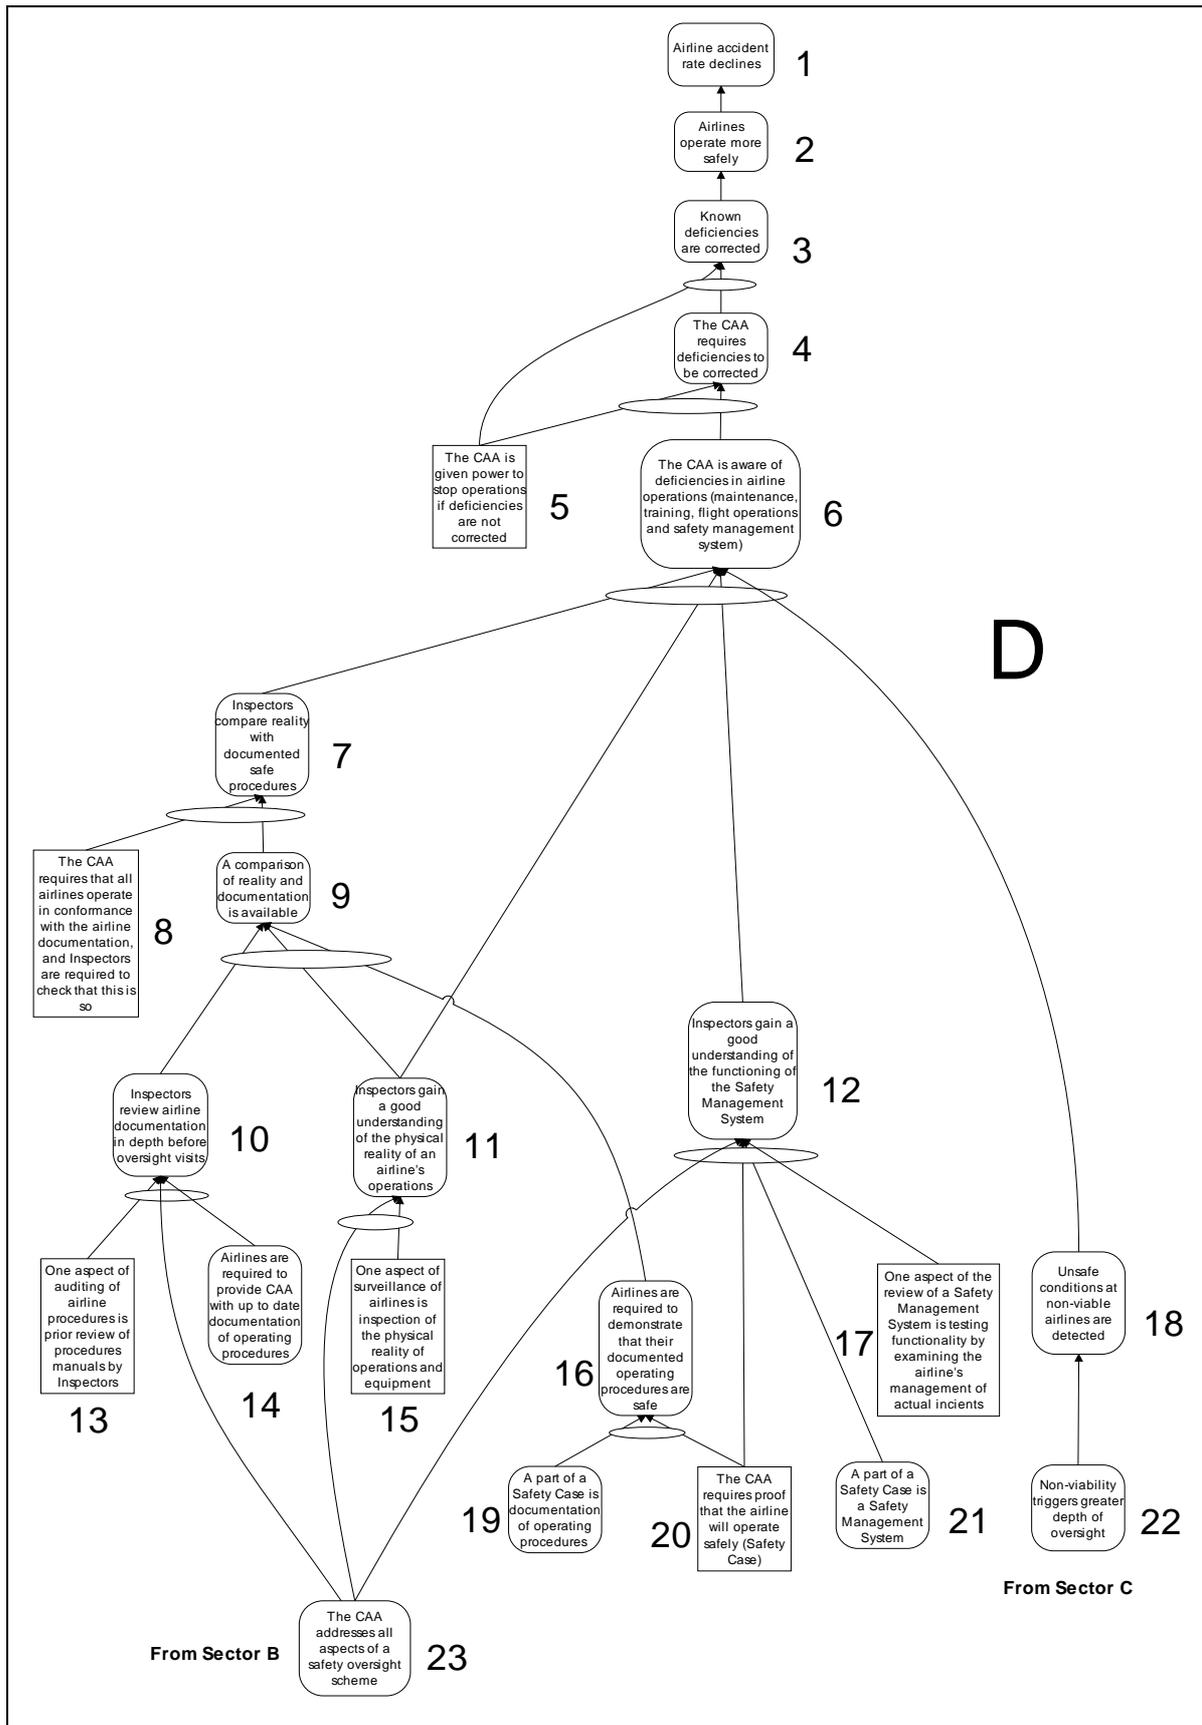
Figure 94. CAA is aware of deficiencies in airline operations.

Figure 94 also addresses a potential ‘negative branch’, that is, a potential undesirable effect arising from an otherwise beneficial injection. Imposing a safety charge on the public could give rise to the perception that the CAA is able to ensure that all airlines are absolutely safe. The CAA cannot do this: it can increase safety by reducing risk, but there is always the possibility that something unforeseen could lead to disaster. If an accident is not to give rise to unwarranted criticism of the CAA, it is necessary that the public understands the CAA’s function, be aware of its success (as shown by a reducing rate of accidents and incidents) and be aware of the limitations of what can be done. This negative branch and response is shown in Figure 96.

Apart from the fundamental injection that ‘The user of CAA services is defined as the travelling public’, there are a number of other required injections, as shown by the square boxes in Figure 94. These are:

- A Safety Case is required⁵⁴
- The CAA requires that all operations are acceptably documented, and conducted in conformance with the airline’s documentation
- The CAA has power to stop an airline operating, if identified deficiencies are not remedied
- The CAA monitors airlines’ financial reports, and
- The CAA’s role and work is publicised.

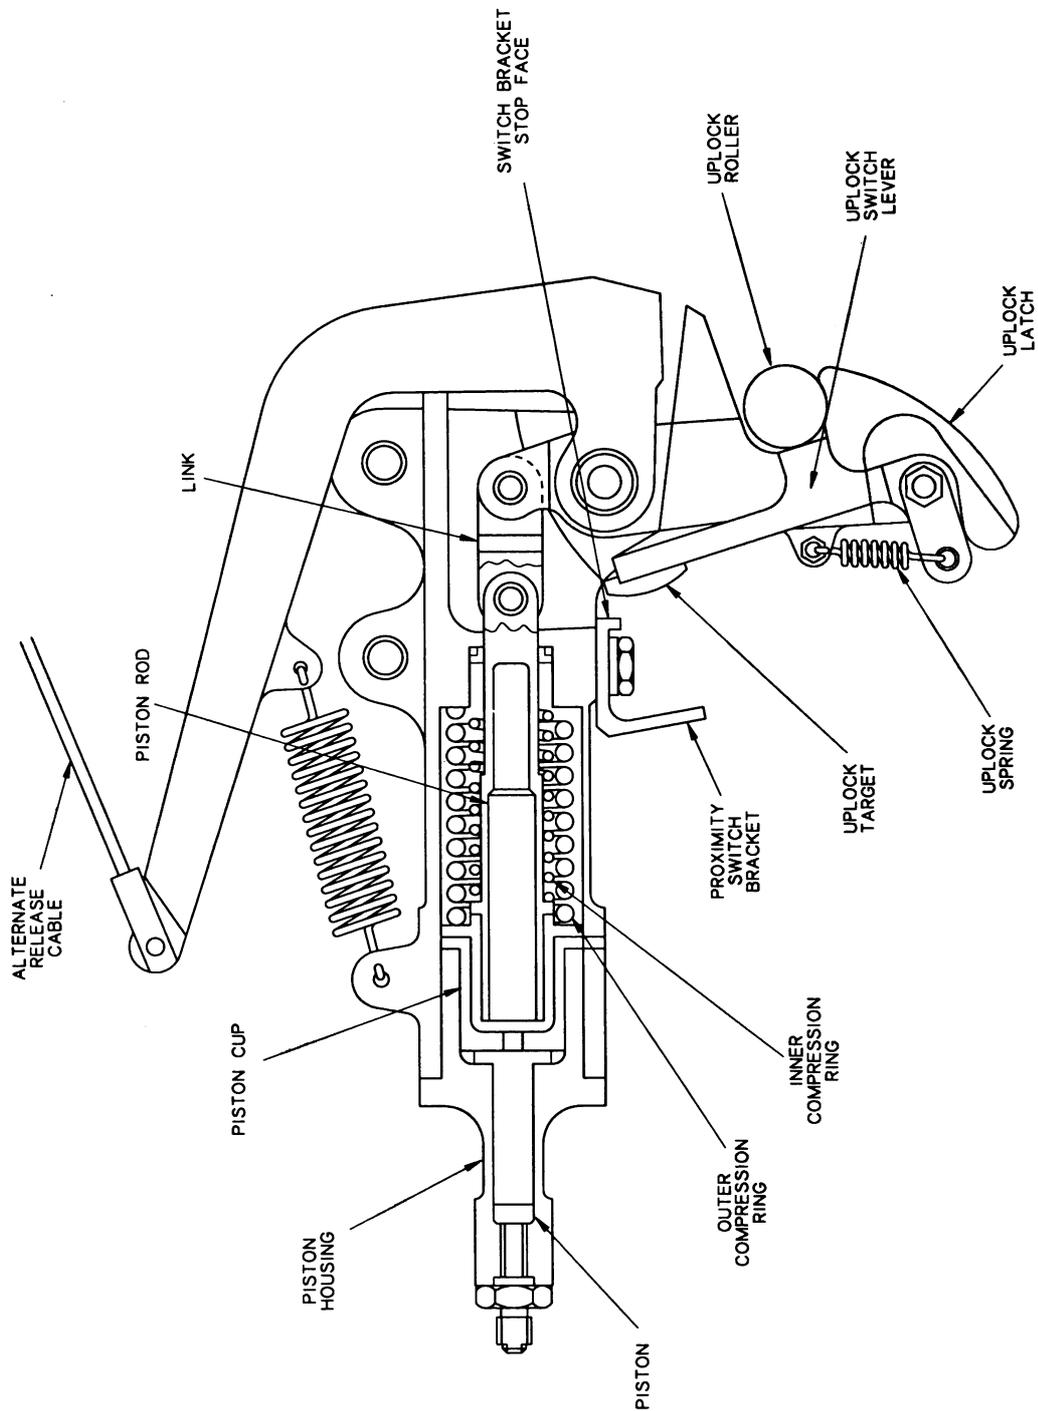
Figure 2
 Uplock assembly view
 (Not to scale)

1.6.24 The main undercarriage uplocks fitted to the Dash 8 aircraft were designed to restrain the respective undercarriage leg in the retracted position under all flight conditions without the aid of hydraulic pressure. They comprised a latch assembly installed within the rear of the engine nacelle which engaged with a roller mounted on the undercarriage leg when the undercarriage was fully retracted, thus mechanically holding the undercarriage leg in the “UP” position. (See Figure 2.) With the uplock latches engaged and the forward, centre and aft doors closed, the solenoid selector valve was de-energised to isolate hydraulic pressure from the system.
