**GRAPPLING WITH COMPLEXITY:
FINDING THE CORE PROBLEMS BEHIND
AIRCRAFT ACCIDENTS**

A thesis presented in partial fulfilment of the requirements for the degree of
Doctor of Philosophy in Aviation

Dmitri Victorovitch Zotov

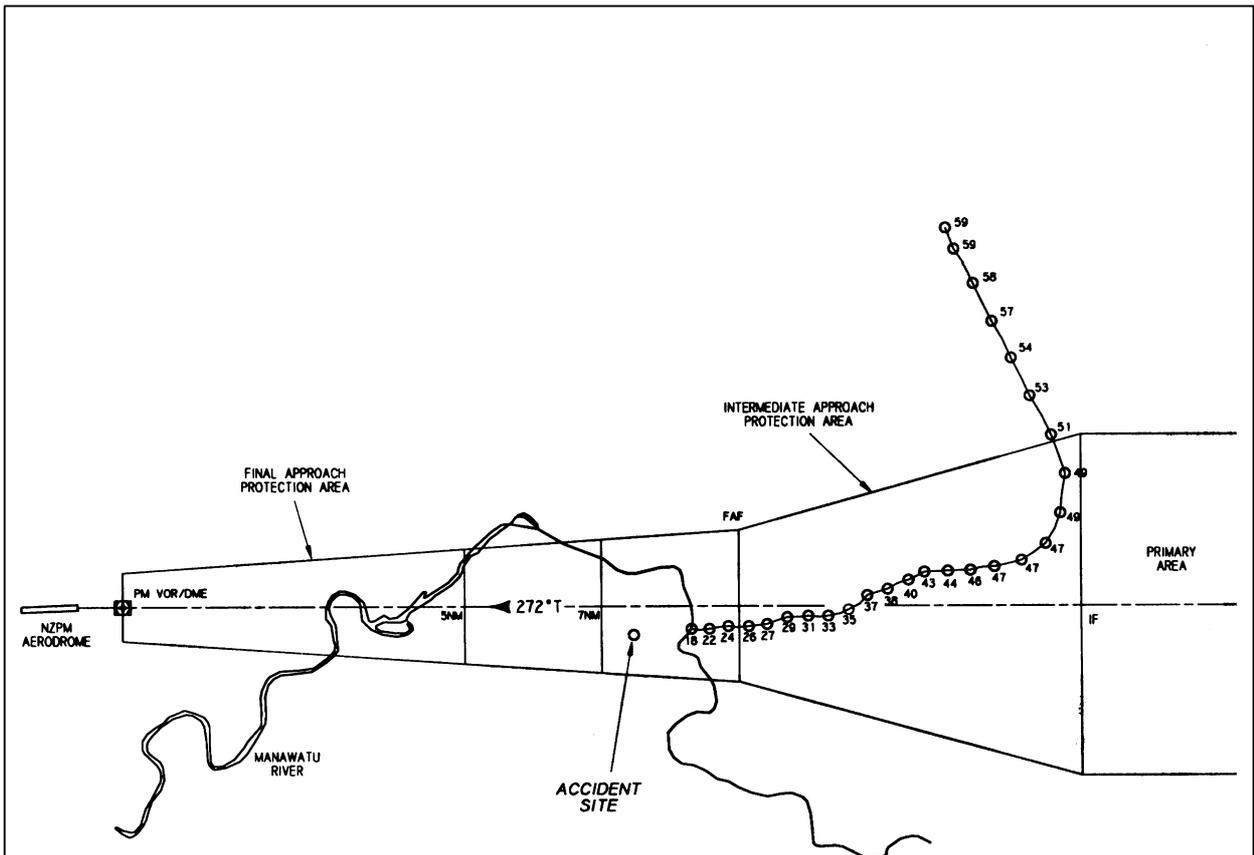
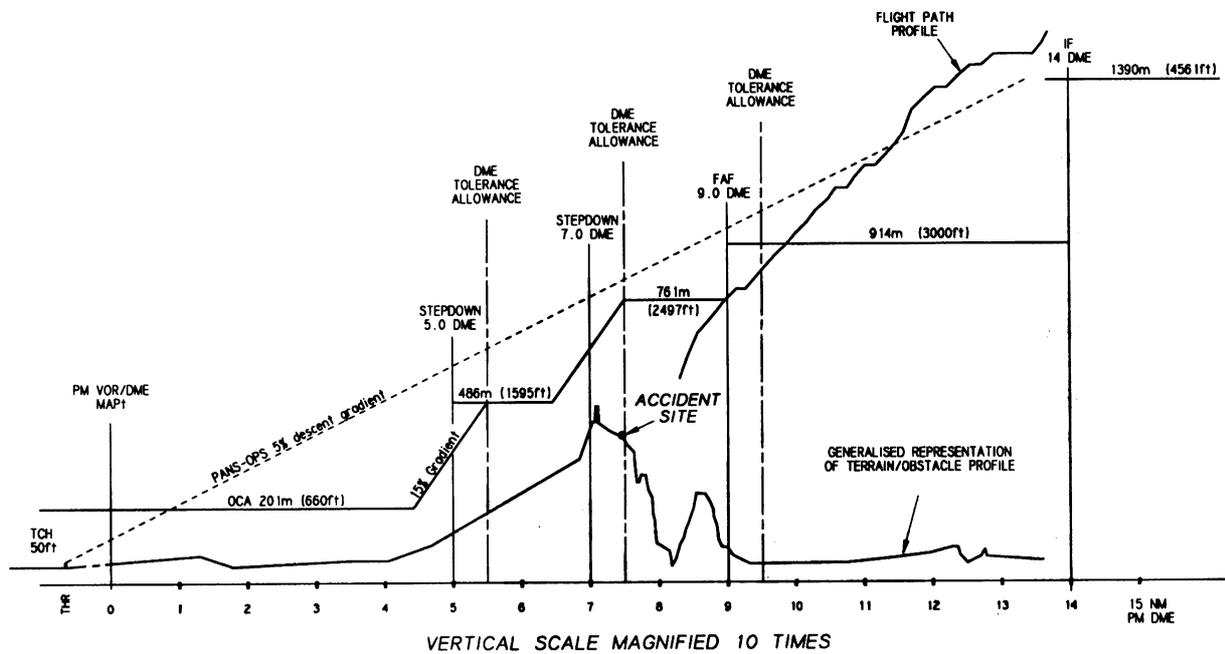
Figure 3
Copy of simplified procedure design
with radar data overlaid

- 1.8.18 The radar recording included Mode C data, identifying the aircraft and adding time and transponder altitude to each return.
- 1.8.19 The printout of the radar recording (see Figure 3) showed that the aircraft had descended around the 14 DME arc and had turned to intercept the final approach track normally at 5100 feet, at 0919.12 hours. On the final approach the aircraft was left of the specified track of 250° M to the VOR, being initially about one degree right of track, then crossing and maintaining about two degrees left of track to the last return. The Mode C altitude data showed a continuous descent through 2500 feet at 9 DME, to 1800 feet at the last return.

- 1.8.20 The study of the radar recording after the accident showed that the Mode C altitude data on the final approach, in conjunction with the aircraft’s position, could have enabled a radar controller to monitor the aircraft’s compliance with the instrument approach procedure while it was being carried out.

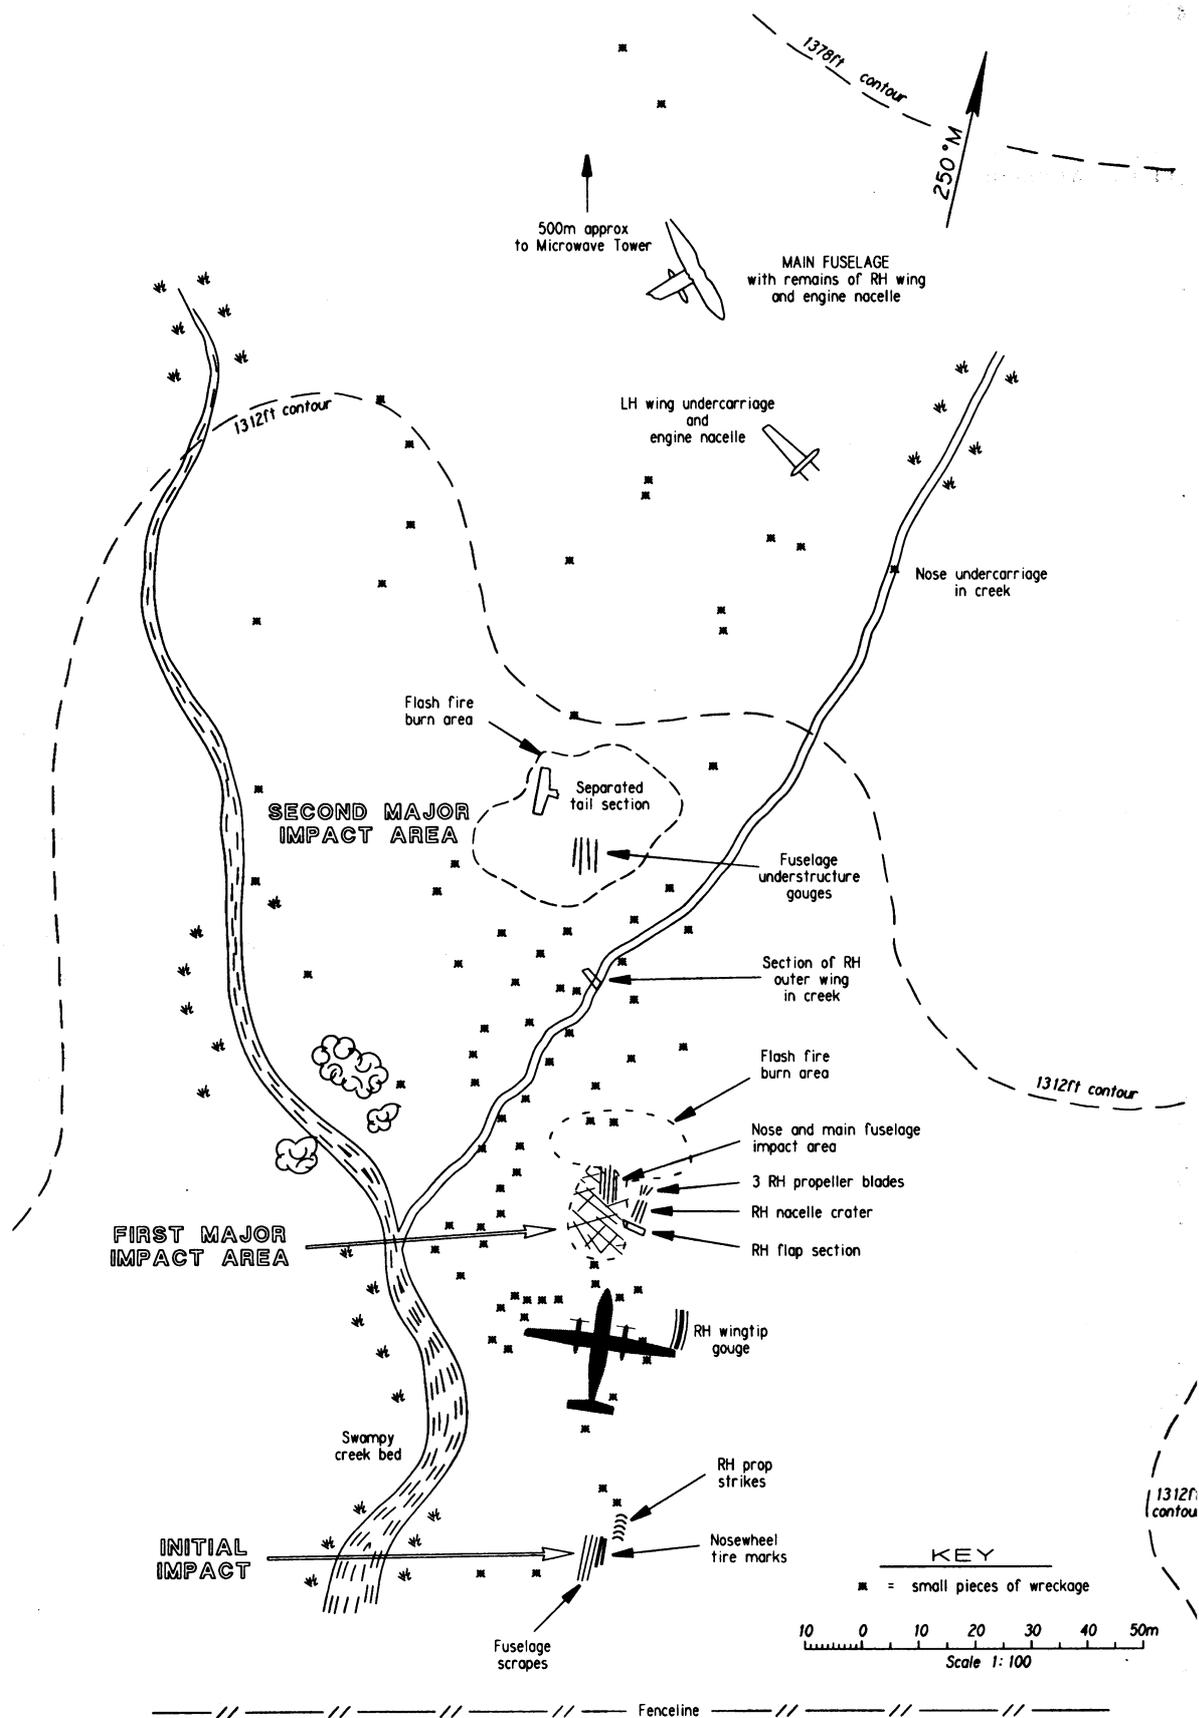
Figure 5
Impact and wreckage diagram

removal of the right wing, outboard of the engine nacelle (Figure 5 in the report). The nose was rising before the first major impact (perhaps because of the initial nosewheel impact) so the wings would have been at a larger than normal angle of attack, and lifting strongly. Removal of the outboard part of one wing would have left the lift from the other wing unbalanced, so the aircraft would have rolled at a rate constrained only by the roll damping of the remaining wing.

How did the right wing come to be removed? There were gouges in the ground from the right wingtip, but these alone do not indicate that the wing was torn off backwards. Wings of airliners form a shallow box structure, which is strong in-plane, and so unlikely to be torn off at part span by contact at the tip. Were the wing to have been torn off by tip contact, it would probably have failed at the point of highest stress, i.e. at the root, but this did not happen. Also, if the outer portion was torn off by ground contact it seems unlikely that it would have finished on the centreline of the wreckage path (Figure 5 in the report): it would have been expected to have been somewhat to the right of track.

This does not explain how the starboard outer wing panel came to be in the bottom of the gully (Figure 5). Nor does it explain the ‘flash fire’. The strike on the starboard wing tip was insufficient to remove the outer wing panel by in-plane bending, and the impact of the engine on the ground would, if anything, have overloaded the wing root, not the outer panel. The answer, as demonstrated in Chapter 5, is that the impact initiated a fuel-air explosion in the starboard wing fuel tank, which blew off the outer panel. The precise initiation mechanism is not available, since the airline was permitted to destroy the wreckage before this question could be answered.

- 1.12.3 The accident occurred on private farmland which was divided by post and wire fences for grazing. The various areas involved in the impact sequence and the pieces of wreckage were all located in one large hillside paddock. (See Figure 5.) The paddock included two gullies and intersecting spurs of high ground rising toward the hilltop. The principal impact zones and general wreckage trail followed an uphill pattern over open grassland, although items of wreckage were distributed into gullies during the accident sequence.

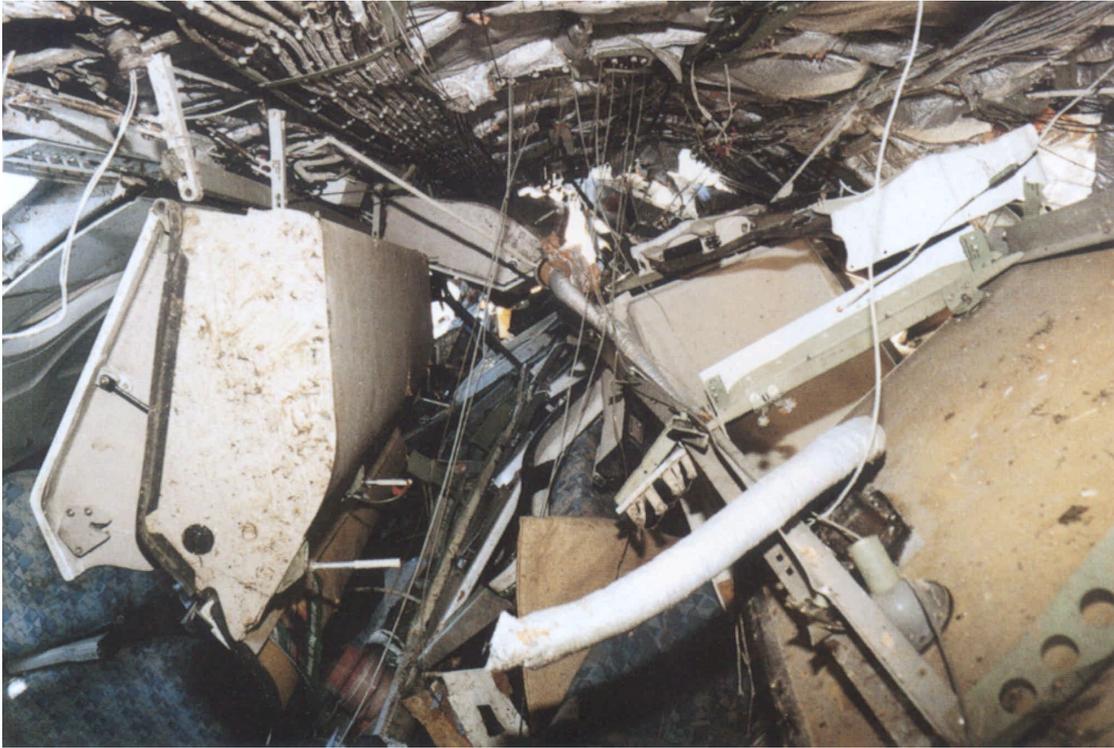
Figure 6a
View of passenger cabin looking aft

- 1.15.20 The limited involvement of the fuselage in the post-impact fire increased the post-impact survivability. Apart from the short-lived fire which occurred in the area of the right engine, most of the spilt fuel was consumed in two flash fires early in the impact sequence. Significant delays in effecting emergency egress were experienced by some passengers because of seat dislodgements and an accumulation of debris in the cabin. (Figures 6a and 6b.)

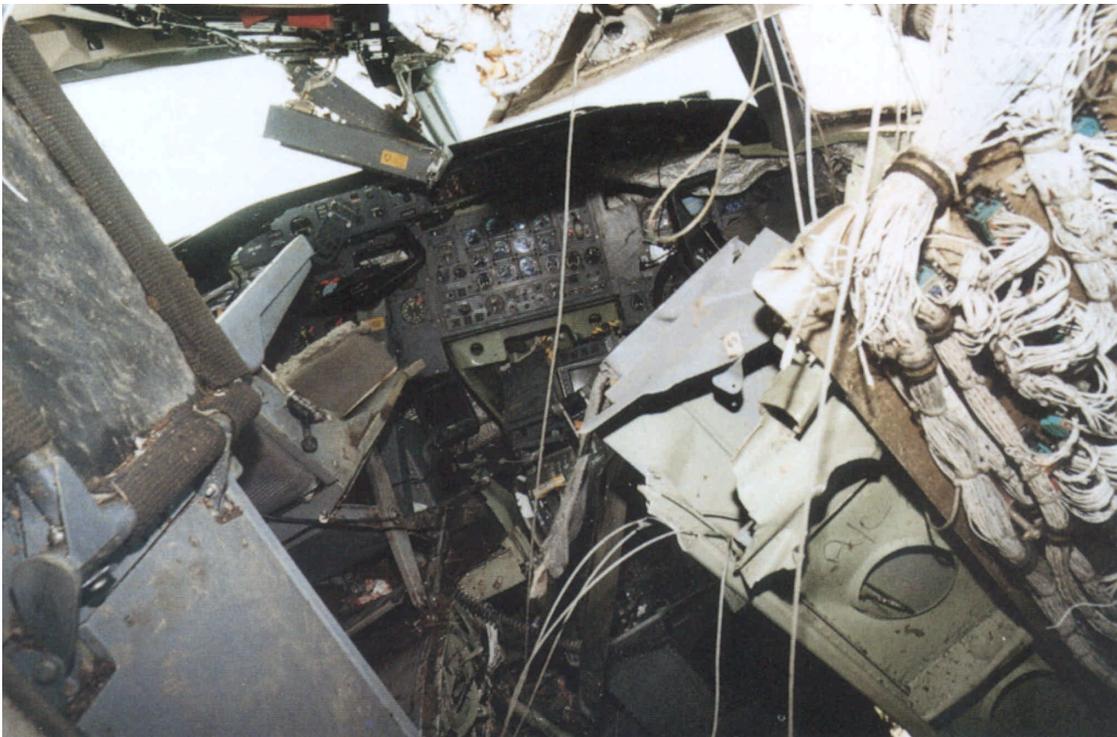
Figure 6b
View of flight deck

The pilots' head injuries (1.13.11, p. 39) are attributed to forward and downward motion on impact (1.13.1, p. 37), but this lacks face validity, since the pilots would have been restrained by inertia reel seat harnesses. Figure 6b in the report (p. 42) shows that there was disruption of the cockpit roof in way of the pilots' heads, and the photograph on p. 4 in the report shows that this disruption was due to external impact. Since the report implies that both major impacts were upright (Figure 1; 1.12.13, 1.12.15, pp. 35, 36) this disruption must have occurred, not at the major impacts, but during or at the end of the ground slide. (This matter is addressed when the graphs are amalgamated, as discussed below).

The pilots suffered head injuries. They were restrained by full harnesses. How, then, could their heads come into contact with the cabin structure? The photograph from the front of the aircraft (report, p. 4) shows that the top of the cockpit was crushed in by the inverted impact, to an extent greater than subsequently found when the wreckage was examined. Since the occupiable space in the cockpit was significantly reduced as found (report Figure 6b, p. 42), it may be concluded that the pilots' head injuries were due to transient lack of occupiable space, while the structure was crushed in by the inverted impact.
