Tsunami damage to coastal defences and buildings in the March 11th 2011 M_w 9.0 Great East Japan earthquake and tsunami

Stuart Fraser · Alison Raby · Antonios Pomonis ·
Katsuichiro Goda · Siau Chen Chian ·
Joshua Macabuag · Mark Offord · Keiko Saito ·
Peter Sammonds

Received: 8 September 2011 / Accepted: 8 March 2012
© Springer Science+Business Media B.V. 2012

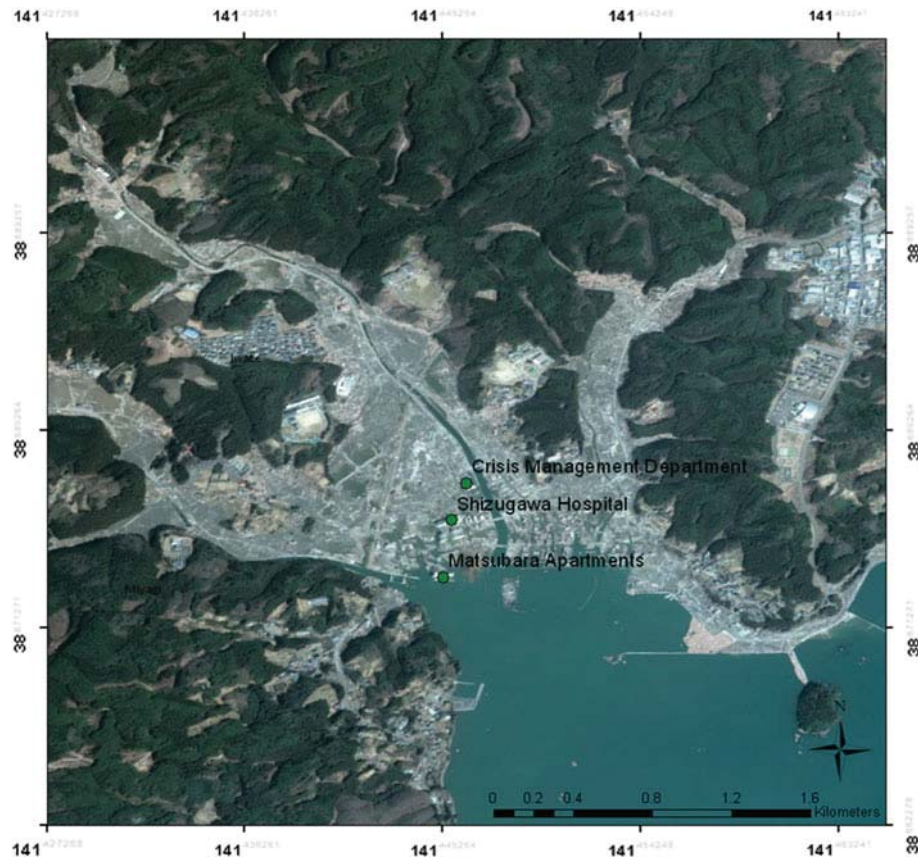
The coastal defences in this town consisted of a sea wall and two flood gates across the two river channels; the concrete pillars of these gates remain standing although the attached steel operating components were washed away. Long sections of the tsunami wall collapsed and evidence of inadequate interlocking of adjacent blocks in the concrete sea walls was observed, with the blocks relying on self-weight for stability.

Steel frame buildings sustained heavy damage and EEFIT observed collapse of several 2- to 3-storey RC buildings from debris impact and significant scour. The 3-storey steel frame Crisis Management Department (CMD) building (38°40' 40.06'' N, 141° 26' 46.82'' E; 470 m from the harbour front) remained standing with heavy damage after being inundated to its roof at 10 m above ground level (Fig. 11).

Fig. 10 Satellite image showing Minami-Sanriku town in its coastal situation. Key buildings discussed in the text are marked: Crisis Management Department, Shizugawa Hospital and Matsubara community housing apartment block, also designated as a vertical evacuation building

Several large RC buildings, including vertical evacuation structures, survived but sustained moderate to heavy damage. In the area up to 500 m from the port front, almost all timber frame structures suffered collapse and many steel frame and RC structures sustained moderate to heavy damage (D2–D3). Several RC structures within 300 m of the coast suffered collapse due to extensive scour and/or debris strike (Fig. 12). The 4-storey RC Matsubara community housing apartment block at the harbour front ($38^{\circ} 40' 25.10''$ N, $141^{\circ} 26' 42.93''$ E; Fig. 13), constructed in 2007, was designated for vertical evacuation. The structure was built parallel to the harbour front in the longitudinal direction, which did not appear to have affected its structural performance despite inundation to the 4th storey and scour of the piled foundations to at least 2 m below previous ground level. The building was protected on the seaward side by a sea wall, which failed during the tsunami return flow; directly in front of this building this wall remained intact, but had failed where it was not sheltered in the return flow. Shizugawa Hospital ($38^{\circ} 40' 34.44''$ N, $141^{\circ} 26' 44.99''$ E; Fig. 14) is a 4-storey RC shear wall construction with steel bracing, and showed significant non-structural damage from debris impact including parts of the steel bracing.

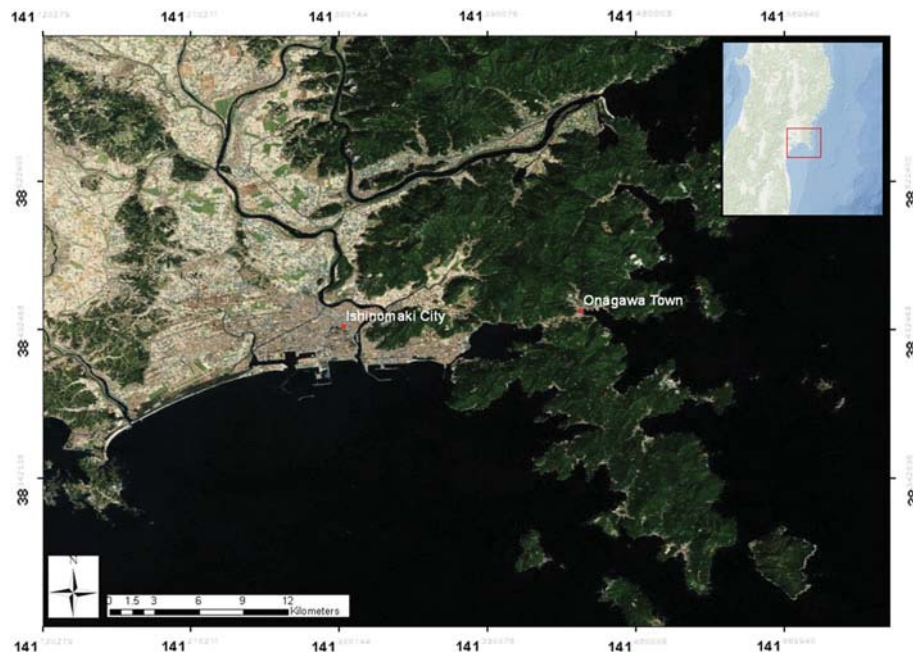
Onagawa Town is situated in a narrow valley exposed to the Ocean to the east, with an estuary at the western end of the valley (Fig. 15). Maximum inundation depths here exceeded 16 m due to flow from the east. The town suffered a high fatality rate (11.9 % of the population living in the inundated zone, see Table 2), which was greater than the rate in Minami-Sanriku for a similar level of population in the inundated area, and similar magnitude of tsunami inundation height. These figures suggest important differences in evacuation response between these towns.

Fig. 15 Satellite image showing Onagawa Town and Ishinomaki City, showing the transition between plains coastline to the west and rias to the east. Figure 16 shows a close up of the eastern harbour of Onagawa Town

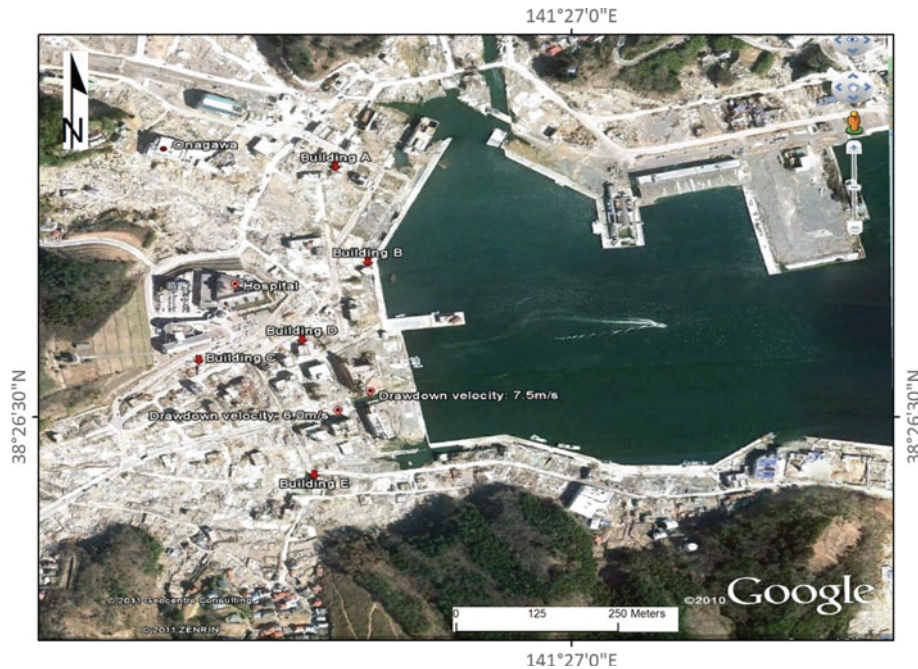
Onagawa Town provided some of the most unexpected observations of this event: 5 RC shear wall buildings and 1 steel frame building, all of 2- to 3-storeys height, were overturned and moved from their original positions during the tsunami (movement indicated by arrows in Fig. 16). This type of failure had not been previously observed for RC shear wall or steel frame buildings subject to tsunami loading. The aspect ratio of these buildings may have been

higher than other nearby buildings and all had a small building footprint. Some had piled foundations, others were on raft foundations—descriptions of each building are provided below. Witnesses described that the 1st incoming wave knocked over these buildings (Read 2011). Potential explanations for the overturning of these structures are offered below.

Fig. 16 Satellite image of the harbour in Onagawa Town, indicating the (i) final locations of overturned RC and steel frame buildings (blue points, marked with building tag A–E) as observed by EEFIT; (ii) the track of building movement from the original position indicated by arrows (Tokimatsu et al. 2011); and (iii) positions of two velocity estimations made for return flow velocity using video footage
