Assessing the value of a geomorphic toolbox to assist with determining ecological health of wadable streams within the Waikato Region

A thesis presented in partial fulfilment of the requirements for the degree of

Master of Science

Geography

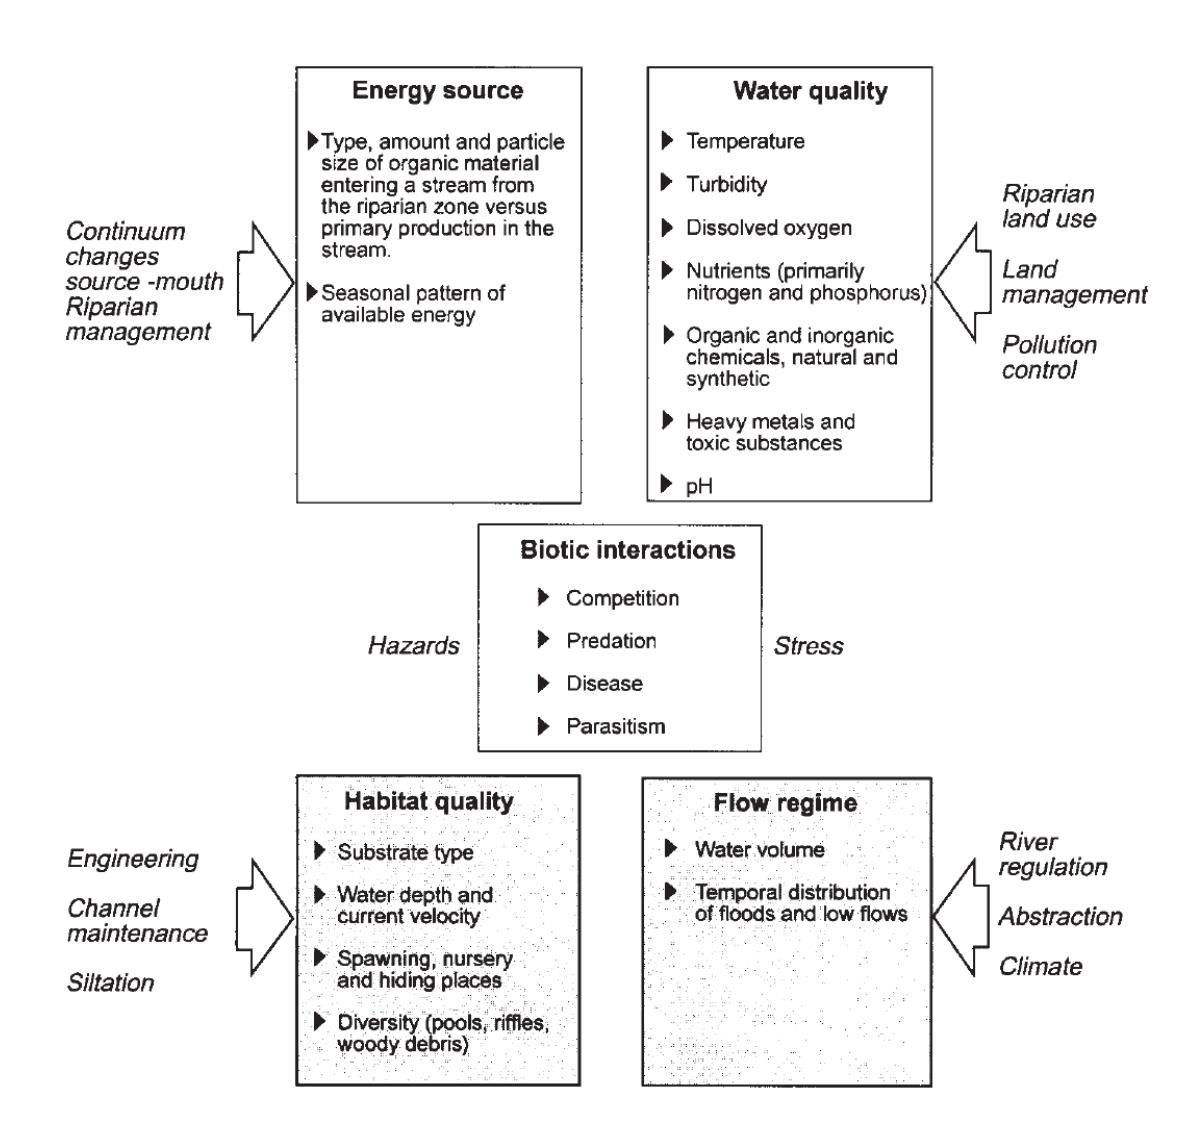
Figure 7 Instream freshwater habitat and its major influences from land use and water management (Newson & Newson, 2000).

Figure 7, with physical aspects of instream habitat dominating the biotic responses in headwater streams and downstream river segments heavily impacted by engineering design. Further, it is recognised that large-scale controls of rivers (i.e. flow regime) on smaller-scale features (i.e. individual patches) operate, resulting in the development of nested hierarchal models of river organisms that may operate to regulate species richness (Lake, 2000; Thomson *et al.*, 2001), as shown in Figure 8.

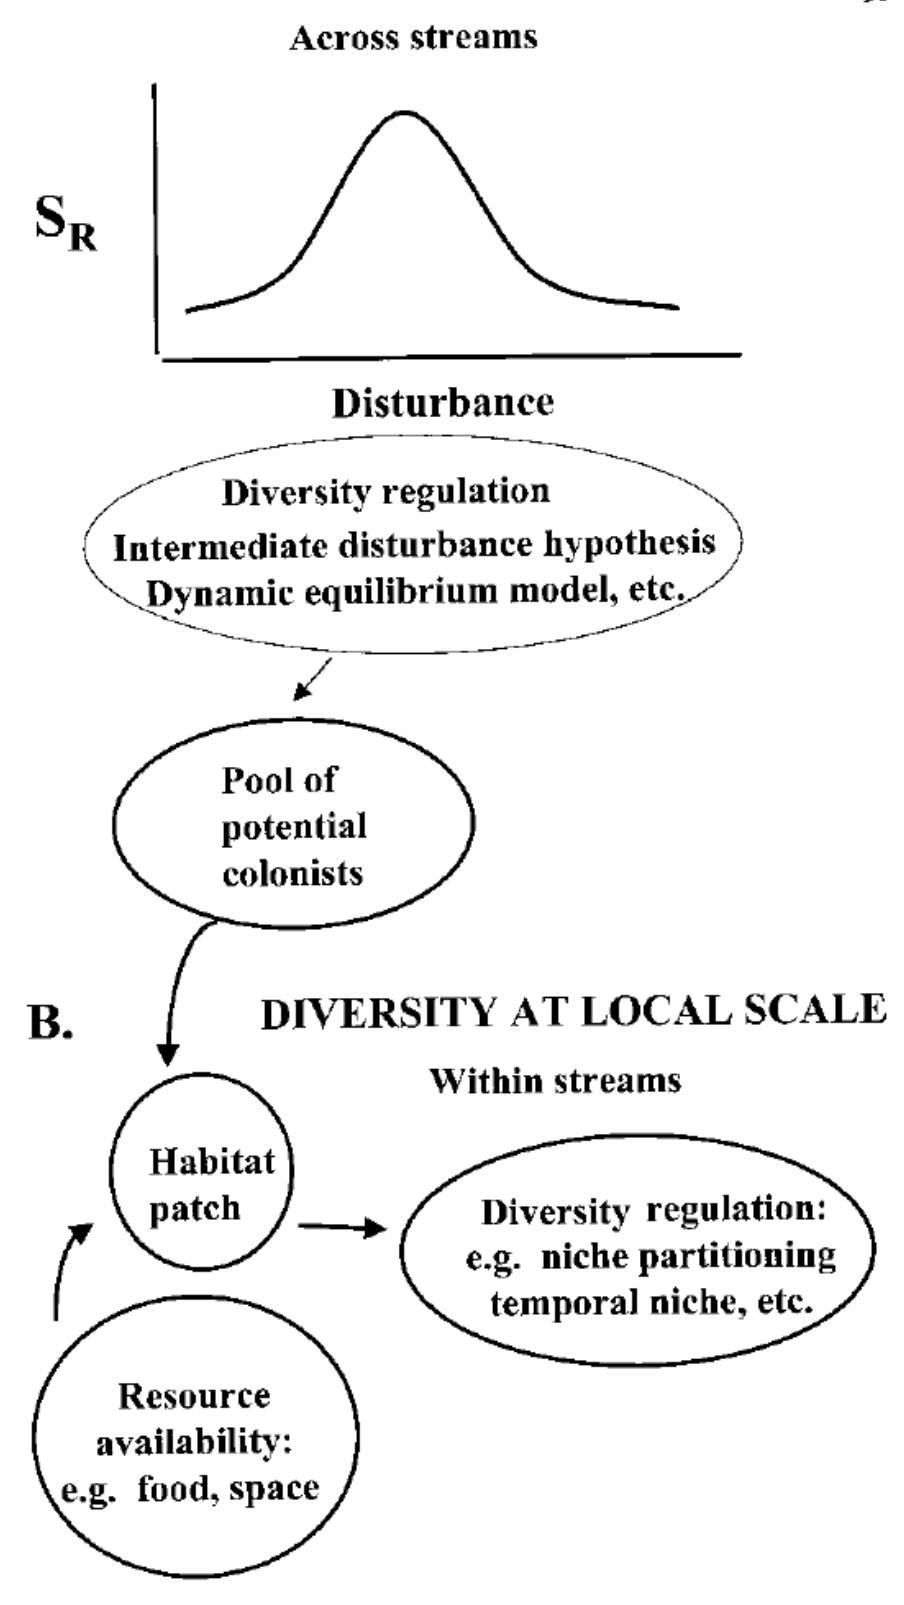
Figure 8 Diversity relationships of fluvial channels, with key processes occurring at both the regional and local scale to form the specific patch mosaic pattern that can be found within a wetted channel (Lake, 2000)

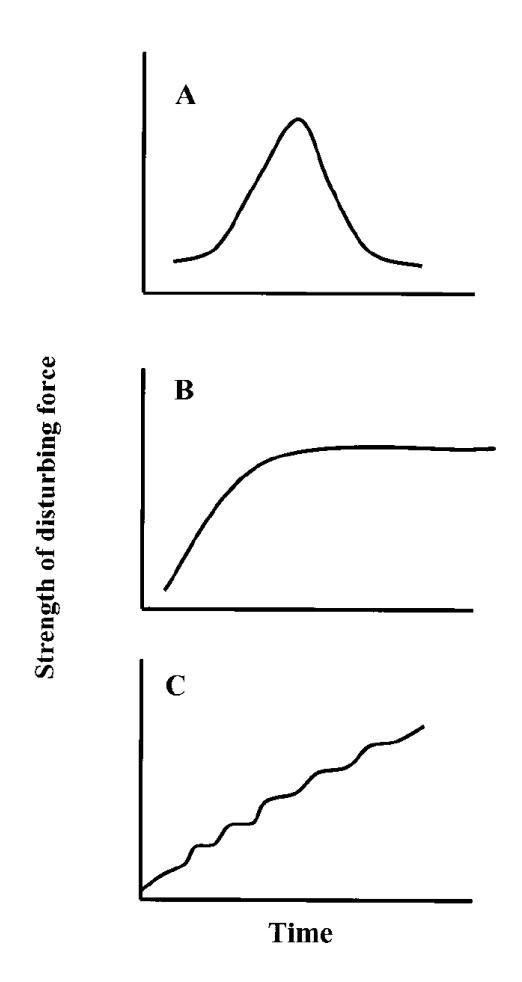
Figure 9 Three types of stream disturbance: A– Pulse, B – press, and C – Ramp. Each are distinguished based on the temporal trends of the disturbing force (Lake, 2000). Thus, a flood may be representative of a Pulse, a dam or blockage representative of a Press, and a drought representative of a Ramp

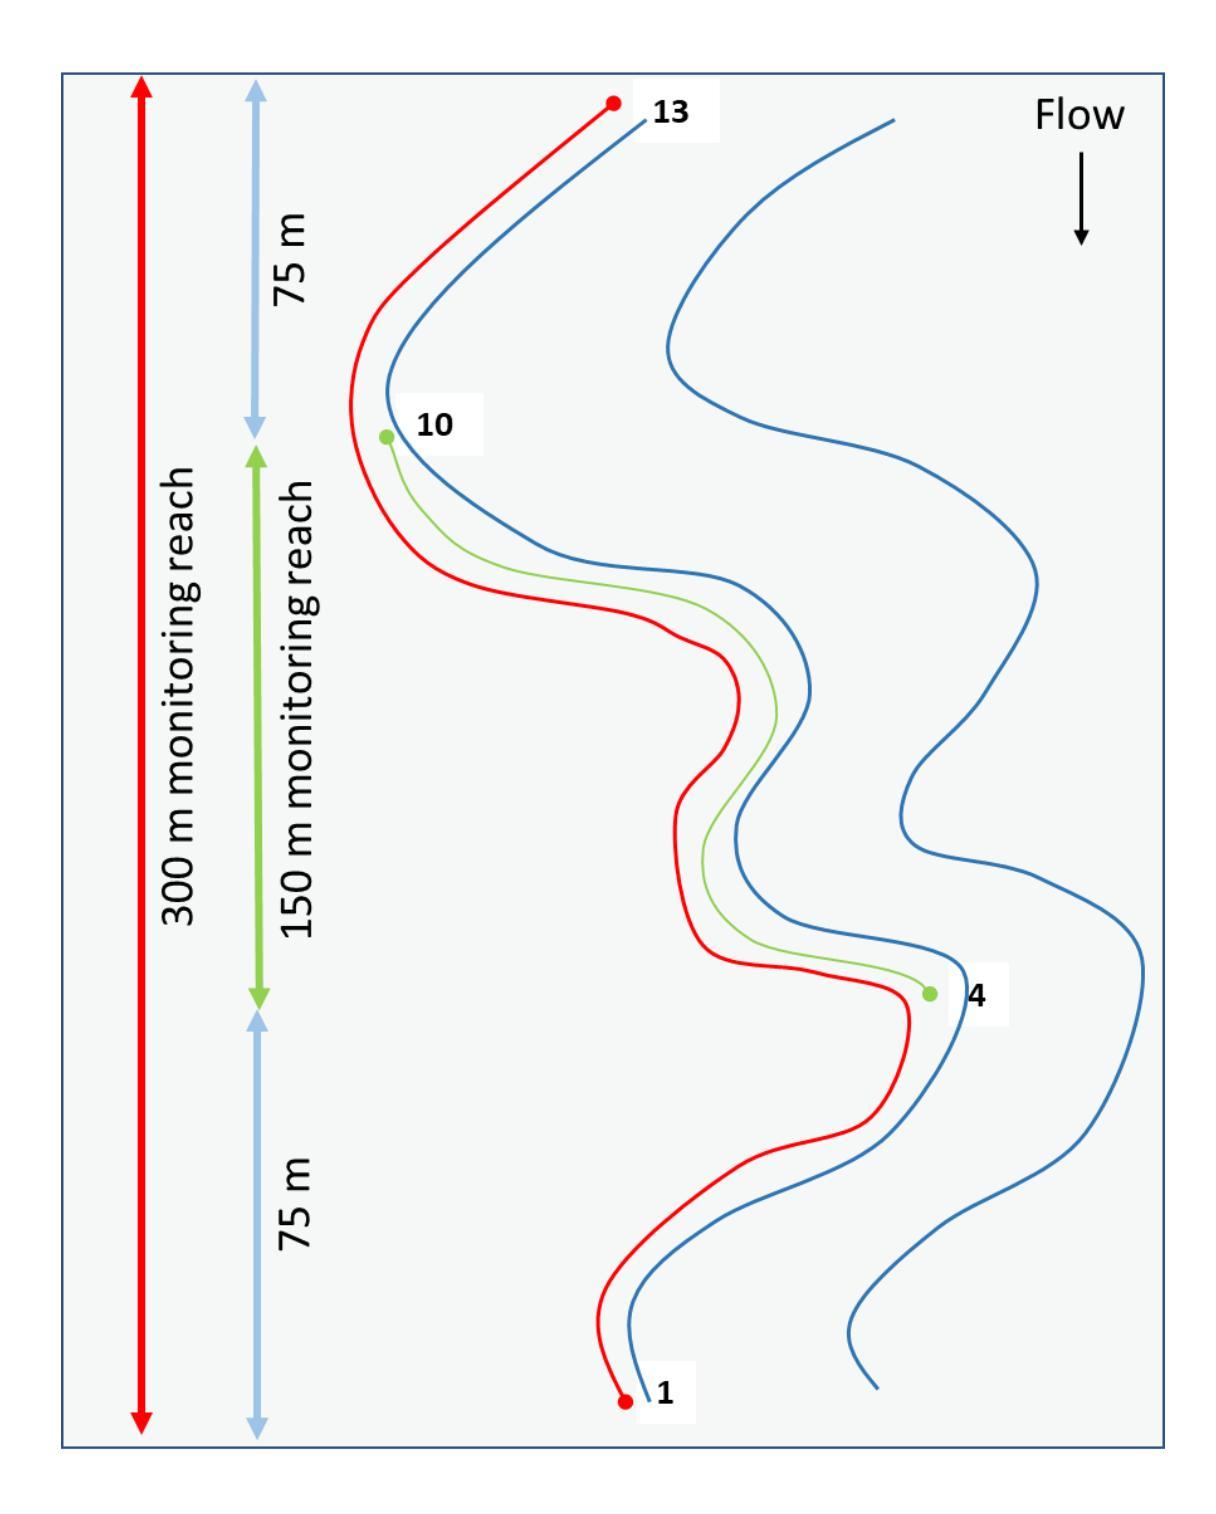
Figure 18 Diagrammatic representation of the monitoring reaches. The 150 m monitoring reach is specified by the WRC monitoring regime (green, between Markers 4 and 10), with an additional 75 m both upstream and downstream of the 150 m reach to create a 300 m monitoring reach as well (red, between Markers 1 and 13).

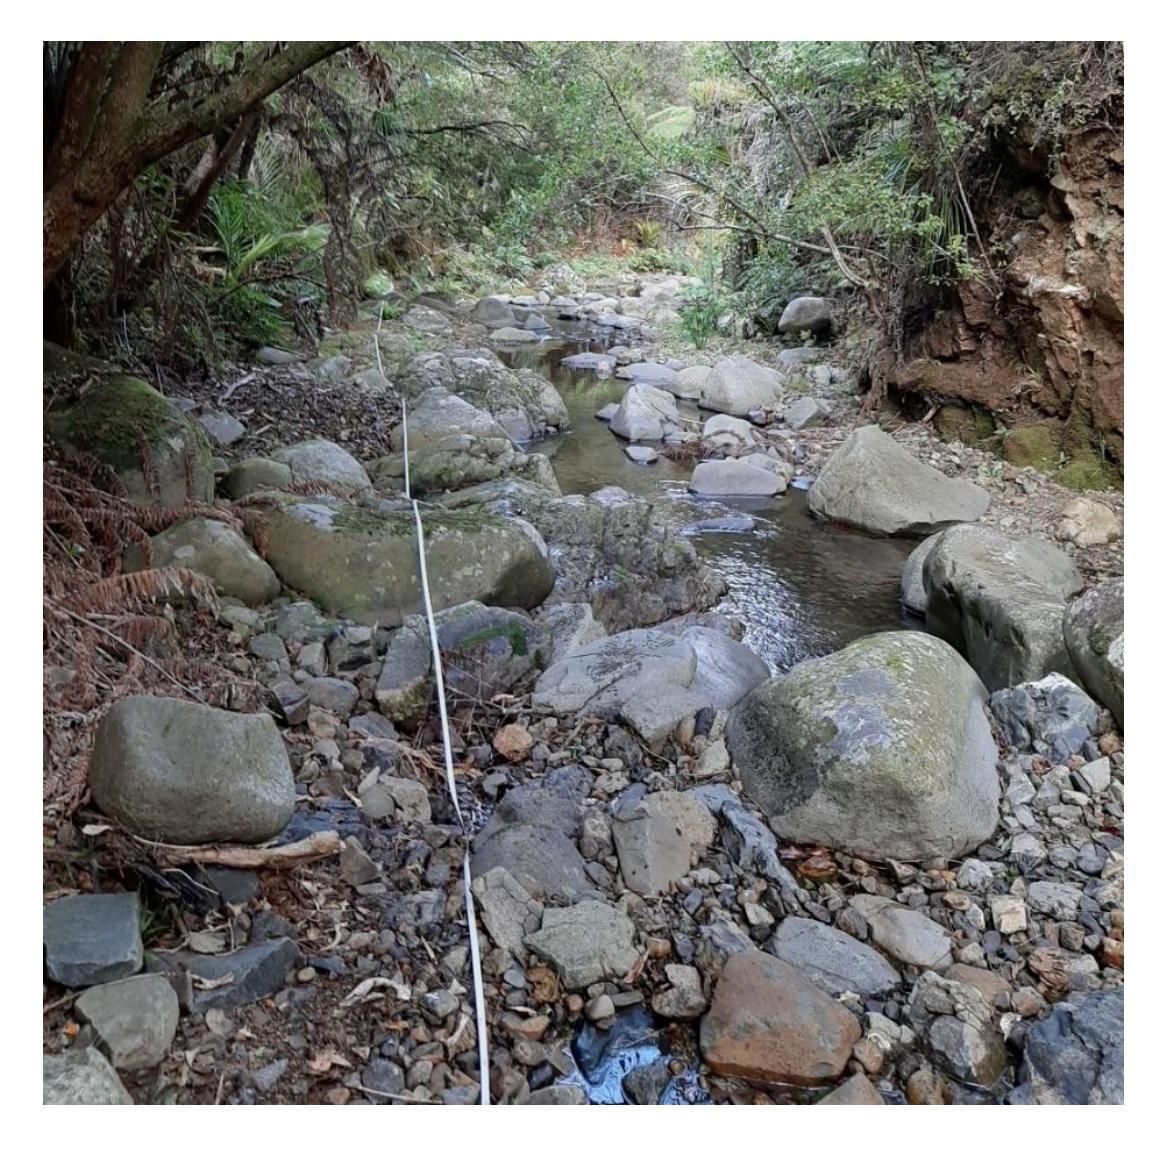
Figure 20 Example of measuring particle size along a transect within the 3rd Order Stony Stream (reference 2079_1). A tape measure was laid out for 30 m and the particle exactly below each metre mark was measured along its b-axis and recorded.

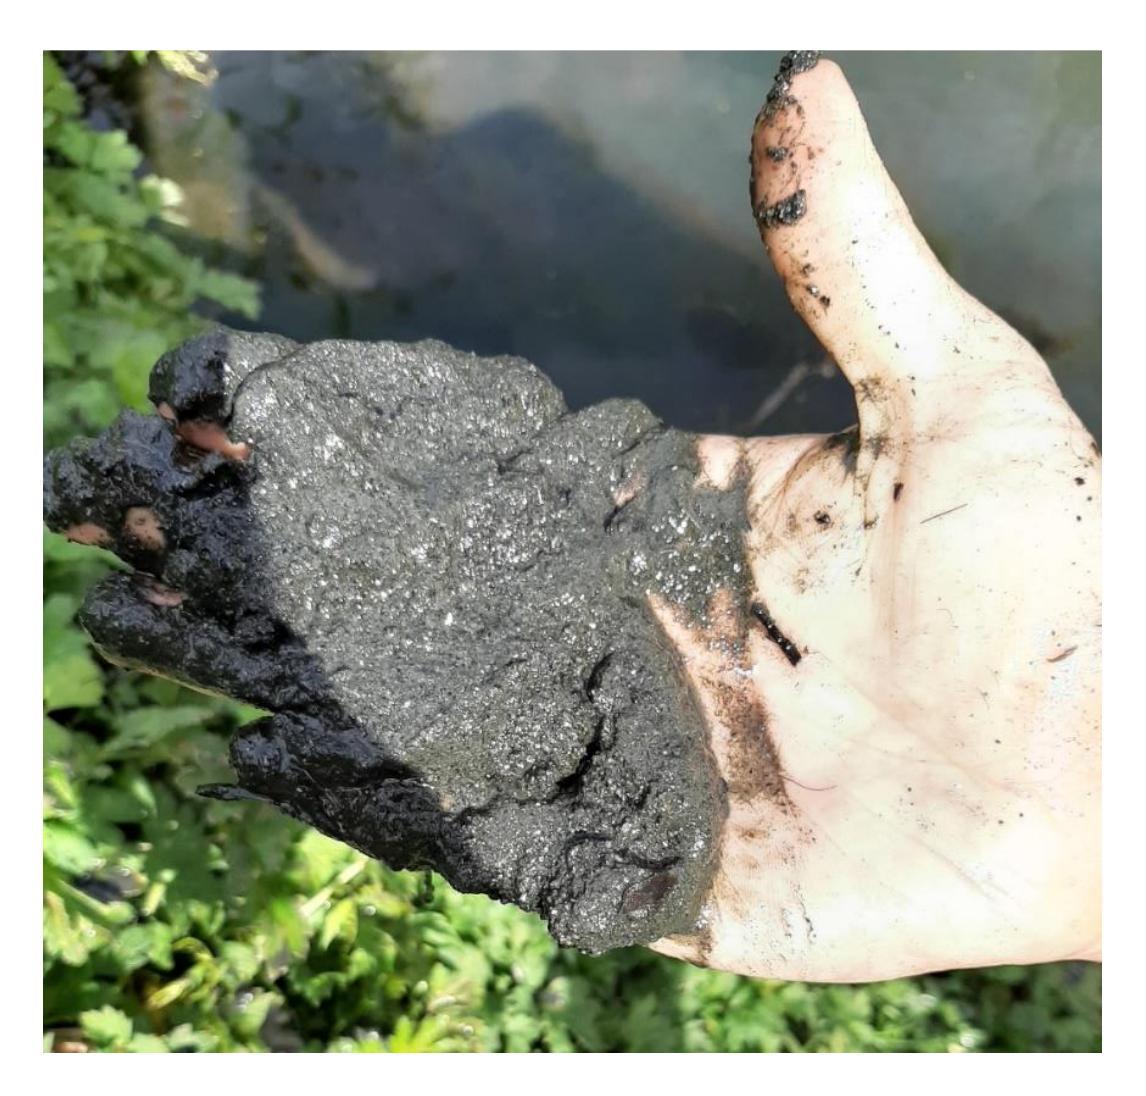
Figure 21 surface bed material obtained from the middle of the channel at Marker 4 within the Waiwhero Stream and assessed for particle type and size. The same process was used to assess the bed material at additional Markers 1, 10, and 13.

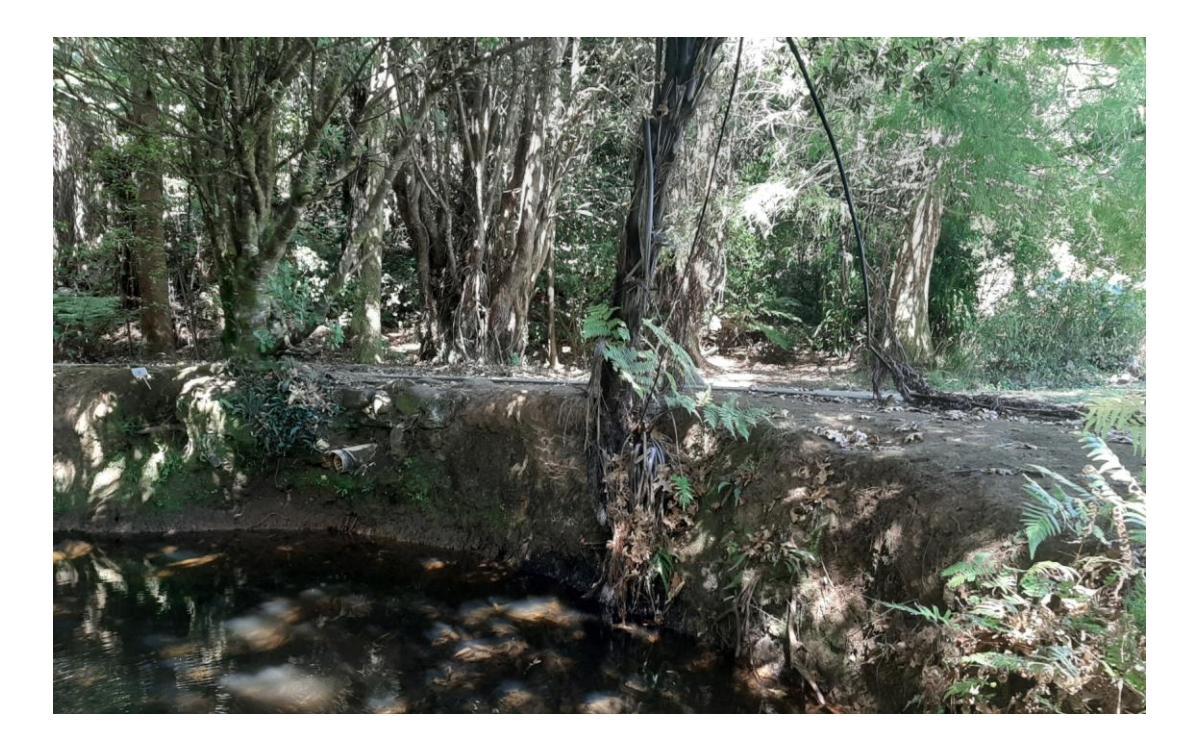
Figure 22 Example of a gap within the riparian zone, near Marker 10 for Wainui Stream (reference 1172_6)

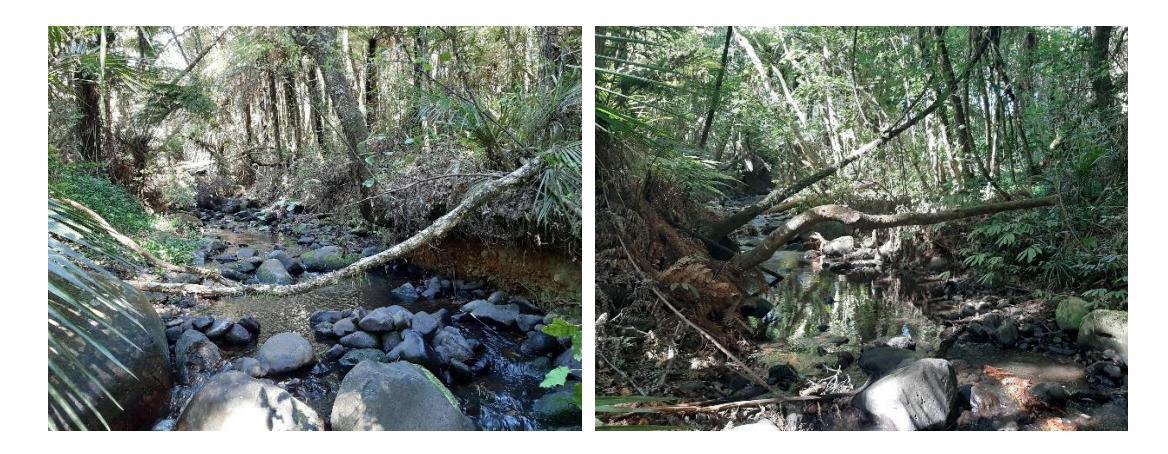
Figure 24 Riparian zone within Segment 4-5 of Monitoring Site 11726_11; dense understory and full canopy exemplifying riparian zone of the true left bank (right hand side of photo).

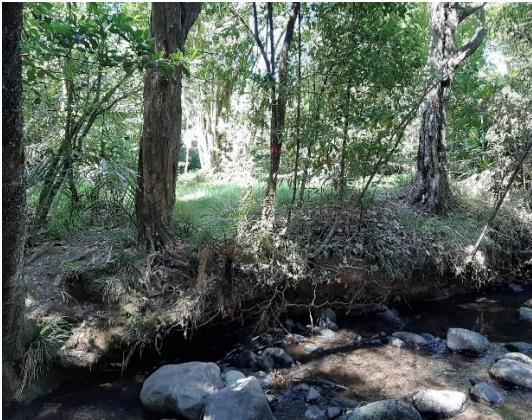
Figure 26 Incomplete Riparian Zone located in Segment 6-7 of Monitoring Site 1126_11; singular trees forming incomplete canopy adjacent to riverbank, with grass pasture located immediately after.

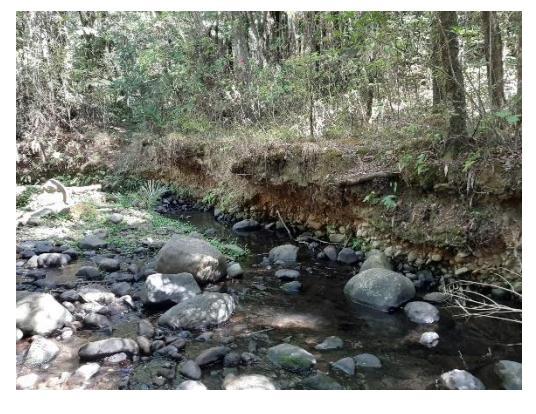
Figure 27 Incomplete Riparian Zone located in Segment 12-13 of Monitoring Site 1126_11; singular trees forming incomplete canopy adjacent to riverbank, with grass pasture located immediately after.

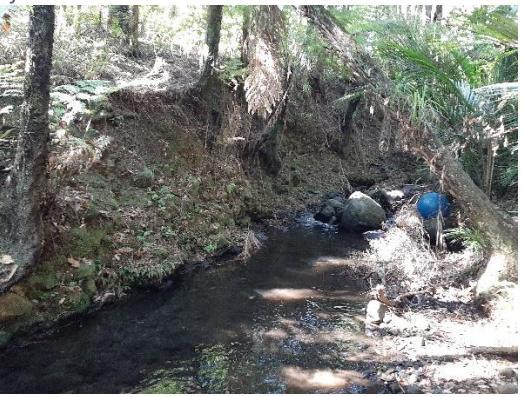
Figure 28 Evidential bank erosion within Segment 8-9 of Monitoring Site 1126_11, which extends uniformly along the true right bank for much of this segment. Note the lateral bar (armouring on the true left)

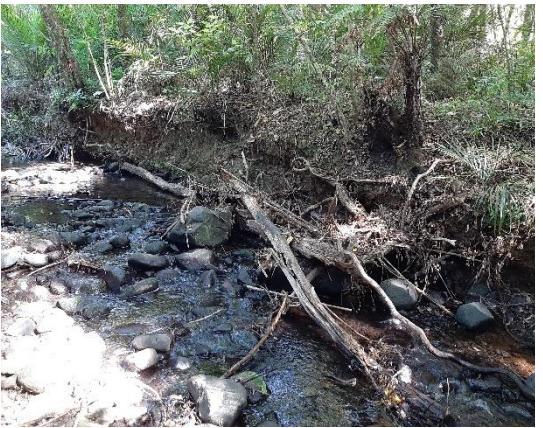
Figure 30 Wood raft within Segment 4-5 exhibiting a range of wood pieces of varying diameters.

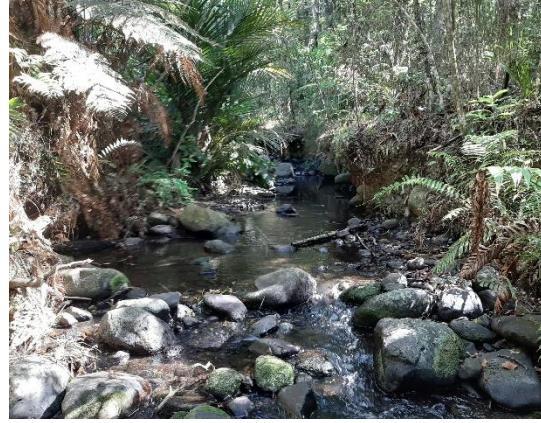
Figure 31 Example of diverse and numerous geomorphic units present within Segment 7-8 of Monitoring Site 1126_11, including pools and riffles, larger individual boulders, a lateral bar on the true right, and variable bank heights and degrees of incision.

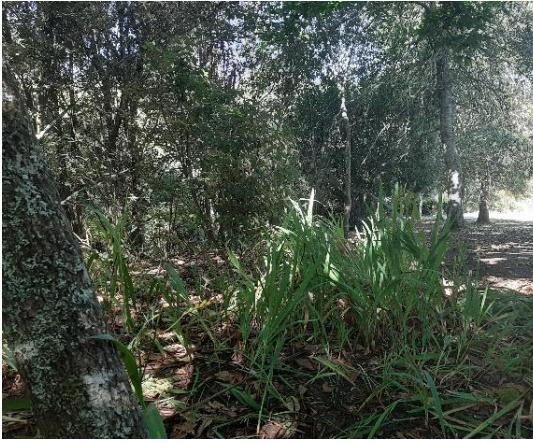
Figure 33 Example of riparian coverage variability located at Segment 8-9 of Monitoring Site 1172_6. True left bank had greater vegetation coverage than the true right (right hand side of photo). Grassed recreational areas were common adjacent to this reach.

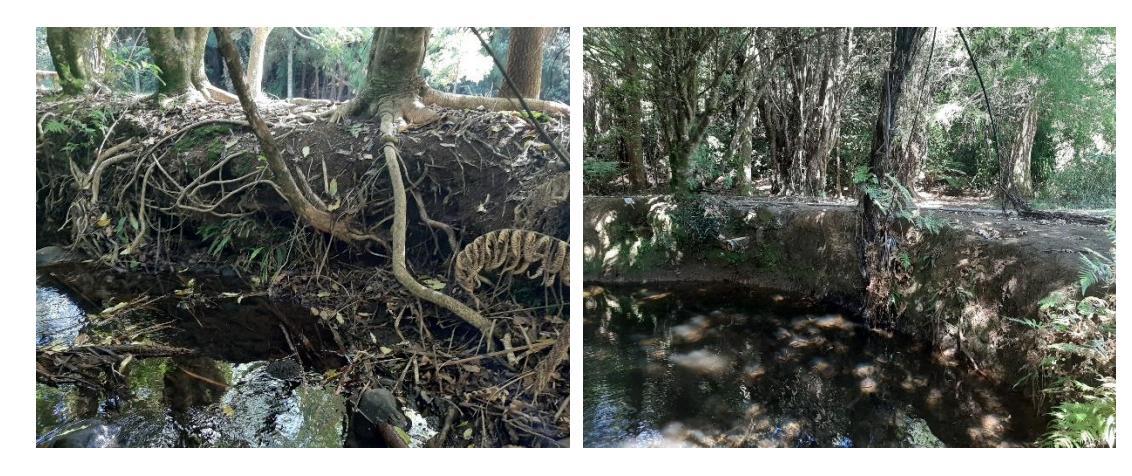
Figure 35 Example of undercutting with Segment 3-4 of Monitoring Site 1172_6, which was observed in numerous locations within the reach. Undercutting was interspersed with slumping, and lengths of reasonable stability

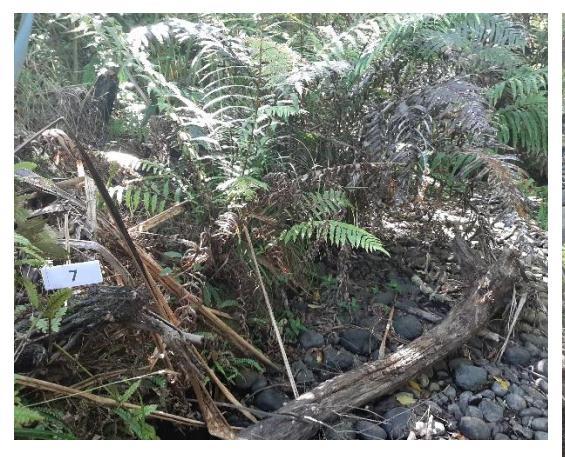
Figure 37 Typical particle size on a bar within segment 7-8 at Monitoring Site 1172_6.

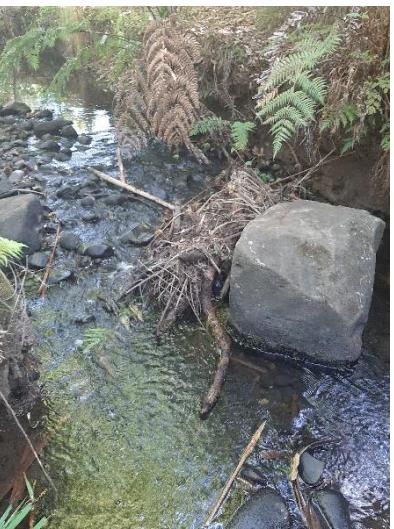
Figure 38 Example of particle size variations within Segment 11-12 at Monitoring Site 1172_11. Individual boulders were rare in this reach, with clasts predominantly pebbles and cobbles.

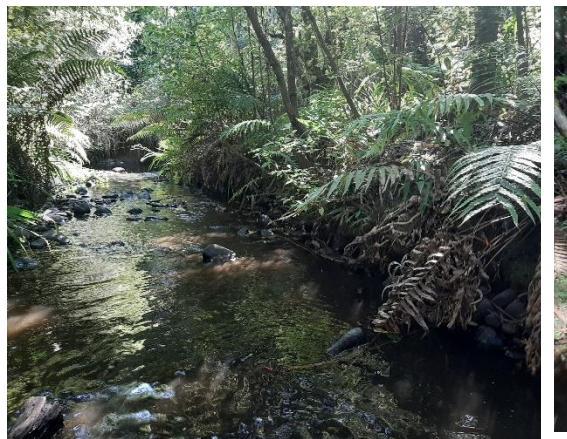
Figure 39 Segment 7-8 of Monitoring Site 1172_6 showing area with minimal wood pieces within channel

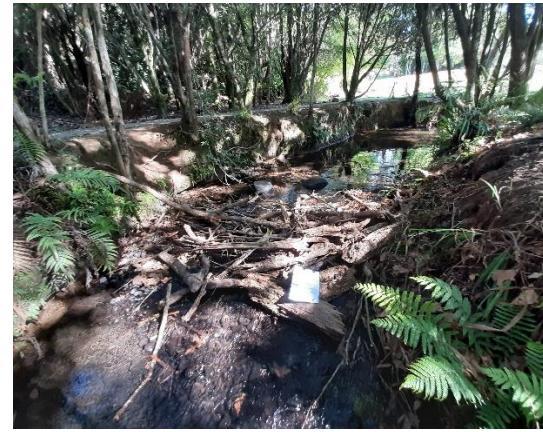
Figure 40 Wood raft located in Segment 9-10 of Monitoring Site 1172_6 comprising a range of wood piece sizes and located downstream of a large bend in the channel.

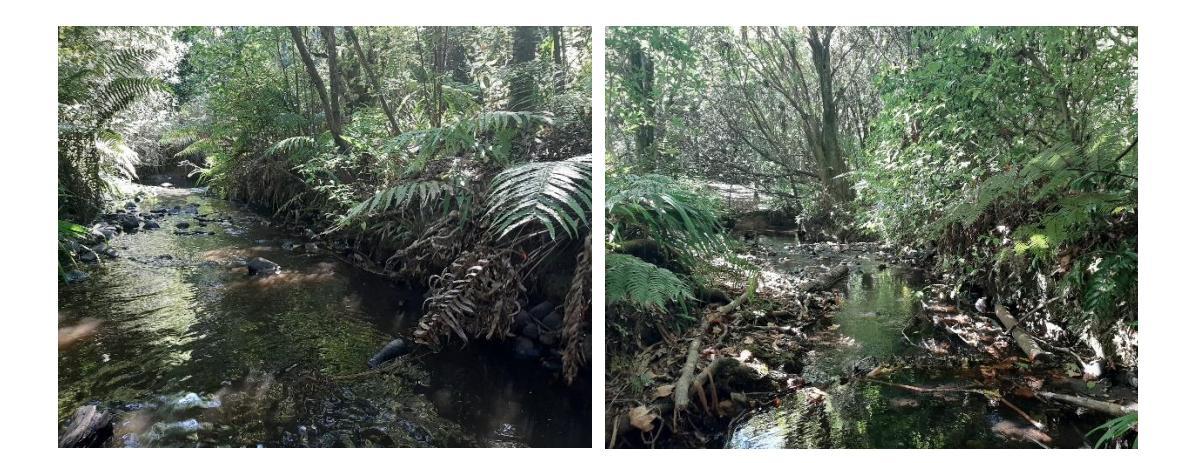
Figure 41 Representative view of Monitoring Site 1172_6 (Segment 7-8) showing predominance of pool, interspersed with riffle sequences and flow interruptions by way of clasts, a minor bar formation on the true left and evidence of armouring of the bank on the true right. Note some vegetation overhanging stream, and bank erosion is evident.

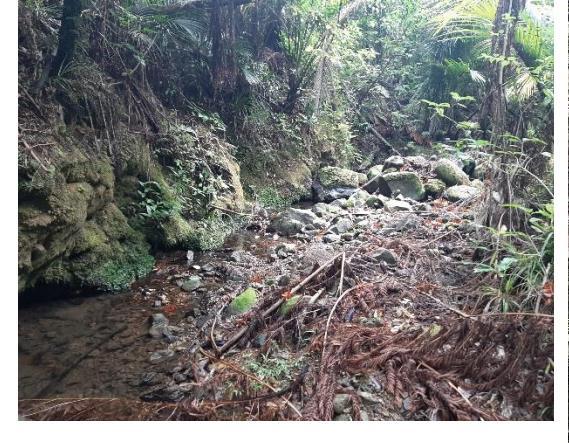
Figure 46 Bedrock bank and channel incision within Segment 5-6 of Monitoring Site 2080_1. Bed rock is pitted and not smooth – erosion occurring at varying rates along the length of the channel. Note the overhang of bedrock over the channel to the left of the photo – both the undercutting and pitting were observed throughout the reach.

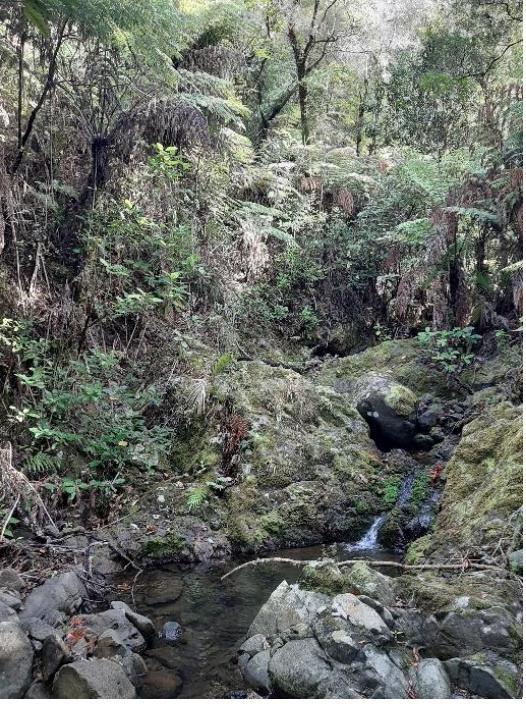
Figure 47 Steps created through erosion of the bedrock where the flow navigates a sharp elevation change over a bedrock outcrop within Segment 1-2 of Monitoring Site 2080_1

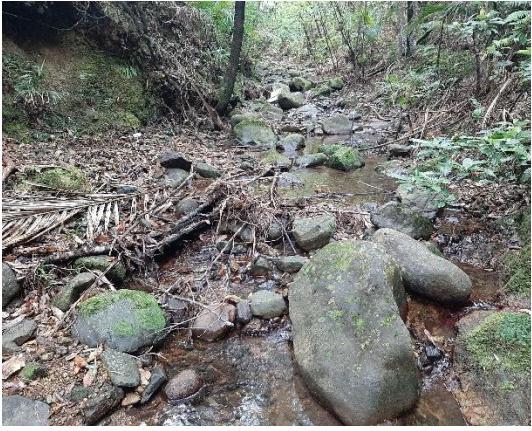
Figure 49 Typical wood loading within the channel -Segment 9-10 of Monitoring Site 2080_1.

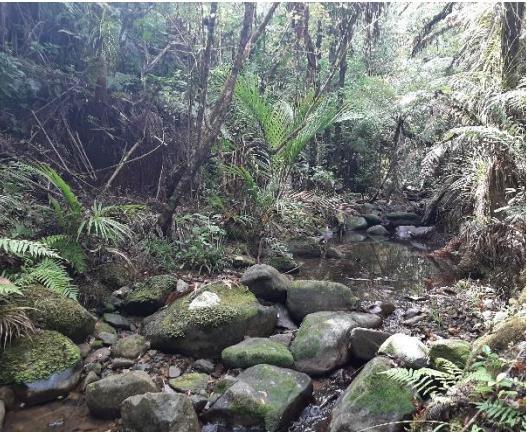
Figure 50 Significant log jam located in Segment 12-13 of Monitoring Site 2080_1. The collection of tree trunks and backed up debris exerts a noticeable influence on flow within the channel.

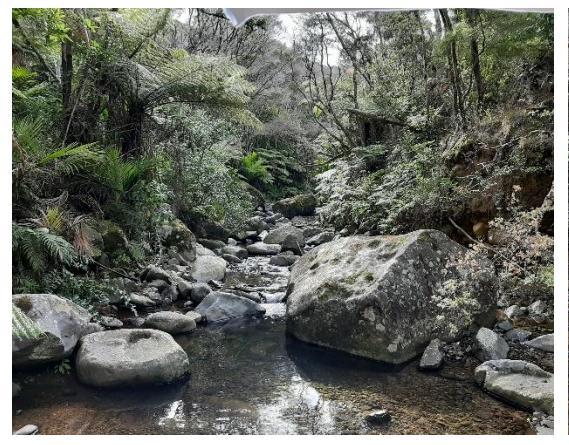
Figure 55 Erosion within Segment 4-5 of Monitoring Site 2079_1. Erosion concentrated around bank where flow deflected around large boulder within channel. Outside of this discrete location, it is evident the banks are relatively stable with little short term erosional processes acting upon them.

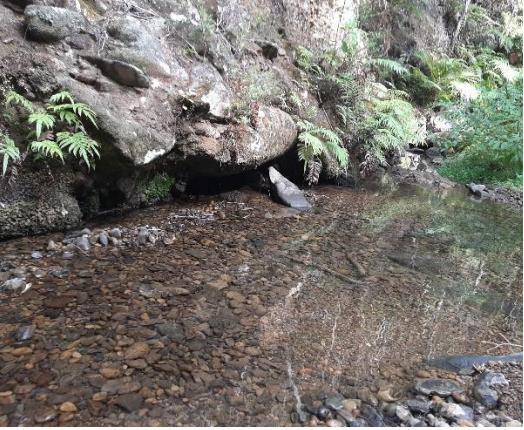
Figure 56 Undercutting of bedrock bank located at the convergence of the primary and secondary channels around an island for much of Segment 3-4 of Monitoring Site 2079_1.

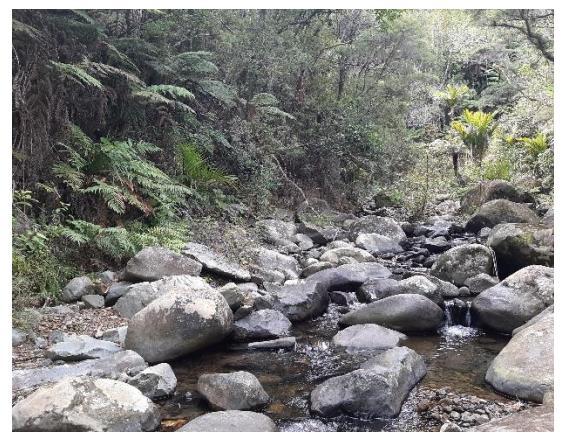
Figure 57 Typical clast distribution, exemplified in Segment 6-7 of Monitoring Site 2079_1. Looking upstream to the island located in Segment 7-8, very large boulders deposited on the island surface are observed

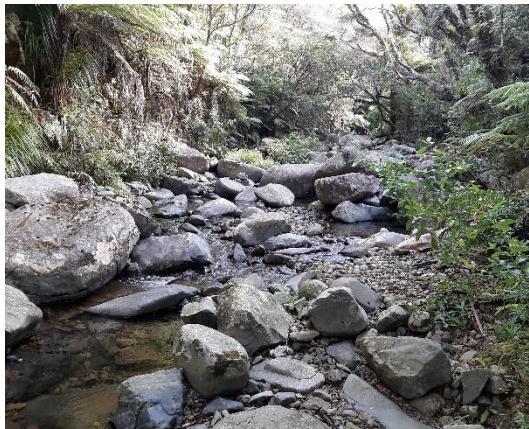
Figure 58 Typical clast distribution as shown in Segment 10-11 of Monitoring Site 2079_1.

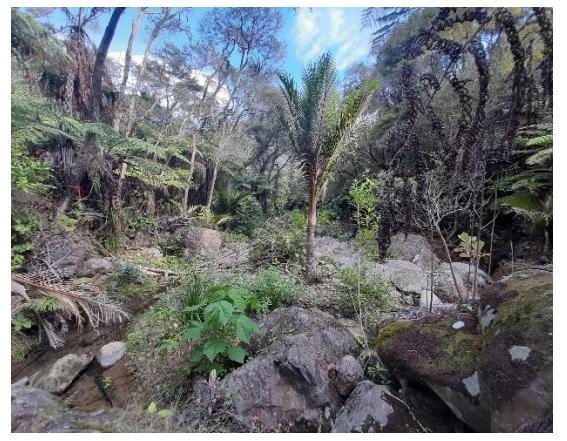
Figure 59 Multiple wood deposits on island within Segment 7-8 of Monitoring Site 2079_1. Likely evidence toward the high stream of the reach acting as a flush for the wetted channel, pushing larger wood pieces further downstream.

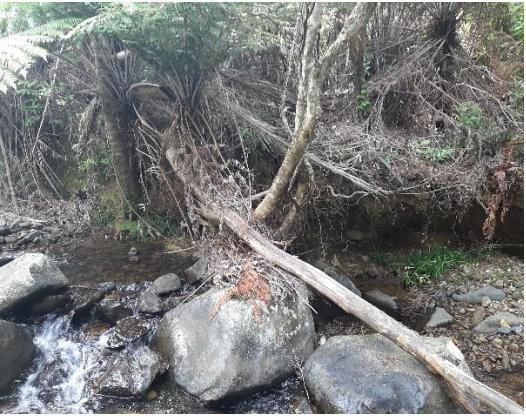
Figure 60 Low quantities of wood pieces found within reach as a whole – this branch and back up of woody and vegetative debris is located within Segment 3-4 of Monitoring Site 2079_1.

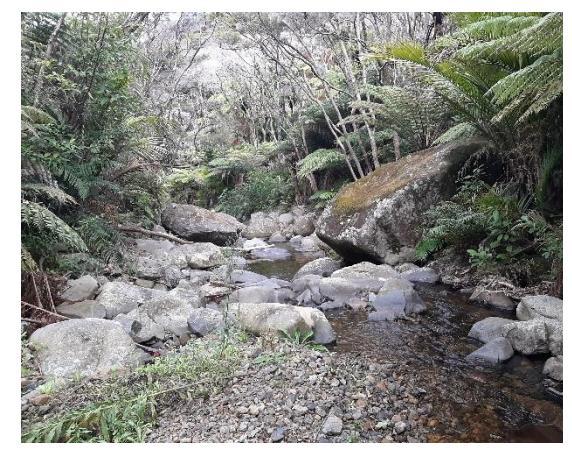
Figure 61 Variable geomorphic units within Segment 5-6 of Monitoring Site 2079_1, including massive individual boulders, lateral bars, pools and riffles (obscured by rocks, but evident by step change), and water depth changes.

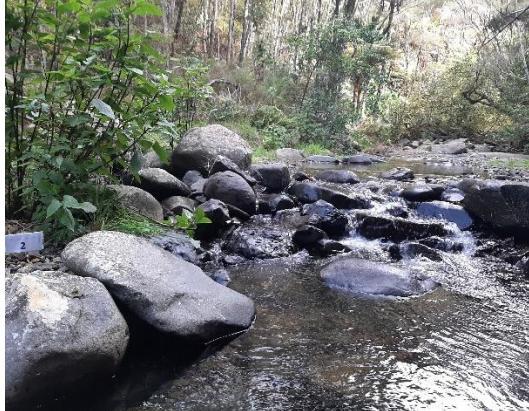
Figure 62 Step change within Segment 1-2 of Monitoring Site 2079_1; pools are located either side of the step change, which is made up of a range of clast sizes. In the distance, the island diverging flow into two chutes within Segment 2-3 is observed.

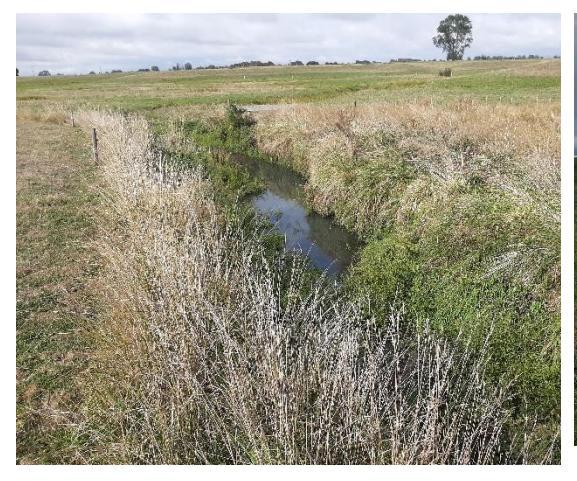
Figure 64 Typical channel located within Segment 4-5 at Monitoring Site 1262_18. Disconnected from floodplain, with no riparian zone and little geomorphic variation.

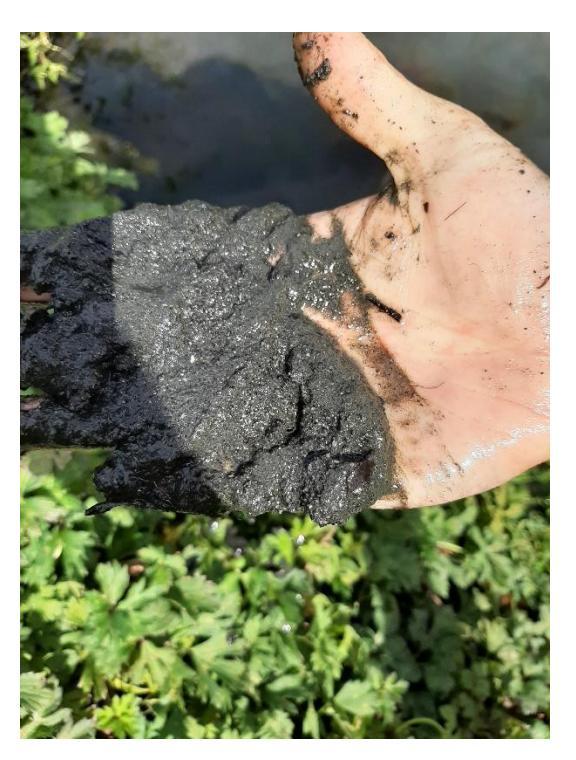
Figure 66 Example of material from channel, located from Segment 4-5 at Monitoring Site 1262_18. Sediment is uniform throughout reach. No larger particles were observed (i.e. pebbles or individual cobbles).

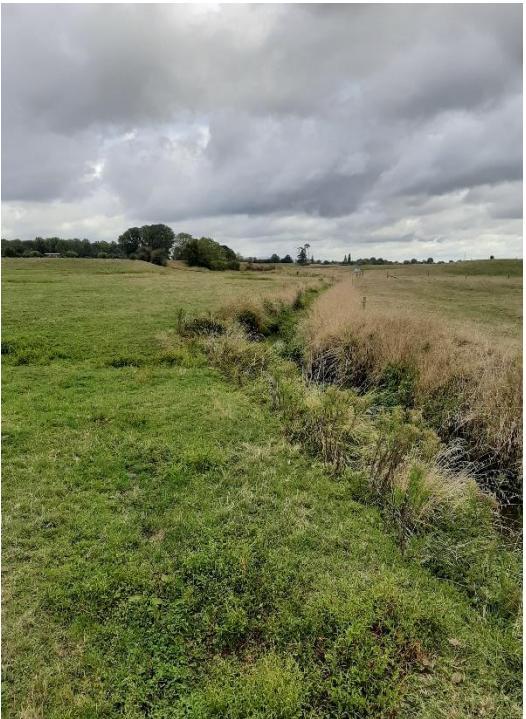
Figure 67 Waiwhero Stream looking downstream from Marker 13. The edges of the floodplain are visible to both the true left and true right. The floodplain reference conditions specify a kahikatea covering across the whole of the floodplain approximately 150 m wide.

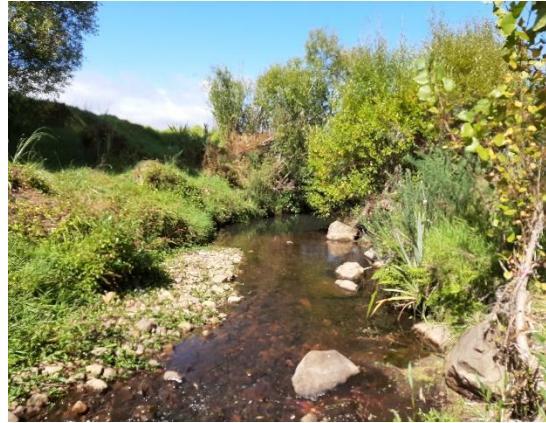
Figure 70 Typical channel geomorphology within Segment 1-2 of Monitoring Site 1307_18, downstream of artificial armouring. Presence of lateral bars, pools, individual boulders, with sloping banks, and vegetation overhanging in parts over channel

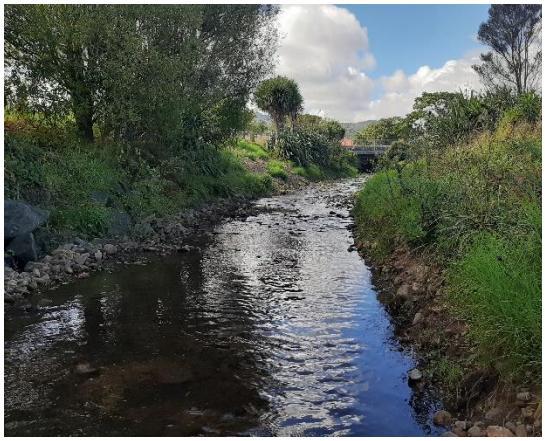
Figure 71 Lack of riparian zone evident in Segment 6-7 of Monitoring Site 1307_18. Gorse and exotic grasses are identified, along with flaxes and ti kouka.

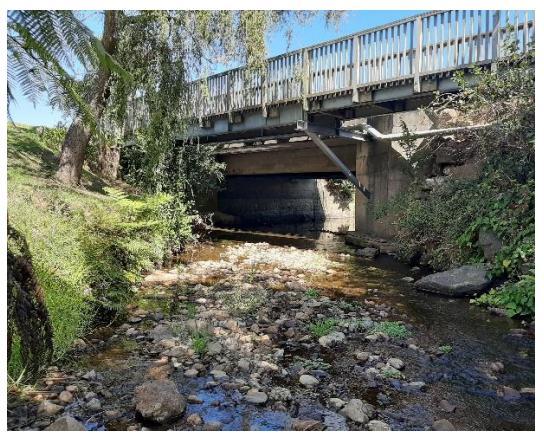
Figure 73 Particle size typified in Segment 8-9 of Monitoring Site 1307_18. Particles generally around 50 mm, with small pockets of coarse grained sands (> 2mm) and isolated cobbles larger than 50 mm.

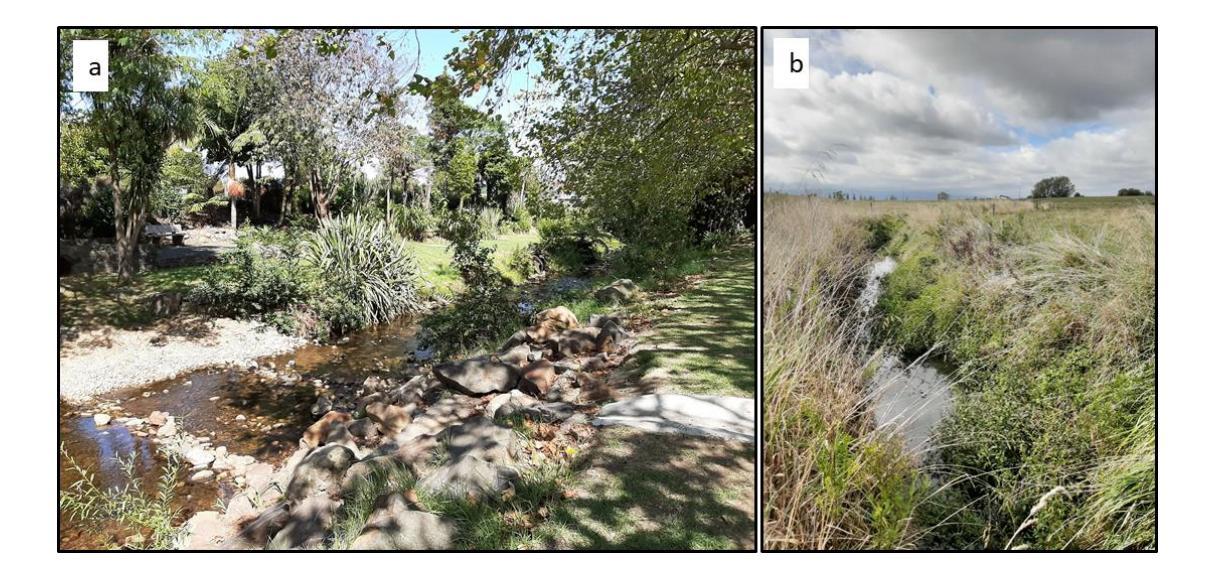
Figure 77 Differing geomorphological settings within the (a) Whangarahi Stream and (b) Waiwhero Stream, despite very similar reference conditions. Land use changes within the catchment are considered responsible for the stark change, as well as location within the catchment; whilst both are lowland reaches, the Monitoring Site for the Whangarahi Stream is near the ocean and with an upstream catchment including both forestry and agricultural land, whereas the monitoring site for the Waiwhero Stream is located a considerable distance inland from the firth of Thames within a large agricultural setting.
